Flood Risk Assessment

Wroxton Motocross

**Land at Manor Farm,
Balscote, Banbury,
Oxfordshire OX15 6HX**

**Report LL071
February 2021**

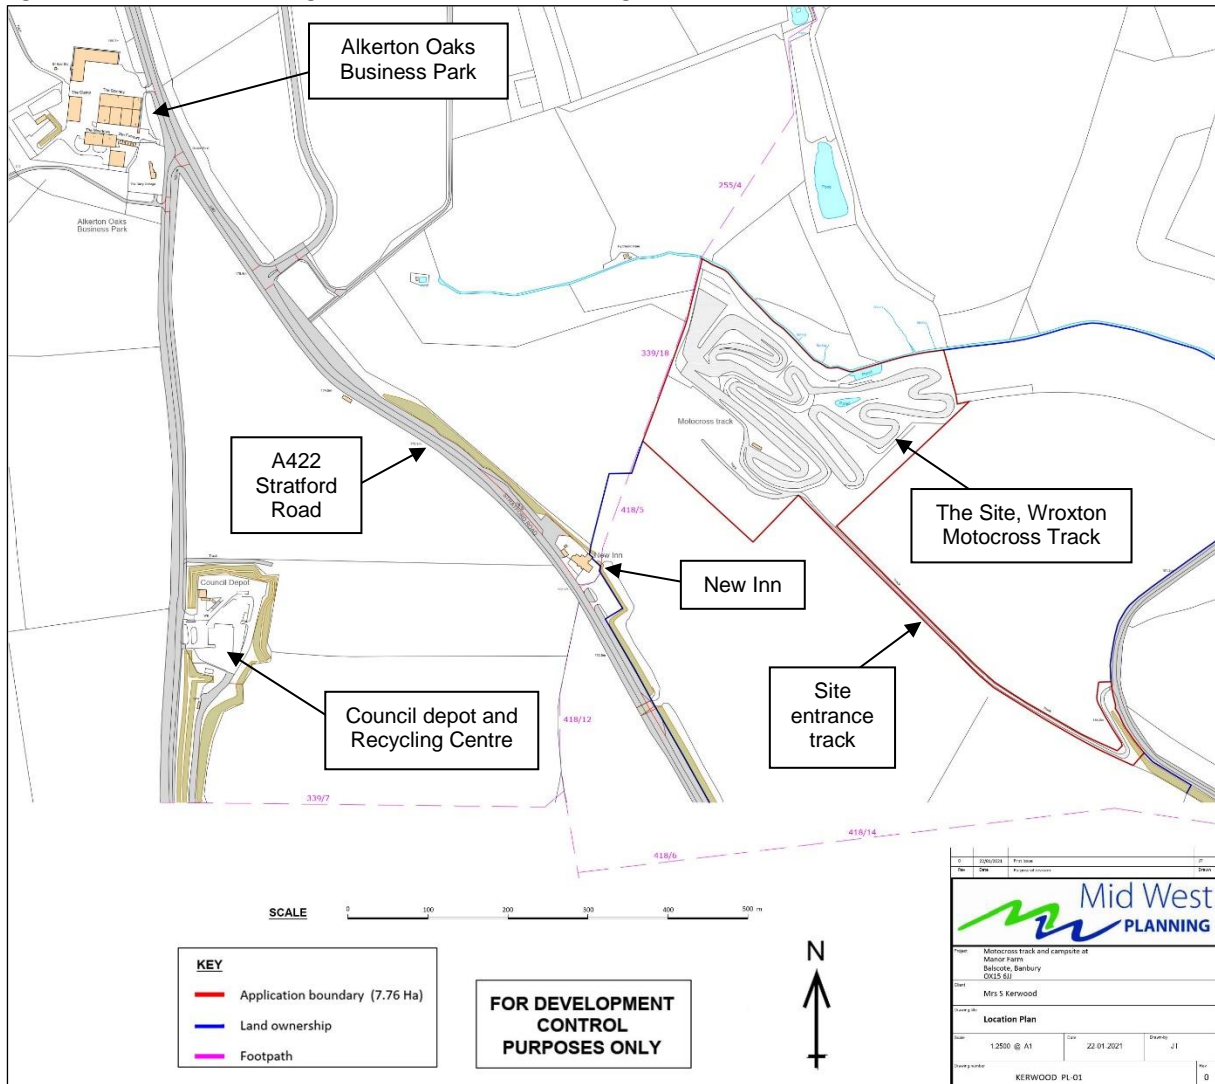
Figure 4 Location Plan, showing the site in relation to bounding features

The location of the site is shown in Figure 4, together with bounding roads, buildings and field boundaries. The application area is delineated in red, with other areas within the ownership of Manor Farm being located within the blue line boundary.

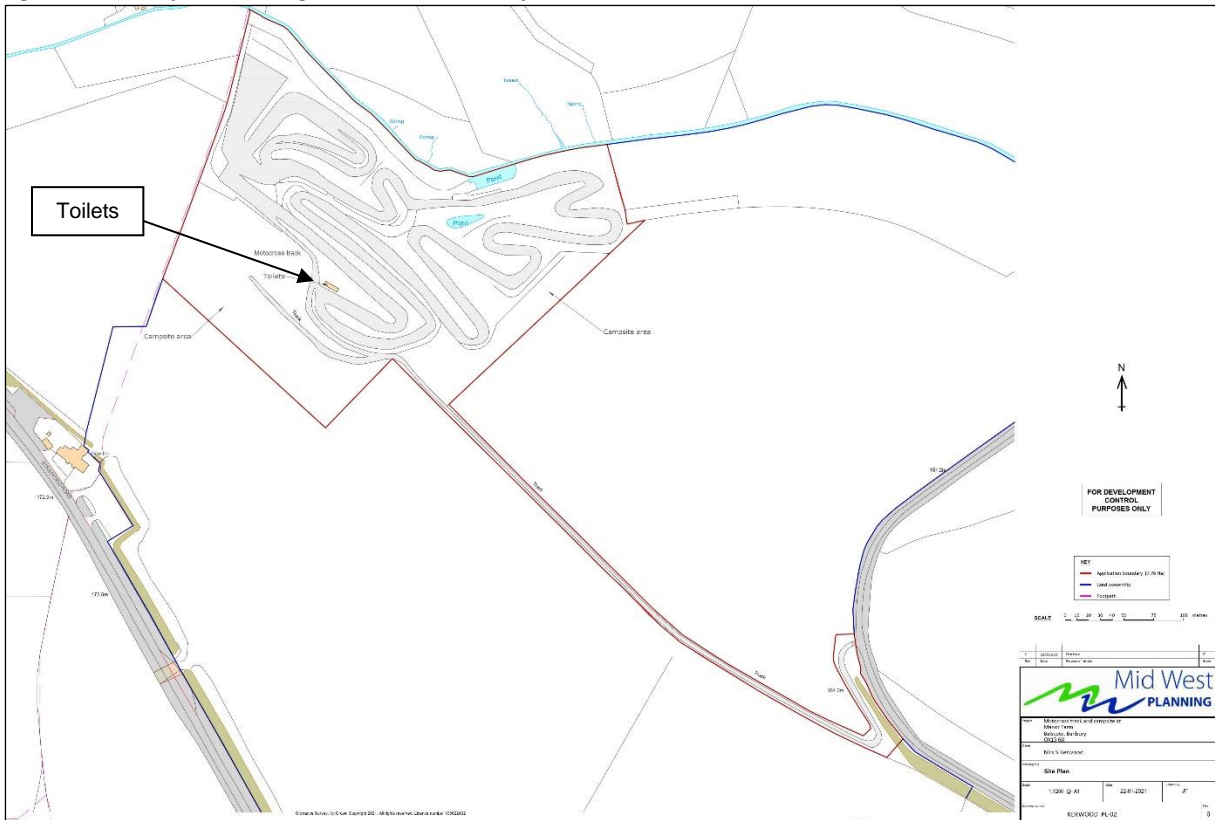
Figure 5 The site plan, showing the red line boundary and features of the track

The Wroxton Motocross Track, referred to within this report as “the site”, is mapped in more detail in Figure 5, while detail of the existing and proposed planting is shown in Figure 6. Both Figures also show the locations of two small ponds on the site and the stream which forms part of the site’s northern boundary. Although agricultural land use is regarded as having low vulnerability, “outdoor sports and recreation” is classified as “Water Compatible”³ and therefore appropriate in areas with a relatively high flood risk.

The only built structures shown on the site plan (Figure 5) are a small group of toilets (portaloos) near the south west of the track area and visible in Figure 25. A number of small wooden shelters were noticed at various locations around the track similar to that shown in Figure 22. These are observation shelters, for the use of officials during race days. The surface area of the structure shown in Figure 22 was not measured but is probably in the order of 2 m² or 3 m², about that of a small car. Runoff from structures such as these and the toilets are likely to be negligible, *de minimis*, having a minimal impact of runoff within the site or elsewhere. Such structures are already managed as part of the drainage design across the whole track area (see below).

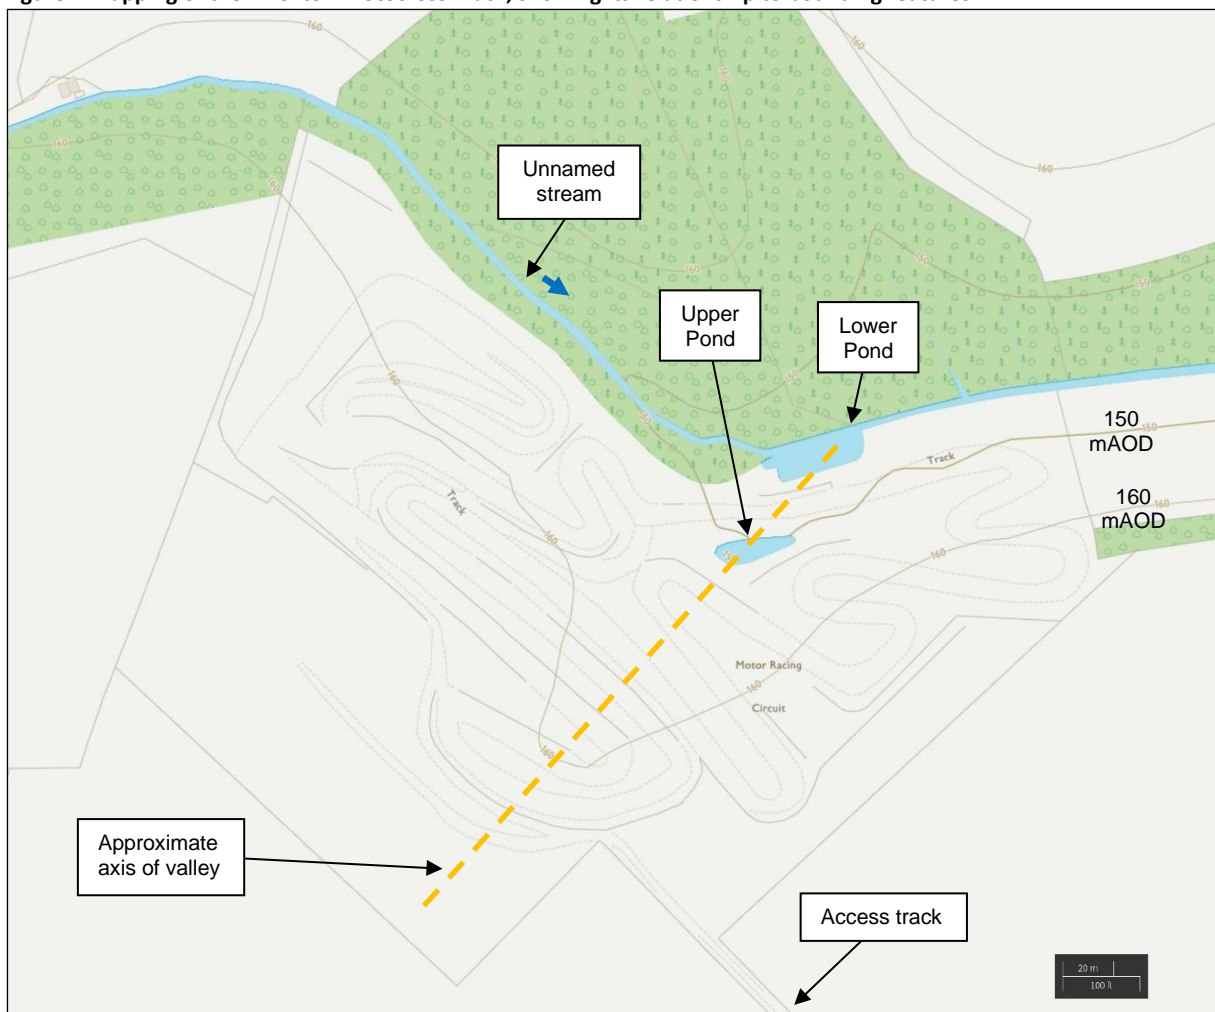
Figure 7 Mapping of the Wroxton Motocross Track, showing its relationship to bounding features

The layout of the site is shown on OS mapping (Figure 7) as a convoluted track, labelled as “Motor Racing Circuit” on the map, located south of woodland. A stream crosses the area approximately from west to east, whose eastward continuation is shown on OS mapping as “Ragnell Bottom”. As shown in Figure 7, the stream flows some 10 m within the woodland margin, before emerging into a small pond. The stream’s eastward continuation follows the woodland margin. A smaller pond is located to the south of the woodland fringe, roughly on the 150 m contour. The ponds are referred to in this report as the “upper” and “lower” ponds, in reference to their relative heights above ordnance datum (AOD).

The 160 m contour is also shown on Figure 7, cutting the racing circuit as a broad, open valley. It is noticeable that the only stream shown on OS mapping is the stream identified above as a headwater of Ragnell Bottom, flowing close to the woodland’s southern margin. No other stream is shown on OS mapping and none was seen during the site visit. The approximate axis of the valley is marked as a dashed orange line over the map and on the air photo (Figure 7, Figure 8).

As described in Section 3.1, no stream could be identified along the axis of the valley through the site (Figure 7) and the track and retaining slopes evidently hold any such flow back, in a manner similar to a series of terraces. It is clear from the air photo (Figure 8) that sections of track which cross this axis are perpendicular to it or nearly so. In places, the surface drops almost vertically, as it does above the two ponds (Figure 13, Figure 14). Some sections of track are steeply embanked, to form slopes which end in swales (Figure 23). These allow infiltration and convey excess water to where it can be managed, at the upper pond. Except for the crest of hill sections, it can be seen from photographs of the track eg. Figure 9 and Figure 23, that all the track is cut below the landscape surface, the area covered in grasses and low-lying plants in these photographs.

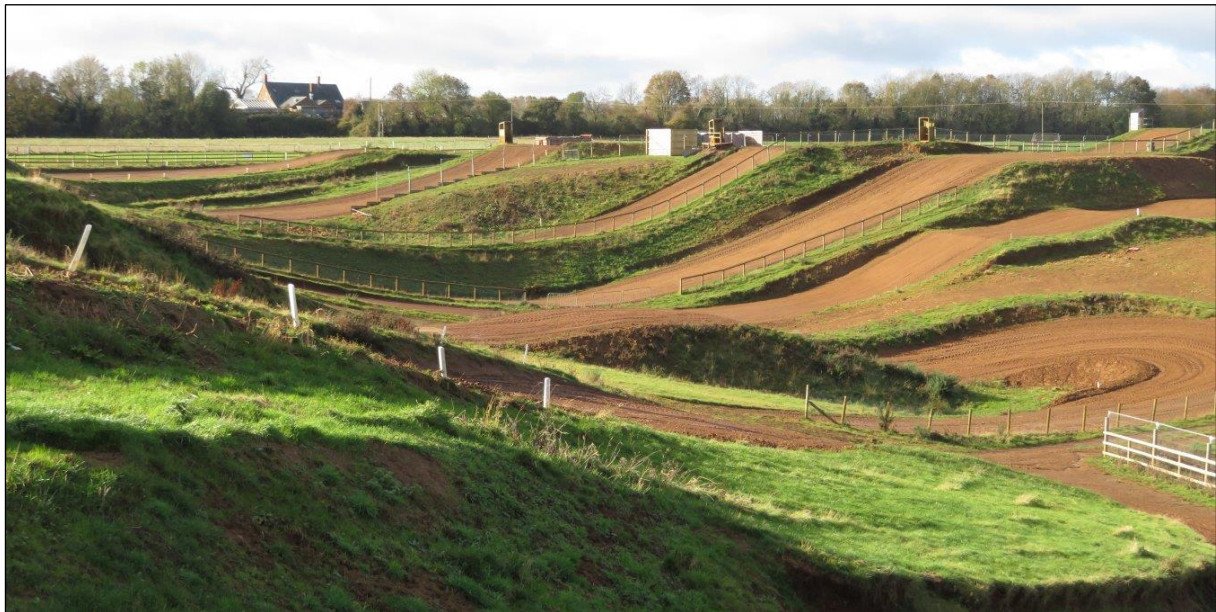
Figure 9 Viewed across the broad valley, the track is bounded by strips of grassland, generally raised above track level

Looking obliquely across the site from the east, Figure 9 shows the track, perpendicular to the valley axis and generally below the bounding vegetated surface. No stream is visible in Figure 9. The existing relief makes the track more challenging for the motocross riders, although straight sections of the track are relatively flat in cross-section. The descent from south west to north east along the axis of the valley occurs mainly at the grassy strips, that divide the sections of track between them in the manner of terraces.

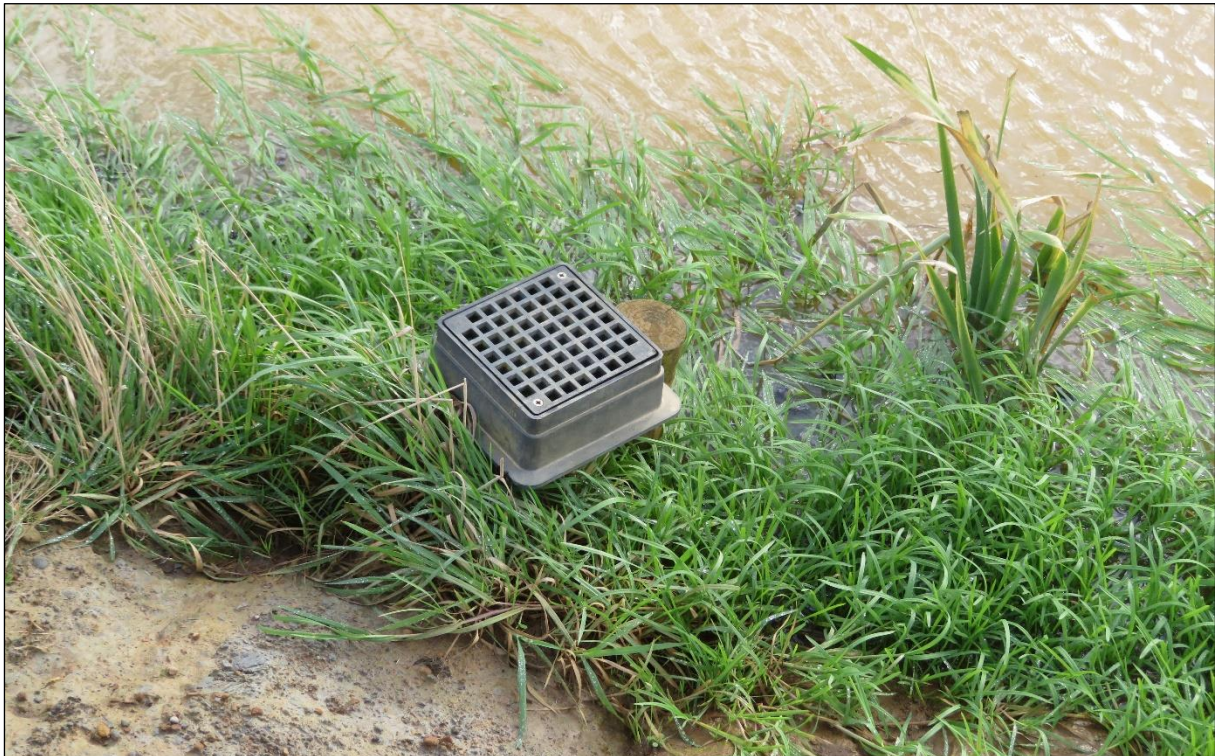
Figure 16 Overflow from the upper pond, installed as a precaution against blockage or exceedance of the outflow

All the flexible plastic pipes shown in these photographs and all those set underground have a 150 mm diameter. Mr. Pounder explained that he initially used 100 mm pipes but found that they were surcharged during high flow events. The larger diameter was installed a few years ago and has so far managed to convey the necessary flow. This system is considered below in terms of groundwater flood risk (Section 5.3) and sediment movement through the site (Section 7). The relationship between the two ponds can be seen from Figure 17. Water level in the upper pond was shown in Figure 10 as 149.75 mAOD and in the lower pond as almost 5 m lower at 145.02 mAOD. These values are expected to vary but a 5 m height difference can be regarded as a likely maximum.

In addition to inflow from the headwaters of Ragnell Bottom, the lower pond receives inflow from the south (Figure 13), derived from the upper pond (Figure 14, Figure 15). In addition to the outflow in Figure 15, an overflow is located near the pond's northern margin (Figure 16). Comparison of Figure 15 and Figure 16 indicates that whereas the pond's outflow offtake (Figure 15) is at the water surface, the pond's overflow (Figure 16) is set above that level. It follows that if the water level reaches the overflow then either normal outflow rates are being significantly exceeded or there is blockage in the outflow pipe (or both). As well as providing relief for flow exceedance, the emergency overflow may warn of blockage. These facilities have been installed and maintained by Mr. Brian Pounder of the Banbury Motocross Club, who kindly provided further detail of the drainage system and how he has maintained it, to preserve the track and mitigate runoff, including the discharge of sediment.

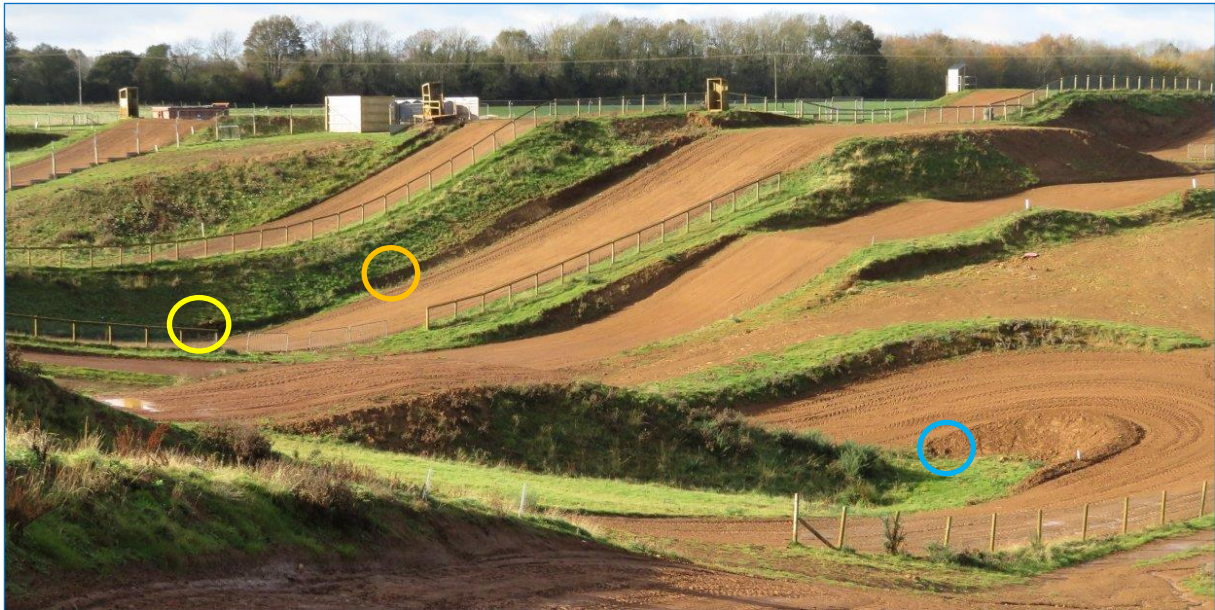
Figure 25 The yellow and orange circles locate springs. A pipe emerges in the blue circle, within the hairpin bend

An area to the southwest of the track was identified by Brian Pounder as almost always wet. He also located the “main spring”, on Figure 24, within the yellow circle in Figure 25, where water reaches the surface almost all the time. Within the orange circle, Mr. Pounder reported that a spring started to flow one day but that flow there is lower and more erratic. Spring flow is collected and piped beneath the track to the area within the hairpin bend, emerging within the blue circle in Figure 25, before being conveyed by another pipe to the upper pond.

The system described above manages sediment discharge from the axis of the valley that passes through the centre of the site (Figure 8, Figure 25) and its catchment. There remains a part of the track that is not currently managed in this way and this Section of the report covers recommended management of sediment in this area. Having visited the site on a rainy day, Mr. Nigel Baskerville took the photographs shown in Figure 28, Figure 29 and Figure 30, we are grateful to him for permission to reproduce them here.

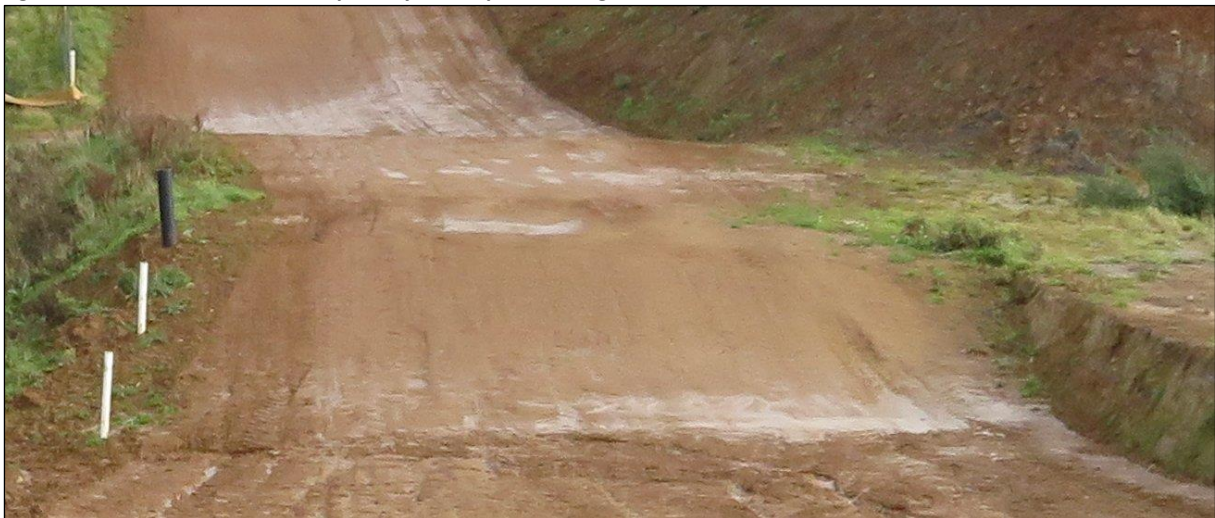
Figure 26 Water accumulates temporarily in low points along the track

The effect of motorbikes and riders repeatedly travelling around a dirt track is to mobilise some of the surface material and also to mechanically break up the aggregates (clods) and possibly even the grains themselves. The track was visited on a dry day but after rain the night before. Puddles were seen on the access road and the surface of the track was seen to be well graded but with water and mud within the low points (Figure 26) and tyre-tracks (Figure 27). Another rainstorm would mobilise much of this material, some of which would be discharged along with the water, through the drainage system.

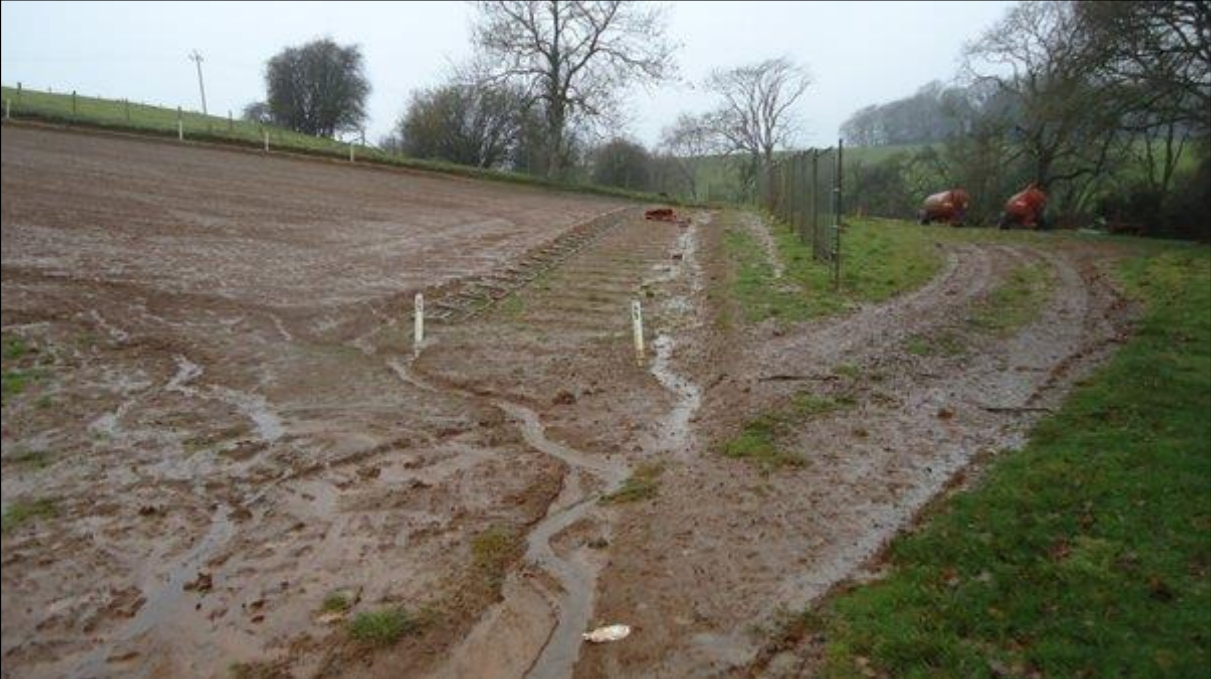
Figure 28 The motocross start line, at the base of a steep section of track

Figure 28 shows the starting grid in the centre of the shot, with the first straight section of track angled up to the left. The service road on the right has evidently been damaged by the passage of runoff over its surface, forming a rill in the foreground of the photo. Looking further east along the service road (Figure 29), runoff is carried within similar small channels, set either side of the road surface. This photo shows the start of a raised area that forms the track margin at this point and is labelled in Figure 29. At about this point, flow follows the local slope, turning towards the north, where it is free to drop into the valley of the headwater stream (Figure 30). The moderate runoff shown in these photographs is unlikely to convey significant sediment, leading to relatively clean water dropping into the valley. High intensity rainstorms could carry a much higher sediment load and should be managed accordingly.

Following discussion with the course manager, Brian Pounder, a solution has been identified that would mitigate such runoff, ensuring that only clean water can be discharged into the valley. The scheme is represented on the topographic map in Figure 31, where outflow from the starting grid shown in Figure 28 is represented by a small blue arrow. From there, set along the service road's northern margin, a series of swales have been located to intercept runoff and convey it off the road. Five such swales are shown, interspersed with barriers shown on Figure 31 as a raised margin to the road and there to prevent runoff from flowing between the swale segments, which are aligned with the contours.

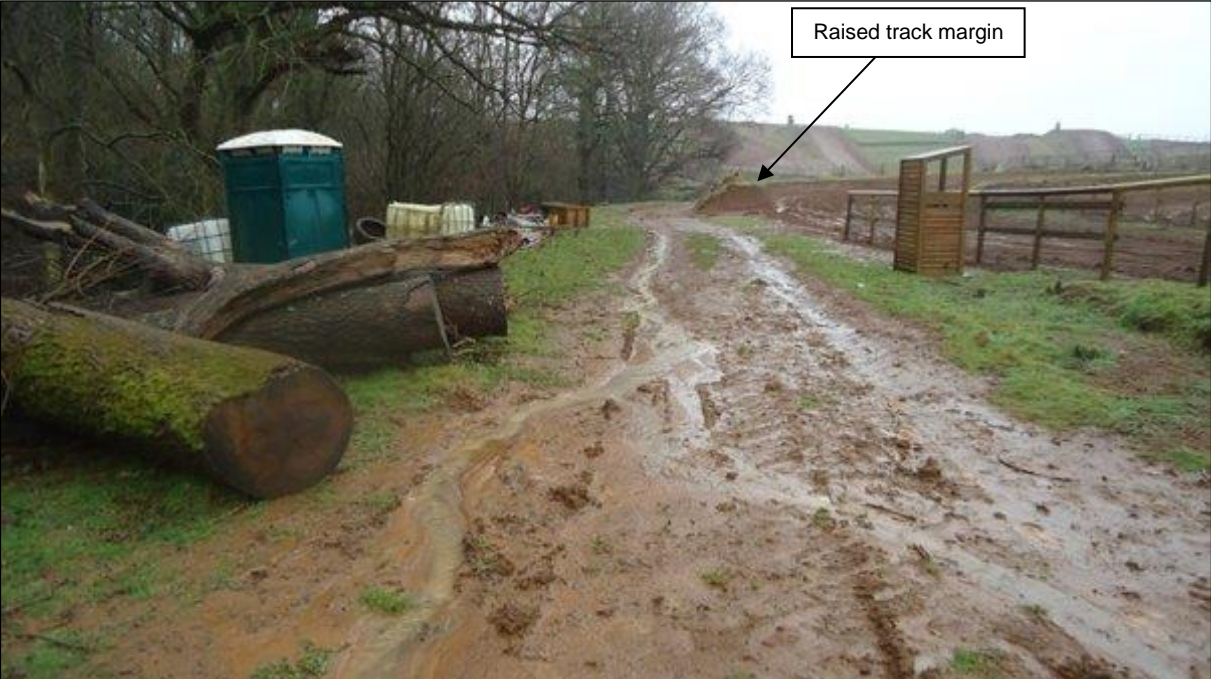
Figure 29 Runoff from the start line, follows the service road towards the east

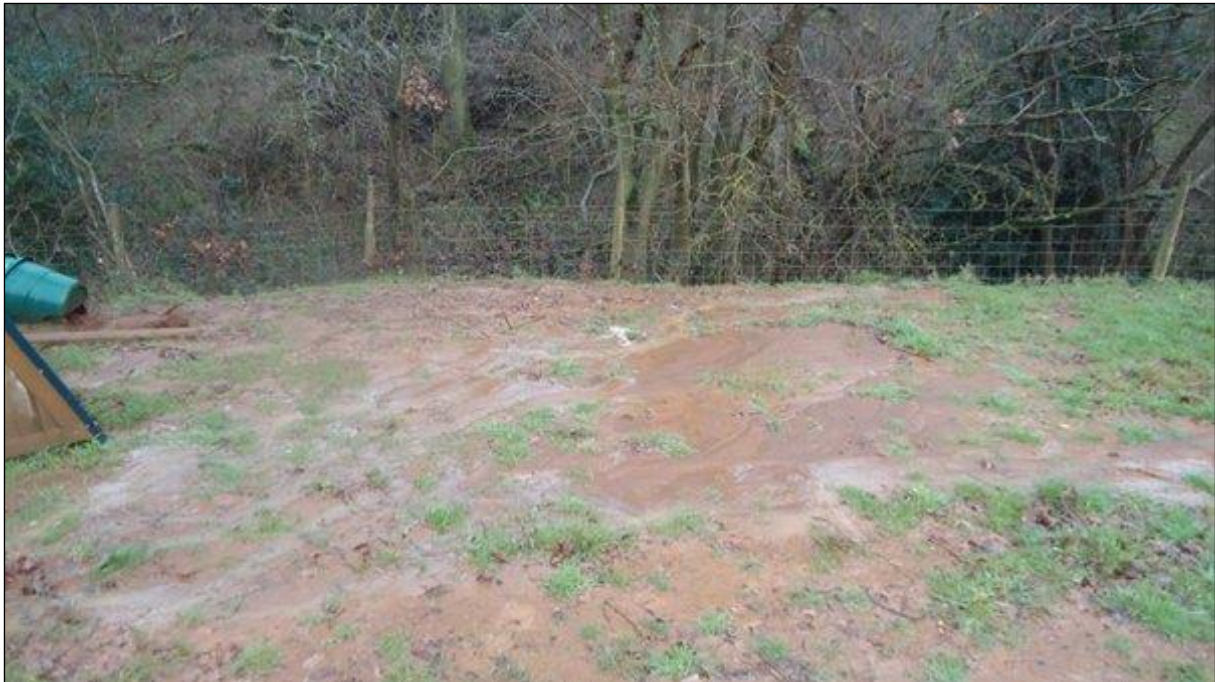
Figure 30 Runoff from the track could convey sediment into the stream valley

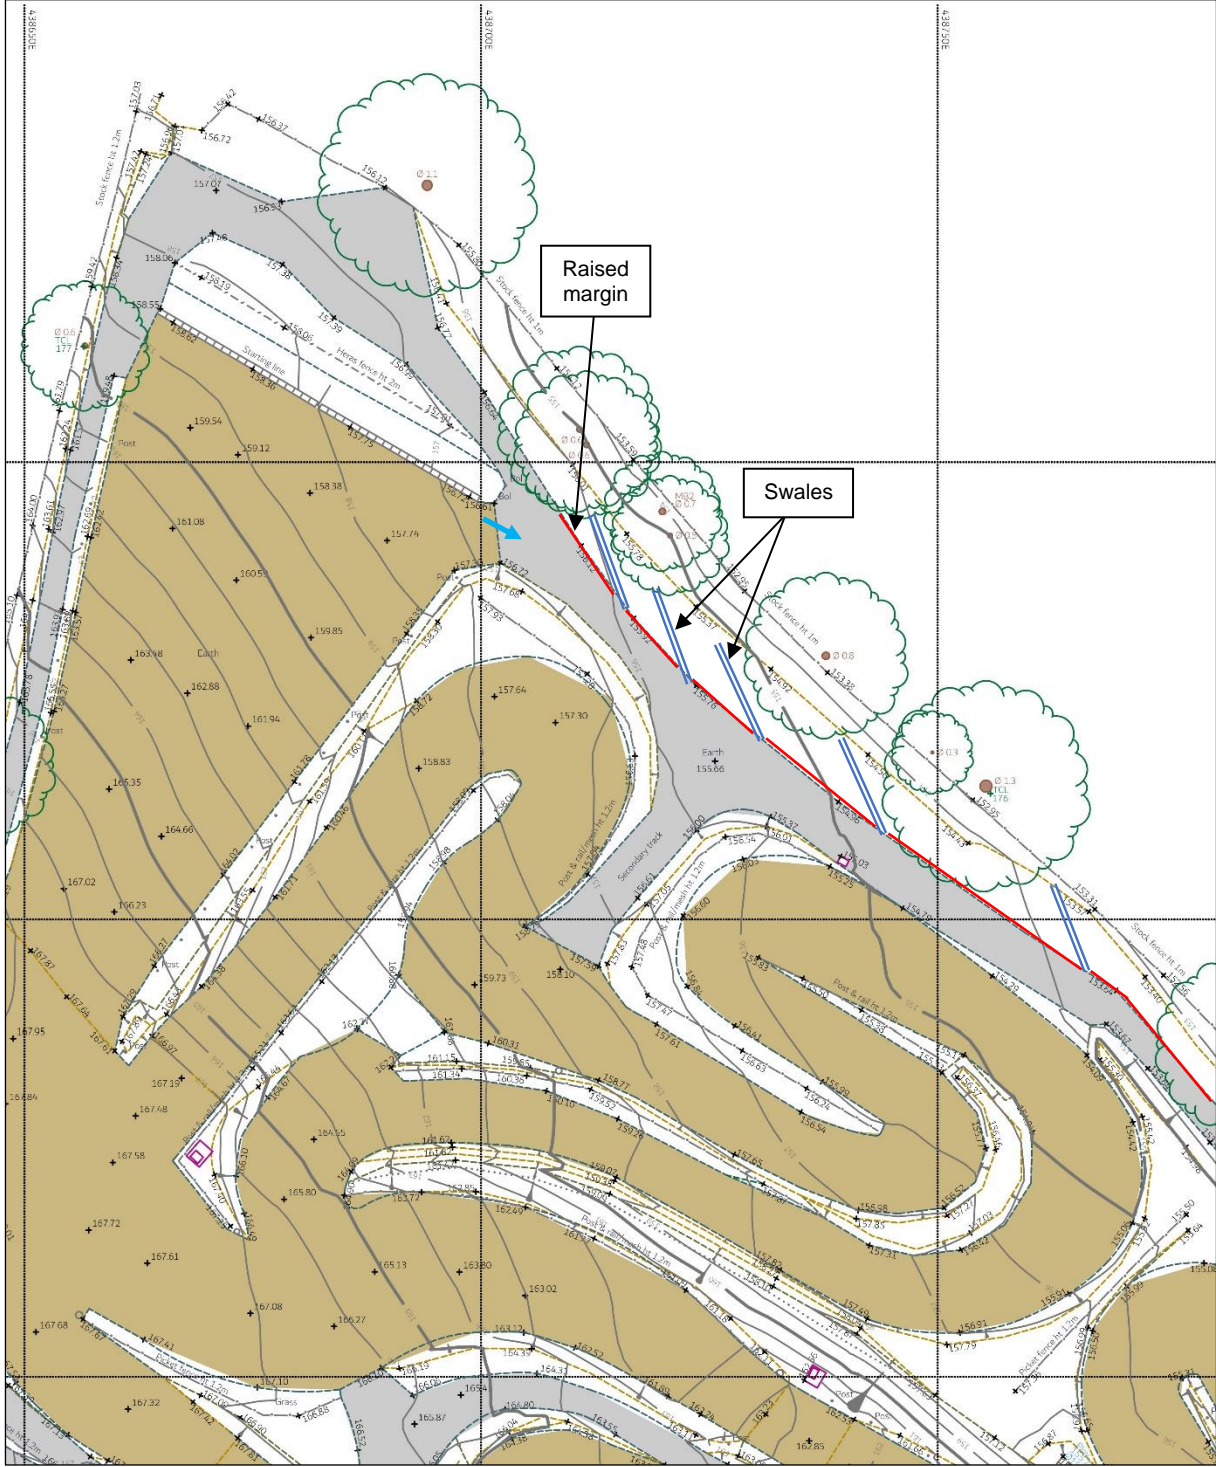
Figure 31 Recommended sediment control measures, along the track's north eastern margin

An important consideration is the root zone of the bounding woodland. It can be seen from Figure 31 that the proposed swales have been located between the mapped crowns of the bounding trees, which approximately defines the edge of the root zone. A more precise measure is provided by the diameter of tree trunks and there should not be a problem in defining suitable locations and limits to the proposed swales. These would be cleaned out on a regular basis, possibly annually, by mechanical digger. Mr. Pounder suggested this scheme, which he would welcome as an addition to his programme of regular maintenance.
