CULTURAL HERITAGE IMPACT ASSESSMENT

Ivy Cottage, Bodicote, Oxfordshire

Date 2nd November 2021

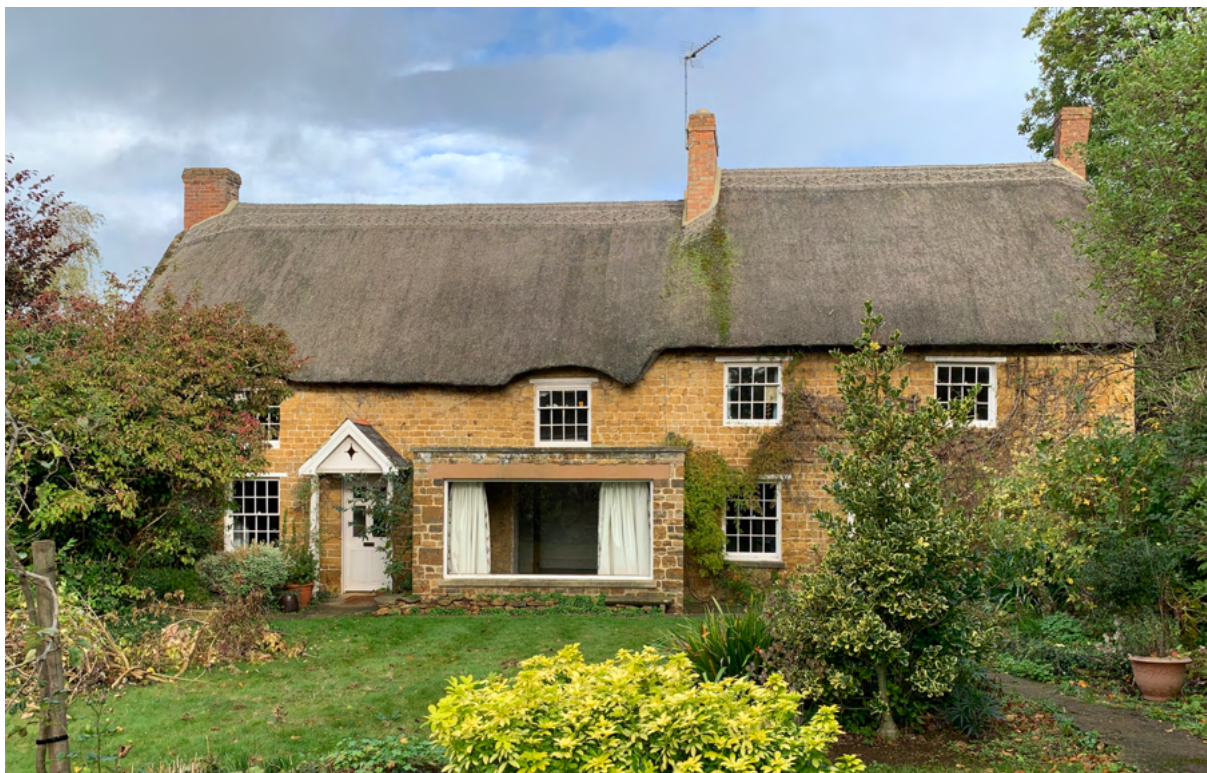
Fig. 1, Ivy Cottage south front

The front elevation (facing south onto the garden) provides clear evidence of the original two cottages (Figs 1 and 2).

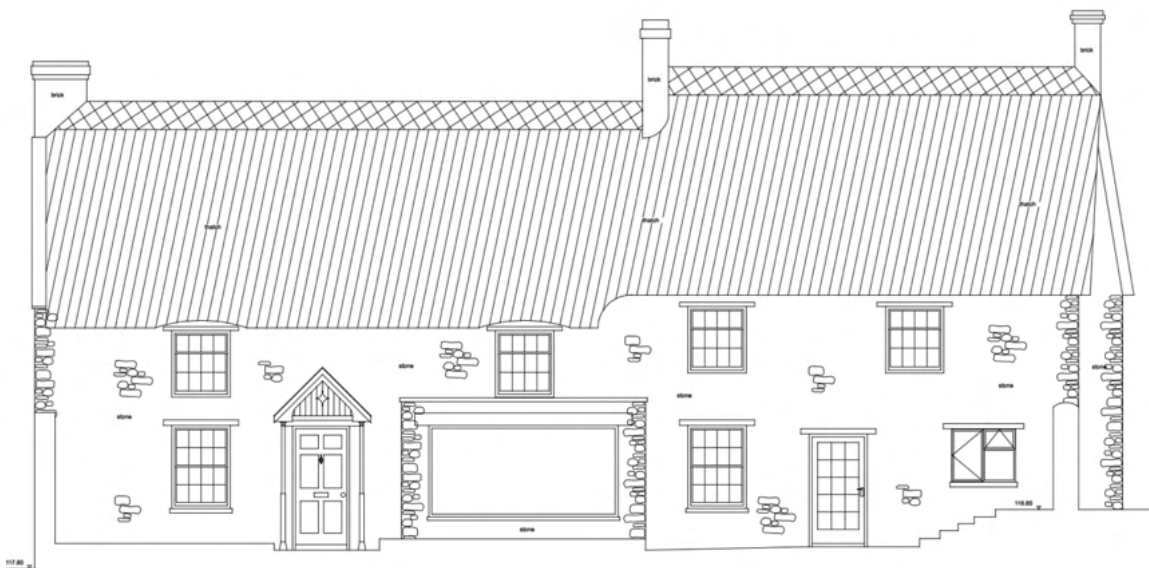
Fig. 2, Ivy Cottage existing front (south) elevation ©SJB Surveying

The western cottage is rectangular in plan and one and a half storey. It has a slightly off-set front entrance under a tiled, gabled porch, with 16-pane sash to one side (all windows are white-painted timber) and the modern extension to the east. Photographs supplied by the client show the extension replaced a square angled bay window, which itself is likely to have been a replacement for a plain sash opening (likely similar to that on the west). There are two windows at first floor/attic level, both 12-pane sashes. The three windows are set back and possibly early C19th as they lack the distinctive later horn on the upper sash. They appear to contain historic glass (again this is the case for all the sash windows).

The eastern cottage is also rectangular in plan, but shorter and taller (being a full two storey with attic above) than that to the west. It is accessed through a central doorway, again with a 16-pane sash to one side and two 12-pane sash at first floor. As with those to the west the windows lack horns but contain historic glass so are likely to be contemporary. To the east of the door at ground is a C20th timber casement off-set from the other openings.

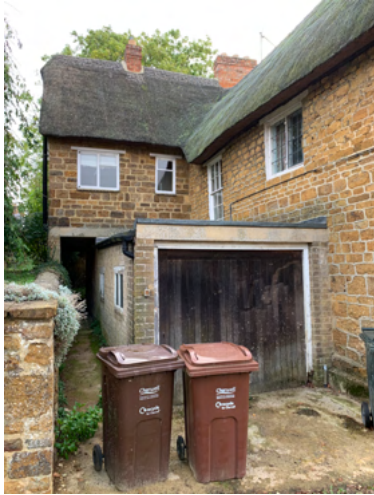
Fig. 3, The modern rear extension.

The rear, northern elevation is mainly taken up by a substantial modern extension located central to the original cottages (Fig 3). Parts of the original fabric are visible at the western end ground floor and first floor, where there are two windows, a metal casement with leaded lights, and a large 15 pane sash giving light onto the stairwell. Original fabric is also visible to the west with two windows at ground floor level, a double and fixed timber casement, both likely C20th.

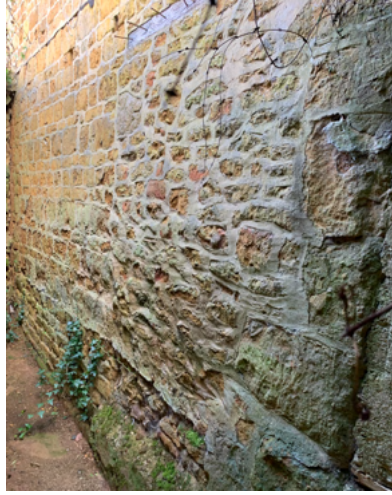
Fig. 4, The chopped and blocked bread oven within the western gable end.

The western gable end has no existing opening and is partly obscured by the boundary wall, although behind this evidence can be seen for the back of a bread oven which has been chopped back and filled, presumably when the boundary wall was constructed (Fig 4).

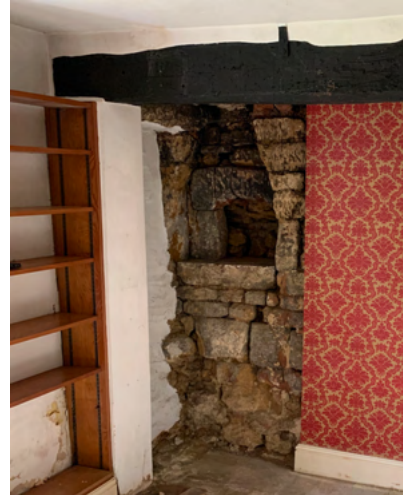
Fig. 5, The interior face of the bread oven with the sitting room fireplace.

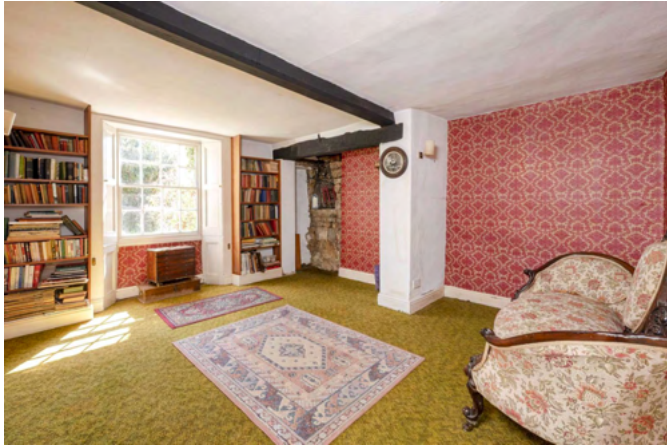
Fig. 8, The current sitting room ©Savills

To the rear of the lobby, to the left of the stairs a door opens to the current sitting room (Fig 8), a sash window to front with shutters and paneling beneath. The ceiling is probably lath and plaster, the joists supported by a longitudinal timber beam, and the floor limestone flags (Fig 9, probably laid on bare earth). A fireplace in the western wall is largely obscured by plasterboard although the timber lintel survives and there is a bread oven at the rear (although this has been chopped back externally –see above, Figs 4 and 5). The partition between this room and the entrance lobby/stairwell appears to be historic, but may be a mixture of builds, some parts stud walling, some parts solid wall. It is unlikely to be original to the earliest cottage and probably, like most of the partitions (at ground and first floor), dates to the amalgamation of the two cottages.

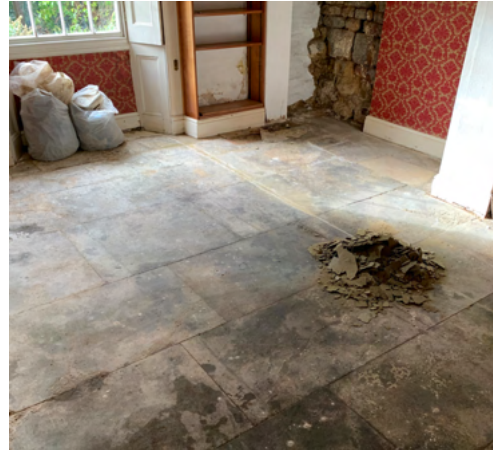
Fig. 9, The newly exposed flagstone floor

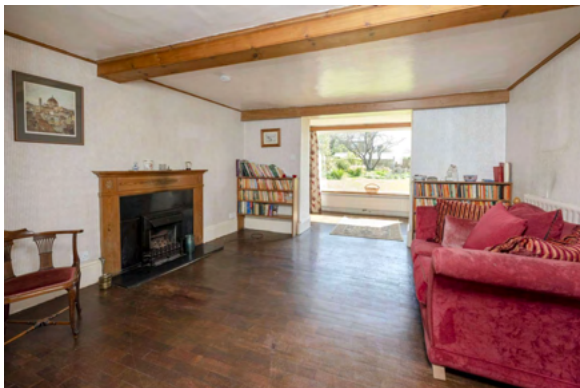
Fig. 10, The current lounge with modern extension beyond. ©Savills

The current lounge is accessed off the rear corridor (Fig 10). While the western partition was likely part of the amalgamation works, and the eastern wall is the original solid wall dividing the two cottages, much of the visible fabric is recent, probably put in place when the front extension was constructed (including the two short sections of stud wall separating this room from the corridor –see Fig 28). A possibly original, but boxed-in (and therefore not visible), longitudinal beam supports the ceiling/first floor, but the ceiling itself is plasterboard. The floor is timber parquet. There is a modern gas fire in the eastern wall, the flue being cut into the back of a chimney on the other side (in the dining room).

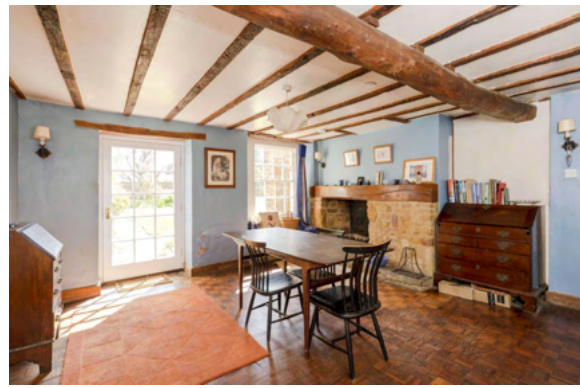
Fig.11, The current dining room. ©Savills

Also accessed from the rear corridor is the dining room (Figs 11 and 12). There is a sash window and modern timber door to front and a modern opening (to the extension) and casement to rear. The ceiling is exposed joists supported by a longitudinal beam. The floor is timber parquet. A fireplace in the front left corner, within the western wall of the eastern cottage, is now largely modern but preserves the location of the original (there may be more original fabric behind plasterboard). This western wall is much altered, partly re-built in brick, with an opening having been made though it at amalgamation, and probably a brick pier inserted to take the load of the timber beam. The eastern end of the room is marked by a partition with the kitchen (Fig 12). This is a solid wall, aligned with the eastern gable end and so slightly out of alignment with the front and rear walls. The joists also respect this gable end alignment although the supporting beam attempts a compromise between the two. It's possible that both the beam and the joists are secondary and there may have been some remodeling when the two cottages were amalgamated.

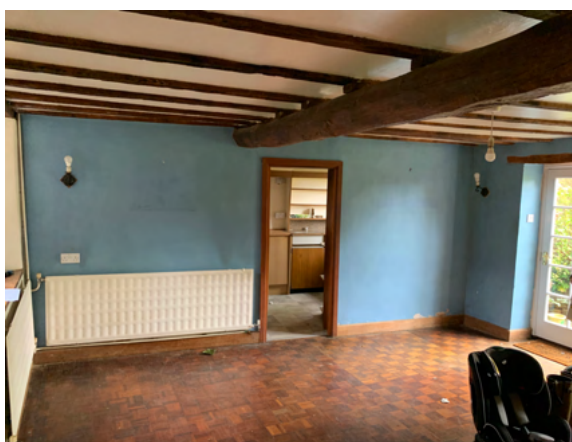
Fig. 12, The dining room/Kitchen partition proposed for removal.

On the ground-floor modern stud walling will be removed in the existing lounge (labelled snug on the proposal drawings). It is also proposed to remove the existing partition between the dining room and kitchen and replace with a structural steel member into which the existing ceiling beams will be slotted. The existing partition is not original to the building, but probably represents a relatively late addition (see above). This could be removed without significant harm to the building and the new arrangement will still illustrate where this division once lay. The existing kitchen door will be re-used in a new cupboard under the stairs.

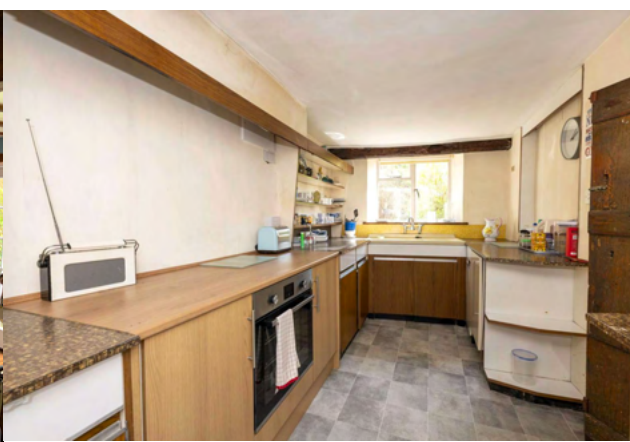
Fig. 13, The current kitchen

Behind the partition lies a narrow kitchen (Fig 13). As noted above, the partition is solid, and examination of the upper part of the wall, exposed by lifting boards in Bedroom 4, shows it to be constructed from un-frogged bricks, but set within cement mortar (suggesting this is probably C20th in date, but re-using earlier, possibly C19th bricks) (Fig 14).

The kitchen is a narrow galley style room with C20th casements to front and rear. The fittings are C20th. There is a modern vinyl floor covering, which was not lifted to inspect the underlying boards. The plastered ceiling is supported by a short longitudinal center beam, placed on a brick pillar in the partition, and a further beam resting on the inside of the front wall.

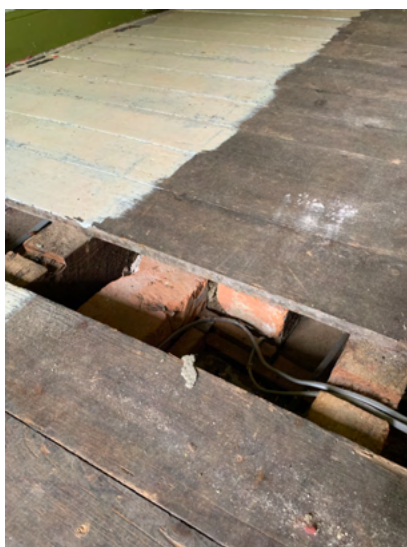
Fig. 14, The upper part of the dining room/kitchen partition exposed beneath the boards in bedroom 4.

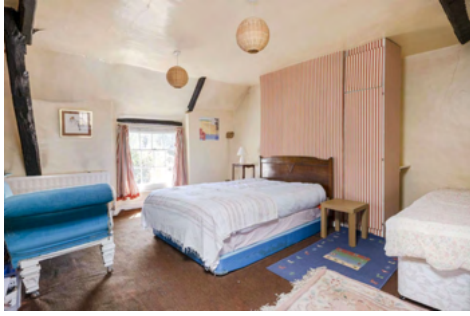
Fig. 16, The current bedroom 1. ©Savills

Bedroom 1 (Fig 16) (as with all the bedrooms) is partly within the attic, with a partly exposed roof truss and purlin (an original tie/collar has been removed and relocated higher up to create passing space beneath, Figs 17 and 18). There is a sash window to front and a side opening iron framed casement to rear, with 12 pane leaded lights. The ceiling is painted lath and plaster. The floor is boarded. Interestingly while the exposed boards elsewhere are largely narrow, probably Victorian or later pine, those in this room include wider, possibly earlier boards.

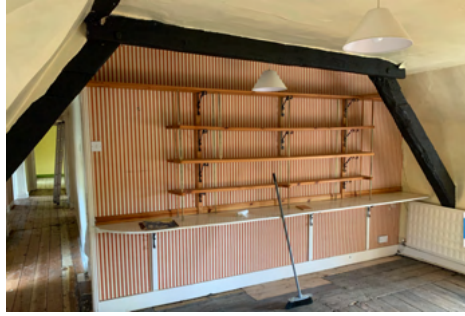
Fig. 17, Bedroom 1 roof truss. Note how the truss blocks the existing entrance to the room. The partition behind is proposed for removal, relocated to this side of the truss.

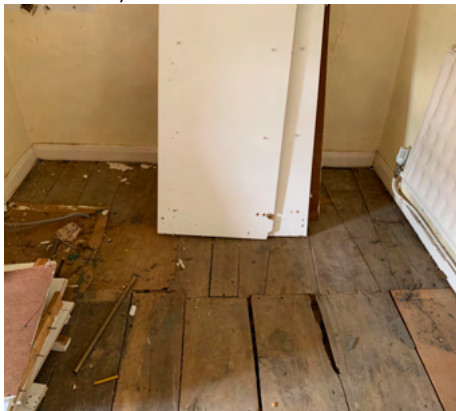
Fig. 19, Bedroom 1 NW corner –boards trimmed and possible early opening covered.

The pattern of the boards in this room is interesting and hints at the development of the house (Figs 18 to 21). In the rear north western corner, to one side of the fireplace, they have been trimmed, possibly for an opening which has then been boarded over (possibly an original staircase?).

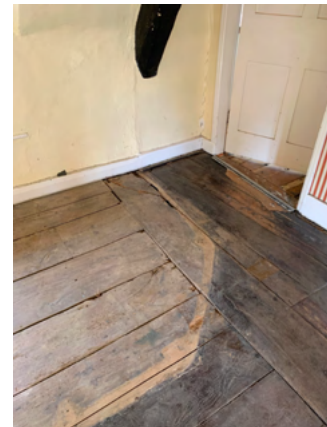
Fig. 21, Bedroom 1 –later partition scar

somewhat is a scar on the boards in the northern part of the room which suggests some kind of internal division –later than the creation of the extended room, and suggesting an even more constrained entrance.

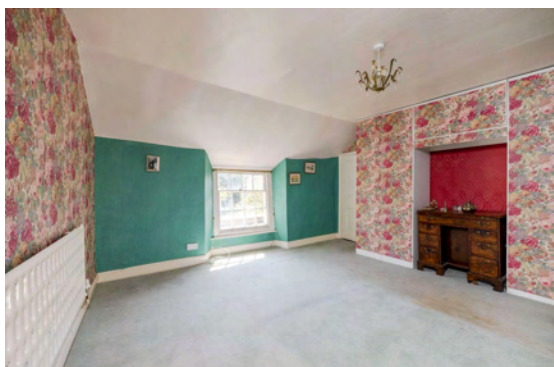
Fig. 22, The current bedroom 2,
©Savills

Bedroom 2 is also partly within the attic although no roof timbers are visible (Fig 22). There is a sash window to the front, and a corner cupboard out over the entrance lobby. Where carpet has been partly removed wide pine boards are visible.

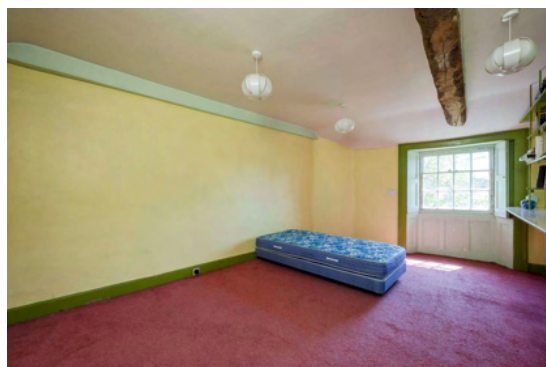
Fig. 23, The current bedroom 4,
©Savills

Bedroom 4 follows a similar pattern to bedroom 3 (Fig 23). There is a sash window to front, with timber surround, but also with timber shutters and paneling below. There was a small corner fireplace which has been removed. Again, a transverse timber beam, the tie-beam for

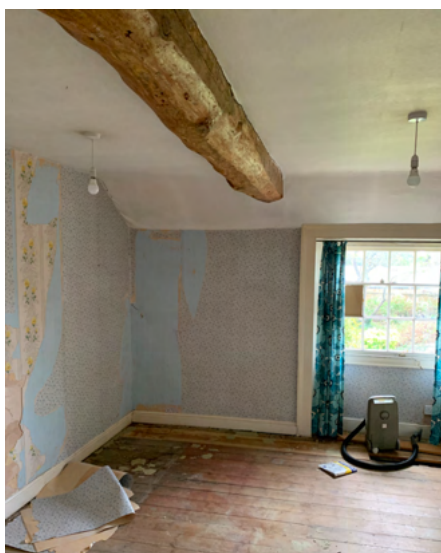
Fig. 24, The current bedroom 3

Bedroom 3 would once have been within the eastern cottage, so the corridor here has broken through the original party wall (Fig 24). Within the bedroom the upper part of the chimney is boarded off. The fireplace surround has been removed although a hearthstone survives. There is a sash window to front with a simple but original moulded timber surround. A transverse timber beam is visible in the ceiling, likely the tie-beam at the base of the roof truss. The floor comprises narrow pine boards.

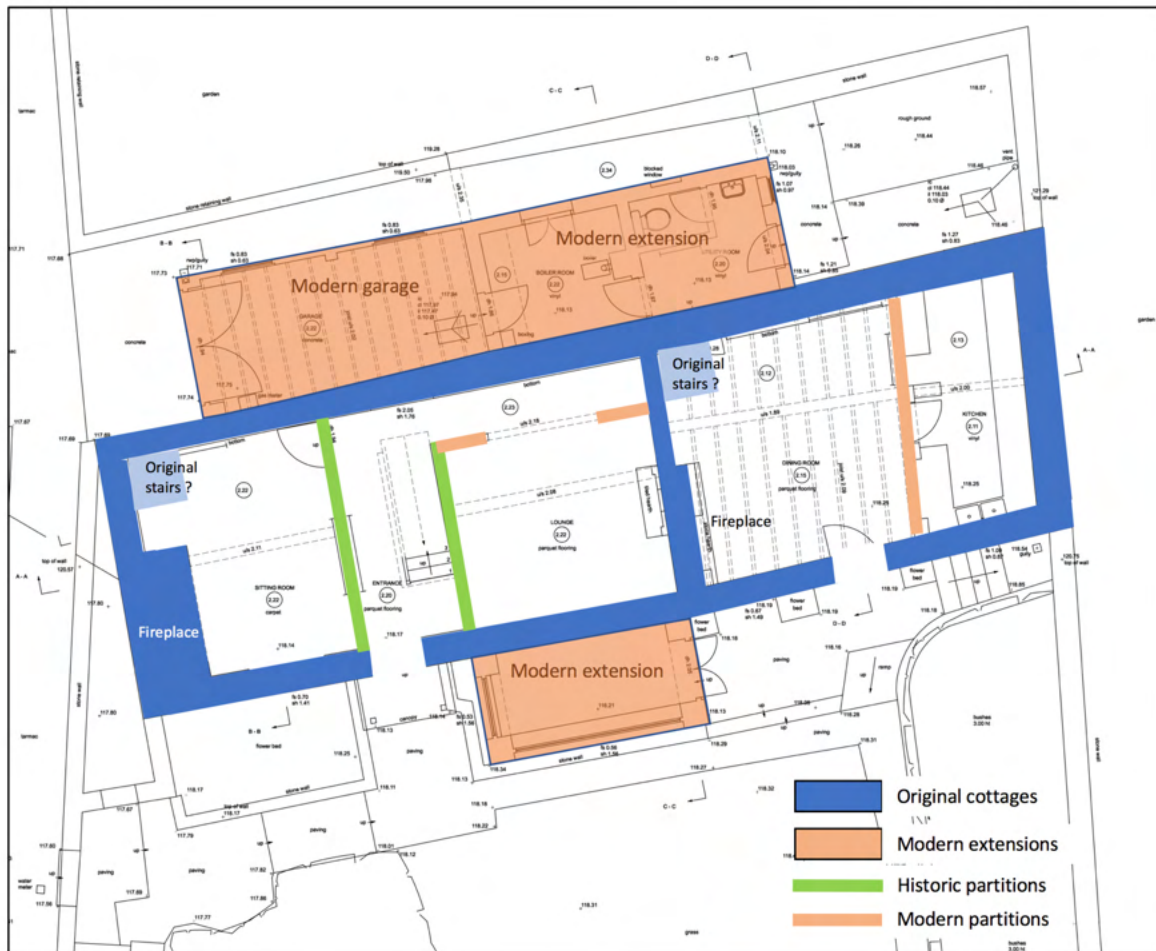
Fig. 25, Interpretation of plan development at ground floor ©SJB Surveying

It's not the purpose of this assessment to undertake a full historical survey of the house and investigate all aspects of its development. What follows is a proportionate summary interpretation based on the observations made during visits (Fig 25).

Clearly the house originated as two separate cottages and a significant amount of subsequent remodeling occurred when these were amalgamated into a single dwelling.

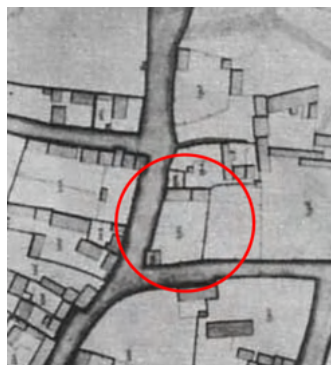
Fig. 26, 1833 survey of the village, showing Ivy Cottage divided into two, although the plot is undivided. (c) Banbury Museum.

Much of the internal layout and partitions probably date to its amalgamation, (although without intrusive survey, it's not always possible to tell whether some of the partitions are historic, or more recent). A new stairwell was created together with rear corridors at ground and first floor to tie the building together. It's likely the main reception rooms and bedrooms were laid out at this time. The date for this amalgamation is uncertain, although there may be some documentary evidence unexamined during this assessment for the creation of a single household. Map evidence suggests the cottages were undivided in 1833, but representations after that are ambiguous (Figs 26 to 28).

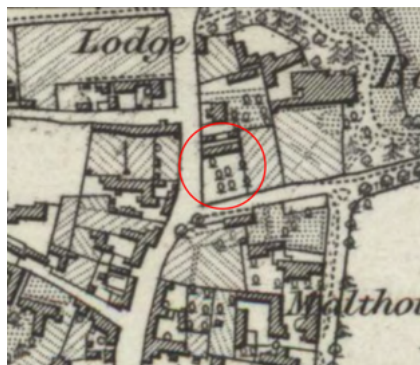
Fig. 27, The 1881 OS 6 inch map shows the house at too small a scale to note any division, with Bodicote House to the east. There are also buildings marked to the rear of the cottages.

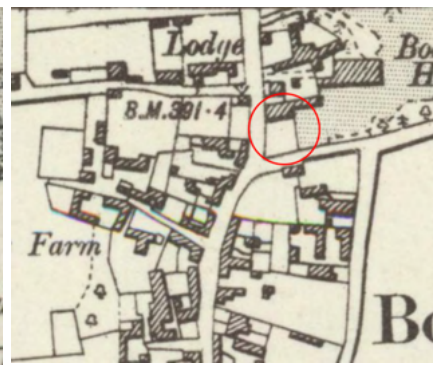
Fig. 28, The 1898 OS 6 inch map shows the eastern end of the house attached to an ancillary building of Bodicote House.

Of note are some steps that run from the eastern front door of the house up to the inner face of this boundary wall –in affect, running under the boundary wall and indicating that this was once an access point that has since been blocked (Fig 29). This also suggests a link with Bodicote House, into an area occupied by ancillary buildings to that property (possibly glasshouses, marked on the 1898 OS (Fig 27), with the rear brick walls surviving today).

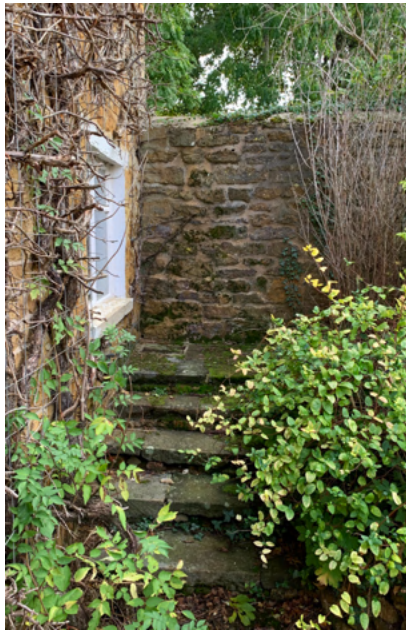
Fig. 29, Steps leading from the front of the house beneath the later eastern boundary wall.

The proposed new access through the eastern wall into the new garden is, in my opinion, uncontentious. The steps up clearly indicate this was once in use, and the wall itself is likely to

be a recent addition (Fig 29). The change to create a small gap is very minor and will have no significant adverse impact.

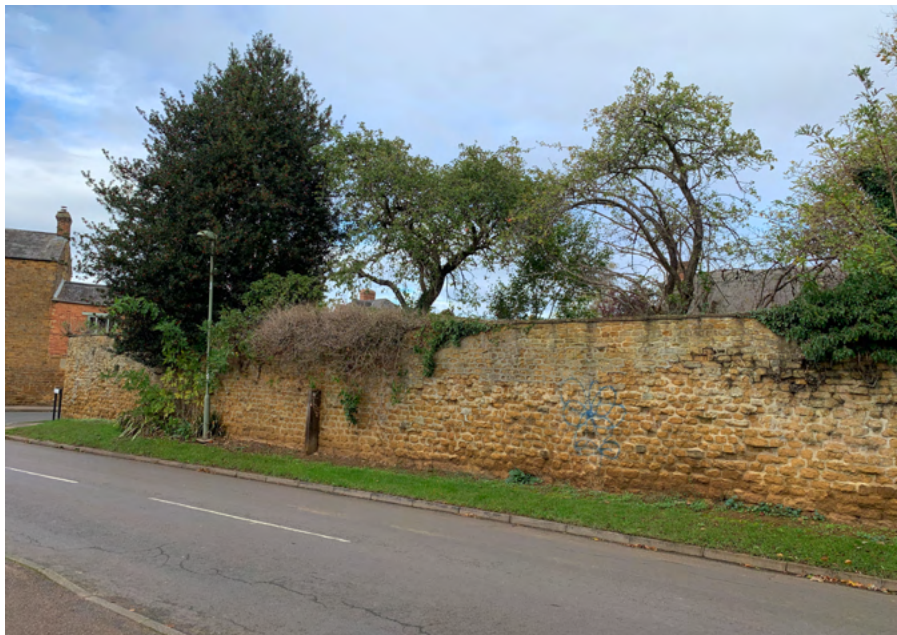
Fig. 30, The boundary wall on Broad Gap, where the proposal is to create new vehicle access, approximately where the graffiti is. This could be mitigated by the insertion of tall gates.

The new access for vehicles is proposed through the southern boundary wall on Broad Gap, into a driveway/parking area constructed out of the south-eastern part of the existing garden (Fig 30).

The wall here is not listed separately (as with that facing on to the High Street), but almost certainly enjoys curtilage listing due to its association with the house, and is obviously also within the conservation area. While only a small part of the fabric of the wall would be lost, the proposals would, to a limited extent, negatively impact the setting of the house, specifically its sense of enclosure and tranquillity –although this could in part be mitigated by installing tall timber gates, similar to those used in other openings within the village (some of these are illustrated in s.11.1 of the *Conservation Area Appraisal*). Regarding the conservation area, the tall stone walls here and elsewhere are important contributors to character. In particular, they signal the division between private higher status spaces, in contrast to some of the more humble village houses that face directly on to the street. Nevertheless, as already noted, the proposals remove only a small part of the wall and this loss could be part mitigated with tall gates, which would continue the built line and continue to mark the division of space. Overall, however, it is difficult to avoid the conclusion that there is a risk here of a low level of less than substantial negative impact. There are good reasons, however, to remove cars from parking on the road (not least because parked cars negatively impact our ability to experience the historic environment) and to encourage the provision of domestic charging infrastructure, and
