Castle Street, Banbury

Flood Risk & Drainage Technical Note

| Project No. | 1260 |

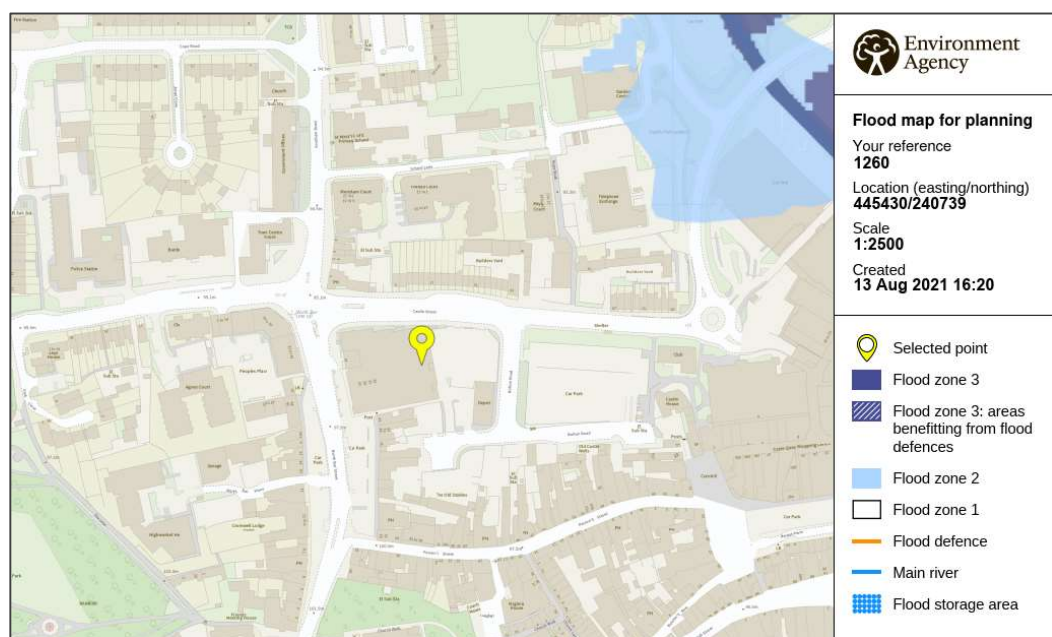
Figure 2.1 – EA Flood Map for Planning

- 2.2 An extract of the 'Flood Map for Planning' has been reproduced as Figure 2.1 and shows the site as being entirely within 'Flood Zone 1', as land assessed as having less than 1 in 1,000 annual probability of flooding from fluvial sources (<0.1%).

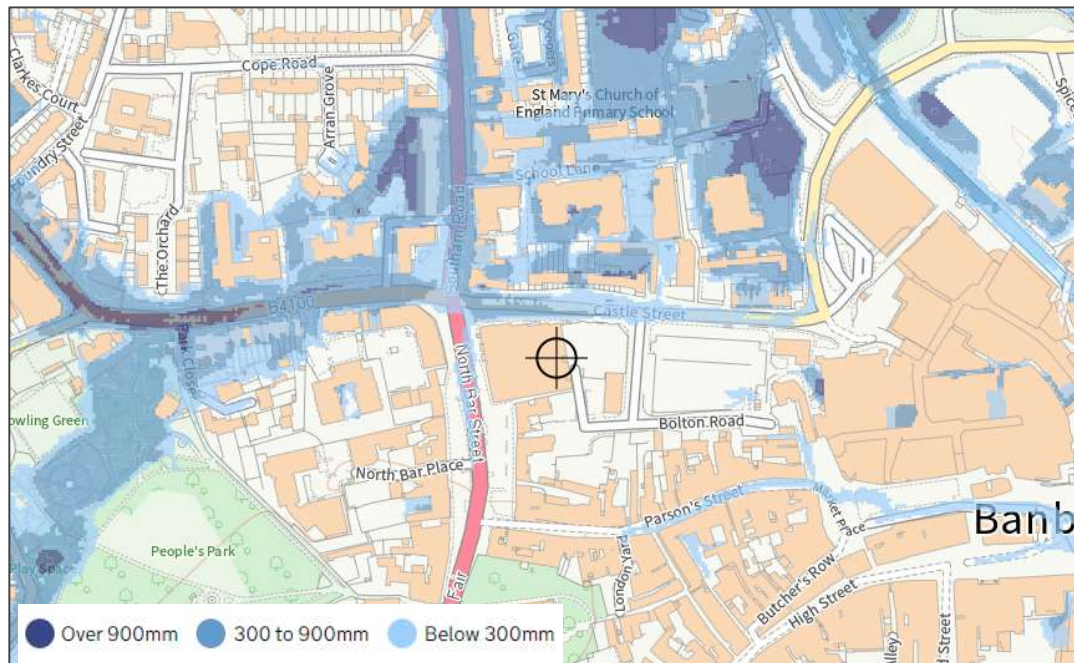
Figure 2.2 – EA Flooding from surface water (low risk, 0.1%)

- 2.3 An extract of the EA's 'Flooding from Surface Water' maps for low and medium risk from surface water flooding are shown in Figures 2.2 and 2.3. The mapping is based on LIDAR data and indicates the typical

conveyance routes of surface water runoff. Figure 2.2 indicates the low risk surface water flooding, in up to the 1 in 1,000 year return period storm (annual probability <0.1%), whilst Figure 2.3 shows the medium risk flooding, in up to 1 in 100 year return period storm (1%).

- 2.4 The mapping identifies that the northern boundary of the site may be susceptible to flooding below 300mm within the 100 year design life of the scheme (medium risk). The same area is indicated to be at risk of flooding

greater than 300mm during the low risk event (beyond the 1 in 1,000 year event).

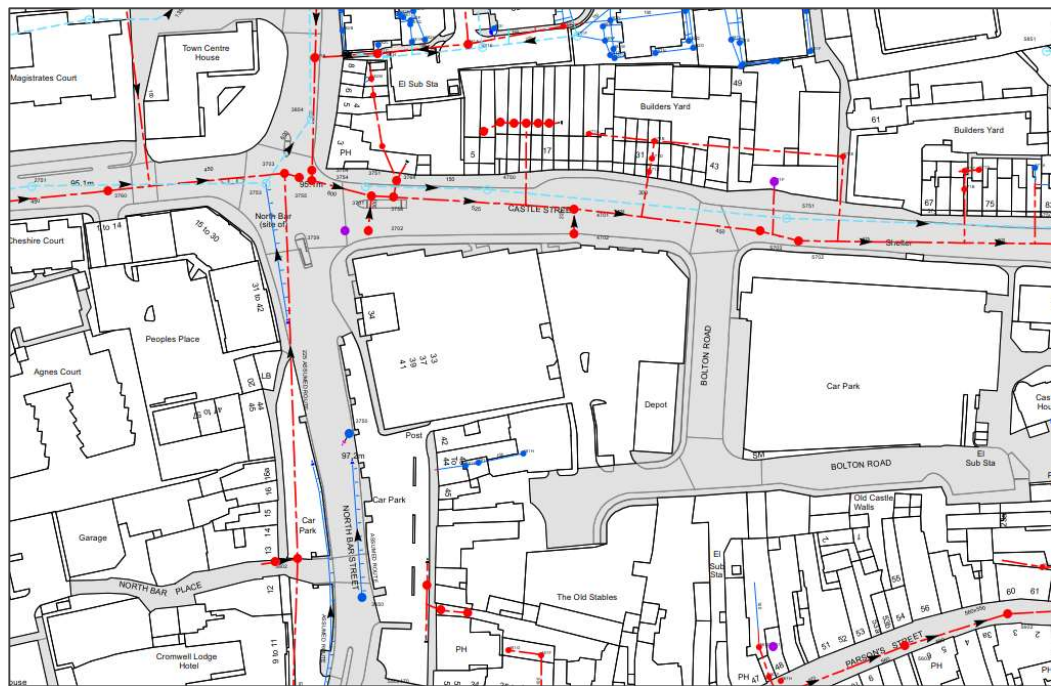
Figure 2.4 – Thames Water sewer asset record

- 2.12 There are no apparent nearby surface water features or watercourses. The Thames Water (TW) records are extracted in Figure 2.4 below which identifies that there are existing surface and foul sewers within Castle Street and North Bar Street to the north and west of the site. There are also combined sewers and gullies indicated south of the site, but these are not operated by TW (ownership is unknown). A full copy of TW records can be found within Appendix C of this report.

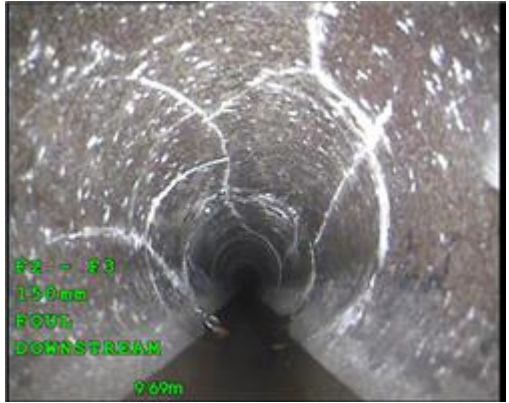
| Pos | Video Ref | Code | Description | Image |
|---|---|---|---|---|
| 09.70m | 0:01:17 | S1 CM | Cracks, multiple 9.7m - 10.85m from 06 o'clock to 06 o'clock - Severity 2 | Image Provided - Ref: 1_3 |

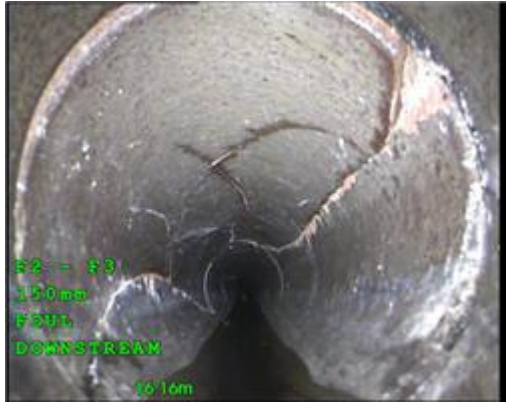
| Pos | Video Ref | Code | Description | Image |
|---|---|---|---|---|
| 16.16m | 0:02:24 | CM | Cracks, multiple from 07 o'clock to 03 o'clock - Severity 2 | Image Provided - Ref: 1_6 |

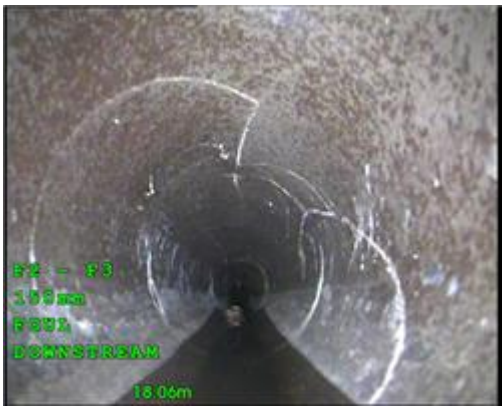
| Pos | Video Ref | Code | Description | Image |
|---|---|---|---|---|
| 18.06m | 0:02:40 | CM | Cracks, multiple from 07 o'clock to 05 o'clock - Severity 2 | <p>Image Provided - Ref: 1_7</p> |

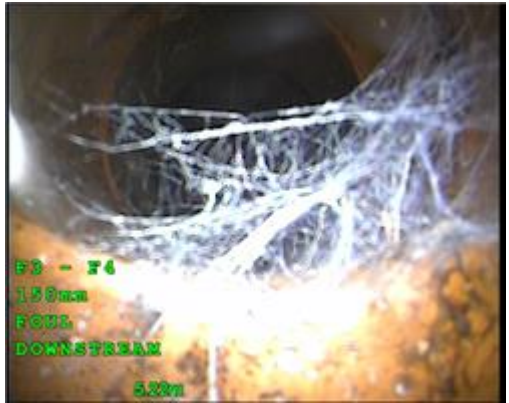
| Pos | Video Ref | Code | Description | Image |
|---|---|---|---|--|
| 04.90m | 0:01:15 | JN | Junction at 06 o'clock: 150mm Diameter BACKDROP AT MANHOLE | Image Provided - Ref: 2_6 |

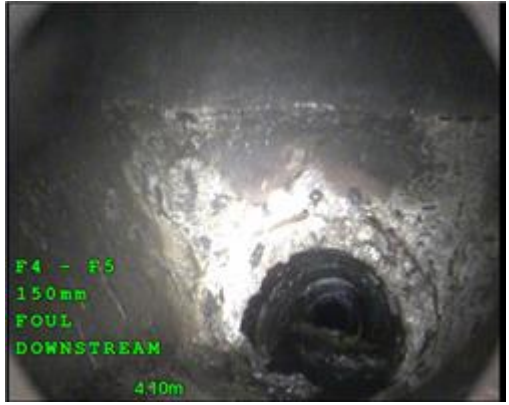
| Pos | Video Ref | Code | Description | Image |
|---|---|---|---|---|
| 04.10m | 0:00:33 | REM | General remark ENTERS MANHOLE F5 | <p>Image Provided - Ref: 3_2</p> |

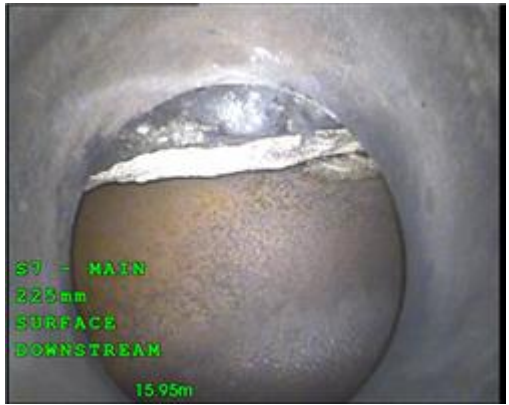
| Pos | Video Ref | Code | Description | Image |
|---|---|---|---|--|
| 16.00m | 0:02:48 | JDL | Joint displaced large - Severity 4 | <p>Image Provided - Ref: 12_9</p> |

- 2.13 A utility survey has been completed for the site which identifies existing foul and surface water drainage, with separate discharges to the adopted sewers within Castle Street.
- 2.14 The existing site drainage also receives separate private foul and storm connections from the adjacent commercial unit (Land Tyre Service). Whilst the existing site drainage can be abandoned, any live connections from other developments will need to be retained or otherwise diverted to accommodate the proposed development.
- 2.15 A CCTV condition survey has been conducted by Utilities Survey Ltd. (CCTV report ref. 071398, August, 2021). The 150mm diameter foul sewer connection to be retained (F4 to F5) is in good condition and is therefore considered adequate for re-use. The 225mm diameter surface water sewer connection from S7 to Mains are reported as DRB Grade: C, due to a large

joint displacement. Thus, there is a defect that requires remedial works before the existing surface water connection can be deemed serviceable.

- 4.13 The proposed attenuation features will be linked by a balance pipe spanning beneath the groundfloor slab. Runoff from the tank, and enlarged diameter pipe, will pass through the new flow control chamber prior to discharging to the retained existing surface water chamber (S7) from which it will discharge to the TW surface water network via the existing lateral site connection. This will be subject to remedial works to correct a joint displacement, based on the CCTV condition report discussed in Section 2.

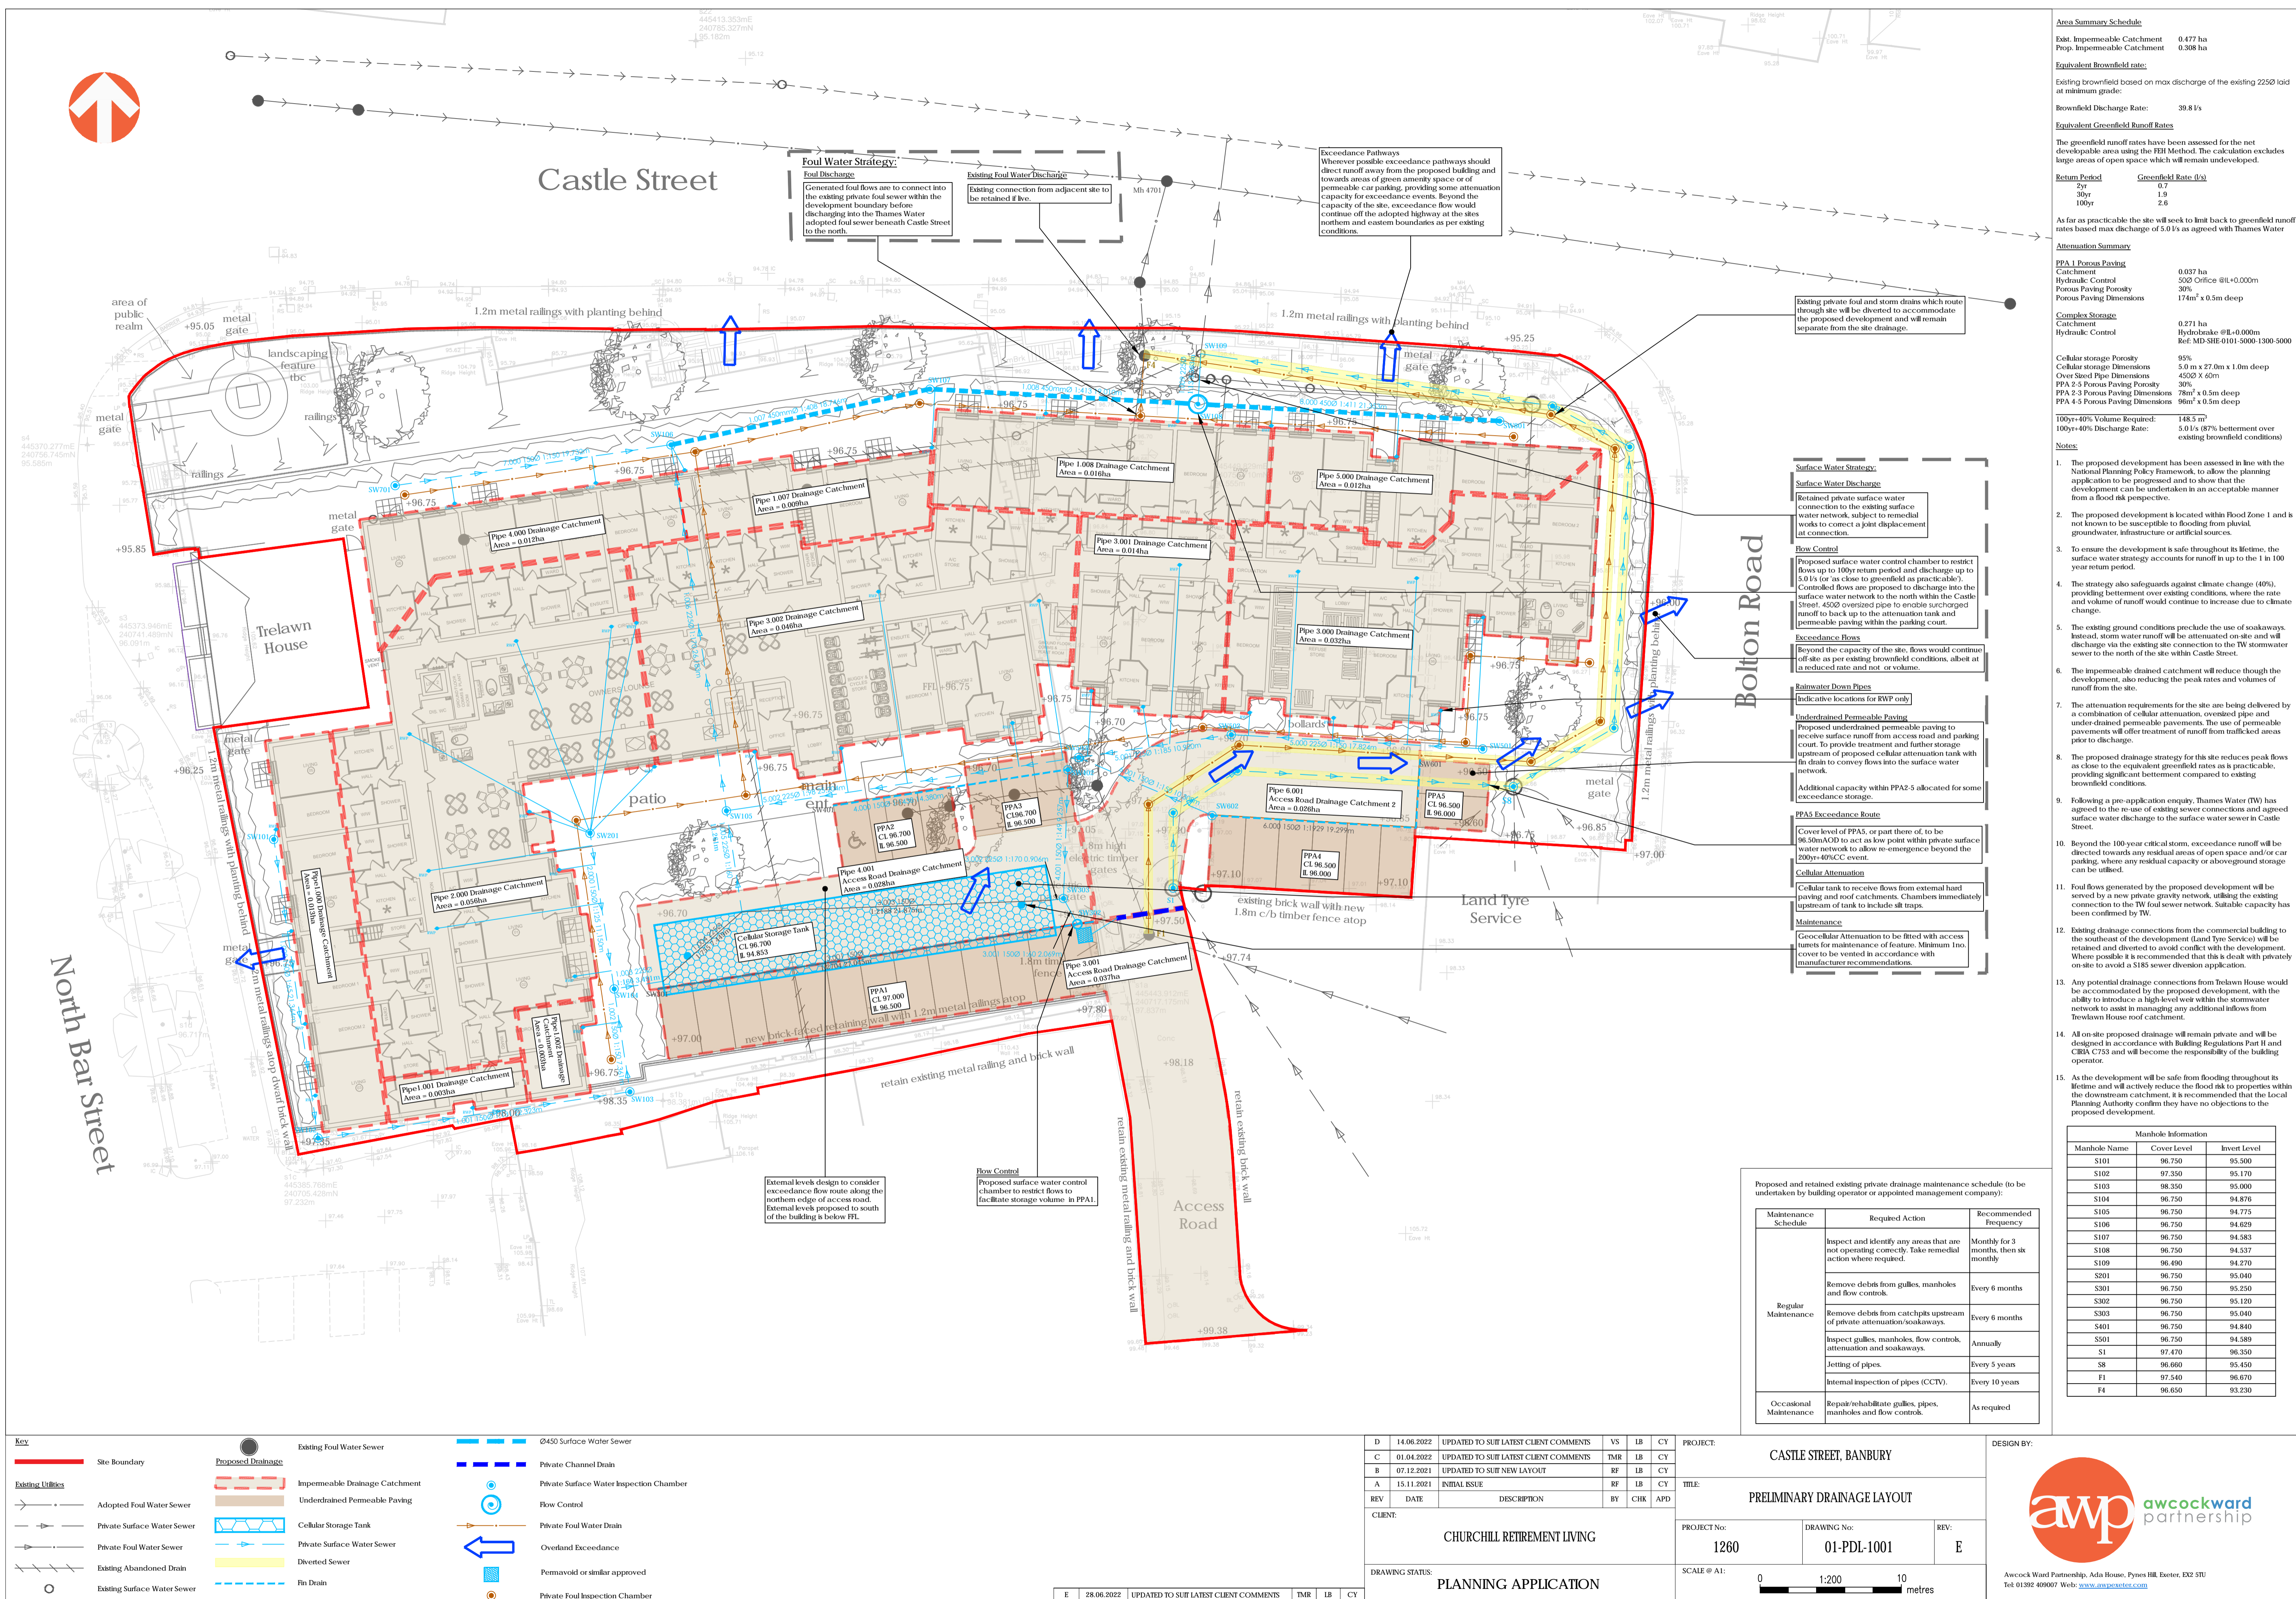
Appendix H Preliminary Drainage Layout

- 4.24 A copy of the updated preliminary drainage layout can be found on drawing 1260-01-PDL-1001 included within Appendix H.

- 8.5 *Remedial works for existing drainage pipes not identified on plan drawing.* Remedial work at point of connection with the surface water network now noted on the updated PDL (Appendix H).

- 8.13 *Surface water catchment plan.* The surface water catchments are shown on the PDL drawing (Appendix H). The total area drained is 0.308ha as stated in the PDL summary notes. Individual catchment areas have been annotated, together with which pipe they are draining to in the network model. It should be noted that some pipe runs receive flow from multiple areas. The text has been made clearer on the PDL drawing.

- 8.14 *Surface water exceedance plan.* The attenuation design provides additional capacity for the management of exceedance events. The residual capacity within the under-drained permeable paving can be accommodate up to the 1 in 200 year, with 40% climate change, beyond which there would be some localised ponding within areas of green space and parking bays. Beyond the capacity of the site, external levels have been adjusted to direct exceedance runoff, to the south of the building, to flow east towards the eastern boundary. External works and landscaping within the site and along the site boundary will accommodate exceedance flows as far as possible. Beyond the limits of the site, exceedance flows would continue to the northern and the eastern boundaries and towards Castle Street as per existing conditions. However, the likelihood of exceedance runoff from the site is significantly improved when compared to the existing conditions (See par 4.16, 4.18 & 4.22).

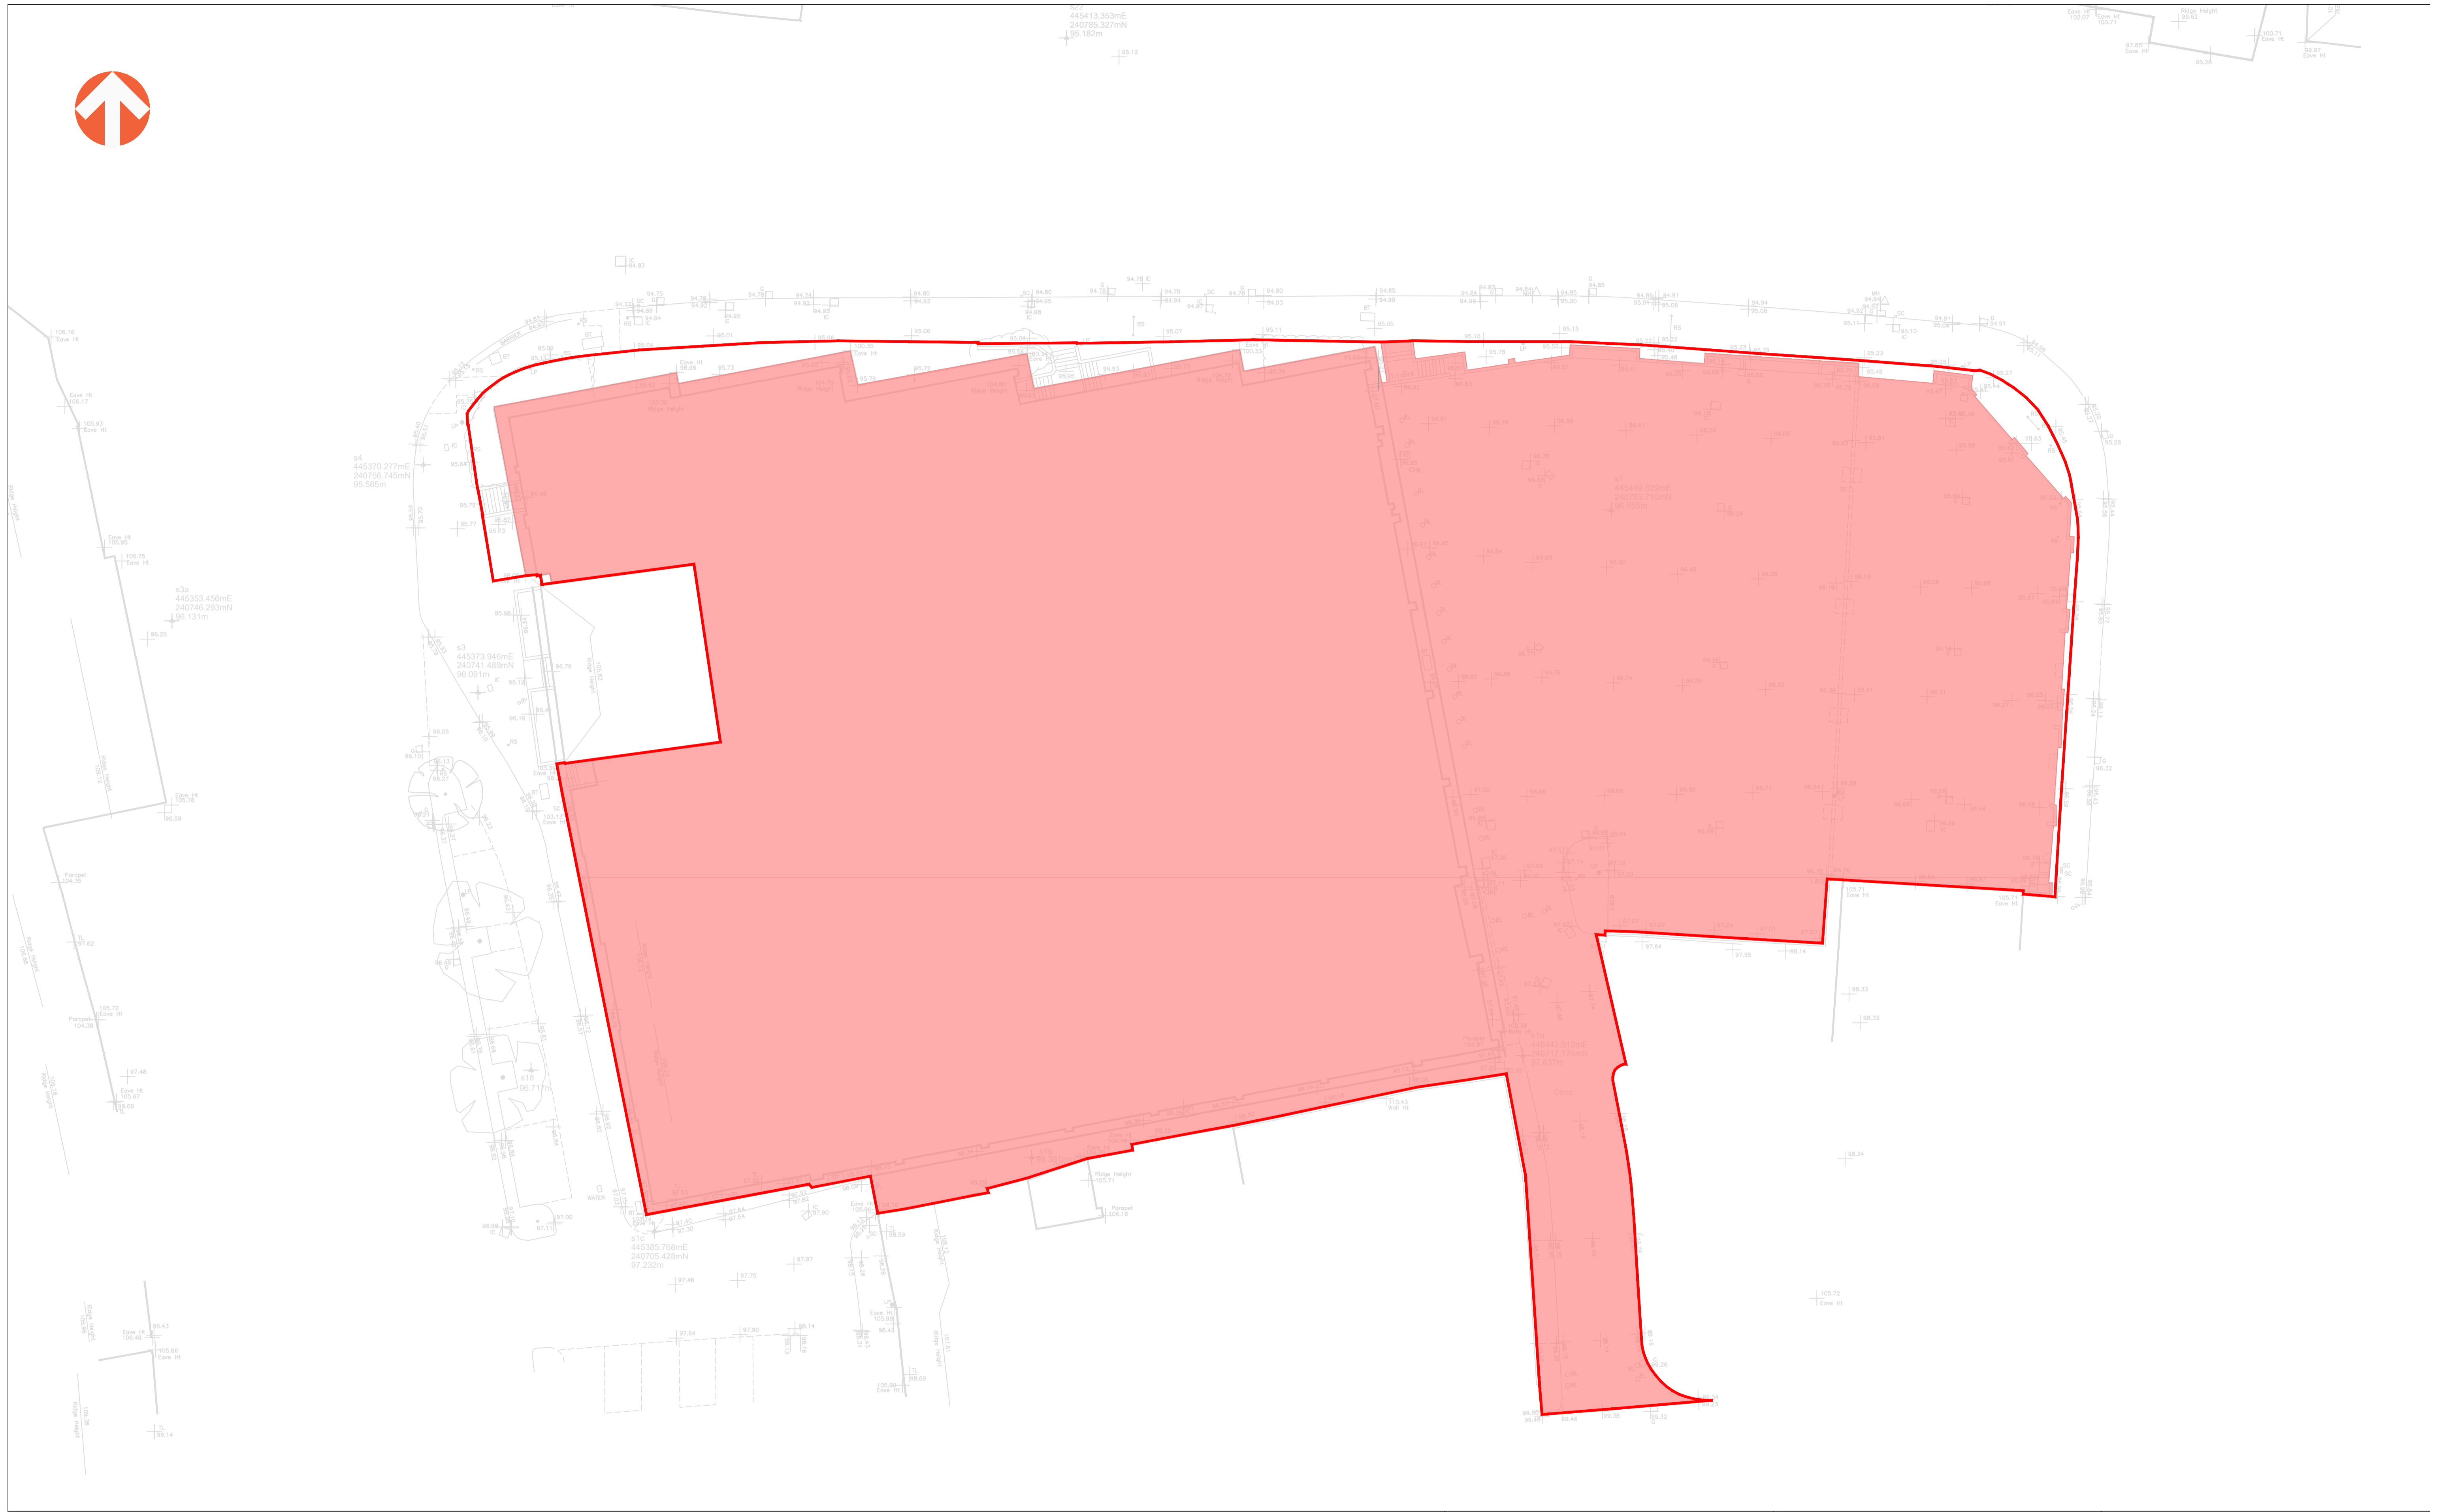
Appendix I Existing Impermeable Areas Plan

| A | 01.04.2022 | INITIAL ISSUE | RF | LB | CY | TITLE: PRE-DEVELOPMENT IMPERMEABLE AREAS PLAN | | | | | |
