PROJECT Stratfield Farm
 OX5 1DL Kidlington

DWG TITLE Block G
 Existing Elevations

STATUS Planning and LBC

JOB/DWG No. 219-117

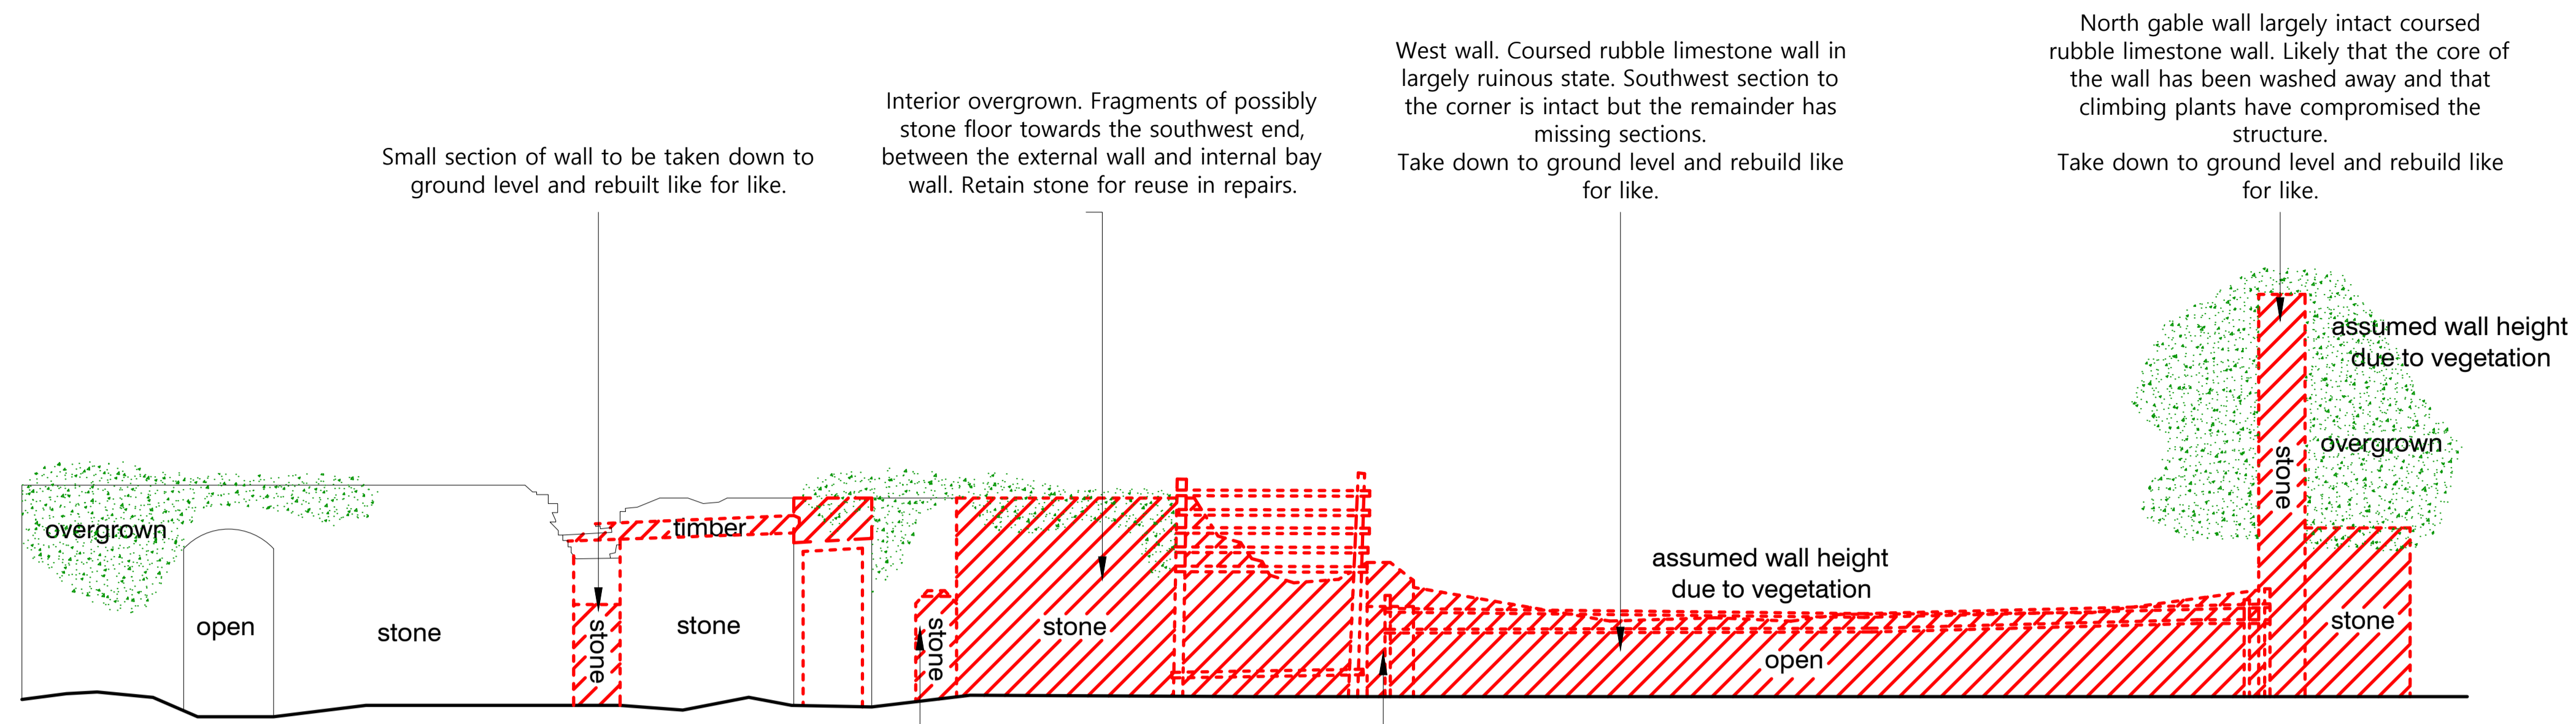
1.0 East Elevation

There is a low internal stone wall with cement pointing and badly rebuilt top section, with substantial root growth from the north side. Take down to ground level and rebuild like for like.

South wall. Coursed rubble limestone wall has been compromised by water ingress into the core of the wall. Visible structural movement. Take down to ground level and rebuild like for like.
