## **STATEMENT OF SIGNIFICANCE**

**Stratfield Farmhouse, Kidlington,  
Oxfordshire**

**Manor Oak Homes**

**Date: September 2018**

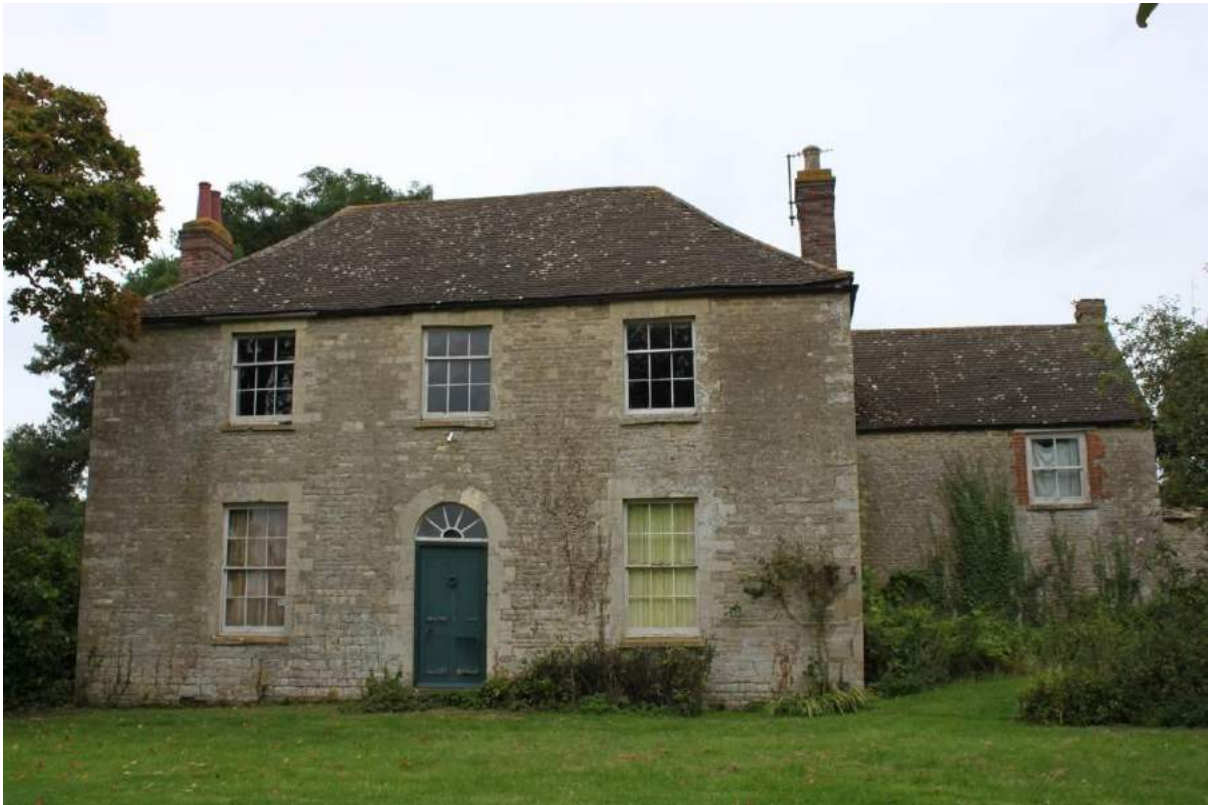
**Plate 1: Stratfield Farmhouse: front (south) elevation of Block 1**

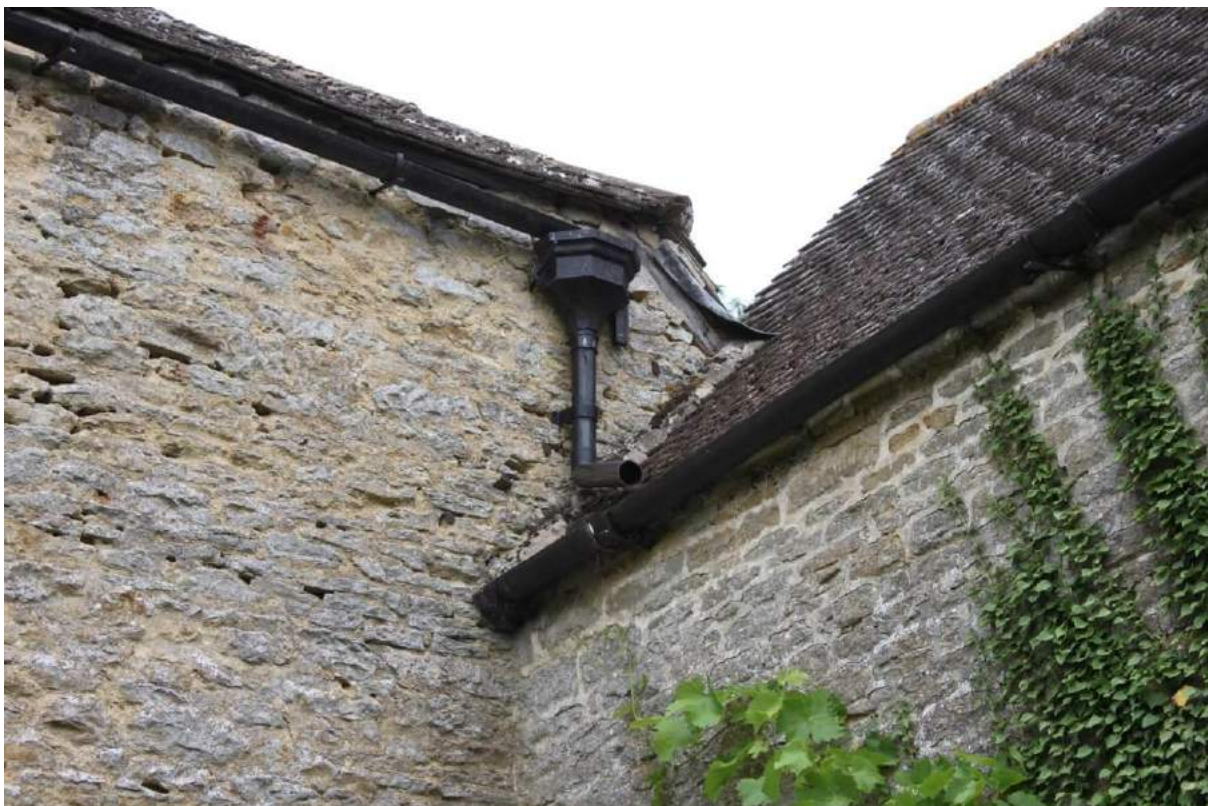
**Plate 4: Junction of east elevation of Block 1 and south-west corner of Block 2, with upper section of outshut roofline shown between the two**

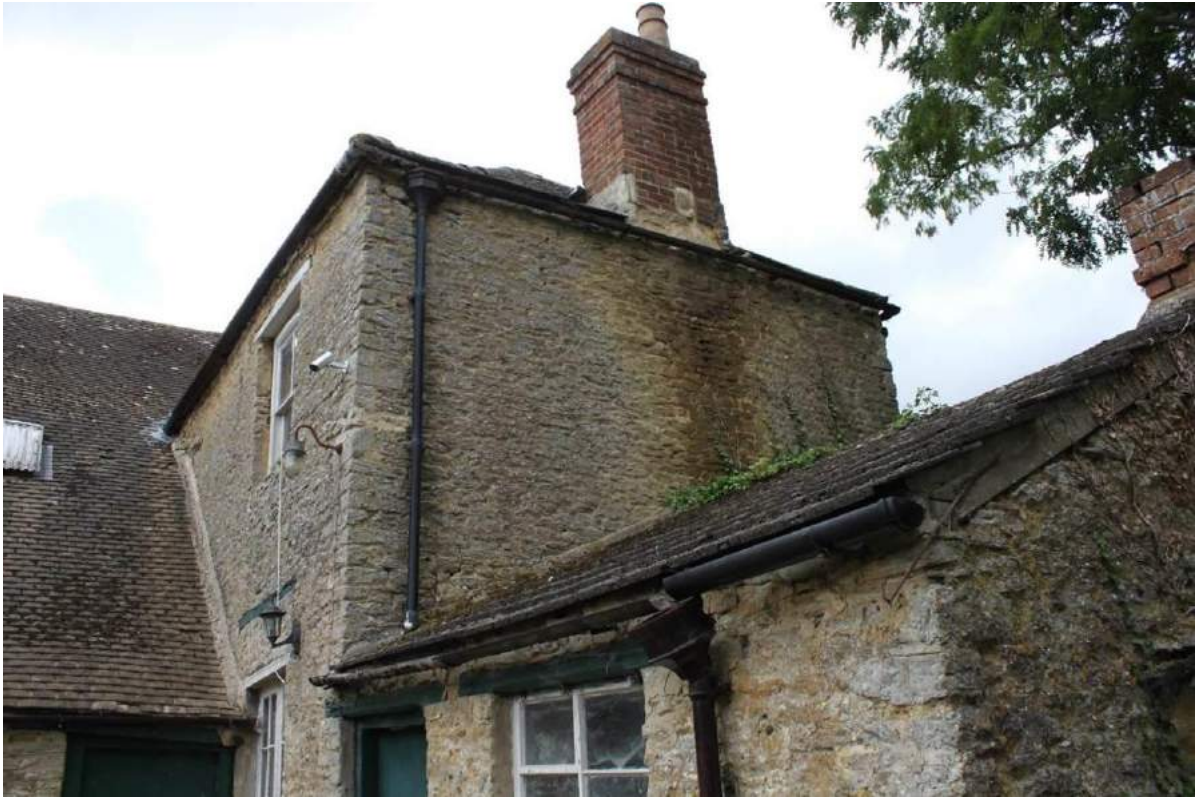
**Plate 7: Rear (north) elevation of rear wing of Block 1, with single-storey Block 3 attached to right, and outshut seen to left**

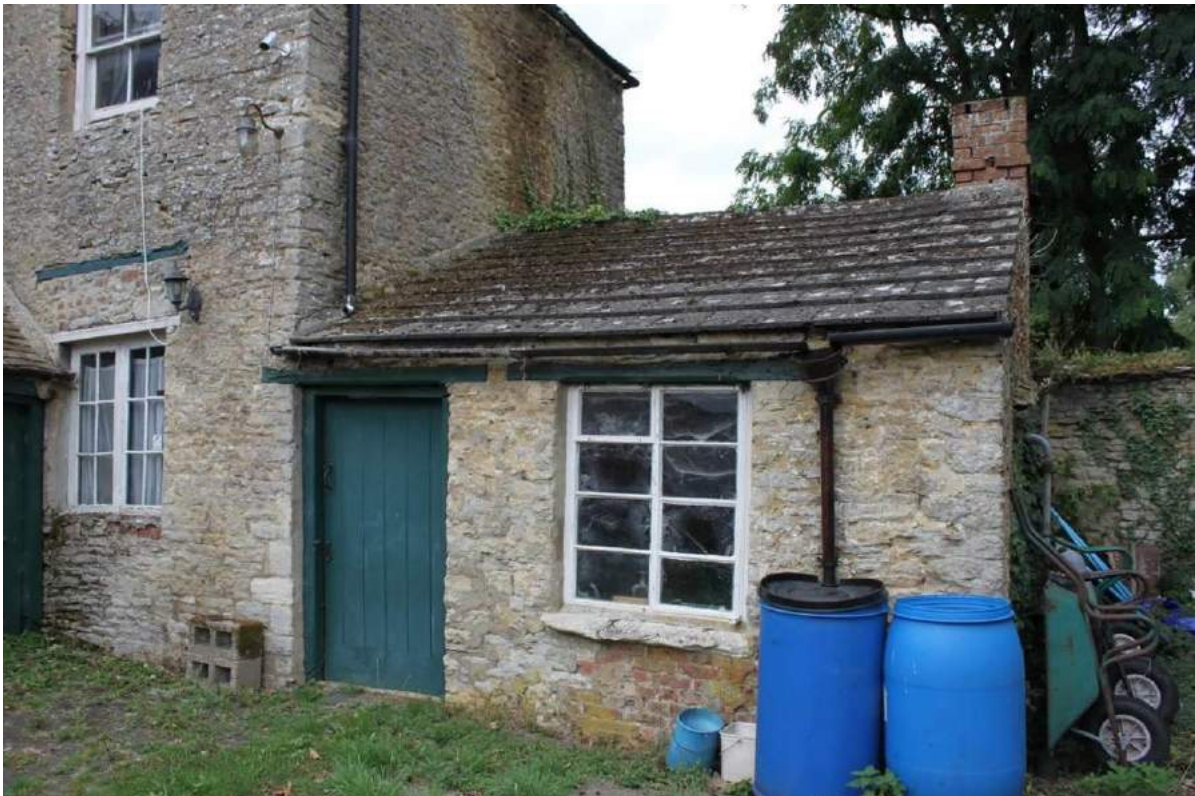
**Plate 8: East elevation of Block 3 (laundry/bake-house)**

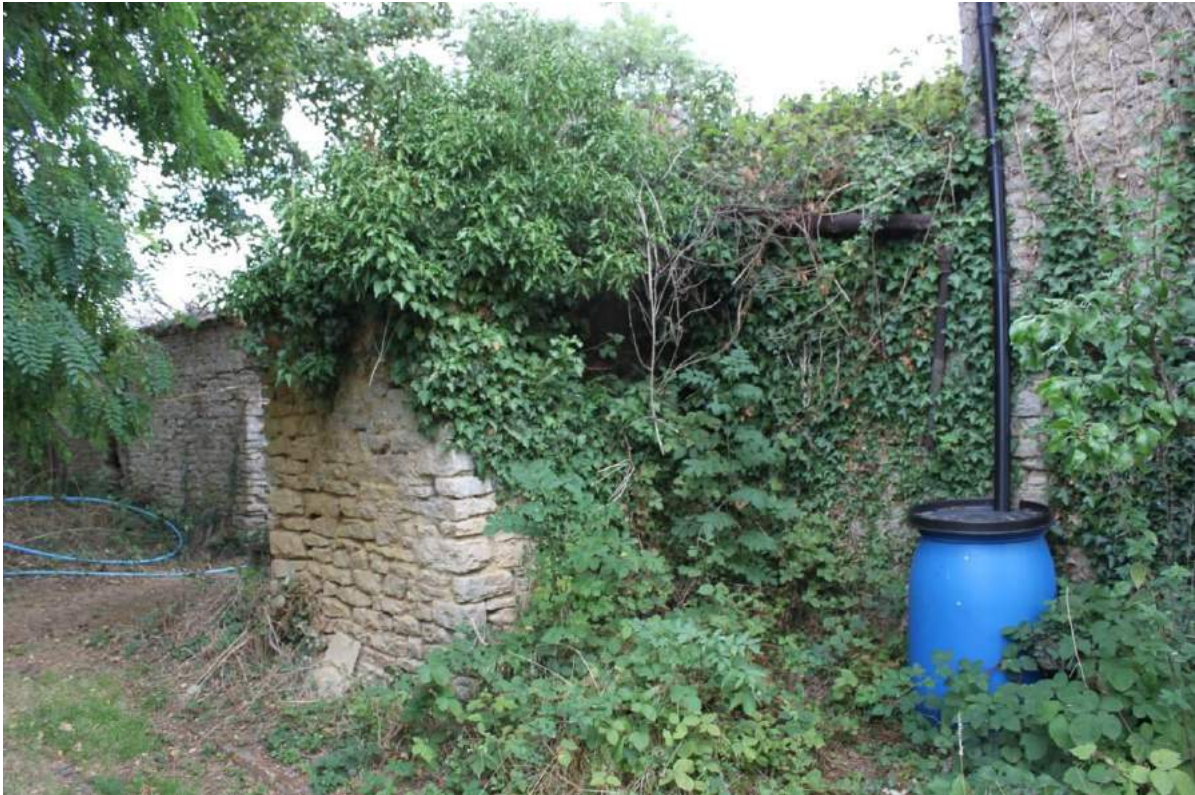
**Plate 9: Western enclosure wall to the farmyard, with projecting bread oven structure against west wall of Block 3**

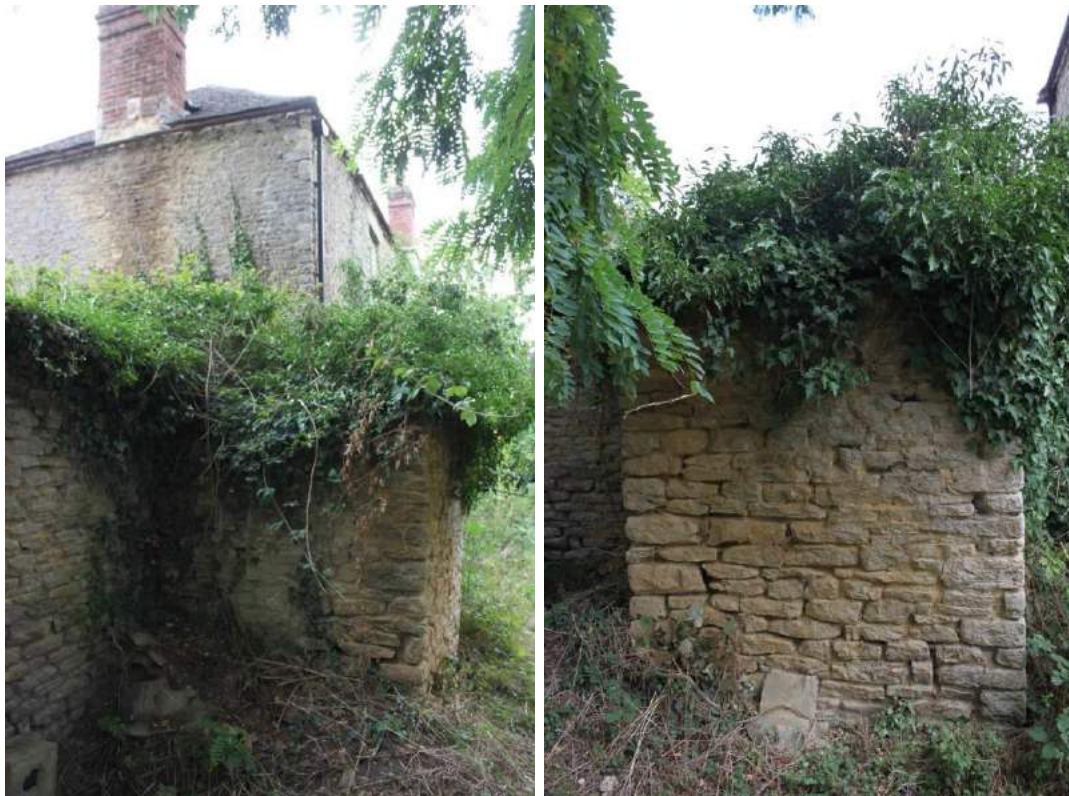
**Plate 10: Bread oven structure**

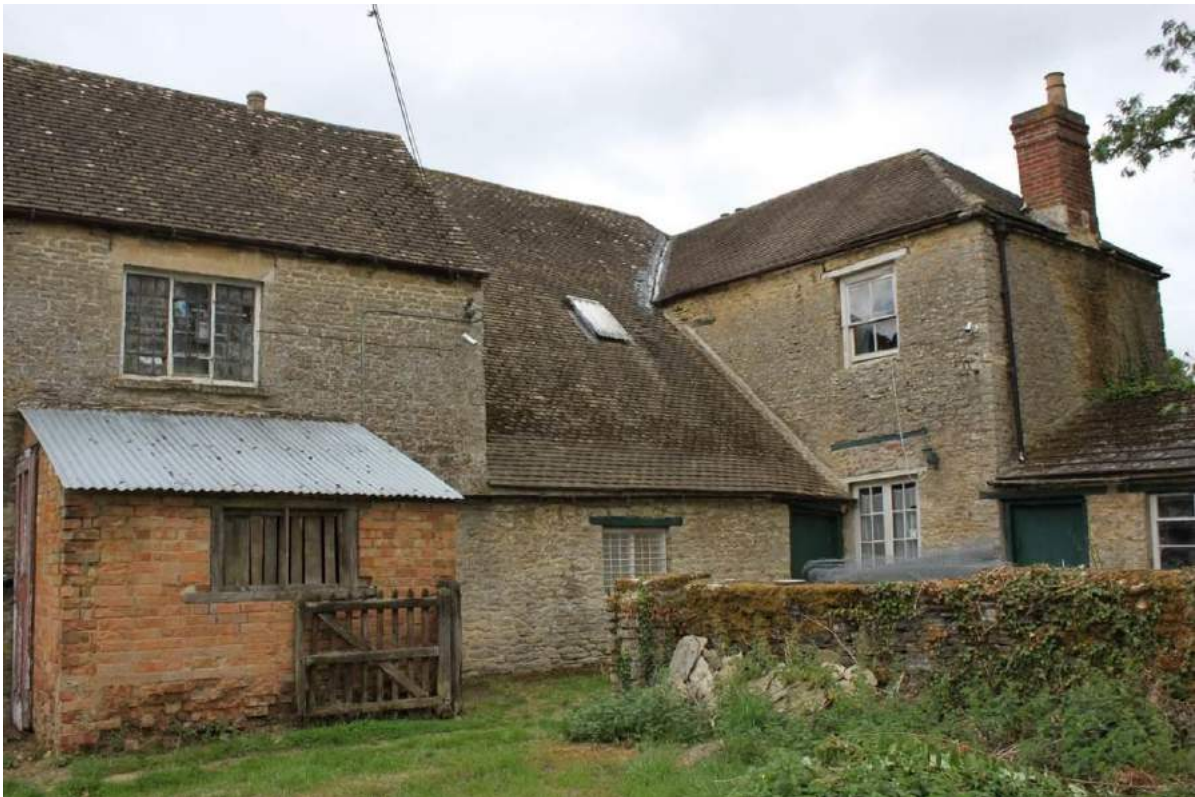
**Plate 12: Rear (north) elevation of farmhouse, with Blocks 2 & 4 to left; outshut to Block 1 in centre; rear wing; and Block 3 to right**

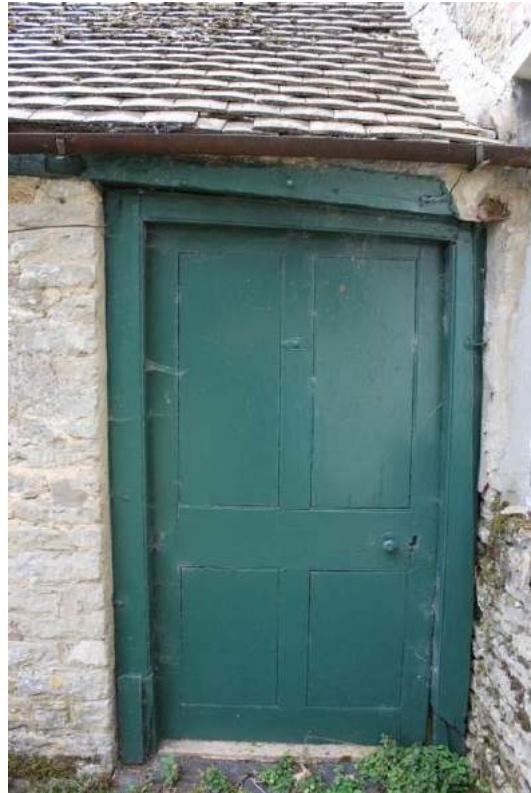
**Plate 14: Rear entrance to Block 1 in outshut**

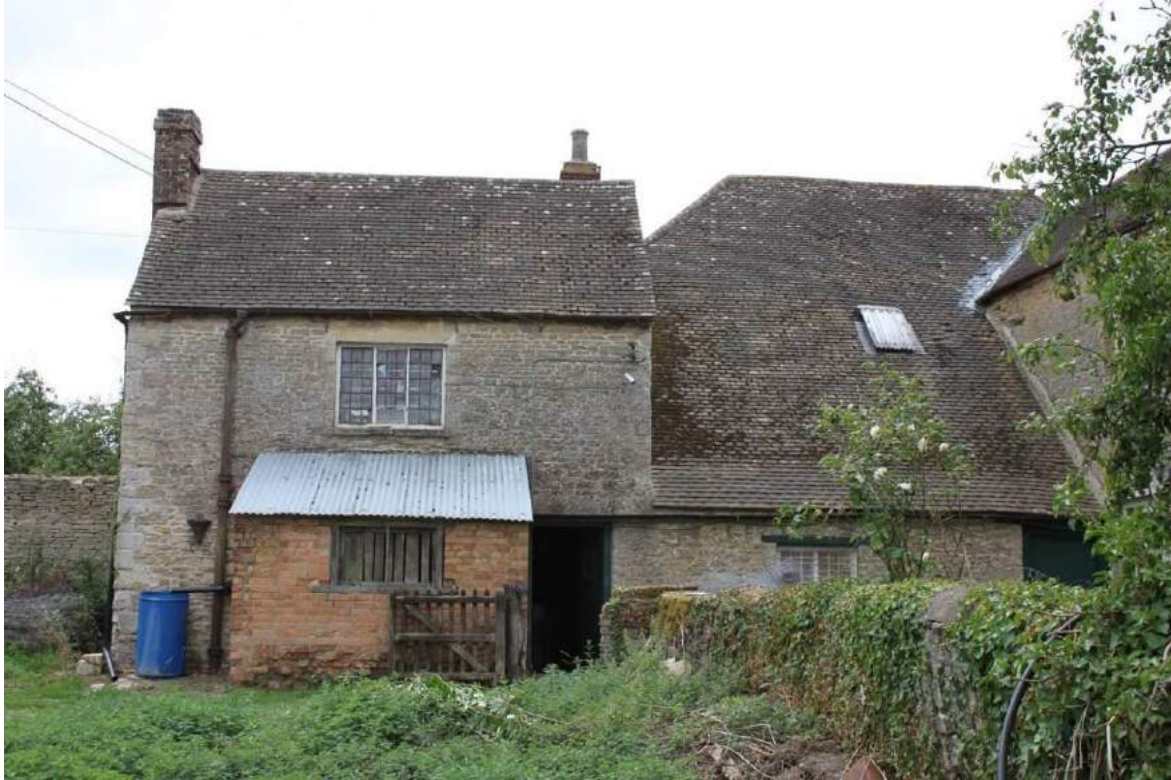
**Plate 15: North elevation of Block 2, with lean-to Block 4 attached**

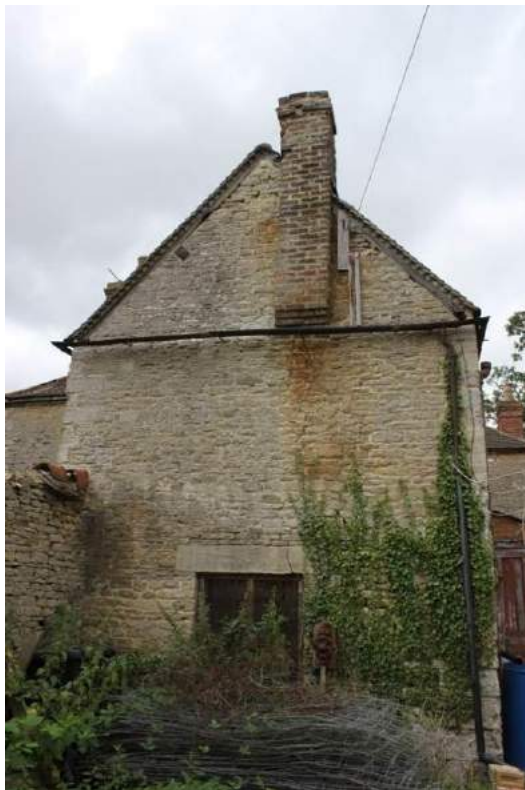
**Plate 16 (left): East gable end of Block 2**

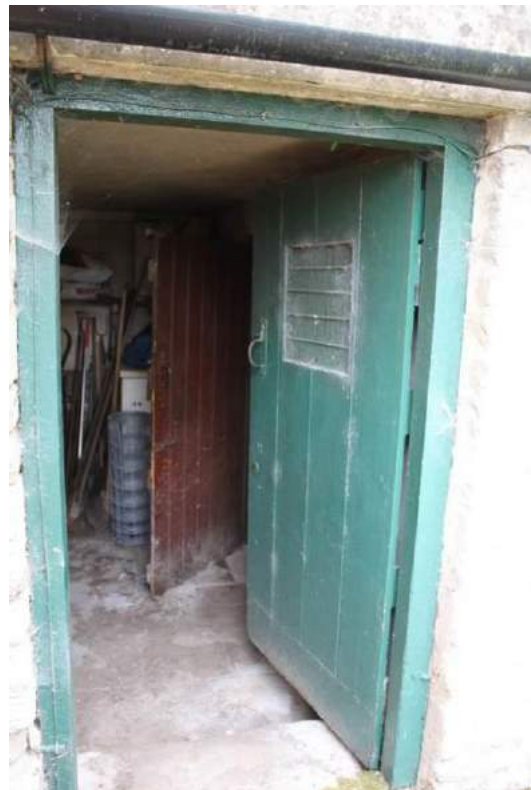
**Plate 17 (right): Boarded door with vented panel to Block 2**

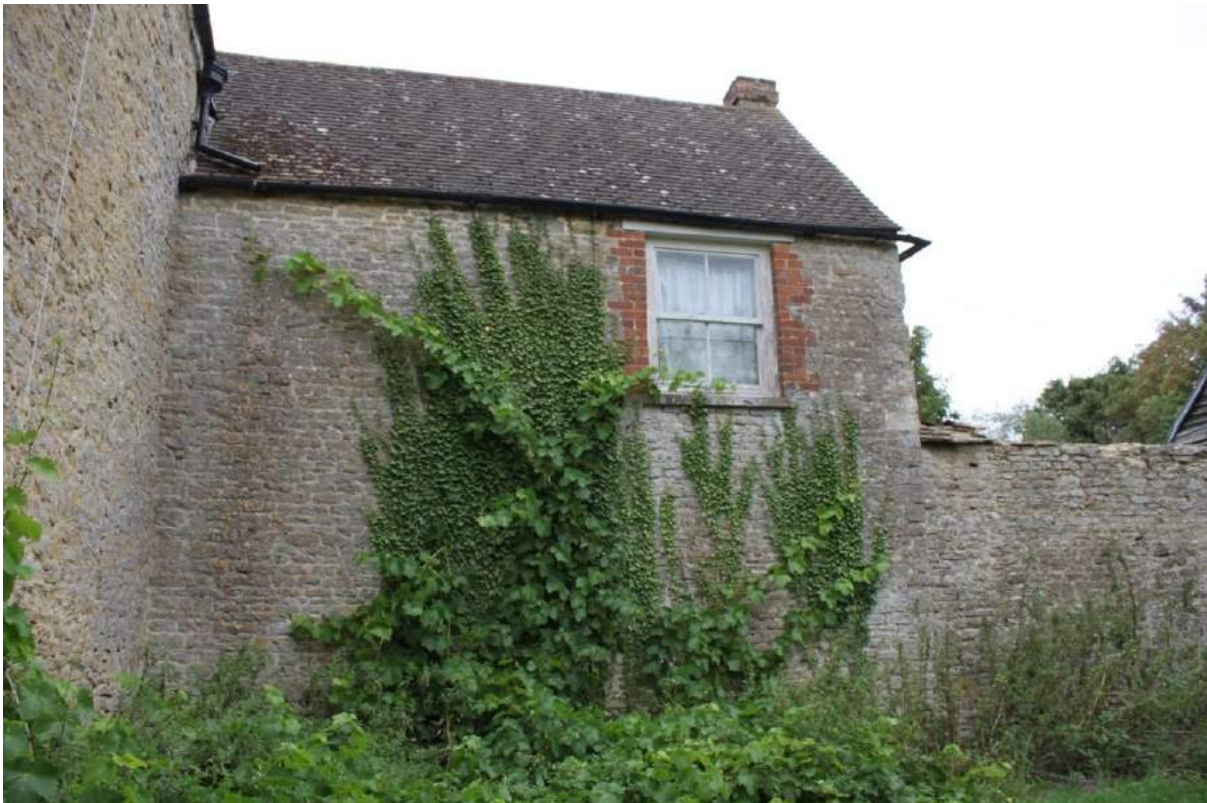
**Plate 19: South elevation of Block 2**

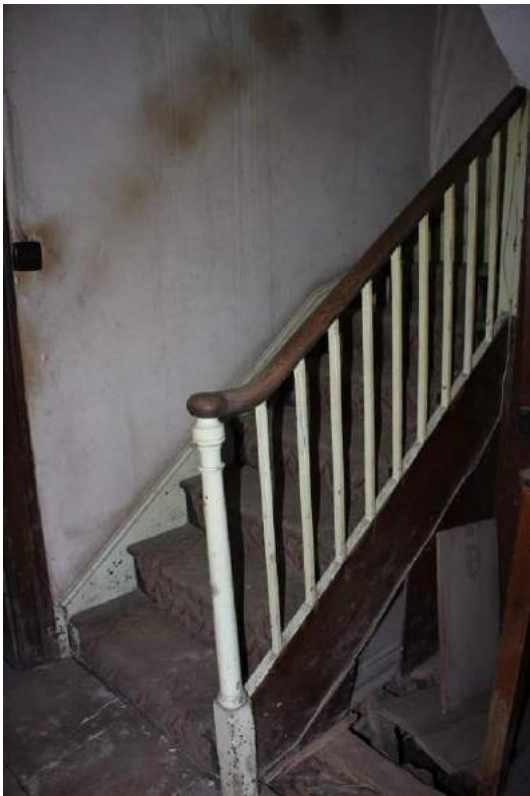
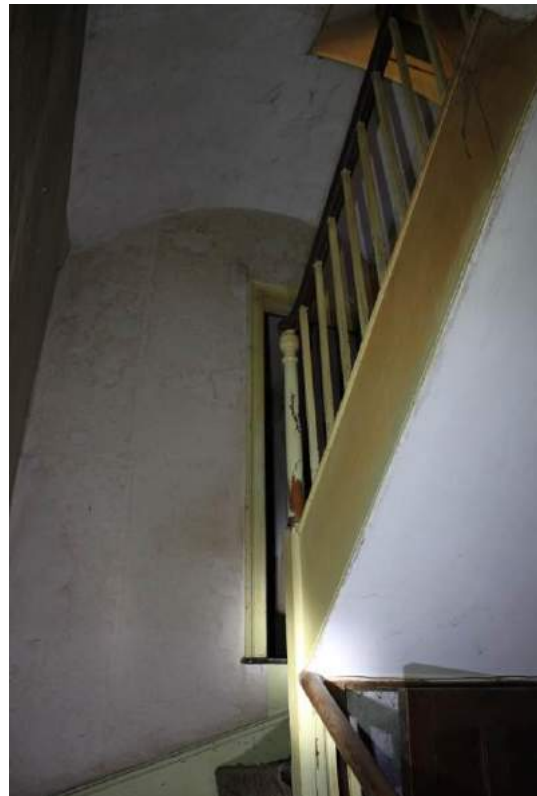
**Plate 21: Staircase**

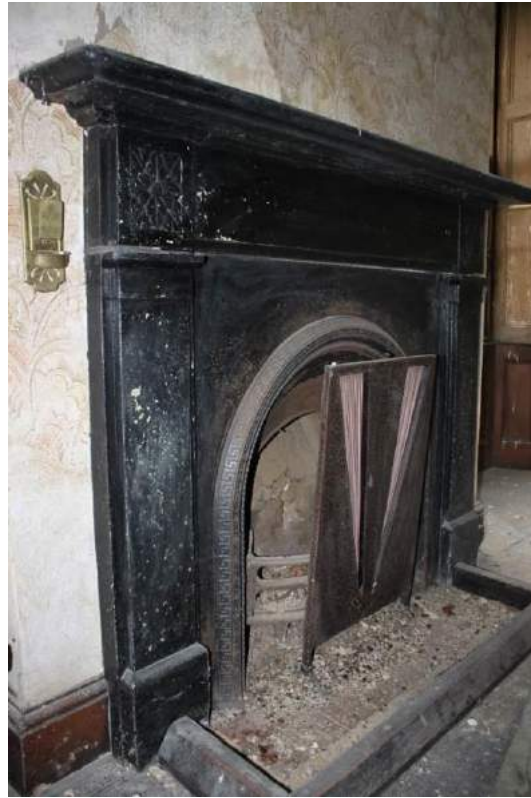
**Plate 28: Detail of fireplace in G3**

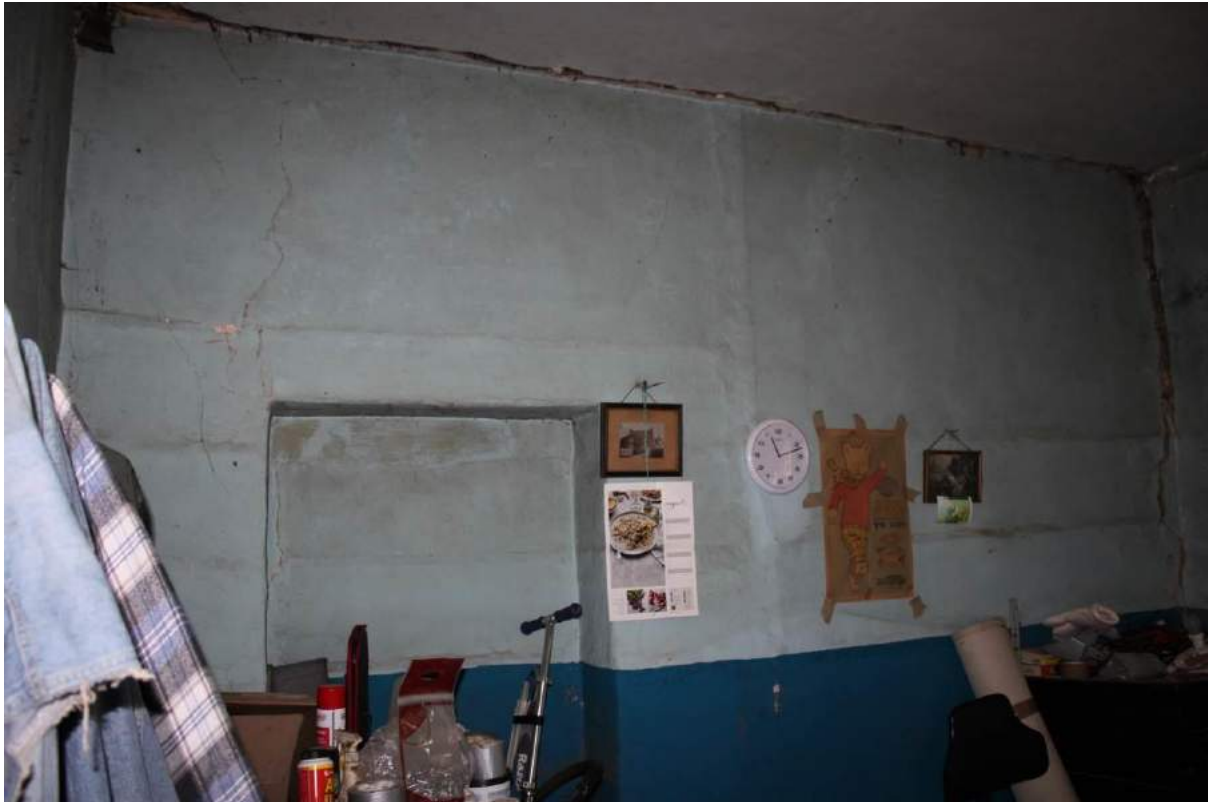
**Plate 31: G7, looking south, with blocked doorway into G3**

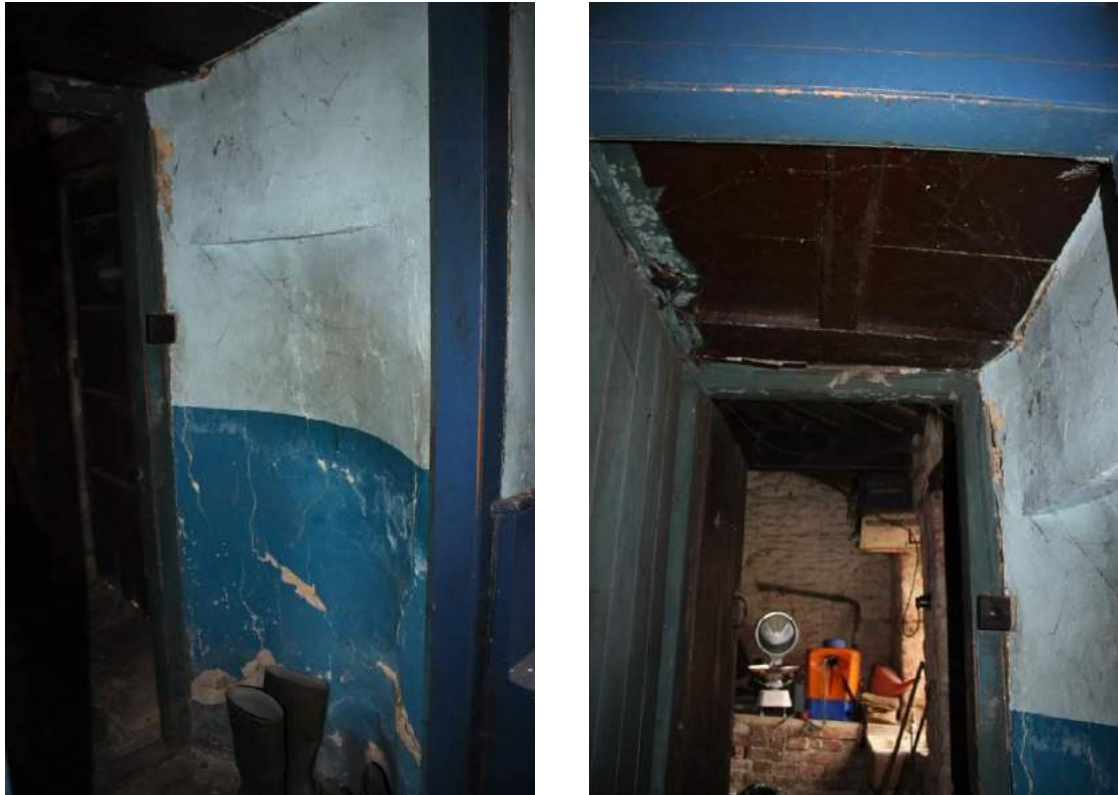
**Plate 32: Looking north through opening into G8 in Block 3**

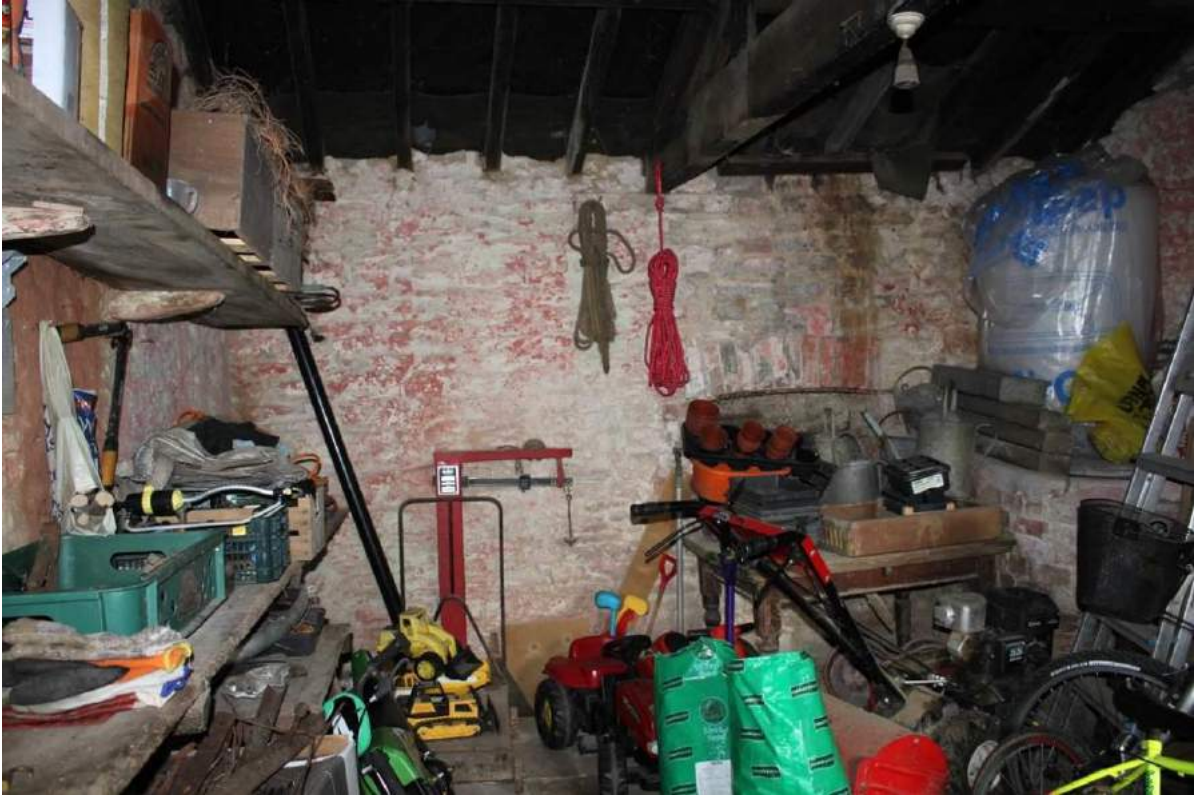
**Plate 34: G8, looking west; segmental arch to right is over opening for bread oven, with copper to right**

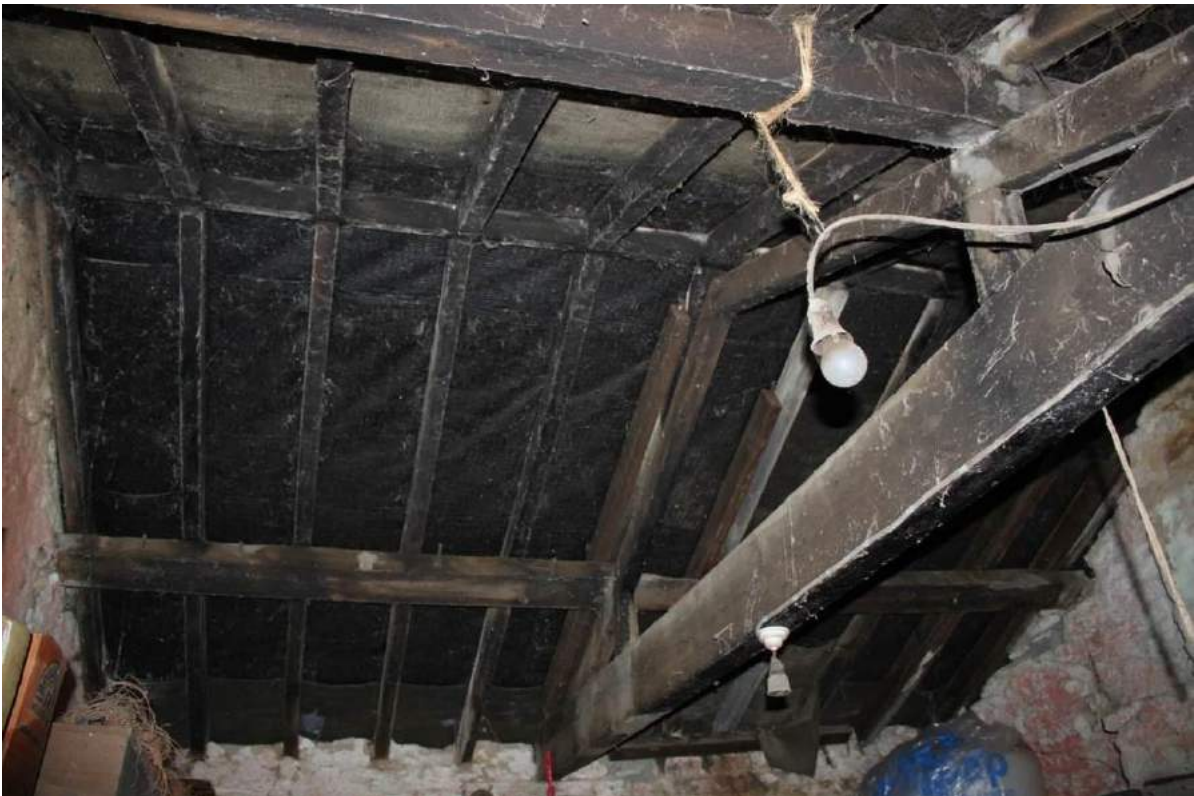
**Plate 35: Roof structure of G8/Block 3**

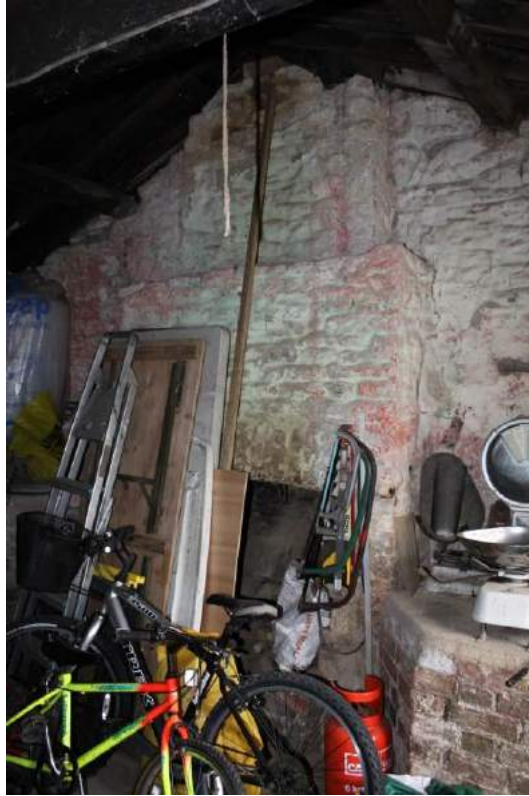
**Plate 36: Chimneybreast and fireplace on north wall of G8, with coppers to either side**

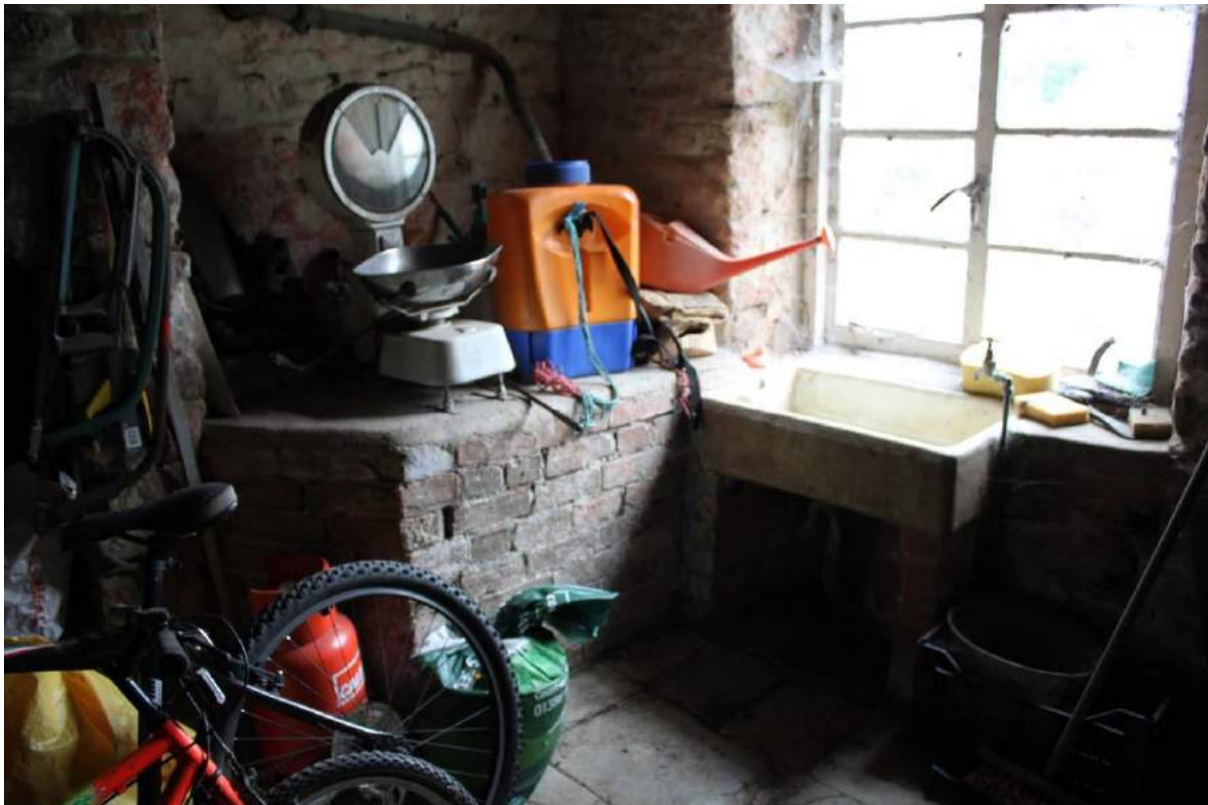
**Plate 37: Copper in north-east corner of G8**

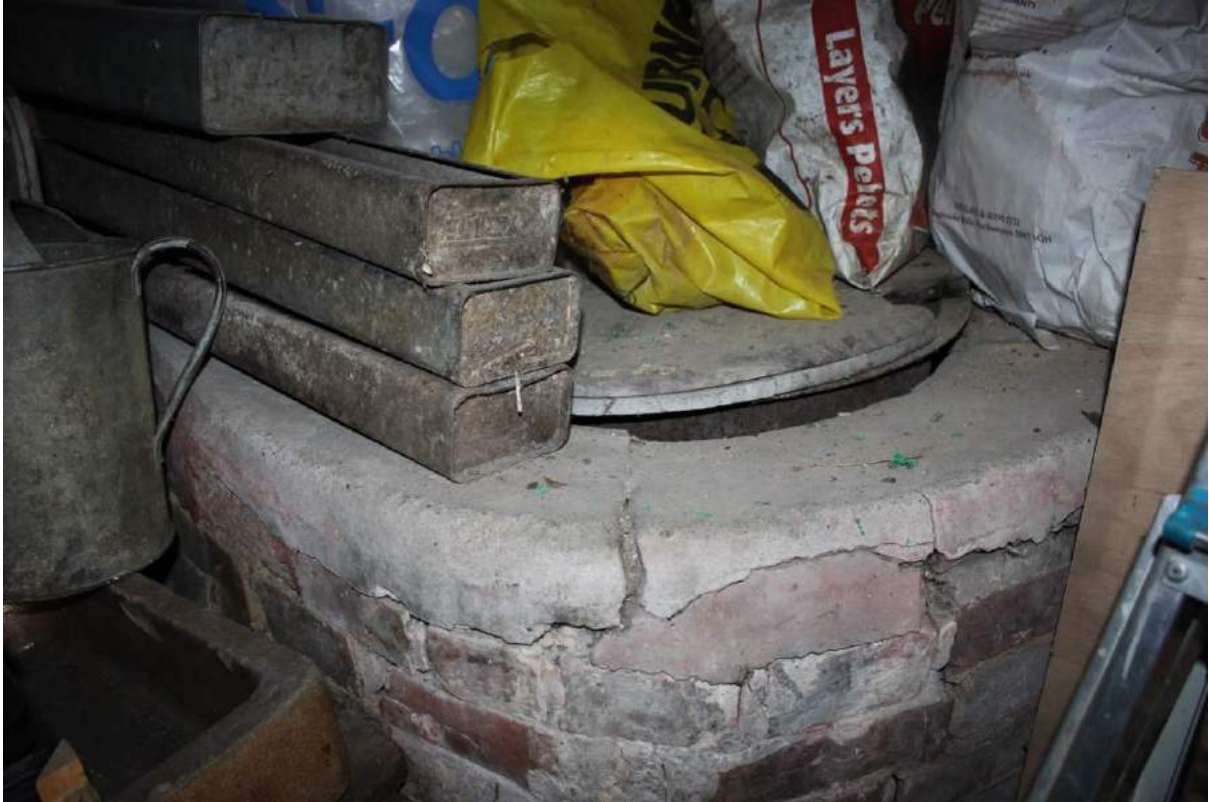
**Plate 38: Detail of copper in north-west corner of G8, with vessel and lid apparent**

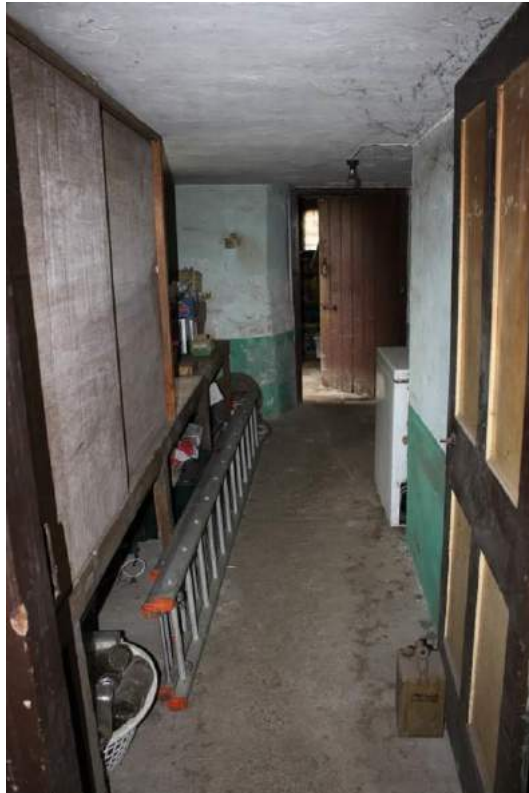
**Plate 39: Looking east into G5**

- 3.2.28 G5, the rear room behind G2, has an 'L'-shaped plan dictated by the presence of the staircase (**Plates 39 & 40**). This is, and no doubt was historically, a service room. It is possible that it and the adjoining G6 operated as a dairy and cheese-room, although the evidence for this is rather scant. G5 has a relatively low ceiling and is contained within the rear outshut. The floor is of concrete and there is a long wooden workbench fitted against the north wall, with a shelf above at one end. There is a single window opening in this wall containing an original two-light square-leaded casement. A door

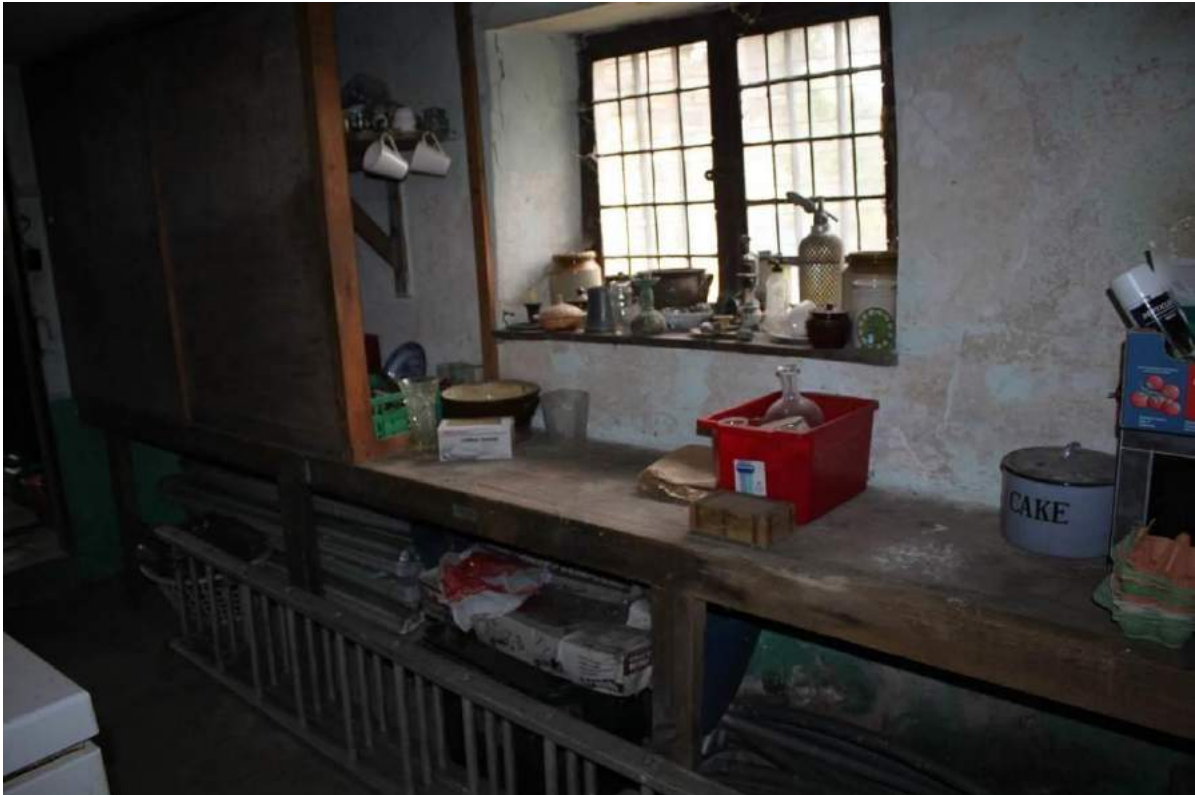
**Plate 40: North wall of G5, with bench**

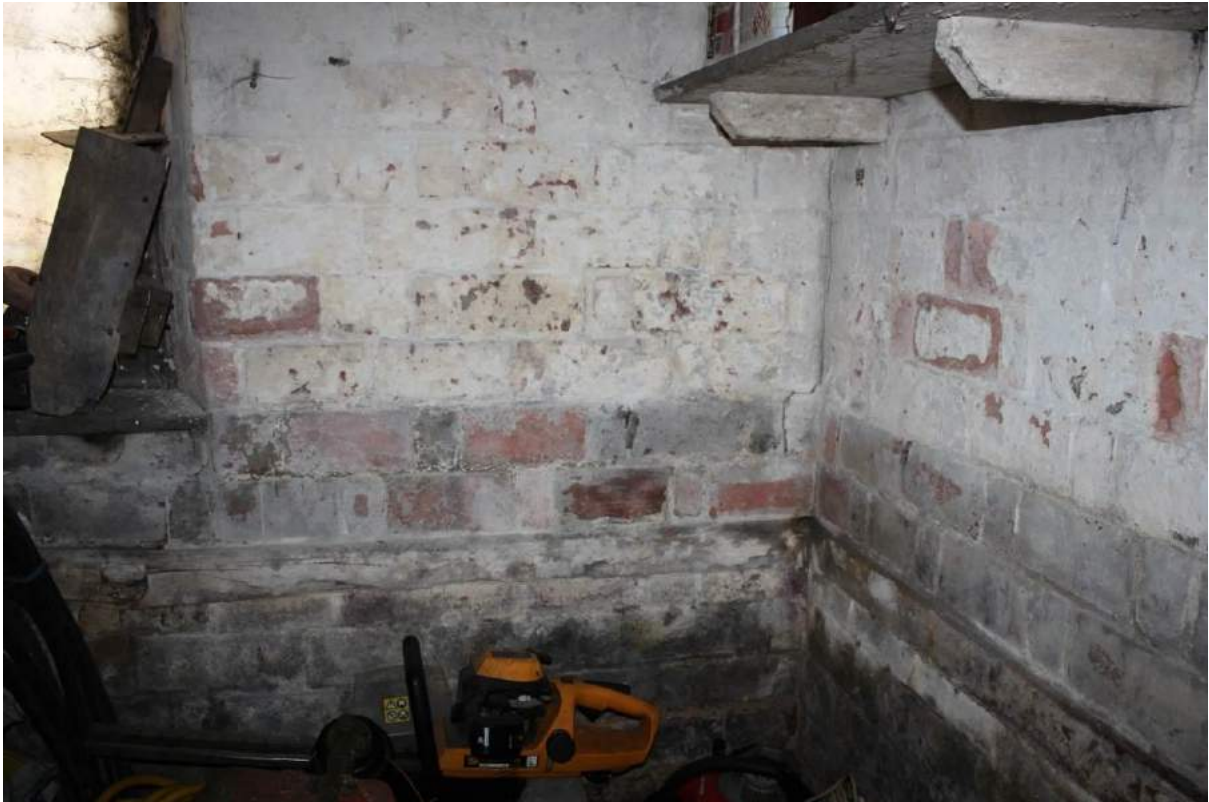
**Plate 43: Detail of Rat Trap Bond brickwork in G6**

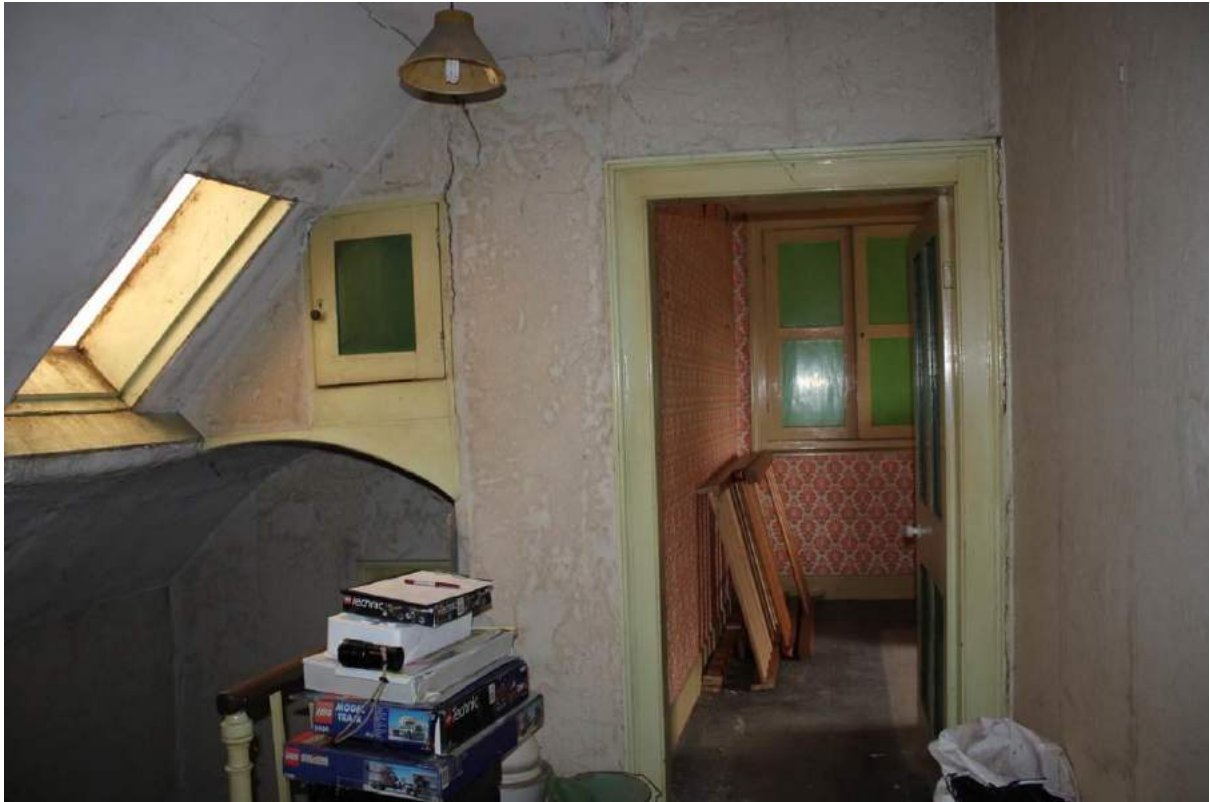
**Plate 45: F1 (landing), looking east towards bedroom F5**

- 3.2.31 The staircase rises within the outshut to a small landing (G1) under the sloping roof and partly within the front range (**Plates 45 & 46**). There are three bedrooms across the front of the house (F3, F4 & F5), with a fourth (F2) in the rear wing. Although there is no half-landing, the stair winders partway up give access via a door opening in the east wall of the stairwell into a small room (F6) within the outshut into the lower first floor of Block 2, where F7 comprises a room divided off at its eastern end to contain a bathroom and WC.

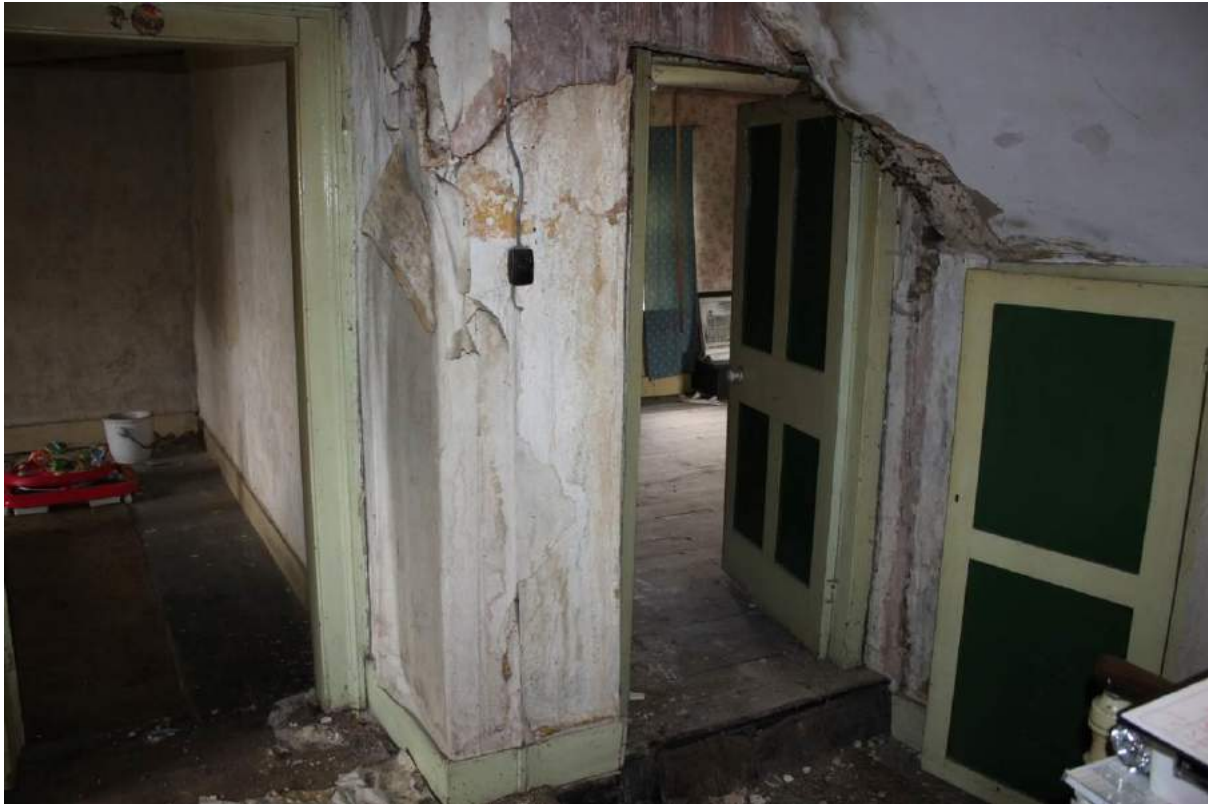
**Plate 46: F1, looking west towards F3 and F2; note line of outshut roof with vertical crack beneath, left of the cupboard door**

- 3.2.32 There is a step up from the landing into F2 in the rear wing and onto the part of the landing within the front range containing the other three bedrooms. There is a cupboard formed beneath the roof slope adjoining the stairwell. A vertical gap has opened up between the western edge of the outshut roof and the eastern external wall of the rear range (**Plates 46 & 47**). Newspaper pushed into the gap dates from May 1953, which may indicate that the apparent movement of the western half of the

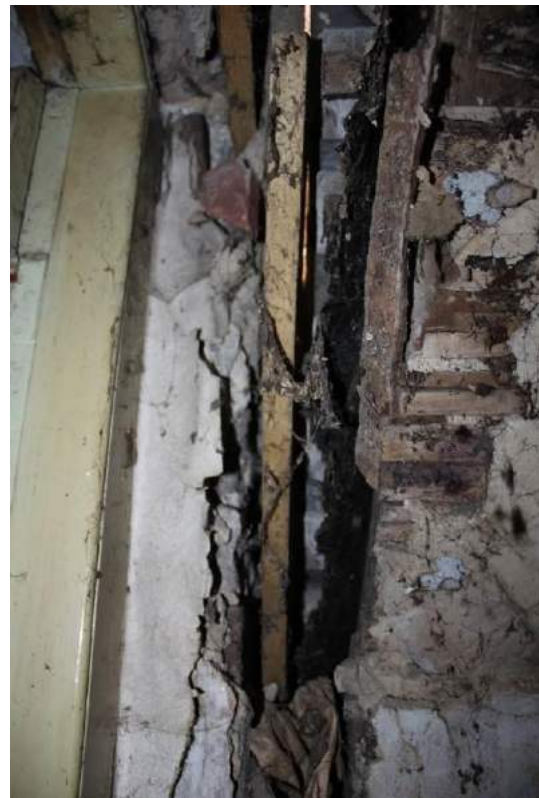
**Plate 47: Vertical crack between rear wing (left) and outshut (right)**
