## **STATEMENT OF SIGNIFICANCE**

**Stratfield Farmhouse, Kidlington,  
Oxfordshire**

**Manor Oak Homes**

**Date: September 2018**

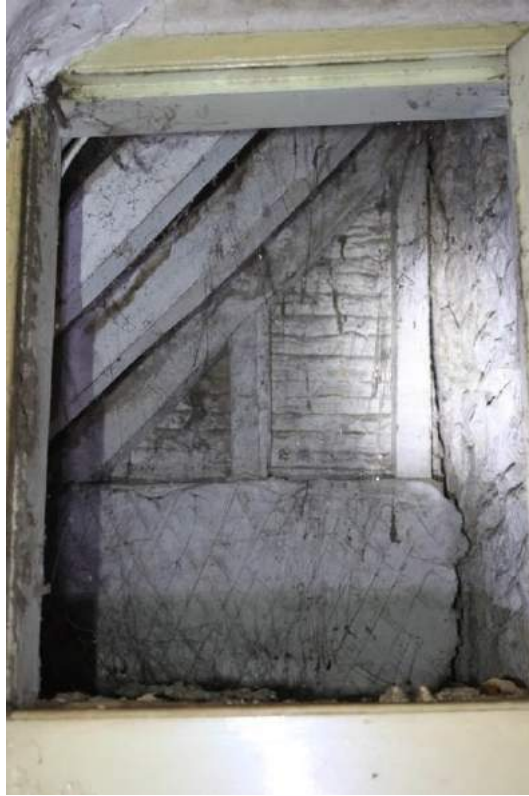
**Plate 48: View east through access door above stairwell (shown on Plate 45) into roof space within outshut**

- 3.2.33 A small access door above the stairwell provides a glimpse into the lime-washed upper part of the outshut roof space over the stairwell; three machine-sawn rafters can be seen, with the stone back wall of the front range to the right and ahead the lath and plaster partition wall forming the east wall of the stairwell (**Plate 48**).

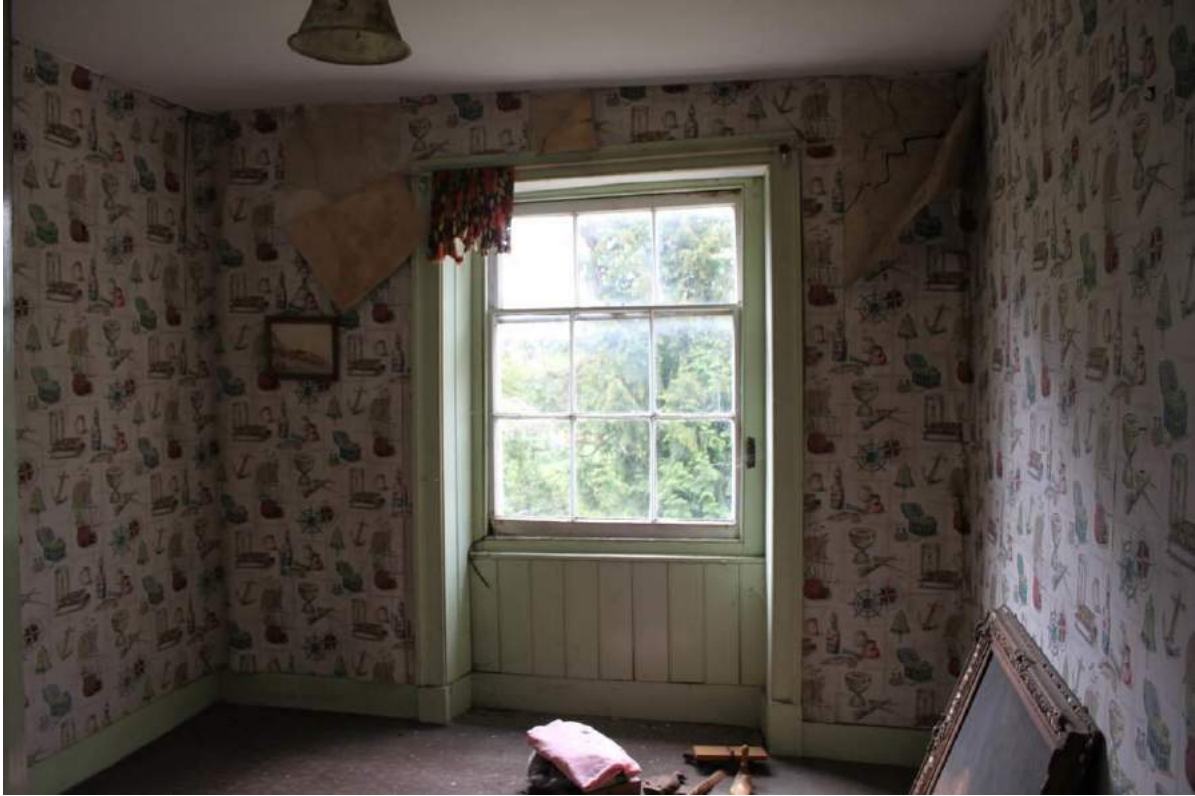
**Plate 52: F4, looking south**

- 3.2.36 F4 (**Plate 52**) is positioned centrally within the front range, sharing its bay with part of the landing and therefore smaller than F3 and F5. It has a similar window opening to F3 with architrave and match-boarded reveals and similar plain skirting. It has a four-panelled door with 19<sup>th</sup>-century coat hook.

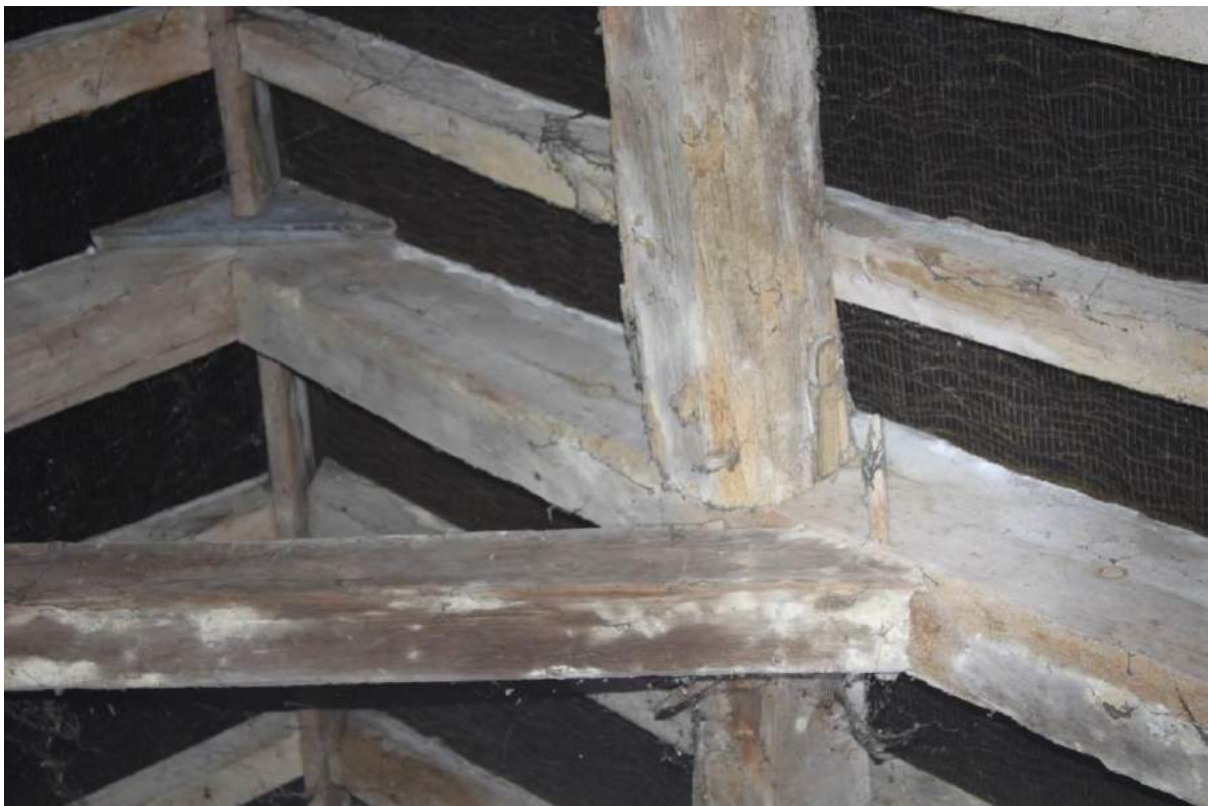
**Plate 53: Detail of roof structure above F4 in Block 1**

- 3.2.37 There is a hatch into the loft space in this room. This was not entered for lack of safe access, but parts of the roof structure could be seen through it, revealing what appear to be the original pegged roof timbers over the front range, including a collared truss with substantial butt purlins and common rafters rising to a ridge plank (**Plates 53 & 54**). The roof has been felted, presumably when the concrete tiles were laid.

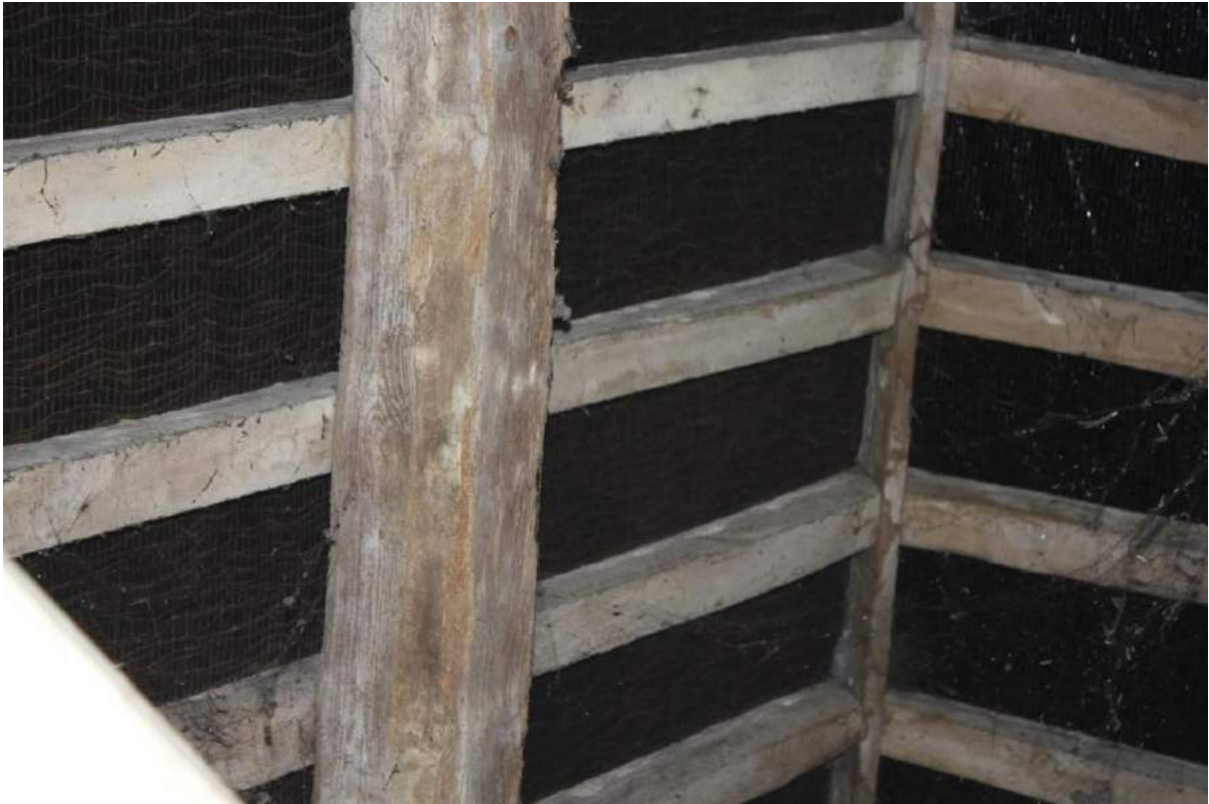
**Plate 54: Detail of roof structure above F4 in Block 1**

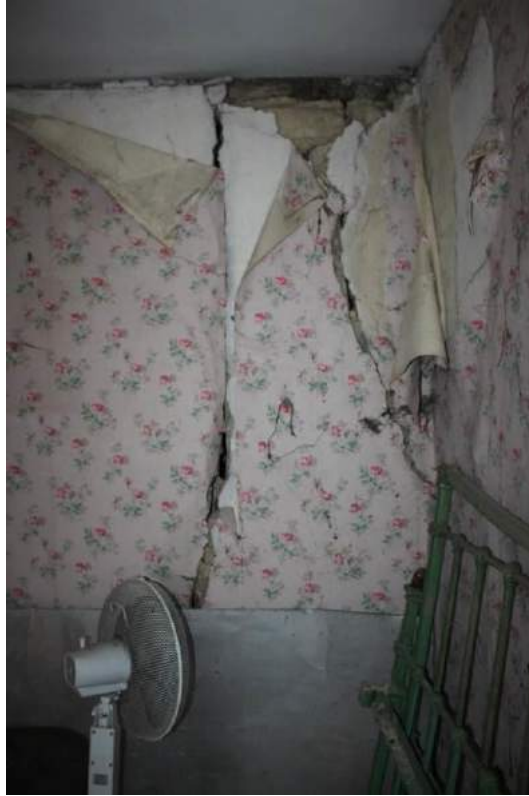
**Plate 60: Detail of cracks in masonry of south wall of F2**

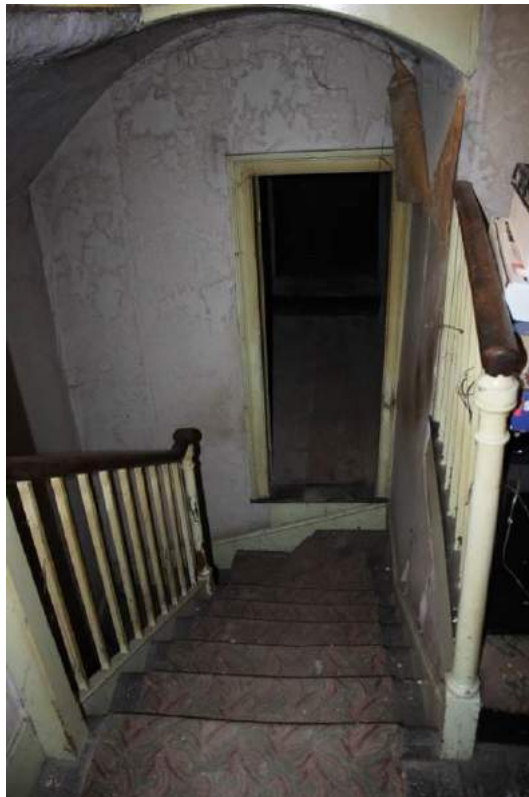
**Plate 61: Looking east down upper flight of stairs towards doorway into Block 2 off staircase**

- 3.2.41 The two remaining first-floor spaces are those at the lower floor level, accessed from partway up the staircase. F6 is entered directly from the doorway off the staircase (**Plate 61**) and comprises a small space under the sloping catslide roof (**Plates 62 & 63**), having no obvious particular use other than as storage and to provide access to F7, the first-floor room of Block 2. F7 is accessed up a step and through a six-panel door (the only such noted in the building), with the upper two panels glazed, presumably to allow a small amount of natural light into F6.

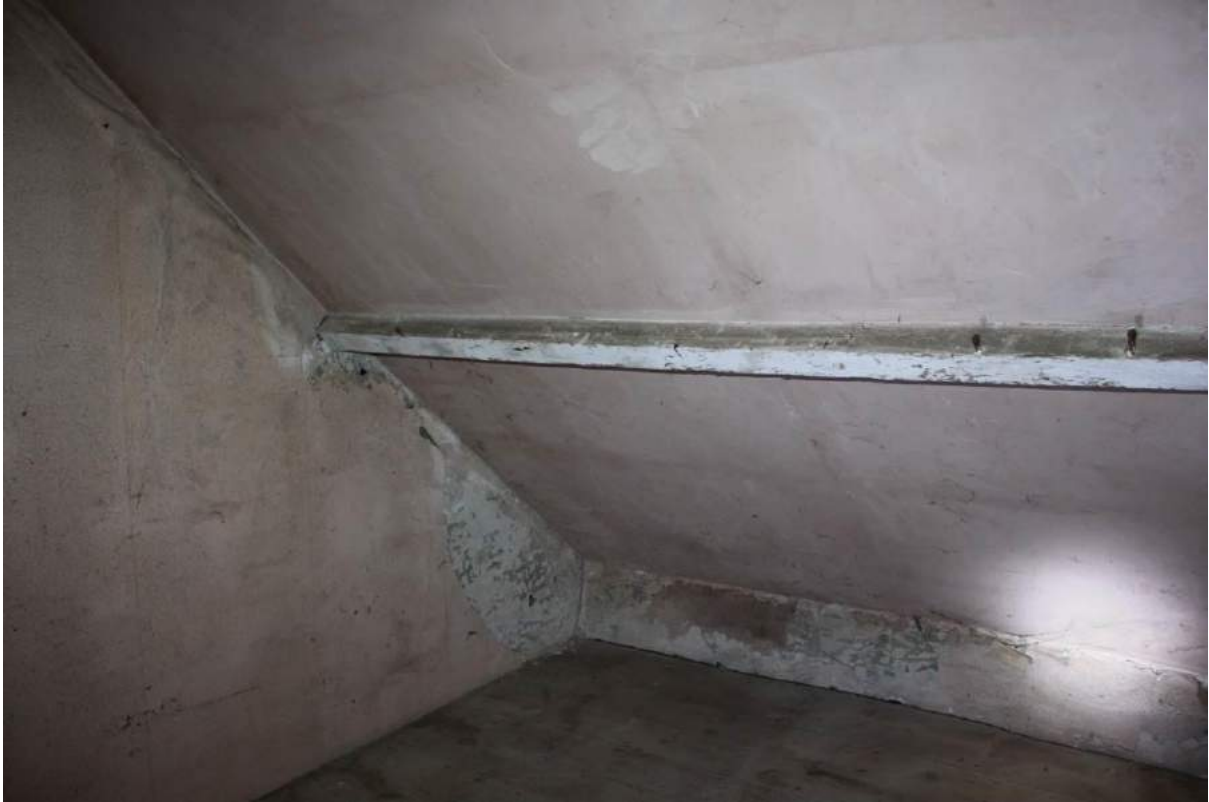
**Plate 62: F6, looking north beneath catslide roof of outshut**

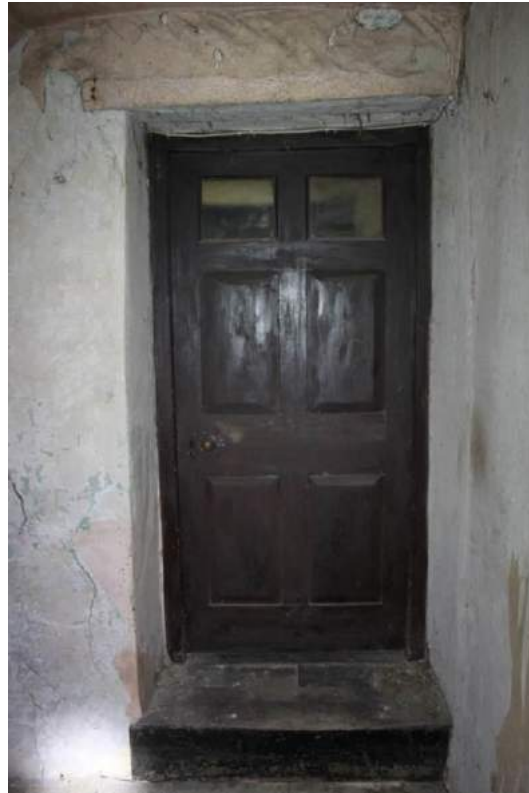
**Plate 63: F6, looking east towards six-panelled door into F7**

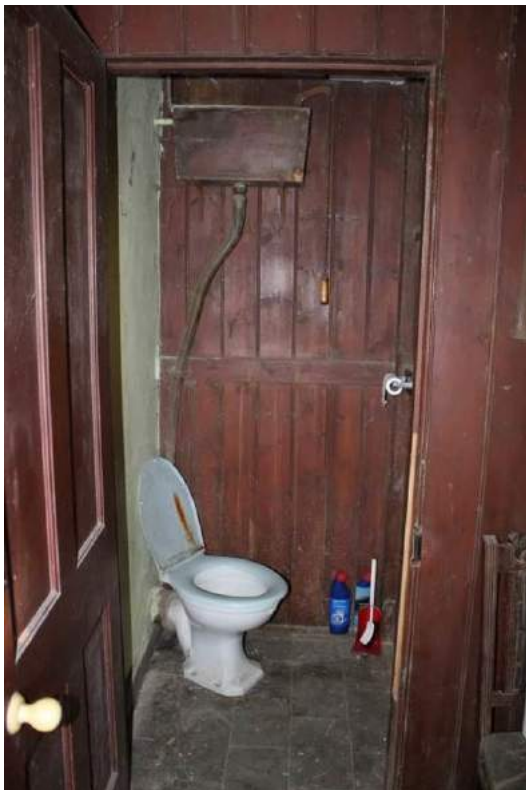
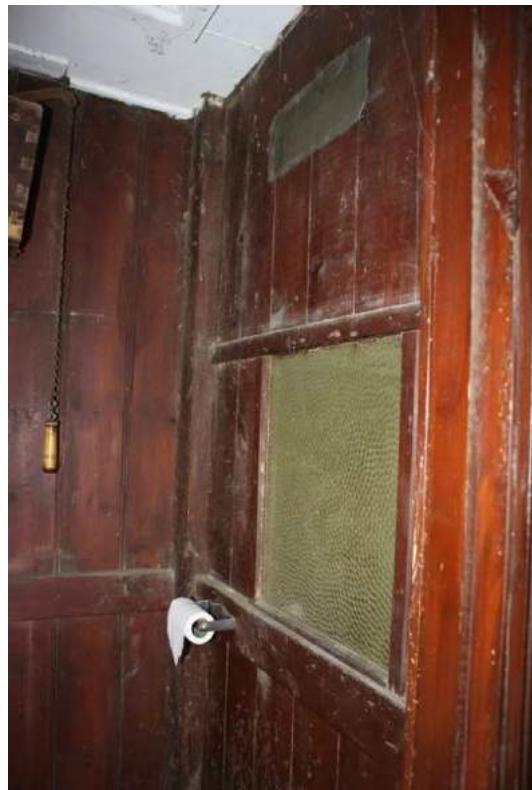
**Plate 67: WC with wooden cistern in F7 (left) and partition between WC and bathroom (right)**

- Plate 67: WC with wooden cistern in F7 (left) and partition between WC and bathroom (right)
- Plate 68: Google mapping aerial view of the farmhouse and outbuildings, looking north

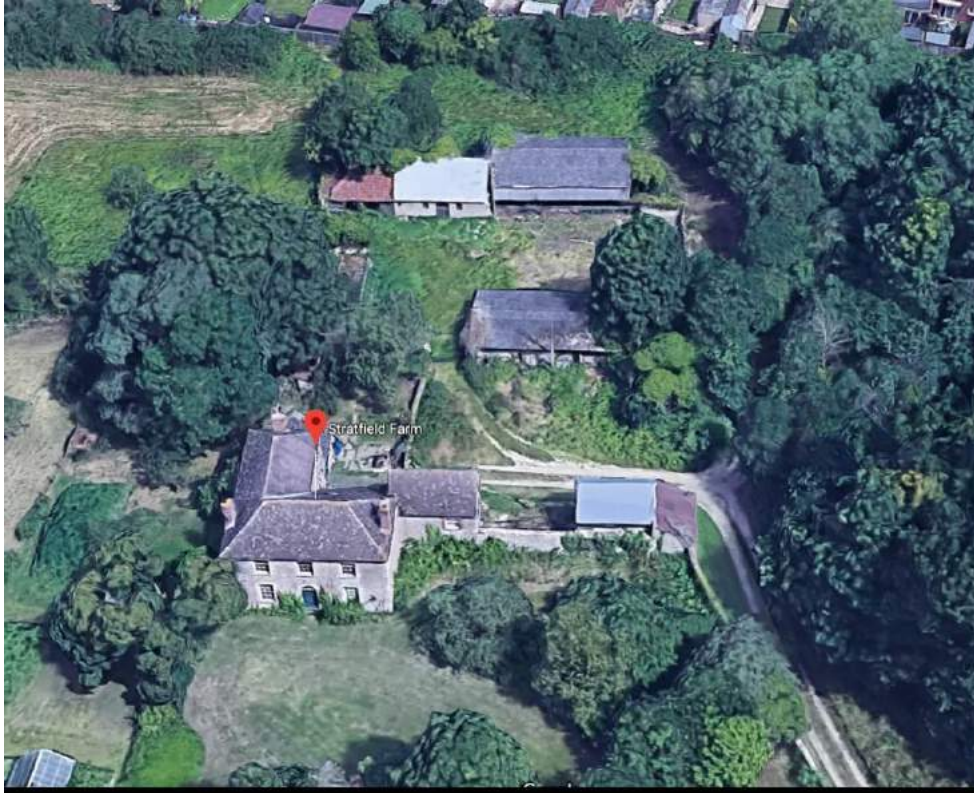
**Plate 68: Google mapping aerial view of the farmhouse and outbuildings, looking north**

- 3.3.1 The group of former farm outbuildings (**Plate 68**) stand around two linked yards north of the farmhouse. The majority of these pre-date 1948 and those which do should probably be considered listed by virtue of curtilage in association with the farmhouse.

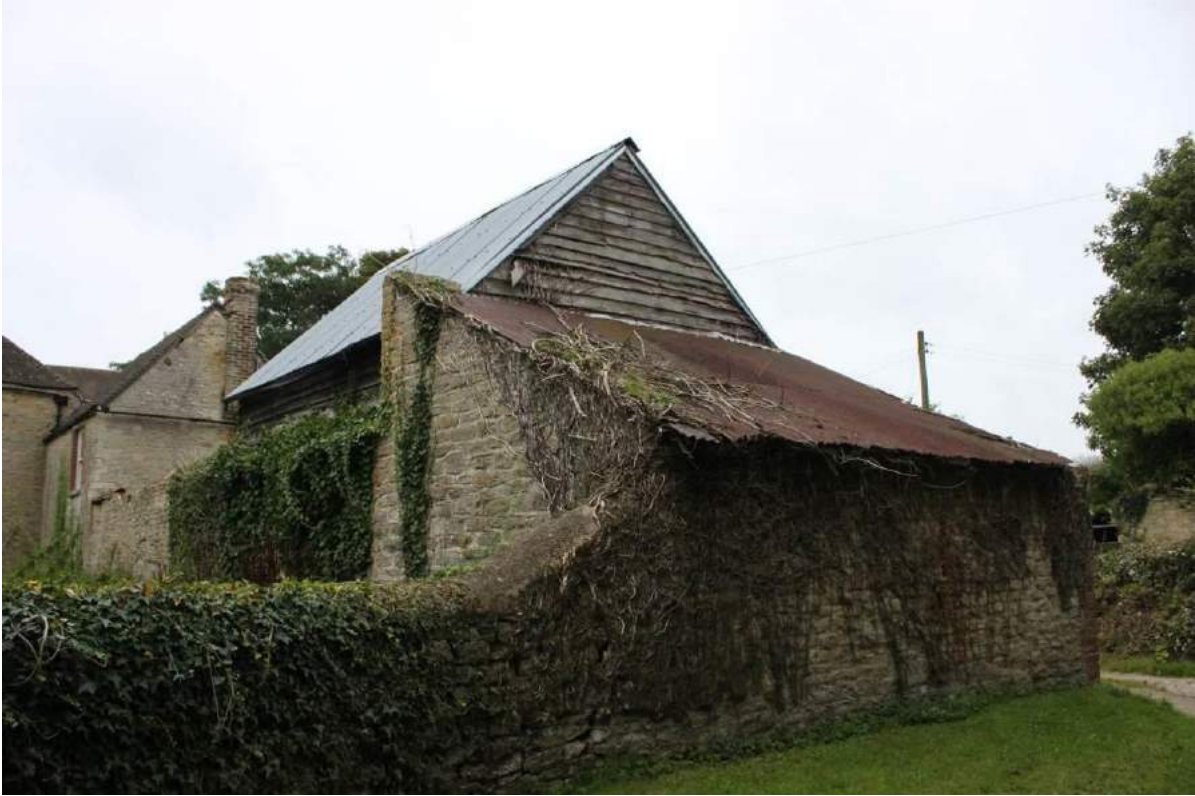
**Plate 72: Outbuilding A1, east elevation**

- 3.3.5 Outbuilding A1 (Plate 72) is the lean-to structure which infilled the space between Building A and the return to the north of the stone boundary wall between 1876 and 1899. To create this structure, the boundary wall appears to have been raised (in stone) to form the southern lean-to 'gable' end. The eastern wall is formed by a continuation (and raising) of the eastern stone boundary wall to the farmhouse garden. The north side is a timber screen with double (plywood) doors. There is a corrugated sheet metal roof.

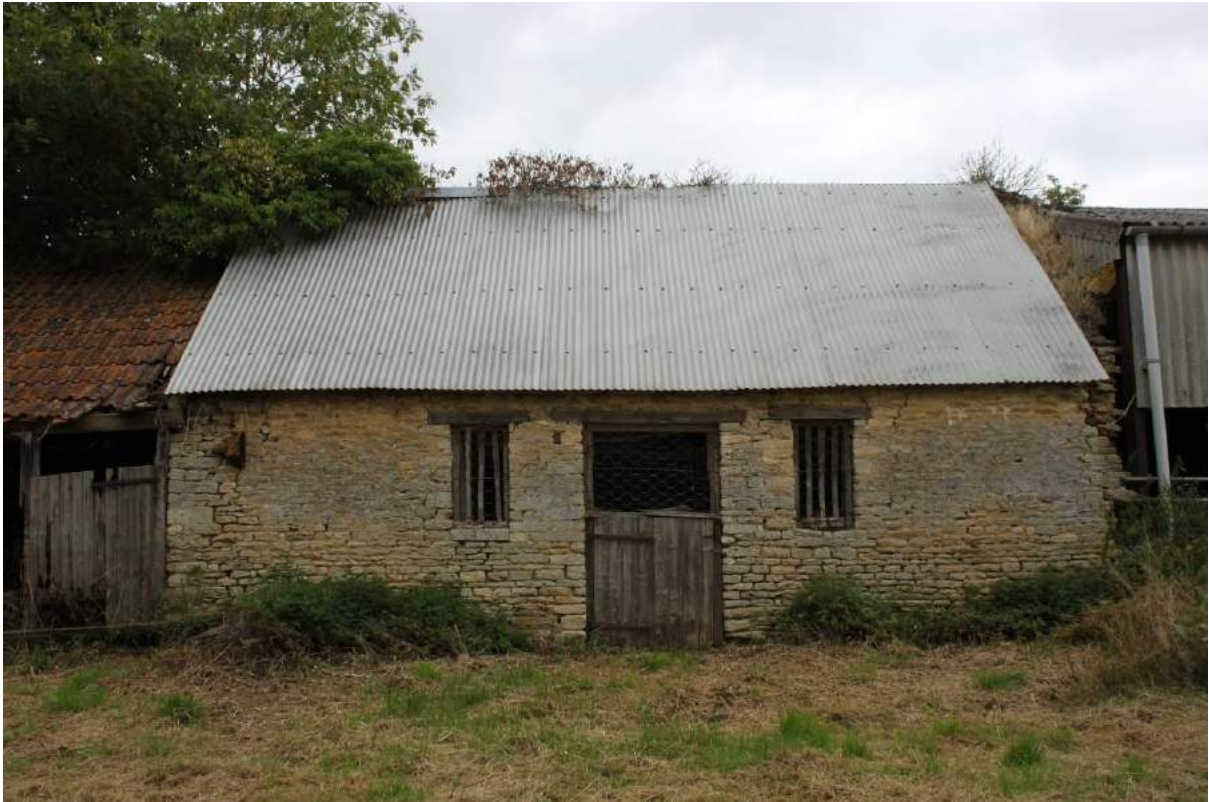
**Plate 75: Outbuilding B, south elevation**

- 3.3.6 Outbuilding B (Plates 75 & 76) is a single-storey range constructed of coursed rubblestone and with a pitched roof covered with corrugated metal sheeting. The building was present by 1876 and was probably constructed in the first half of the 19<sup>th</sup> century contemporary with the farmhouse.

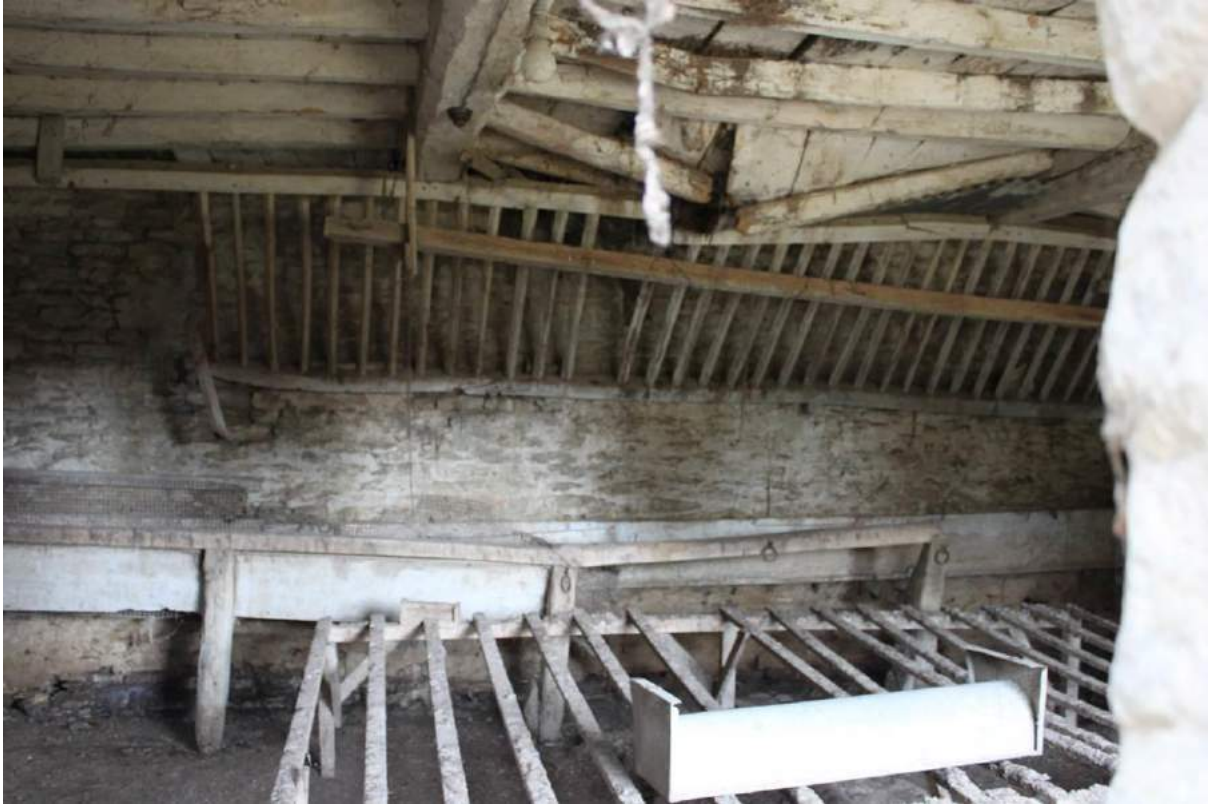
**Plate 76: Interior of Outbuilding B, with troughs and mangers against north wall**

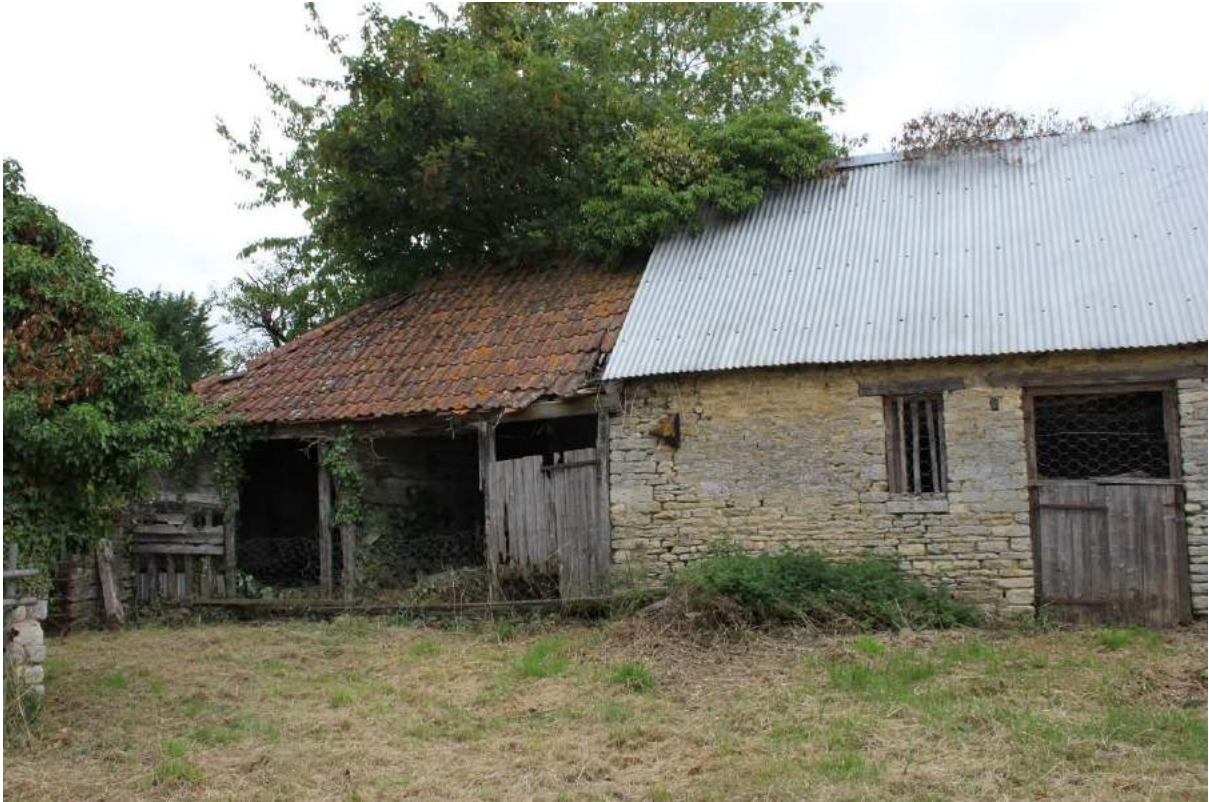
**Plate 77: Outbuildings B1 (left) and B (right)**

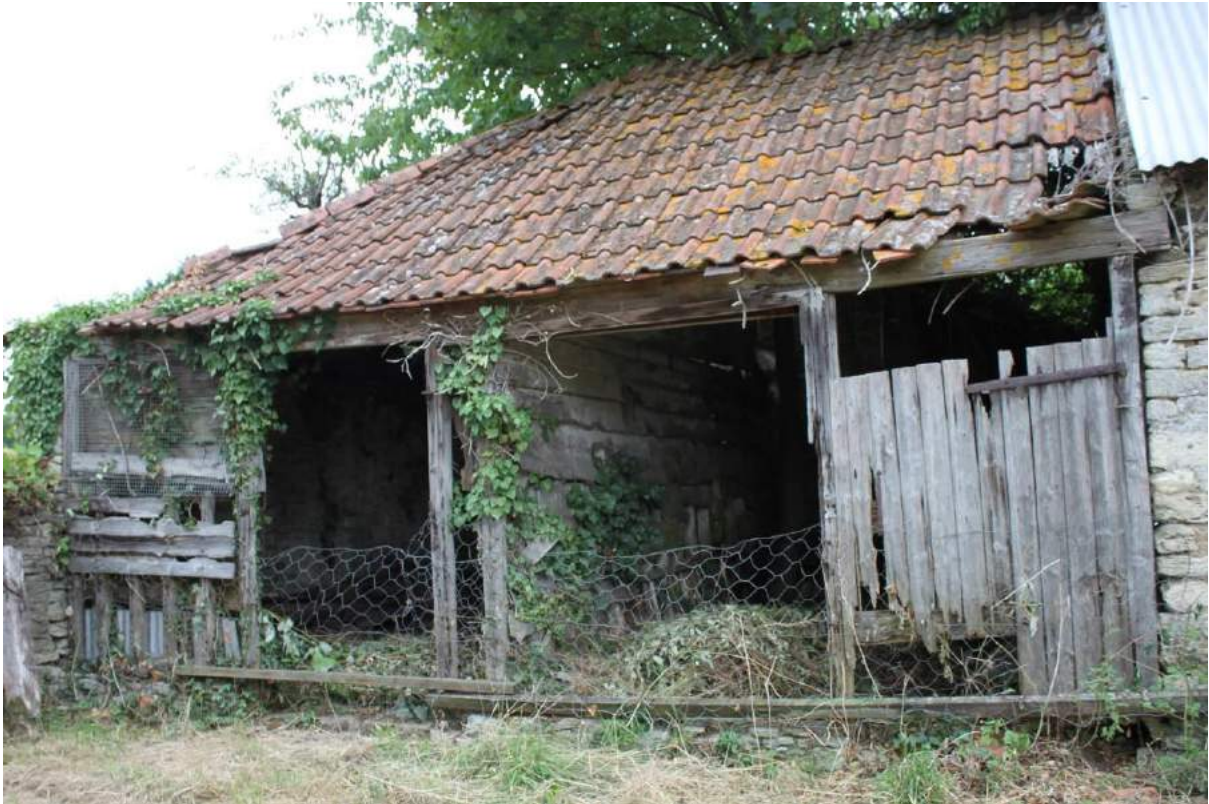
**Plate 78: Outbuilding B1, south elevation**

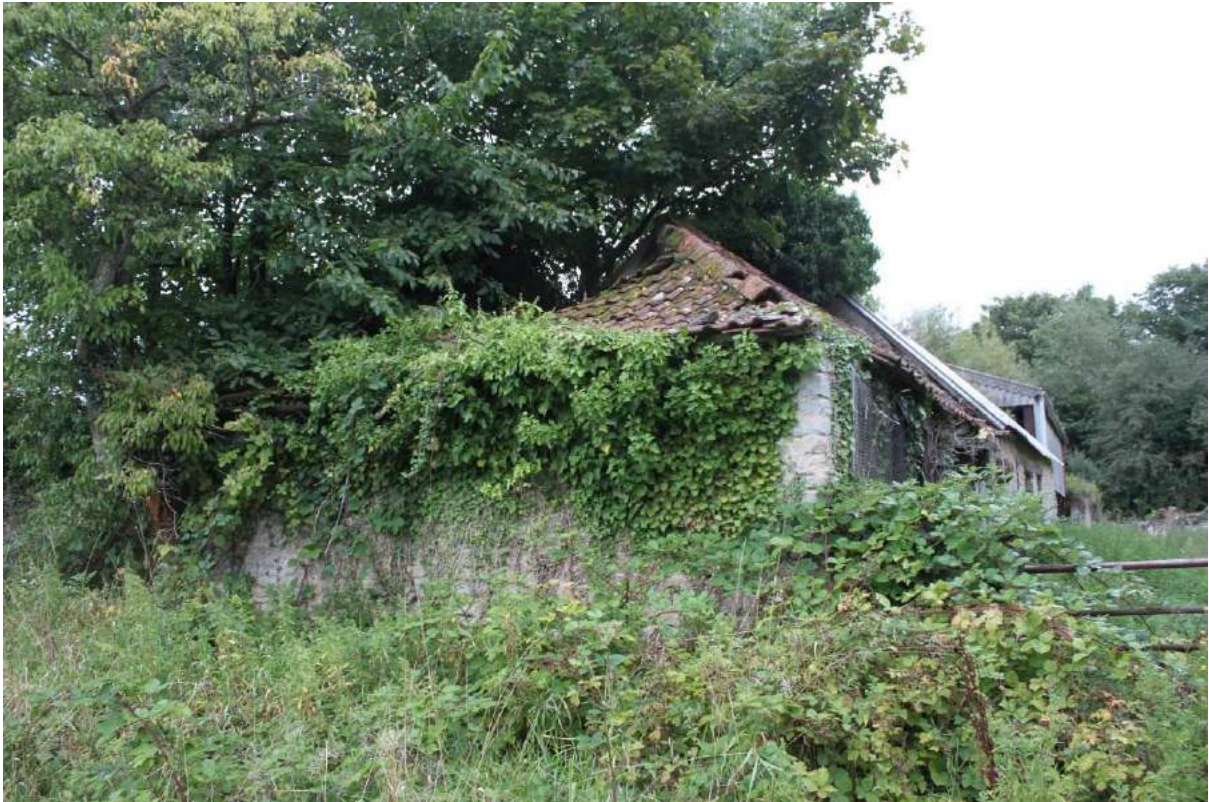
**Plate 79: Outbuilding B1, west elevation**

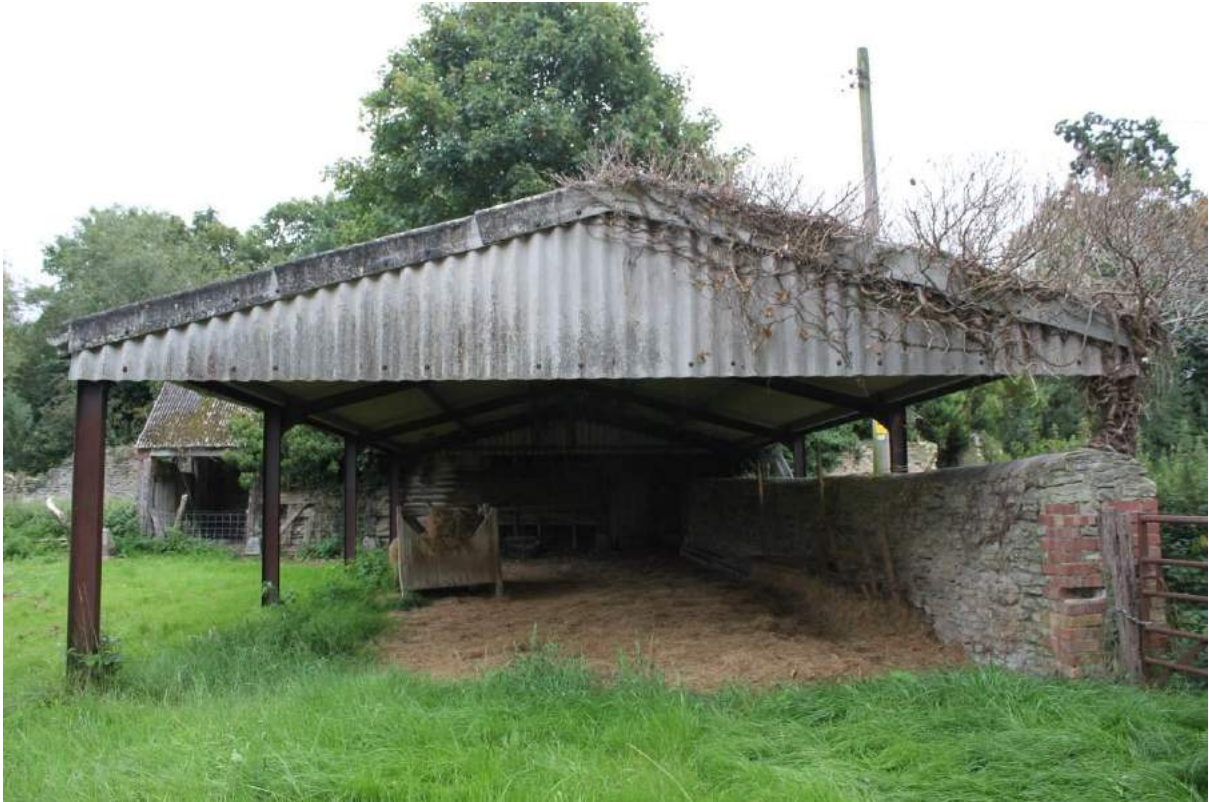
**Plate 80: Outbuilding C**

- 3.3.9 Outbuilding C (**Plate 80**) is a 20<sup>th</sup>-century steel-framed agricultural barn part-clad with corrugated sheeting and part open-sided, which replaced an earlier building on a similar footprint between 1936 and the 1970s.

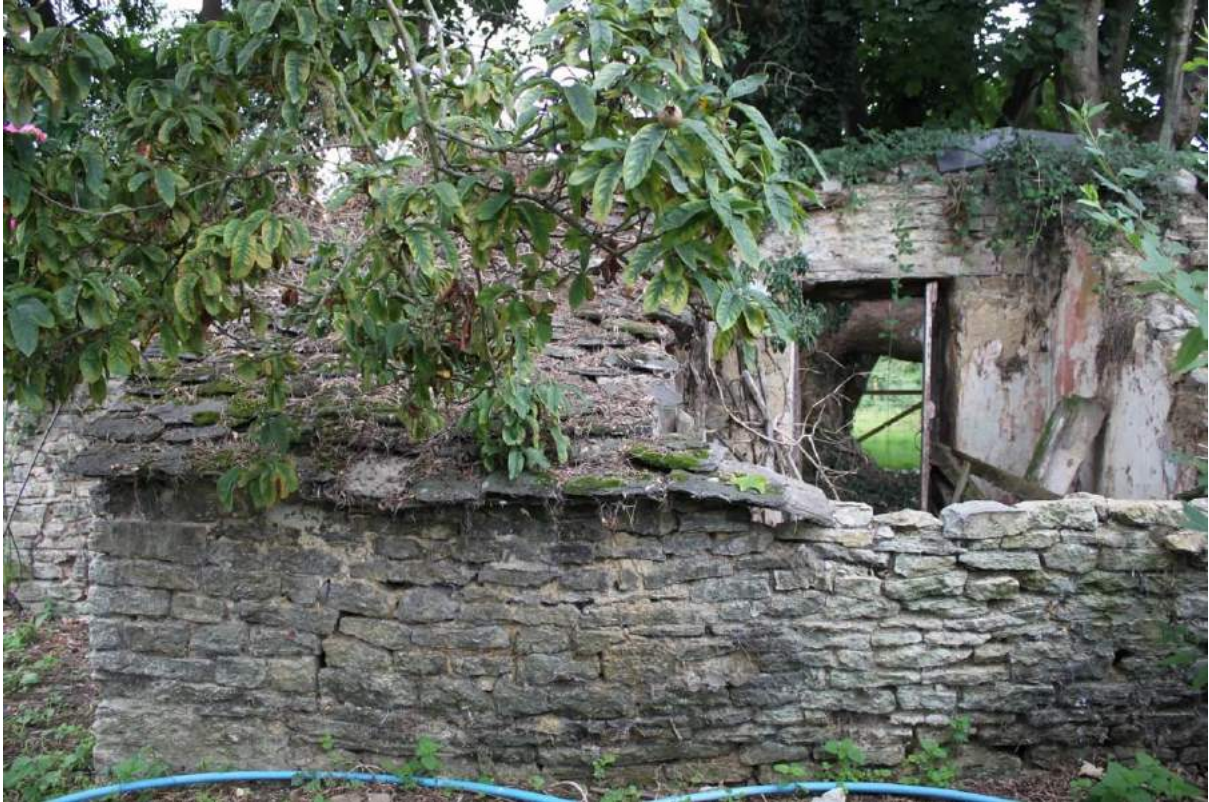
**Plate 81: Outbuilding D, with historic boundary wall**

- 3.3.10 Outbuilding D (**Plate 81**) is another 20<sup>th</sup>-century steel-framed open-sided agricultural barn with corrugated sheet metal cladding to the roof. This appears to have been erected between 1922 and 1936. The steels forming the structural posts along the southern side of the barn stand on the south side of a stone boundary wall which runs parallel to the structure, effectively incorporating the boundary wall into the barn as a partial south wall. This wall was in place by 1876, dividing the main farmyard from the yard to its south and the farmhouse garden.

- 3.3.20 The two lower-height stone dividing walls within the farmyard that are shown on the 1876 OS map have survived (**Plate 96** and see **Plate 81**).

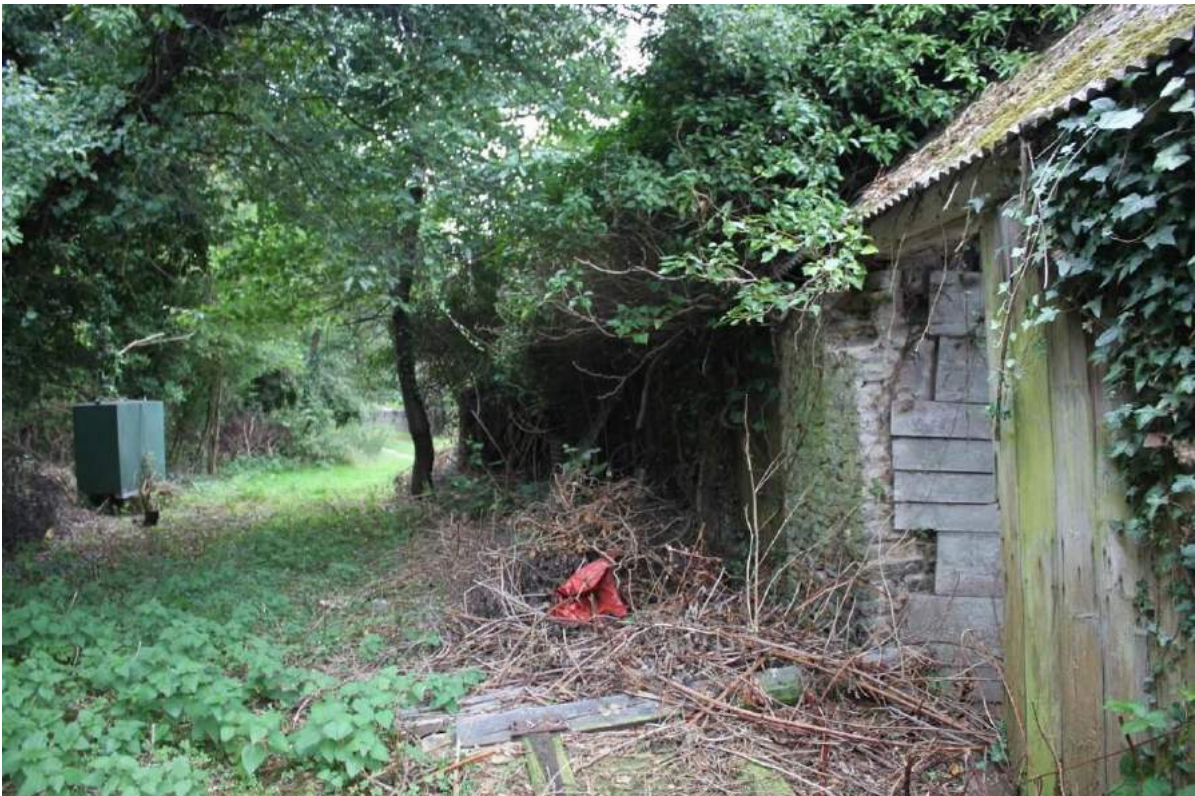
**Plate 86: Outbuilding F, showing northern gable end of southern range and, in the foreground, the ruined northern range**

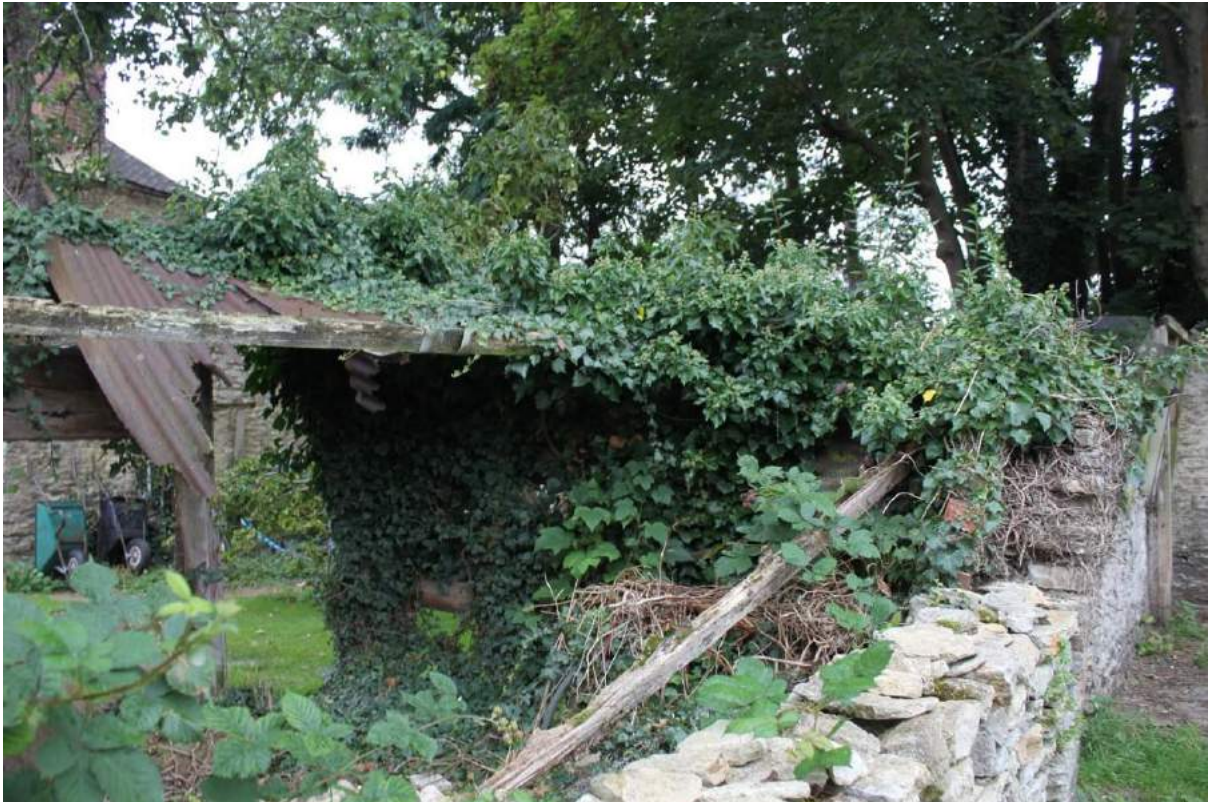
**Plate 90: Detail of roof structure of Outbuilding F**

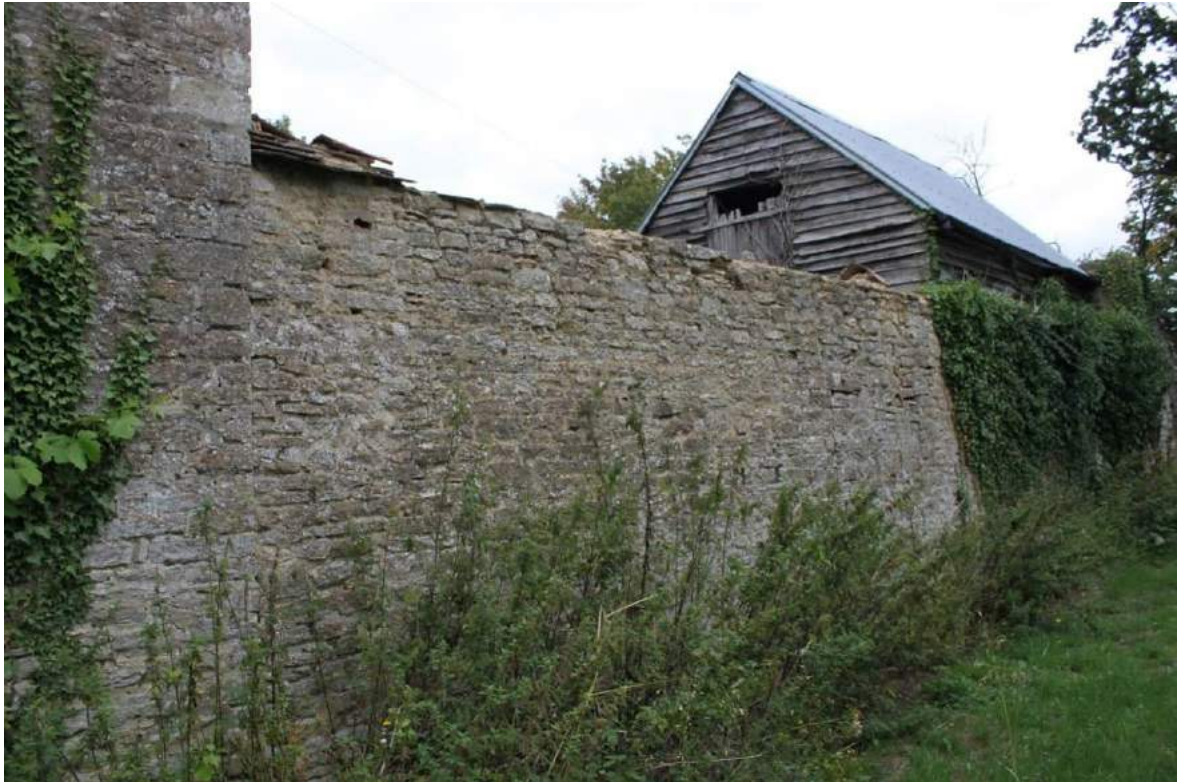
**Plate 91: Outbuilding G**

- 3.3.17 Outbuilding G (**Plate 91**) represents the remains of a small and largely collapsed former timber shed of probable early 20<sup>th</sup>-century date, which stands against the north wall of the rear garden/service yard to the farmhouse.

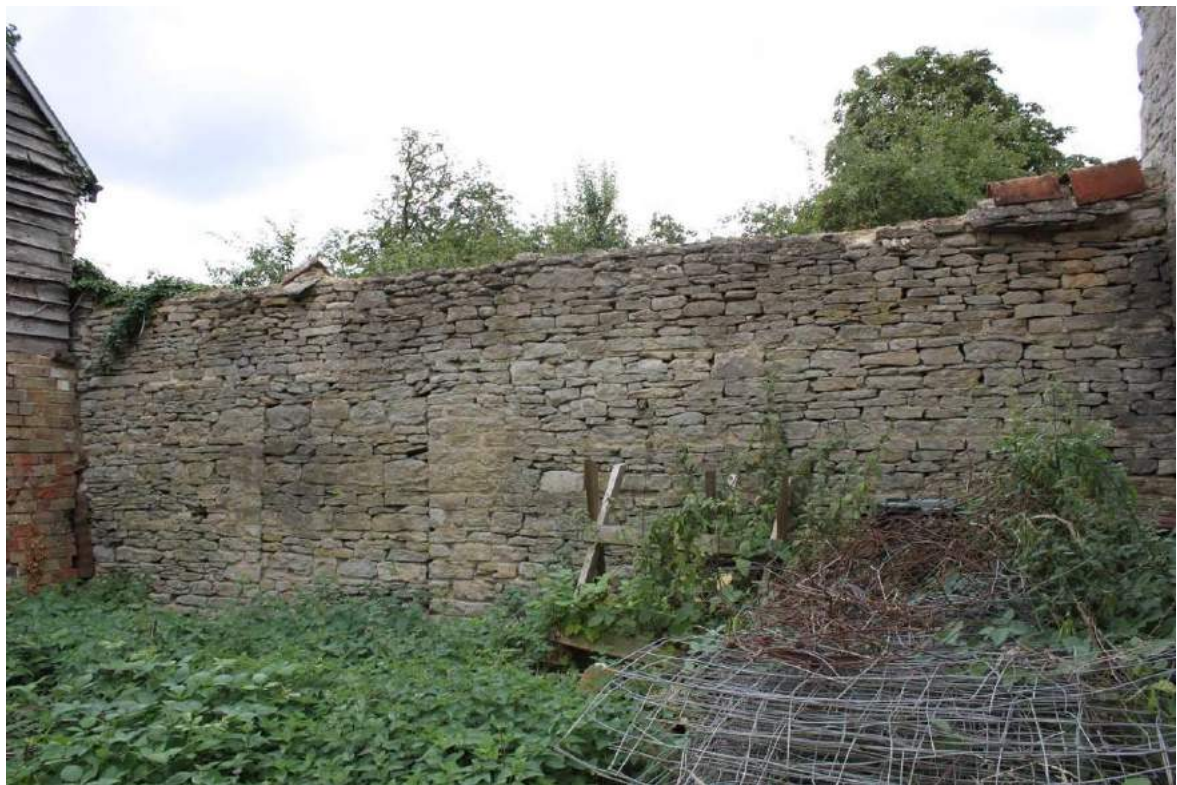
**Plate 92: South face of southern boundary wall extending between Block 2 of the farmhouse and Outbuilding A**

- 3.3.18 The farmyard is surrounded by high stone boundary walls, some forming part, or previously forming part of farm buildings, as described. The high boundary wall to the south which divides the farm from the main front garden to the farmhouse is physically attached to Block 2 of the farmhouse and will thus be included in the statutory listing (**Plates 92 & 93**). This wall has a blocked door opening in it.

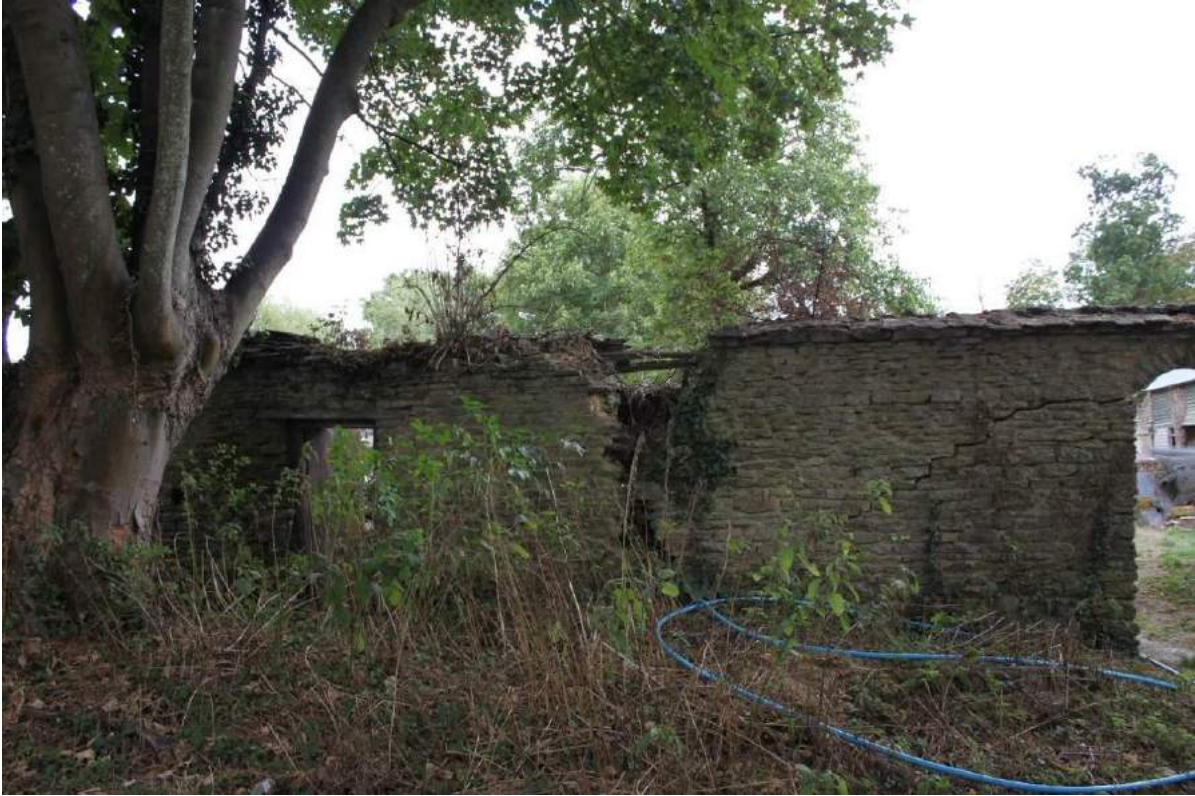
**Plate 93: North face of southern boundary wall extending between Block 2 of the farmhouse and Outbuilding A; note blocked door opening**

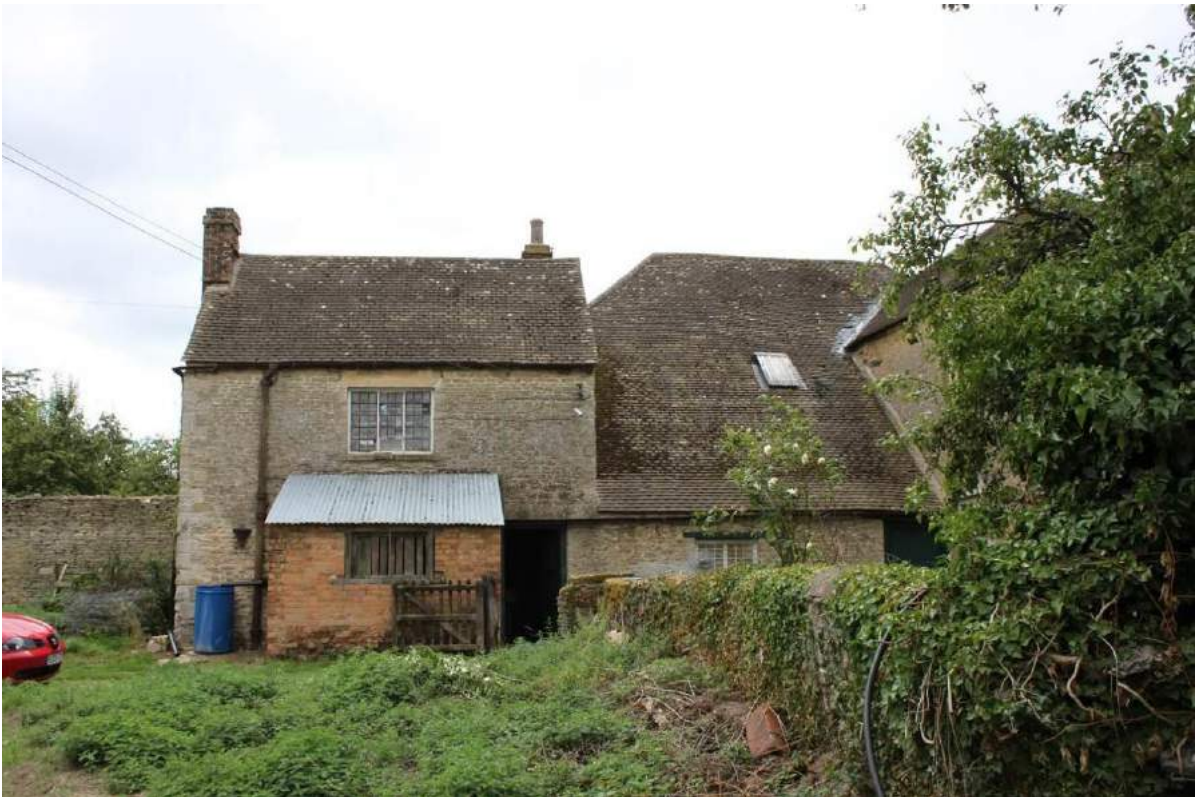
**Plate 94: West face of western boundary wall**

- 3.3.19 The high west wall which divides the rear garden/service yard from the garden to the west of the farmhouse is also attached to the listed building (**Plate 94**). This incorporates a round-arched opening into the service yard from the western garden. Both these walls retain remnants of stone slate capping. The condition of the west wall is generally poor, with cracks and collapsed sections.
