Elliott Wood Partnership Limited

**Bicester Golf Club,
Bicester, Oxfordshire**
*Geotechnical and Geoenvironmental
Interpretative Report*

March, 2022

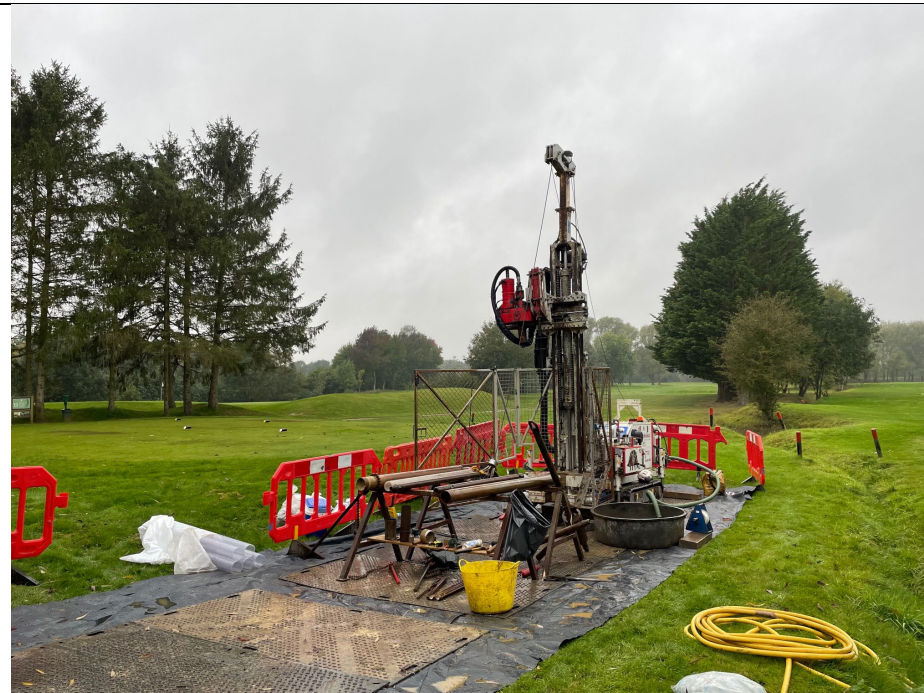
Photo 1. Photo showing typical rotary borehole rig setup

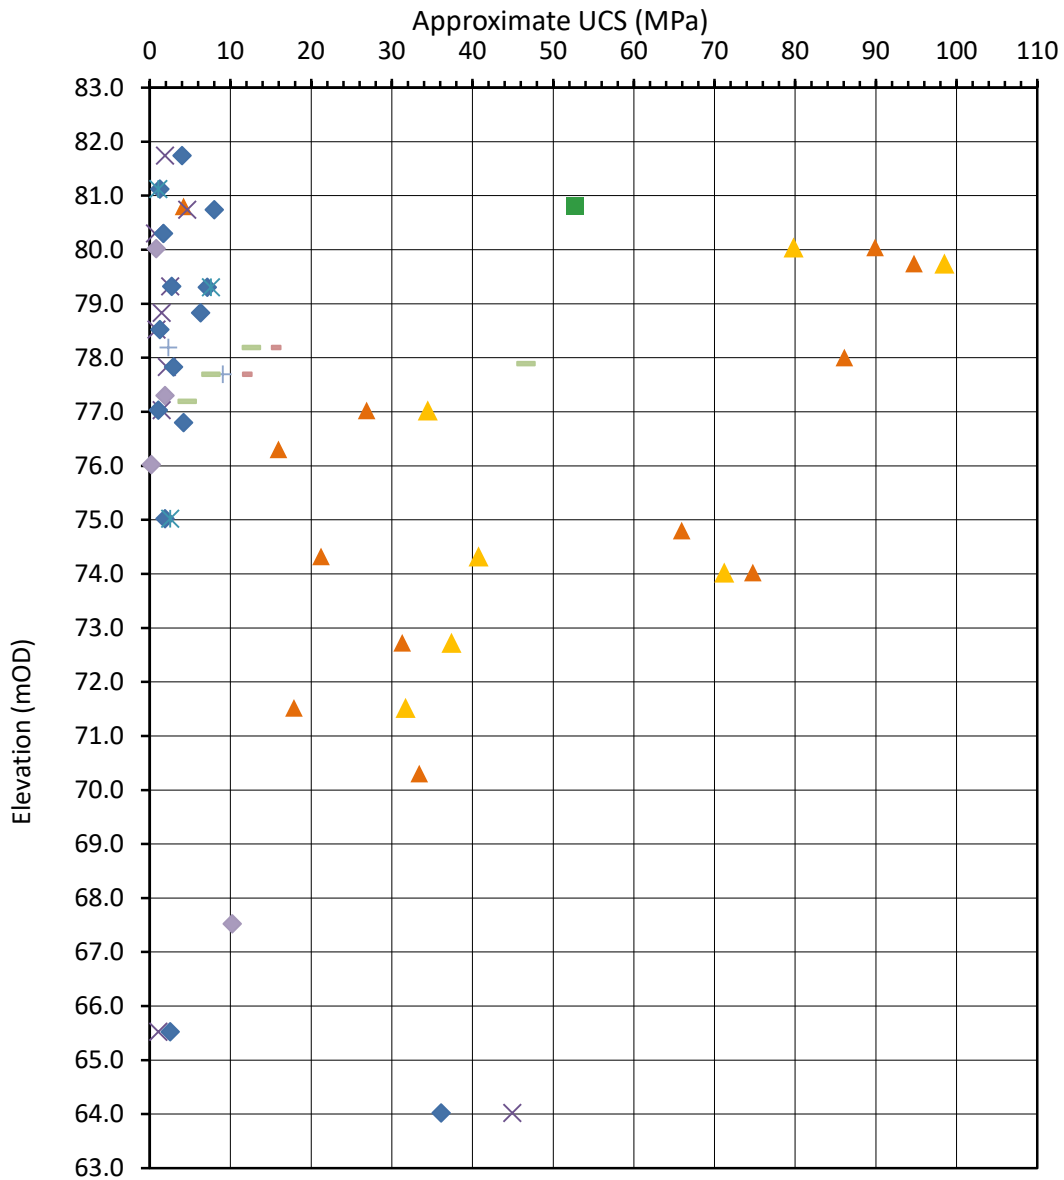
Title UCS vs Level - All Data	Figure 6

Note: Point load index $IS_{(50)}$ to approximate UCS based on correlation where approximate $UCS = 21 \times IS_{(50)}$

The ground conditions encountered during the CGL site investigation are summarised in Table 5. The observed strata are discussed separately in the following sections, together with the results of in-situ and geotechnical laboratory tests. Plots of SPT values, undrained shear strength against level, UCS values against level and a Plasticity Index Chart are presented in Figures 4 to 10.

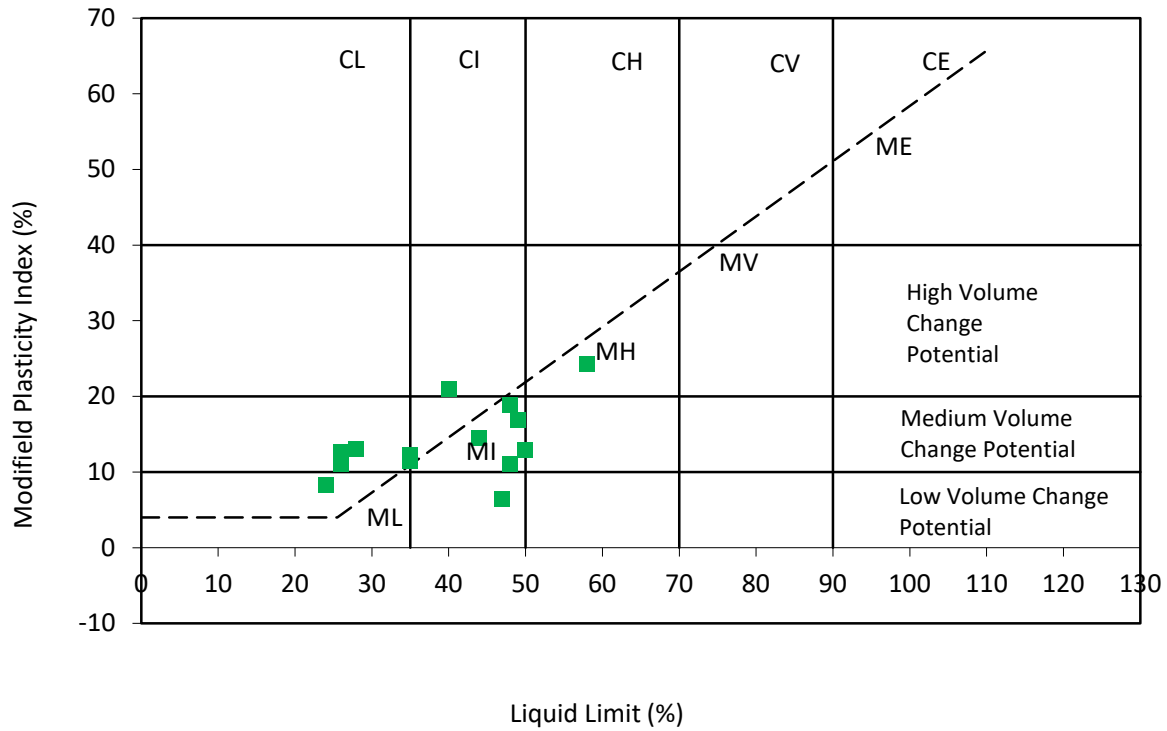
Client Elliott Wood Partnership	Project Bicester Golf Club, Bicester	Job No. CG/39017
 	Title Plasticity Index Chart	Figure 10

Key:
 C Clay M Silt
 L Low plasticity
 I Intermediate plasticity
 H High plasticity
 V Very high plasticity
 E Extremely high plasticity

■ Cornbrash Formation - - - A Line

Notes. Volume change potential based on NHBC 4.2 : 2016 : Building near trees. Plasticity of the soils is based on BS 5930 : 2015 : Code of practice for site investigations. British Standards Institution, London.
