Project Name: The Bungalow White Post Road Bodicote OX15 4BN Post

Project Description: Post Repair CCTV Survey

**Project Date:** 21/11/2022

## Section Inspection - 14/11/2022 - MH02X

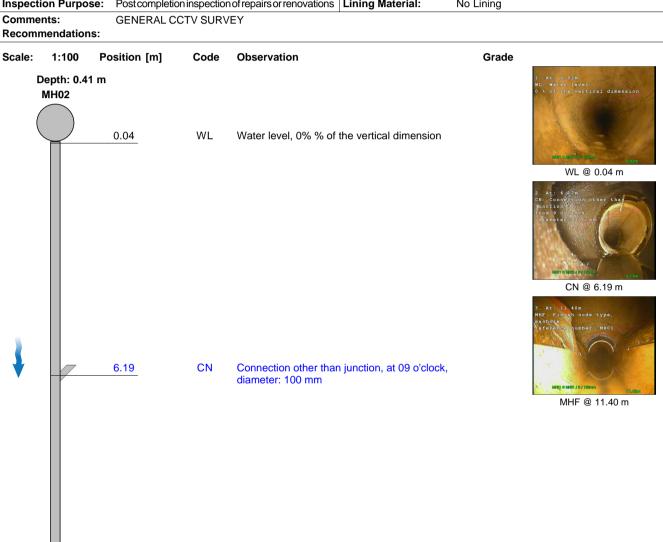
Town or Village:	Bodicote	Inspection Direction:	Downstream	Upstream Node:	MH02
Road:	White Post Road	Inspected Length:	11.40 m	Upstream Pipe Depth:	0.410 m
Location:	Gardens	Total Length:	11.40 m	Downstream Node:	MH01
Surface Type:		Joint Length:	0.00 m	Downstream Pipe Depth:	0.730 m
Use.	Foul	•	Pine Shape	Circular

ipe Shape: Type of Pipe: Gravity drain/sewer Dia/Height: 100 mm

Fibreglass reinforced pipe Flow Control: No flow control Lining Type: Cured in place lining

Inspection Purpose: Post completion inspection of repairs or renovations **Lining Material:** No Lining
