E.P. Barrus Ltd

**Planning Application for a
Proposed Warehouse &
Service Yard Extension**

**Glen Way, Launton Road
Bicester, Oxfordshire**

**Foul & Surface Water
Drainage Statement**

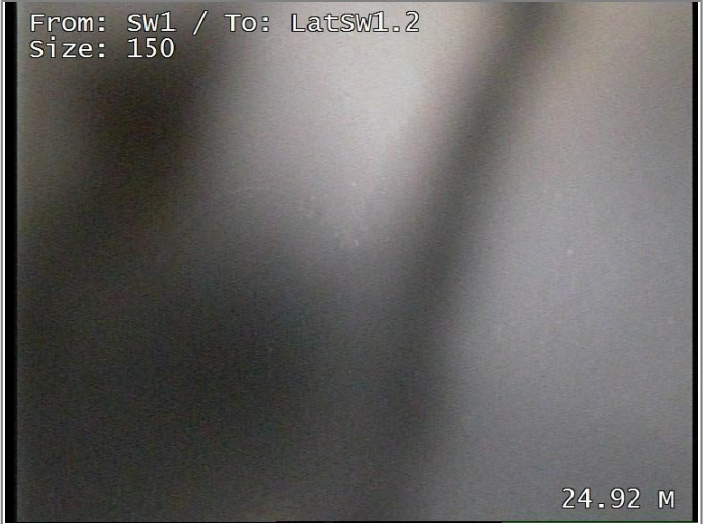
Survey abandoned - Remark: Loss of vision

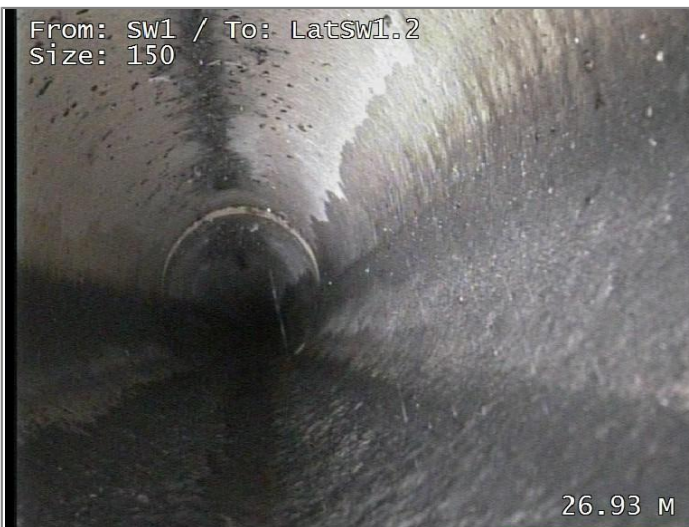
Survey abandoned - Remark: Unable to push further

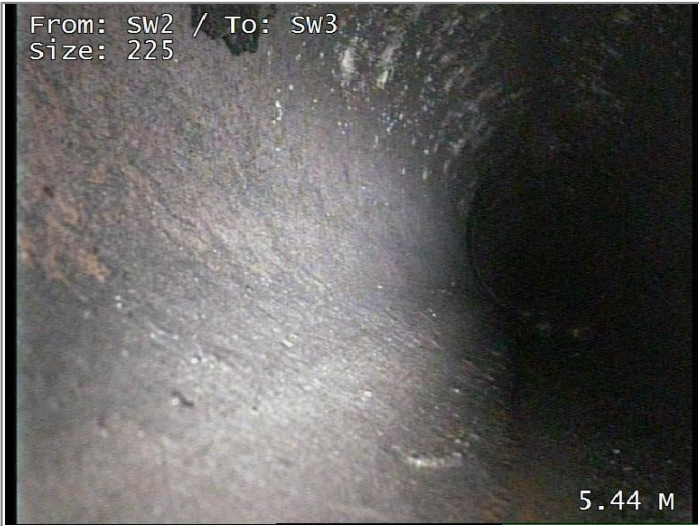
Survey abandoned - Remark: Unable to push further

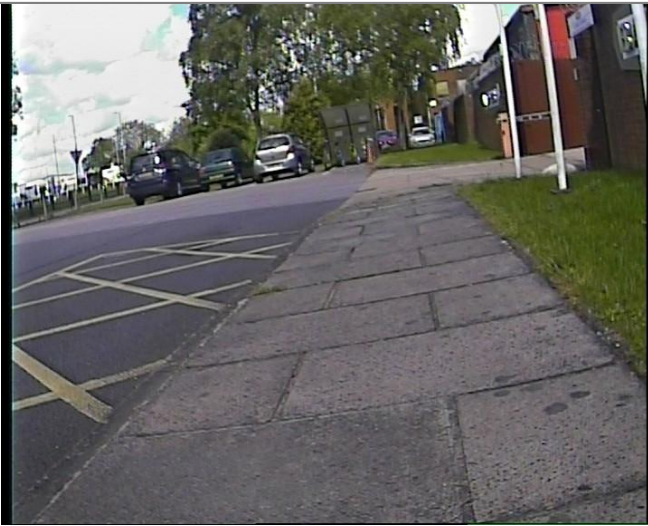
SW4 Location

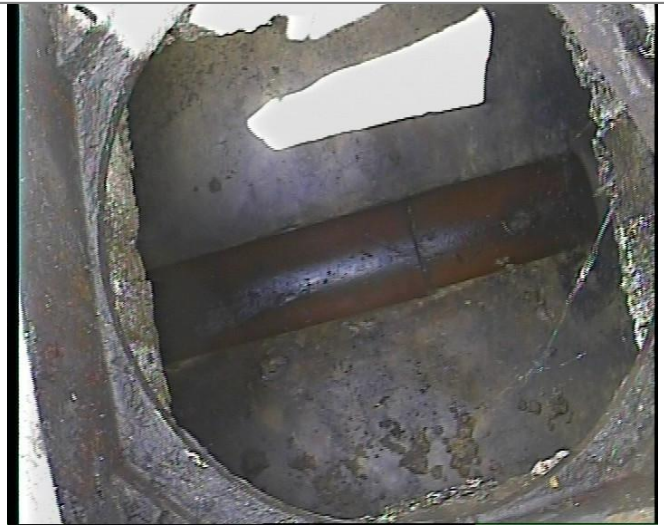
SW4 Internal

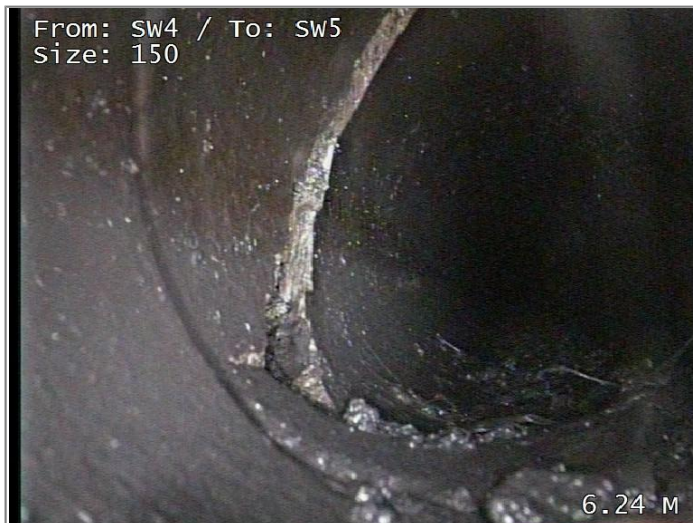
Broken pipe at 7 o'clock, at joint

| Position | Code | Description | Photo | Type/Grade |
|---|---|---|---|---|
| 6.26 | BJ | Broken pipe at 7 o'clock, at joint | 6397828 | Structural / 4 |

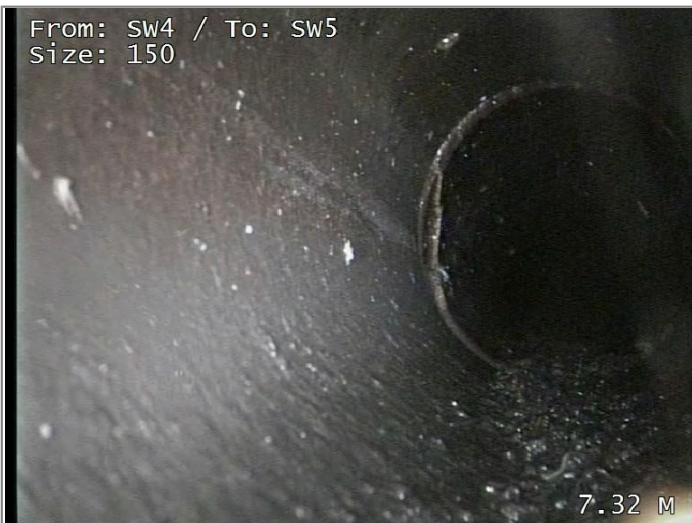
Other settled deposits 5% cross-sectional area loss - Remark: Slit, Start

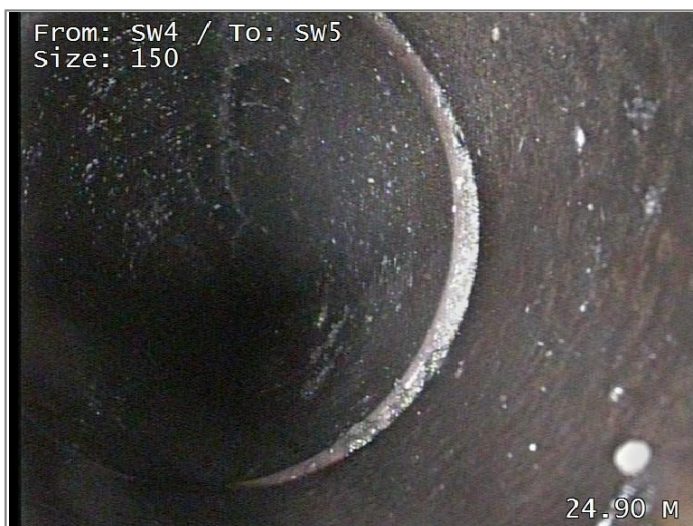
Survey abandoned - Remark: Unable To Push Further

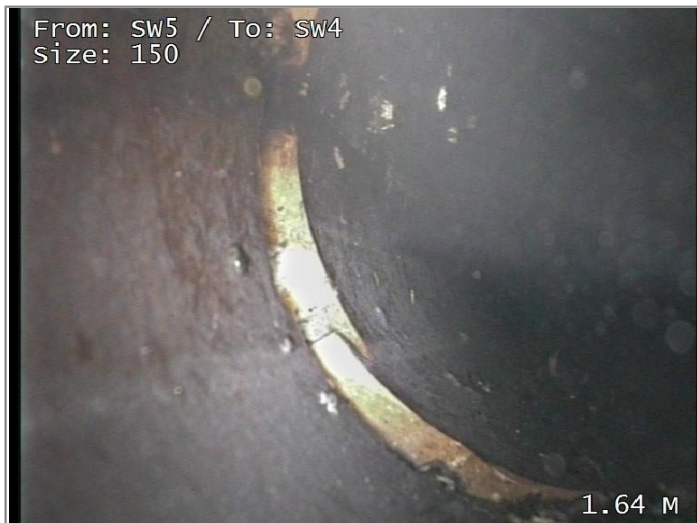
Broken pipe at 8 o'clock, at joint

| Position | Code | Description | Photo | Type/Grade |
|---|---|--|---|---|
| 1.64 | BJ | Broken pipe at 8 o'clock, at joint | 6398274 | Structural / 4 |

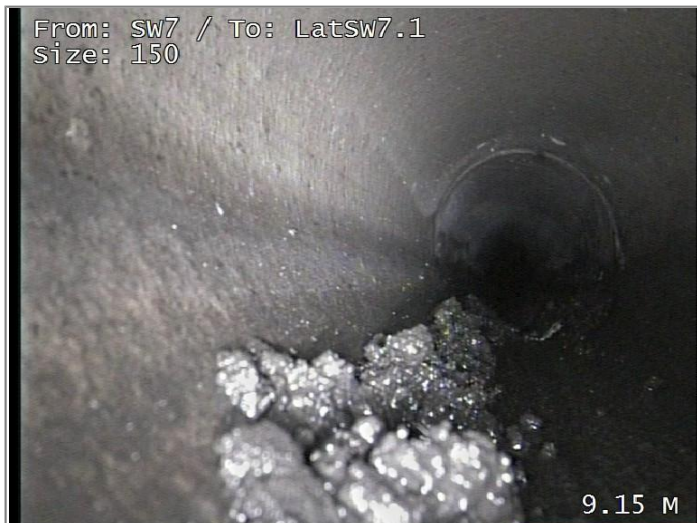
Other settled deposits 10% cross-sectional area loss - Remark: Slit, Start

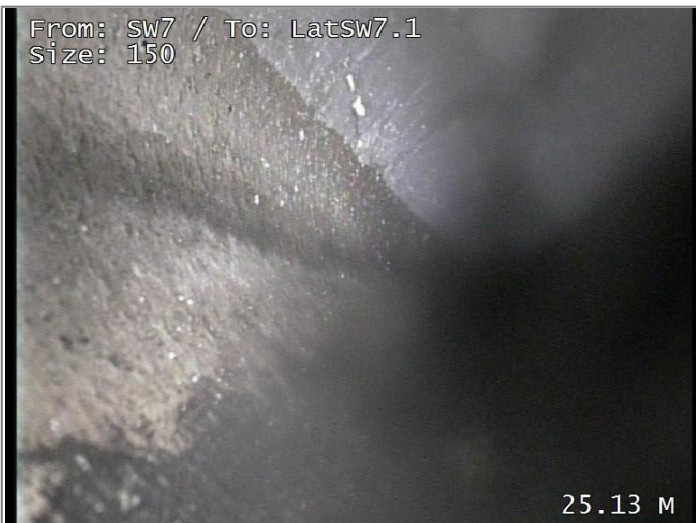
Other settled deposits 10% cross-sectional area loss - Remark: Slit, Finished

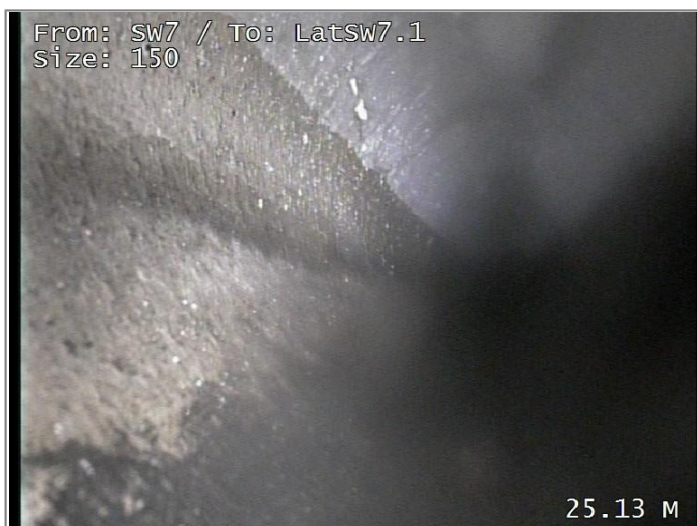
Survey abandoned - Remark: Unable To Push Further

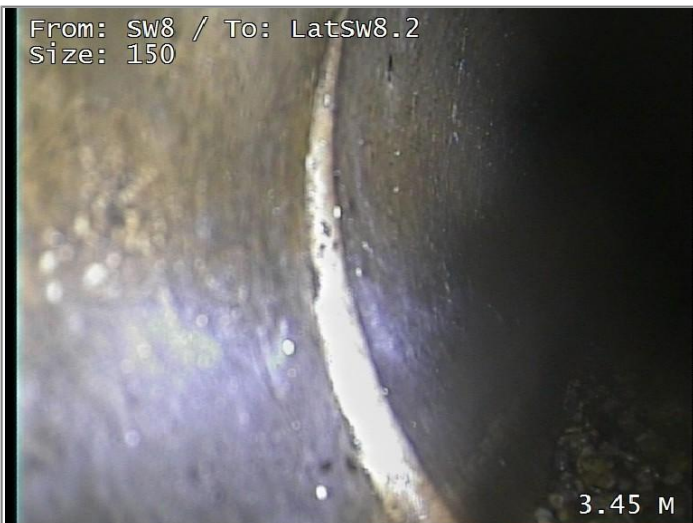
Other settled deposits 5% cross-sectional area loss - Remark: Silt/Stones, Start

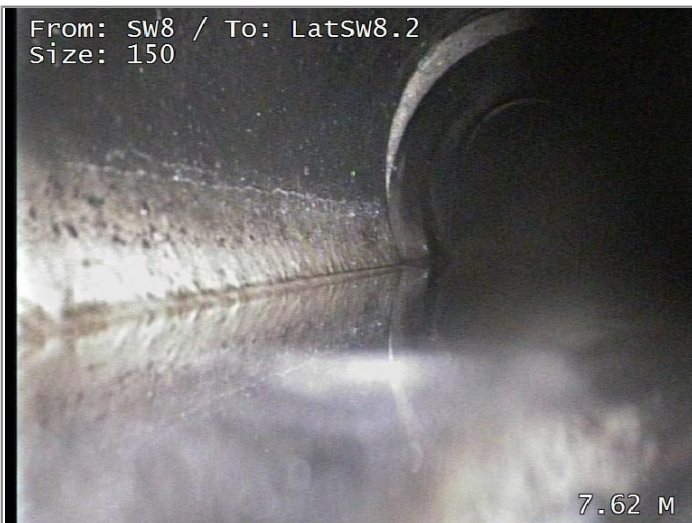
Other settled deposits 5% cross-sectional area loss - Remark: Silt/Stones, Finished

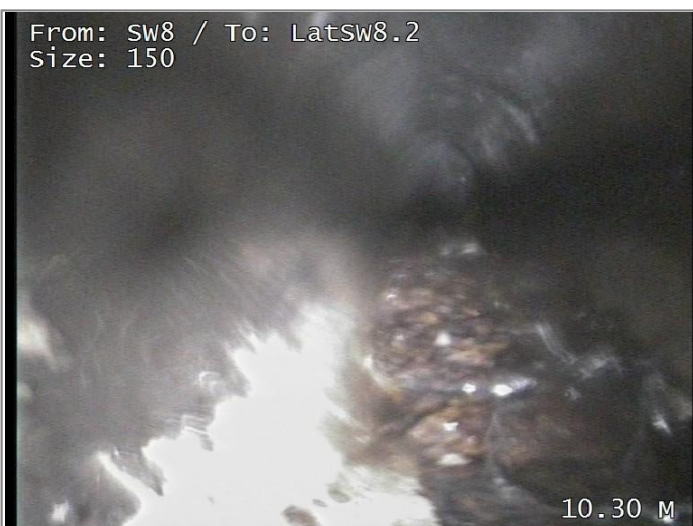
Settled deposits fine 5% cross-sectional area loss, Start

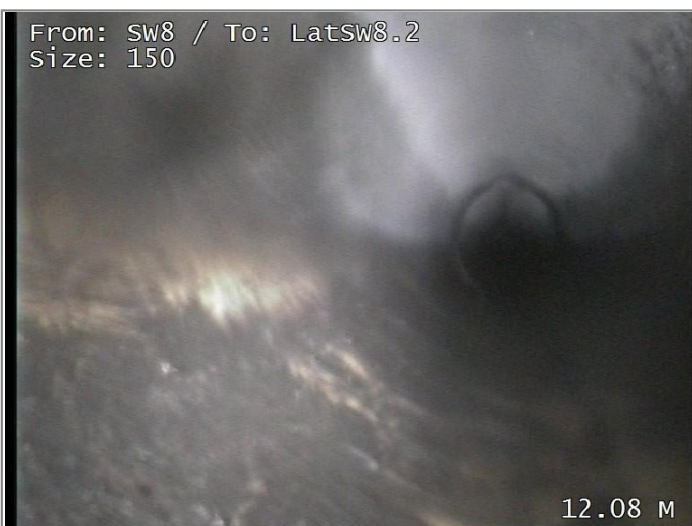
Settled deposits fine 5% cross-sectional area loss, Finished

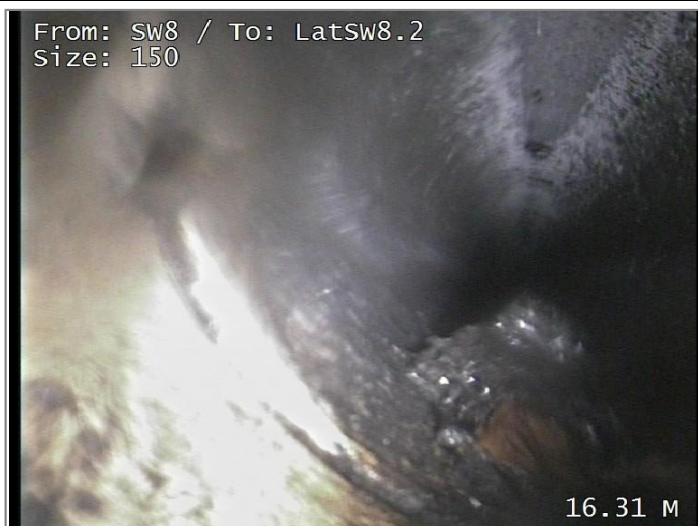
Other settled deposits 5% cross-sectional area loss - Remark: Silt

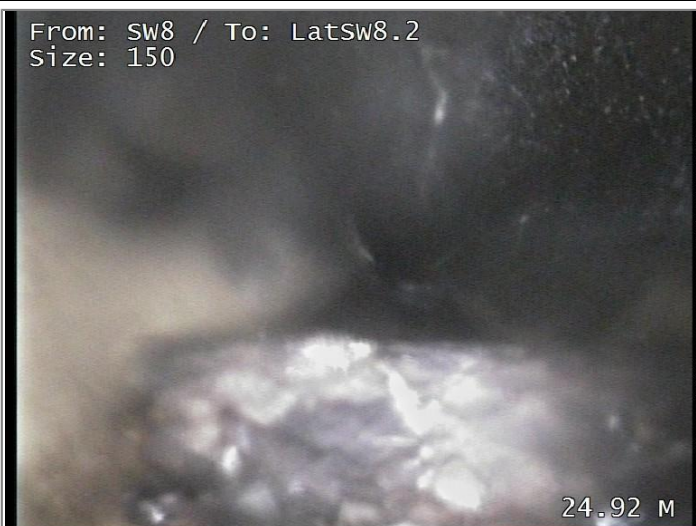
Settled deposits fine 5% cross-sectional area loss

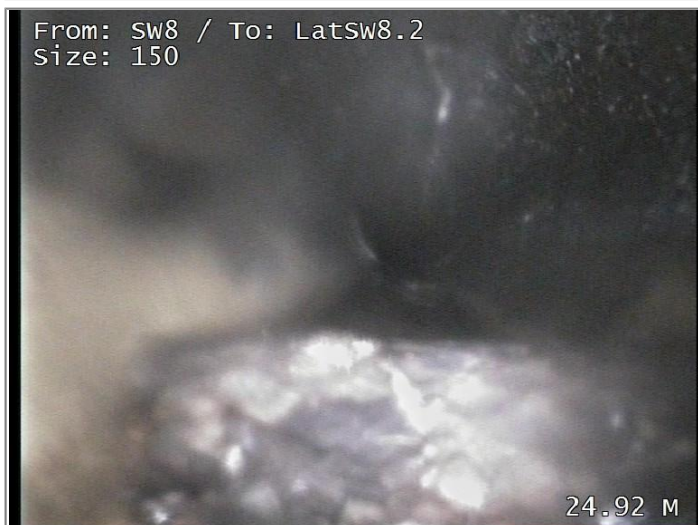
Survey abandoned - Remark: Unable to push further

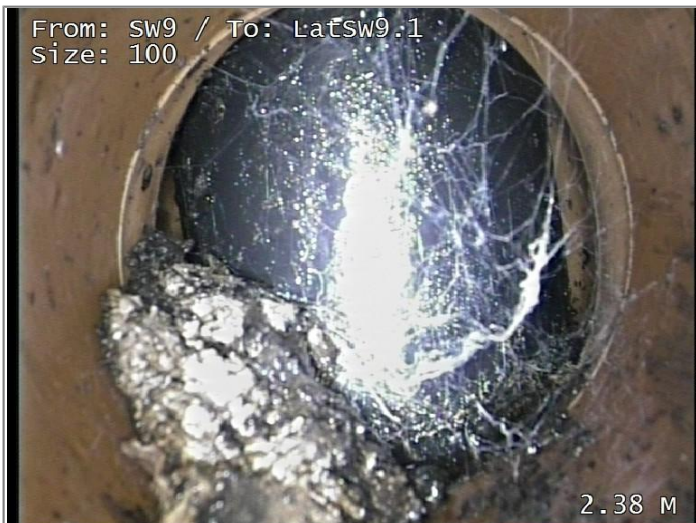
From: SW9 / To: LatSW9:1
Size: 100

Settled deposits hard or compacted 10% cross-sectional area loss

| Position | Code | Description | Photo | Type/Grade |
|---|---|--|---|---|
| 2.38 | DEC | Settled deposits hard or compacted 10% cross-sectional area loss | 6399353 | Service / 3 |

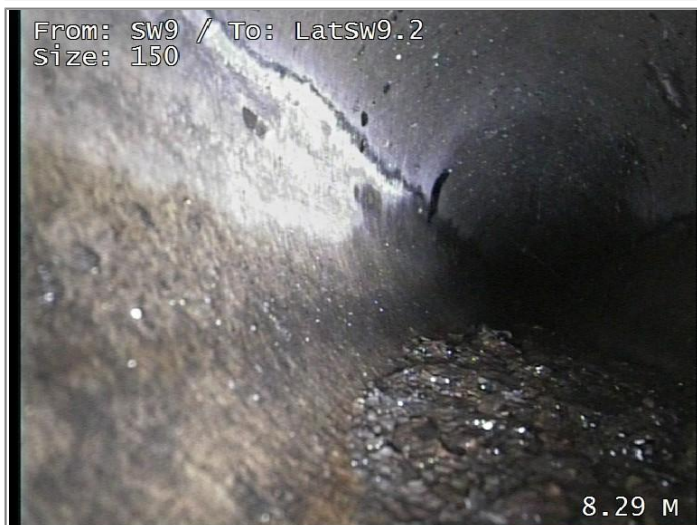
Settled deposits fine 10% cross-sectional area loss, Start

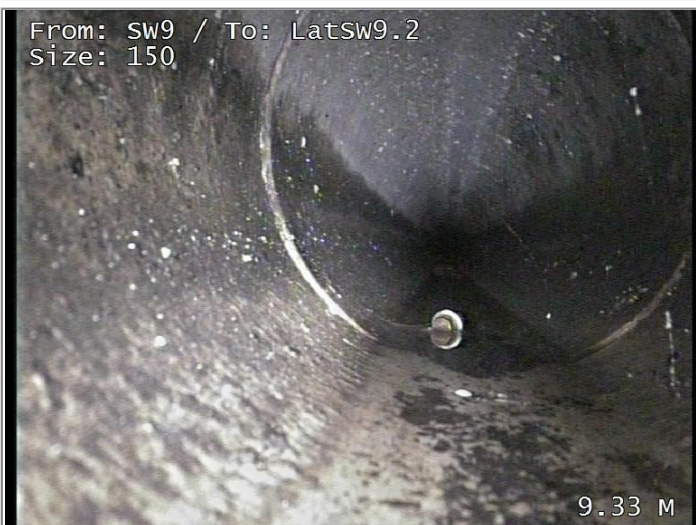
Settled deposits fine 10% cross-sectional area loss, Finished

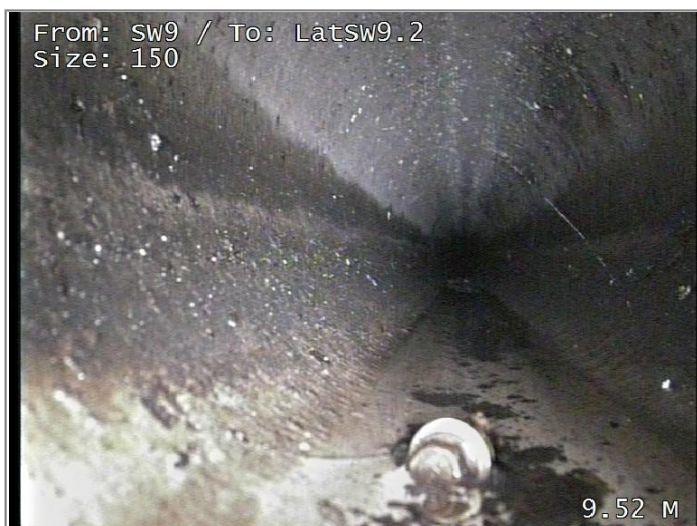
Bolt in pipe

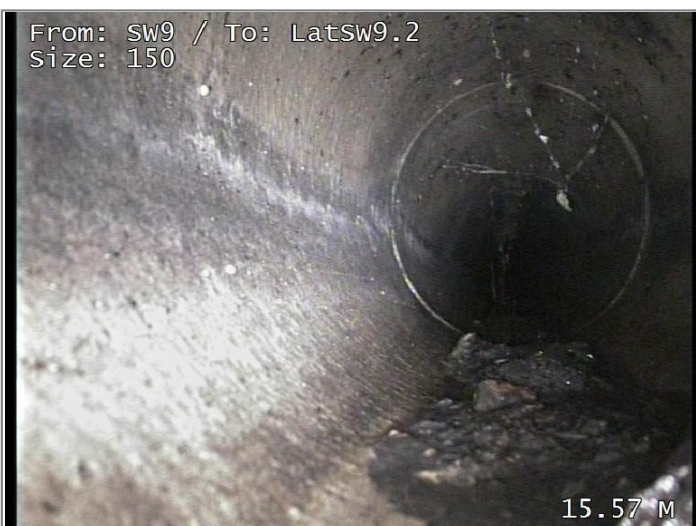
Settled deposits fine 5% cross-sectional area loss, Start

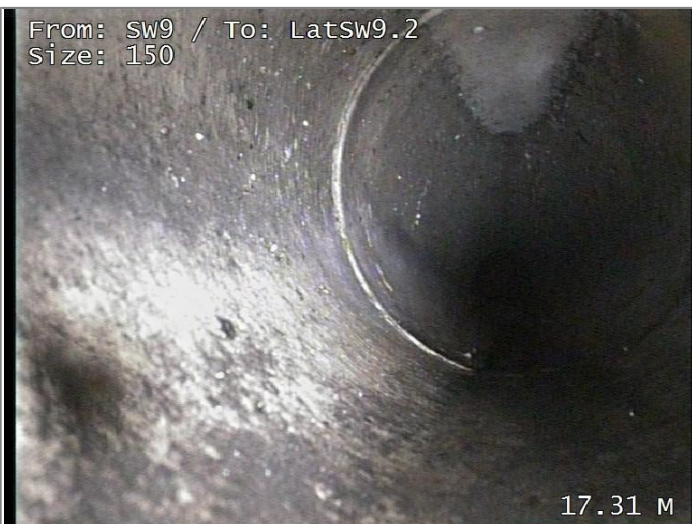
Settled deposits fine 5% cross-sectional area loss, Finished

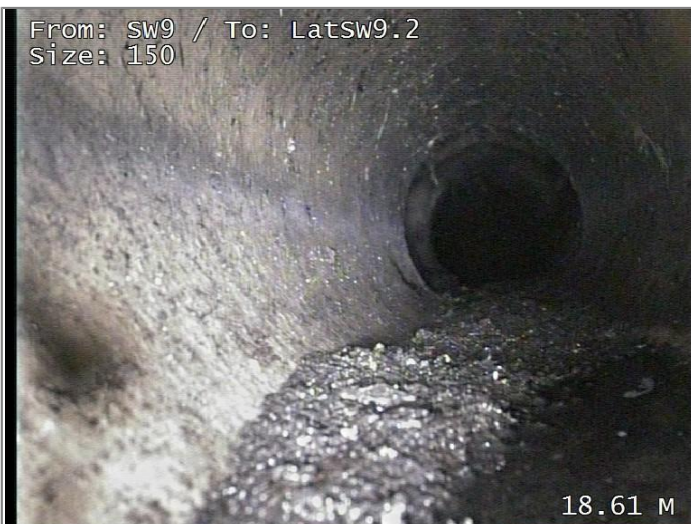
Settled deposits fine 5% cross-sectional area loss, Start

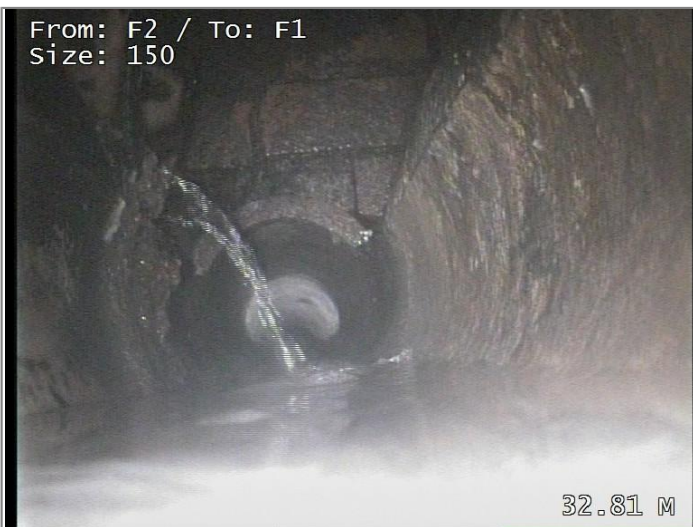
Water level throughout pipe work due to constant flow

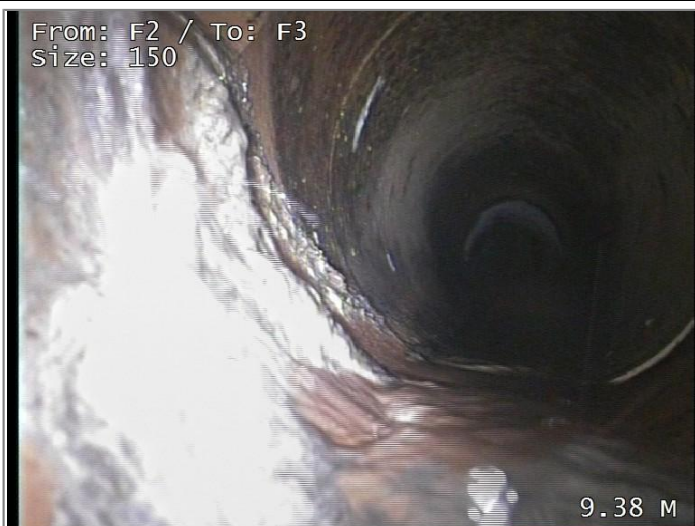
Other attached deposits at 10 o'clock 5% cross-sectional area loss - Remark Scale

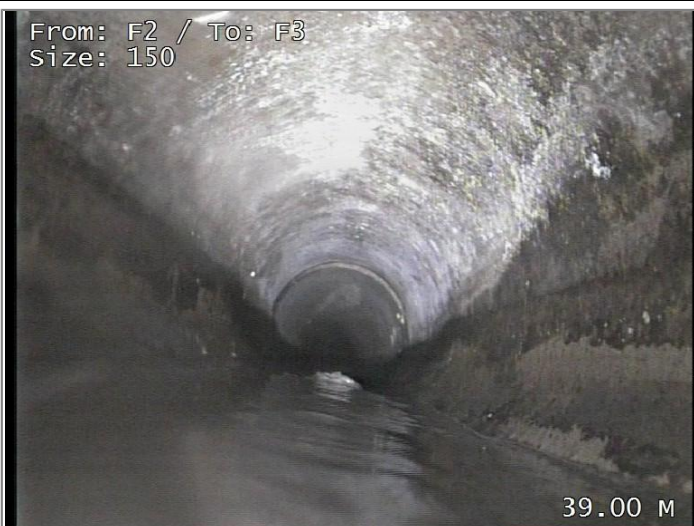
Survey abandoned - Remark: Out of reel

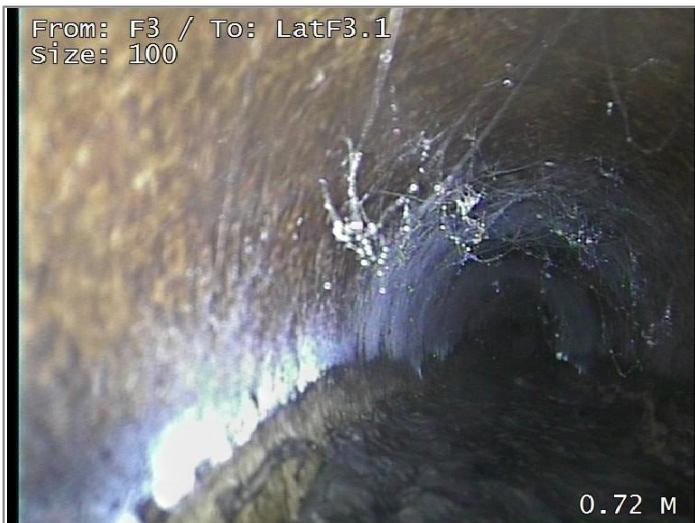
Settled deposits fine 5% cross-sectional area loss, Start

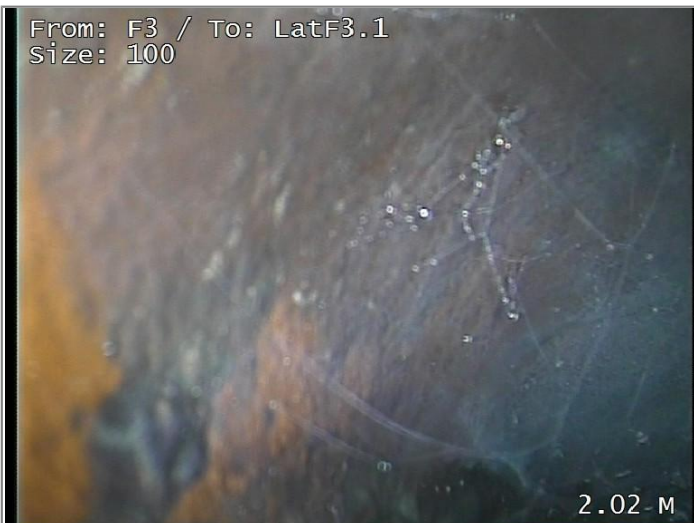
Settled deposits fine 5% cross-sectional area loss, Finished

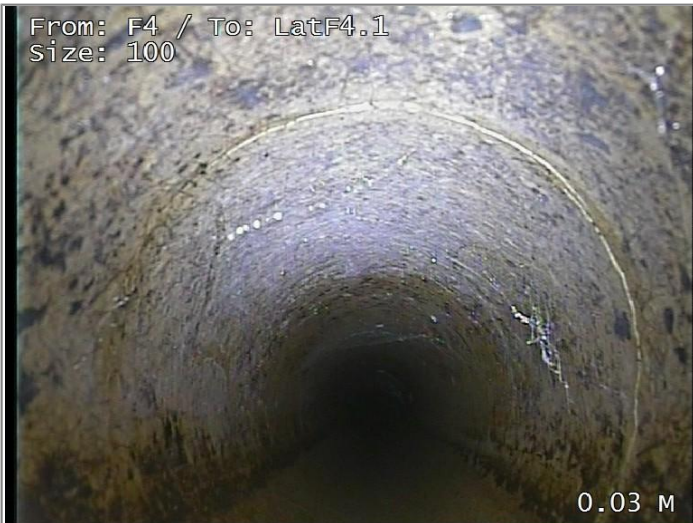
Crack circumferential from 9 to 5 o'clock

| Position | Code | Description | Photo | Type/Grade |
|---|---|---|---|---|
| 0.03 | CC | Crack circumferential from 9 to 5 o'clock | 6401076 | Structural / 2 |

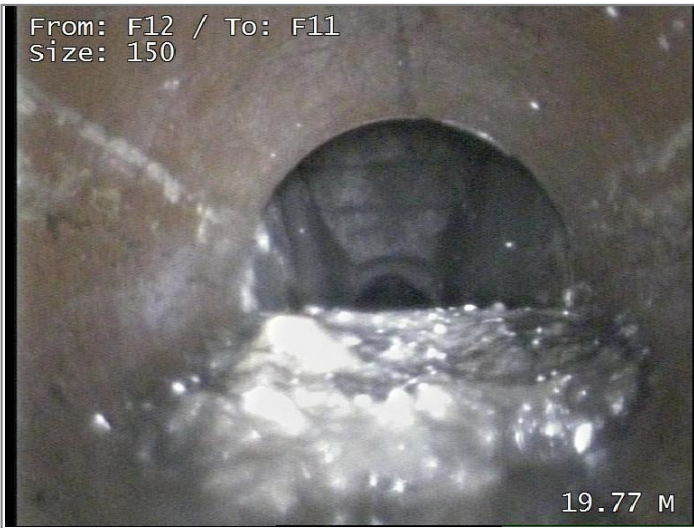
Other attached deposits from 8 to 4 o'clock 25% cross-sectional area loss
- Remark Scale

| Position | Code | Description | Photo | Type/Grade |
|--|---|--|---|---|
| 19.77 | DEZ | Other attached deposits from 8 to 4 o'clock 25% cross-sectional area loss - Remark Scale | 6402266 | Service / 4 |

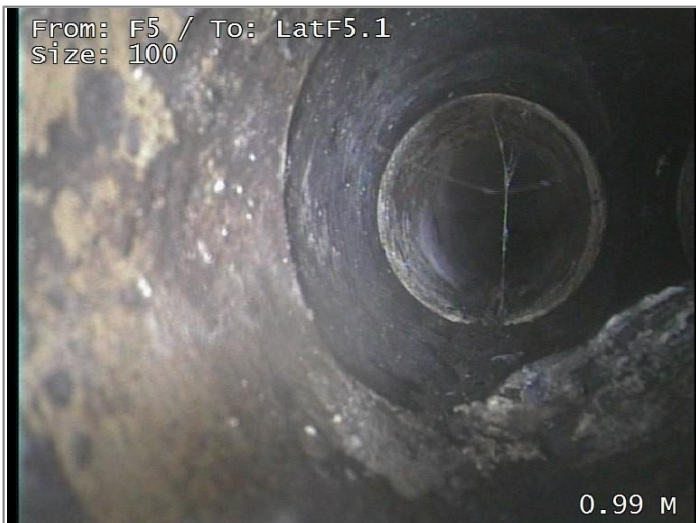
Settled deposits fine 10% cross-sectional area loss, at joint

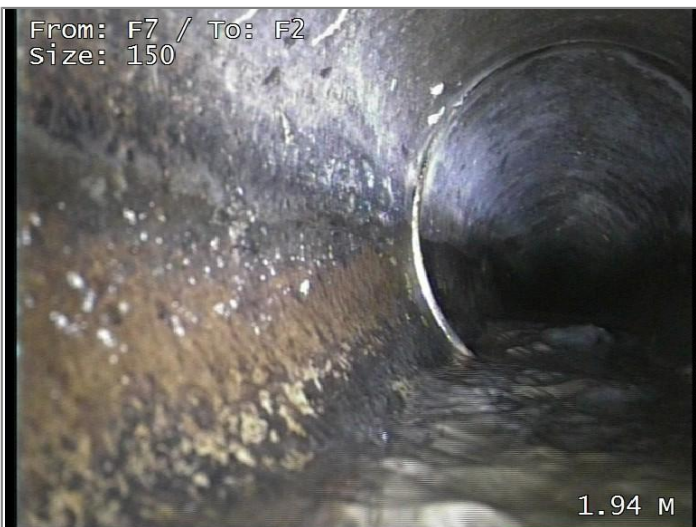
Other attached deposits from 7 to 5 o'clock 5% cross-sectional area loss - Remark Scale, Start

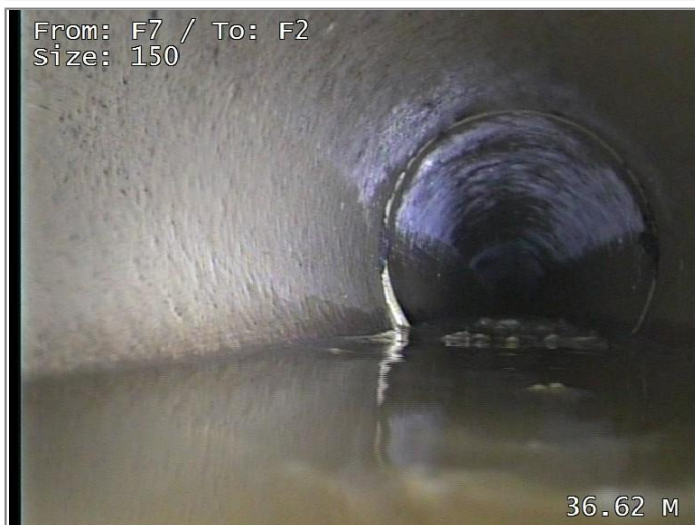
High flow rate through pipework

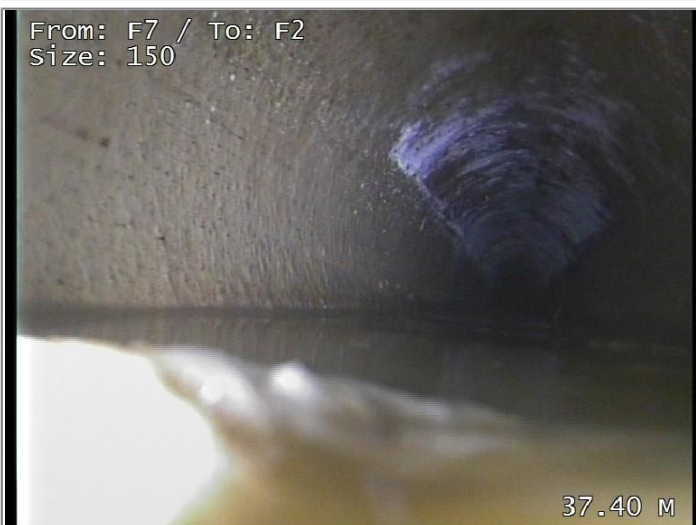
Other attached deposits from 7 to 5 o'clock 5% cross-sectional area loss - Remark Scale, Finished

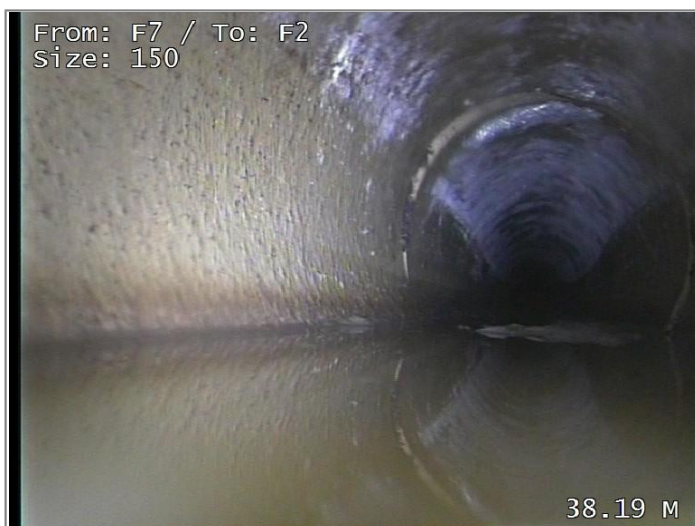
Survey abandoned - Remark: Out Of Reel. Have Surveyed downstream from F2 as well

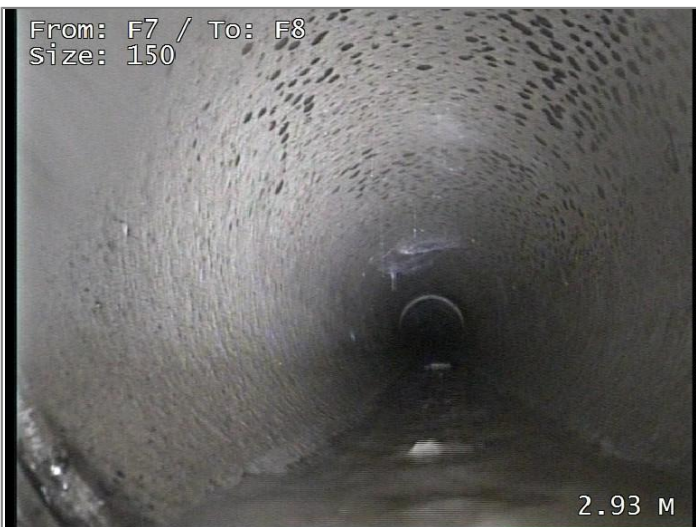
High rate of flow from upstream

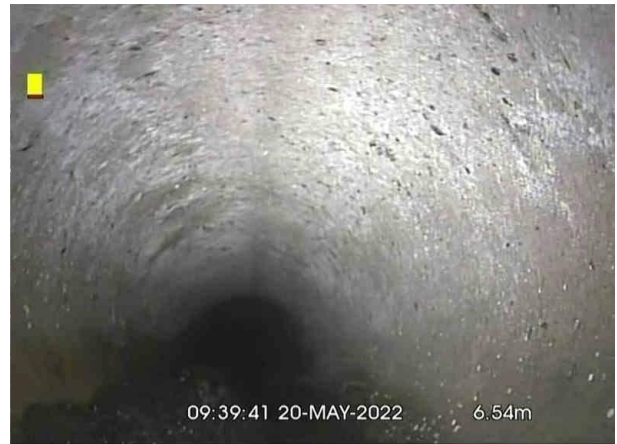
SW9X_bf174e5f-7231-42d9-a190-5e3acabe447a_20220524_153346_311.jpg, 00:00:32, 6.54 m
Settled deposits, fine, 10% cross-sectional area loss, start

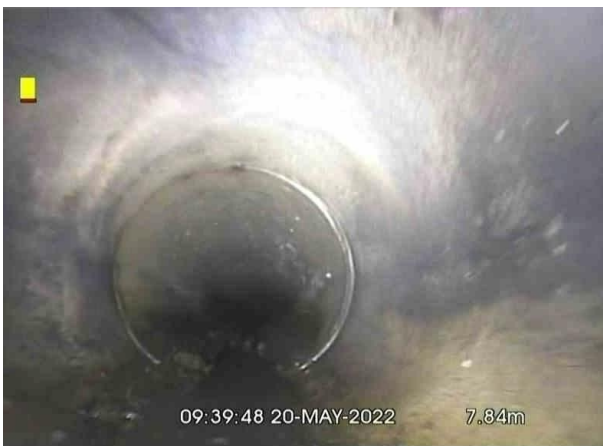
SW9X_09760fb7-84e8-4291-9d2e-5da4e6c0aa3f_20220524_153419_676.jpg, 00:00:39, 7.84 m
Junction at 9 o'clock, diameter: 150mm

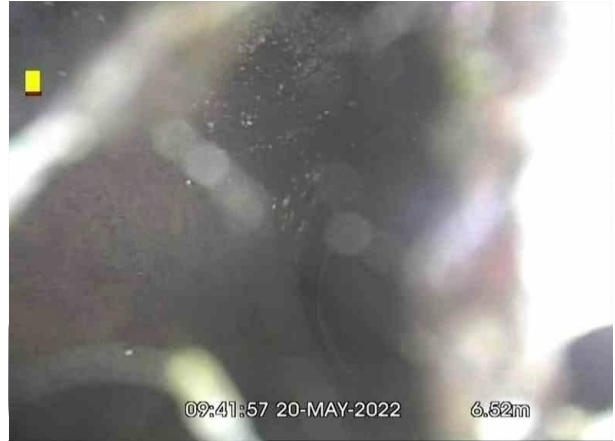
SW9aX_25ac594d-fd63-472f-92d9-7faca6f72f29_20220524_153818_334.jpg, 00:00:41, 6.19 m
Loss of vision, other, obscured by cobwebs

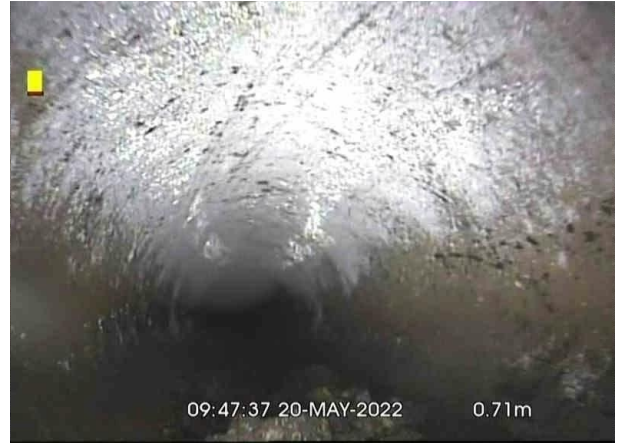
SW8X_4007ea33-9ca3-47e4-84b9-524f0be99d4e_20220524_154241_227.jpg, 00:00:15, 0.51 m
Settled deposits, fine, 10% cross-sectional area loss, start

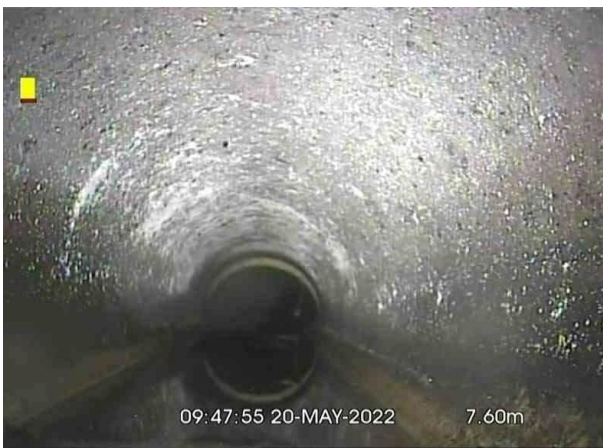
SW8X_342466c4-9ade-445f-b00d-9a2e7e0cc48a_20220524_154336_648.jpg, 00:00:33, 7.60 m
Water level, 15% of the vertical dimension

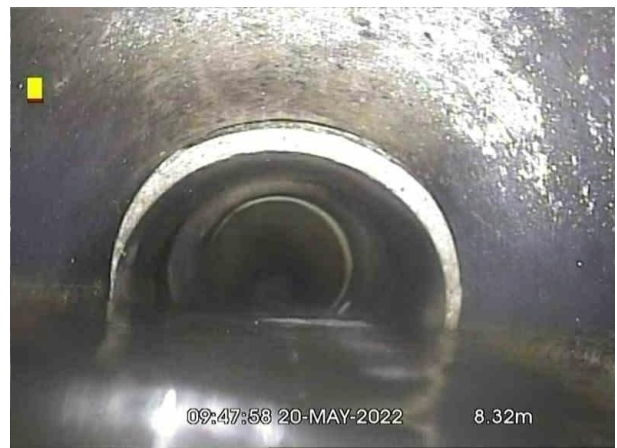
SW8X_e9f3c9bc-7f79-452e-9013-7e3c0039f48b_20220524_154353_069.jpg, 00:00:36, 8.32 m
Joint displaced, medium

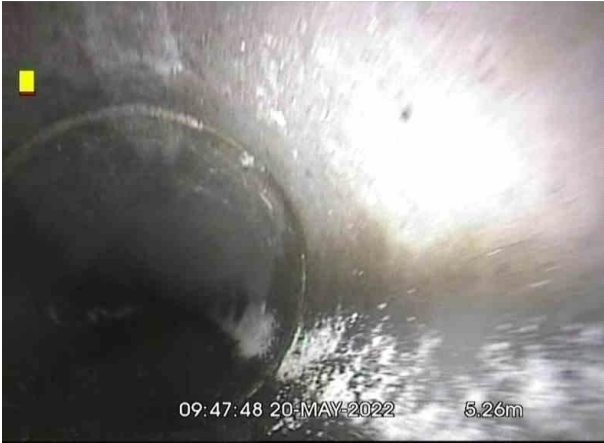
SW8X_4f221960-a994-46da-b7d0-640ef9967412_20220524_154449_738.jpg, 00:00:27, 8.57 m
Junction at 10 o'clock, diameter: 150mm

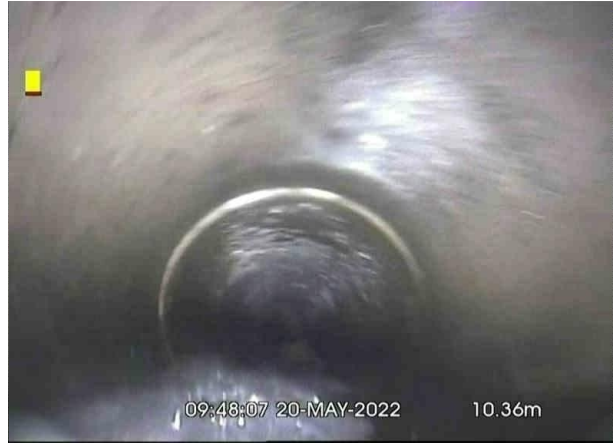
SW8X_454c33e9-644a-4d73-b1cc-f96f7c16f1d4_20220524_154643_591.jpg, 00:00:45, 10.36 m
General remark, frothy water?

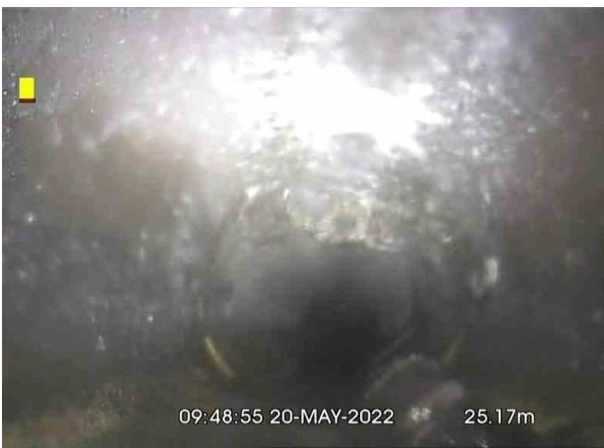
SW8X_4b8631f0-a9bb-4ee2-b759-69b4075cb24a_20220524_154757_309.jpg, 00:01:33, 25.17 m
Other obstacles from 4 o'clock to 5 o'clock, 5% cross-sectional area loss

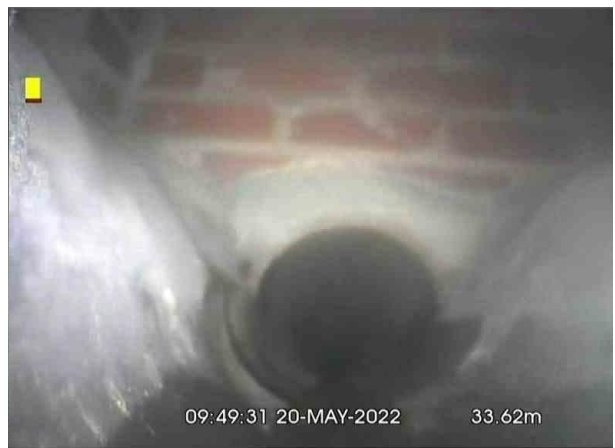
SW8X_21172983-4912-4885-a99f-58da5612fb49_20220524_154854_773.jpg, 00:02:09, 33.62 m
Finish node type, manhole, reference number: SW8a, internal

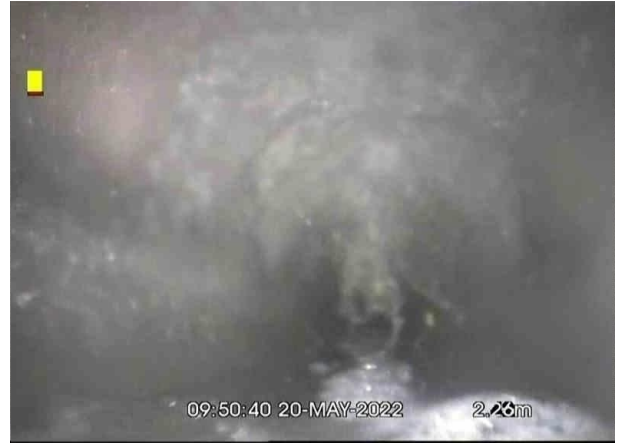
SW8aX_af97abca-b69c-4581-80f3-69327043c02c_20220524_155111_170.jpg, 00:00:19, 2.26 m
Water level, 10% of the vertical dimension, froth on water?

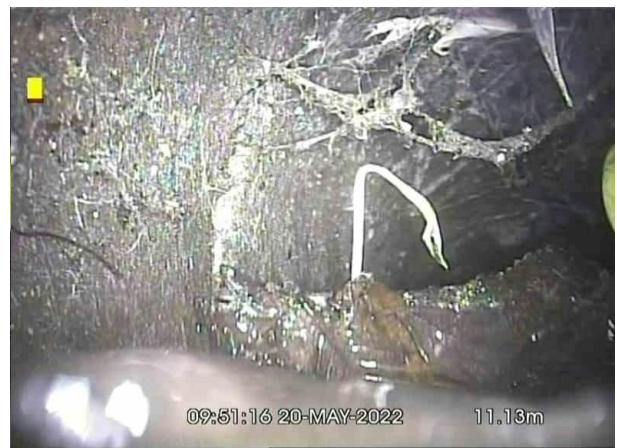
SW8aX_17b95e9e-220e-4be2-a1a7-3f4044087fcb_20220524_155231_647.jpg, 00:00:55, 11.13 m
Settled deposits, hard or compacted, 20% cross-sectional area loss, start

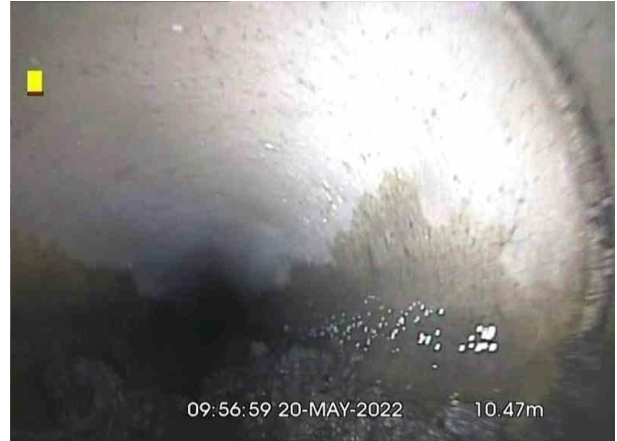
SW7X_dc245387-ccb8-4121-b59f-93122fa6a0b2_20220524_155543_172.jpg, 00:00:36, 10.47 m
Settled deposits, fine, 10% cross-sectional area loss, start

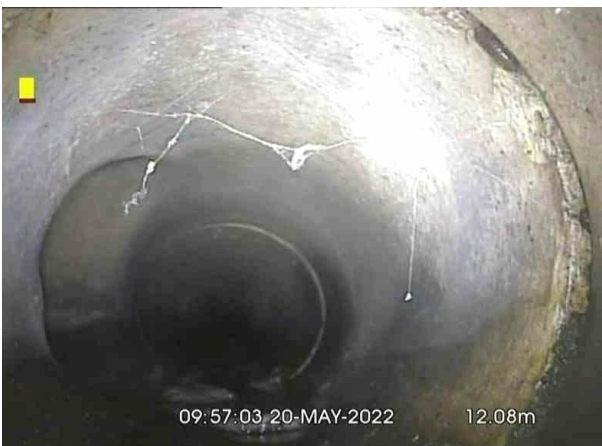
SW7X_dc5a9c8d-b0b0-4b9f-9e3a-5ba773705f6a_20220524_155603_277.jpg, 00:00:41, 12.08 m
Junction at 9 o'clock, diameter: 100mm

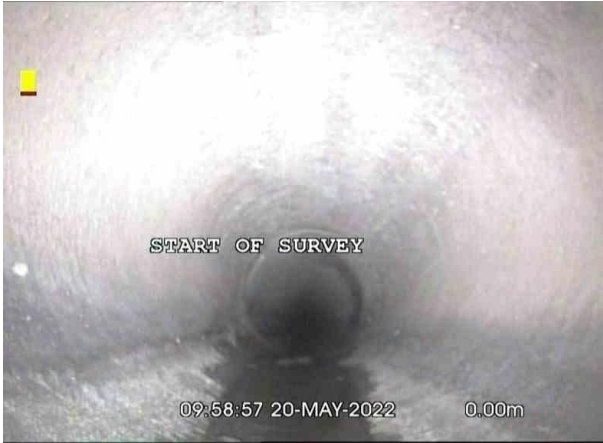
SW7aX_f8e248c1-7179-4abf-b528-9a0e76aa3fa1_20220524_155855_981.jpg, 00:00:11, 0.00 m
Water level, 0% of the vertical dimension

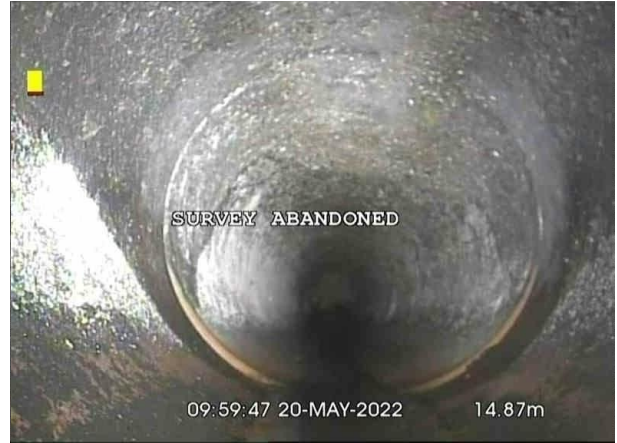
SW7aX_5a3407ad-2d90-450c-9c57-37b4580906bc_20220524_160033_913.jpg, 00:01:01, 14.70 m
Survey abandoned, Out Off Cable
