E.P. Barrus Ltd

**Planning Application for a
Proposed Warehouse &
Service Yard Extension**

**Glen Way, Launton Road
Bicester, Oxfordshire**

**Foul & Surface Water
Drainage Statement**

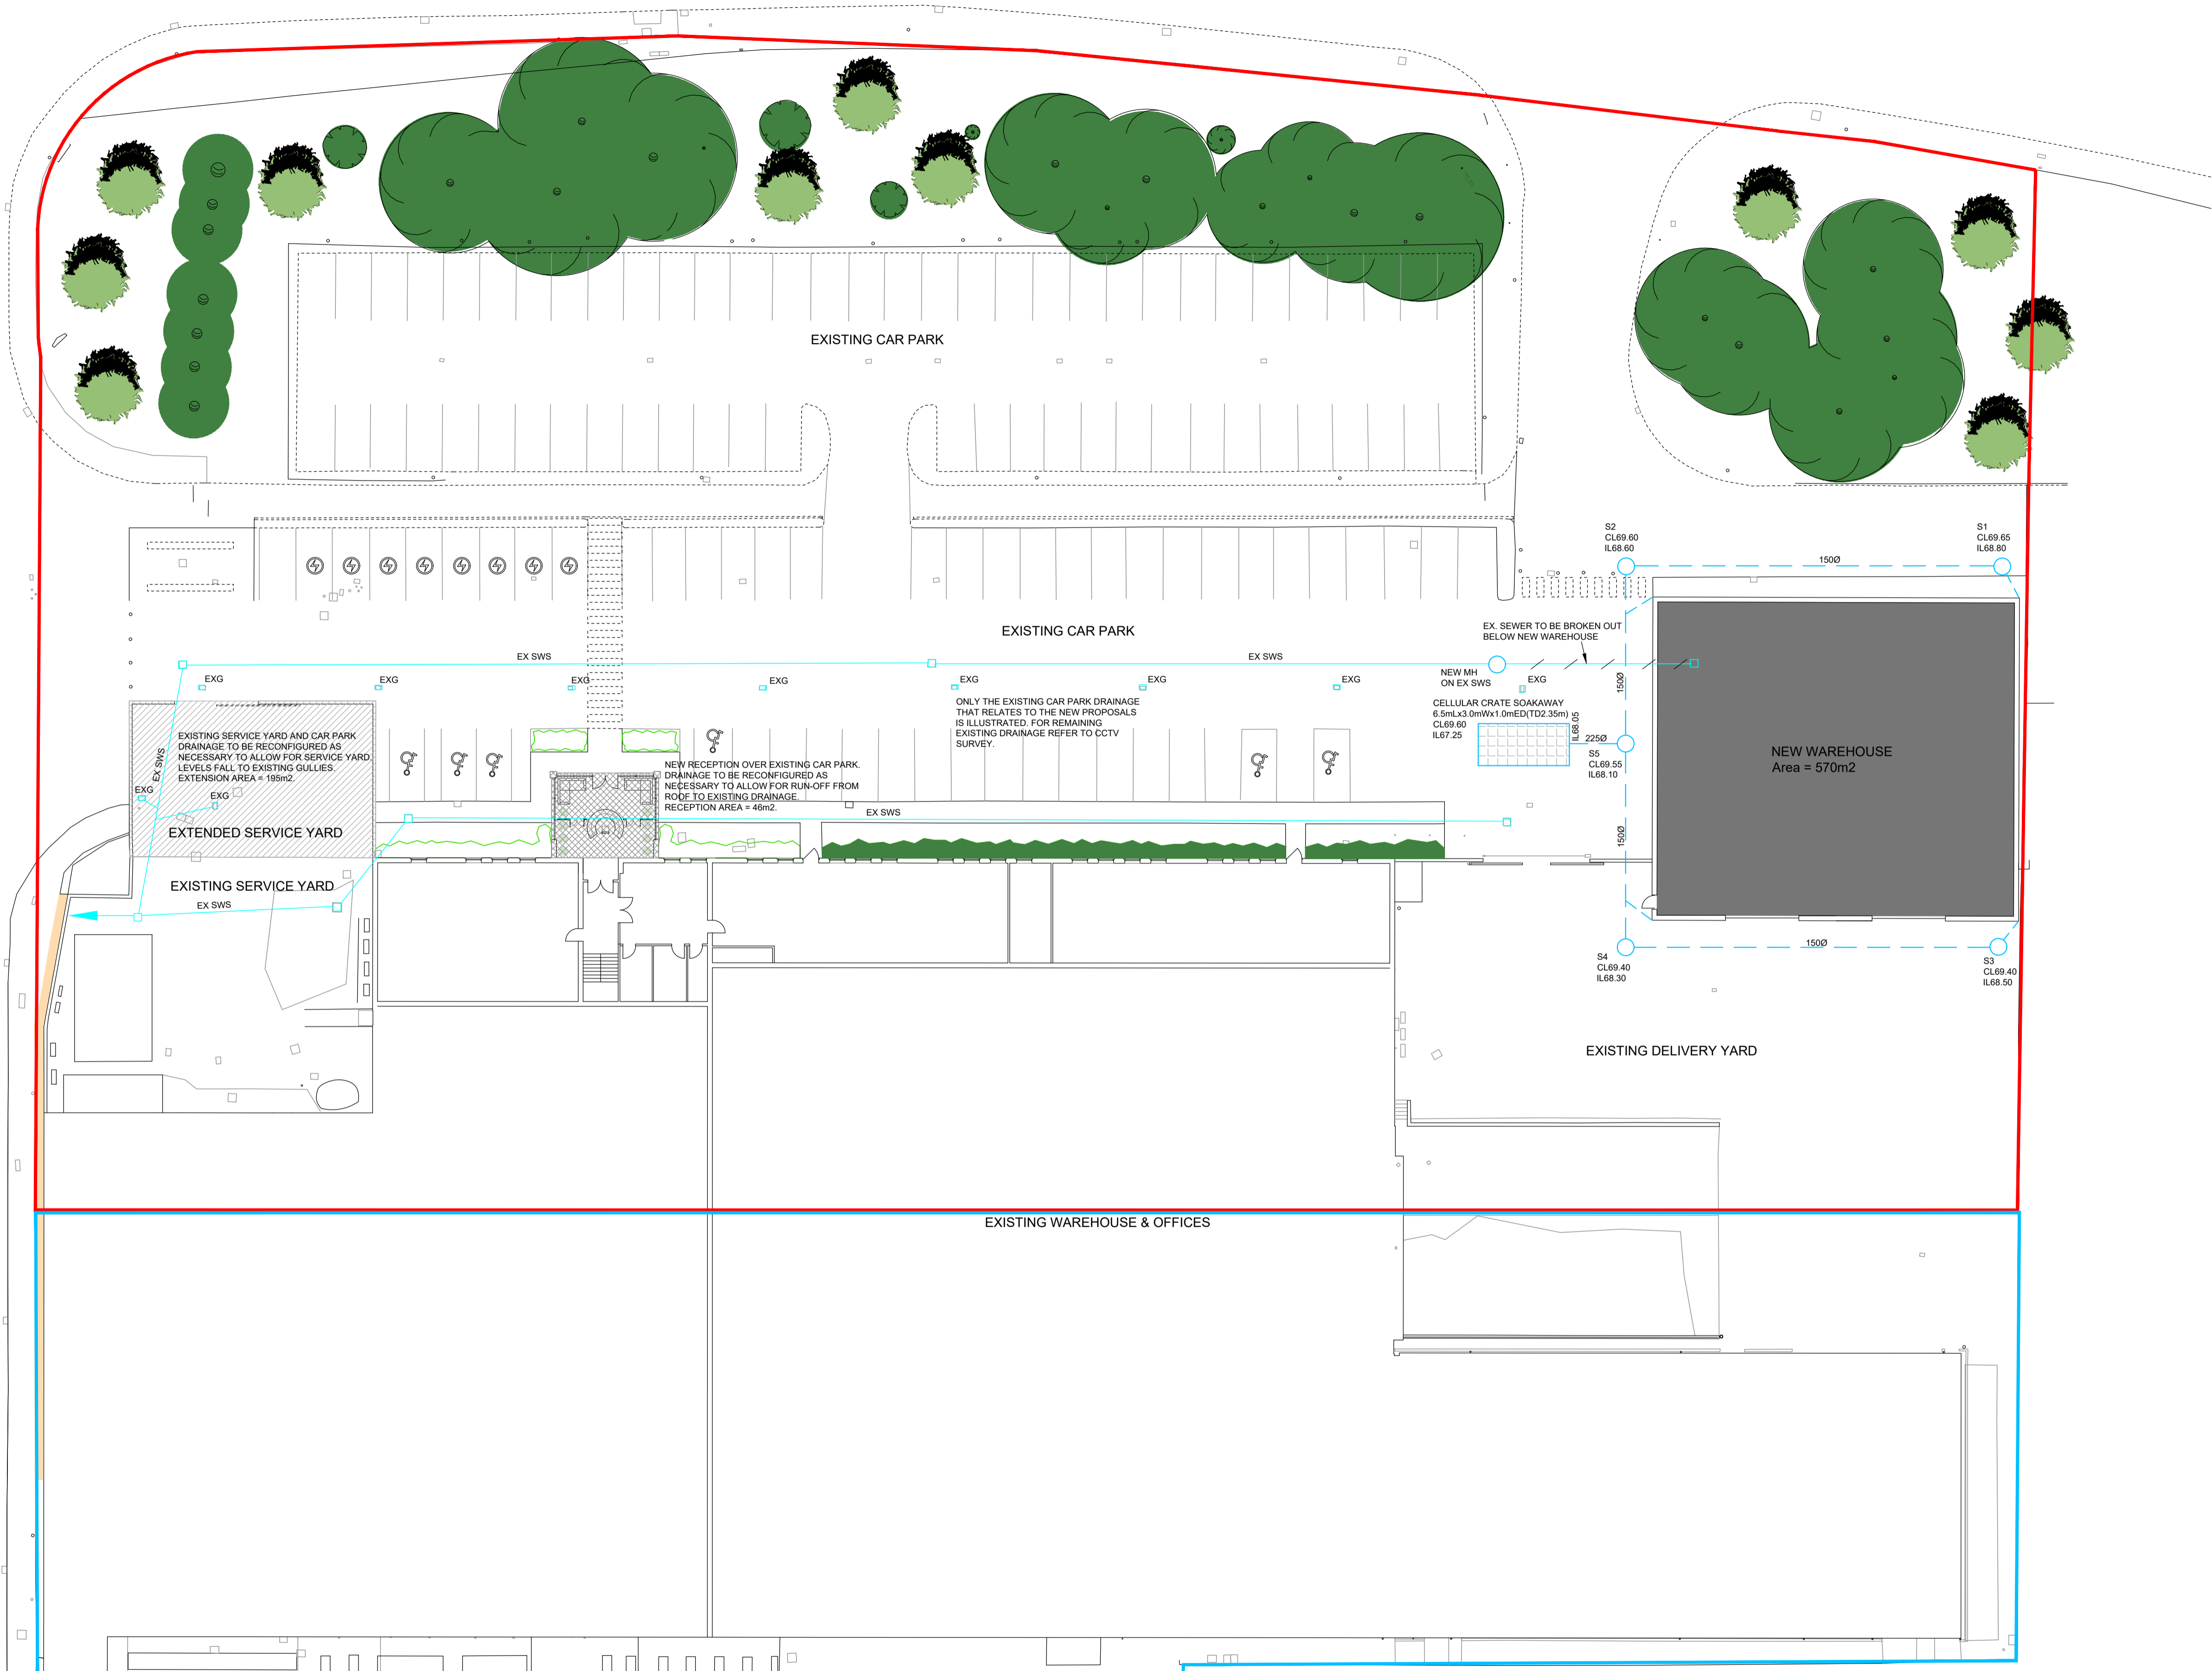
Drainage Layout

Proposed Cellular Soakaway (vented). Polystyrene or similar approved type. (a protective concrete cover slab may be required subject to manufactures recommendations)
-
