TONY HERRING ASSOCIATES LTD  
 CHARTERED ARCHITECTS

JOB  
 CEDAR LODGE NORTH SIDE  
 STEEPLE ASTON OX25 4ET  
 CLIENT  
 ALEX & FRANCIS PASTEUR

TITLE  
 PROPOSED ALTERATIONS TO  
 OUTBUILDINGS-JOINERY SCHEDULE

SCALE  
 Not to scale  
 See Figured Dims.  
 DATE  
 Sept 2023  
 DRWG. REF  
 668.09

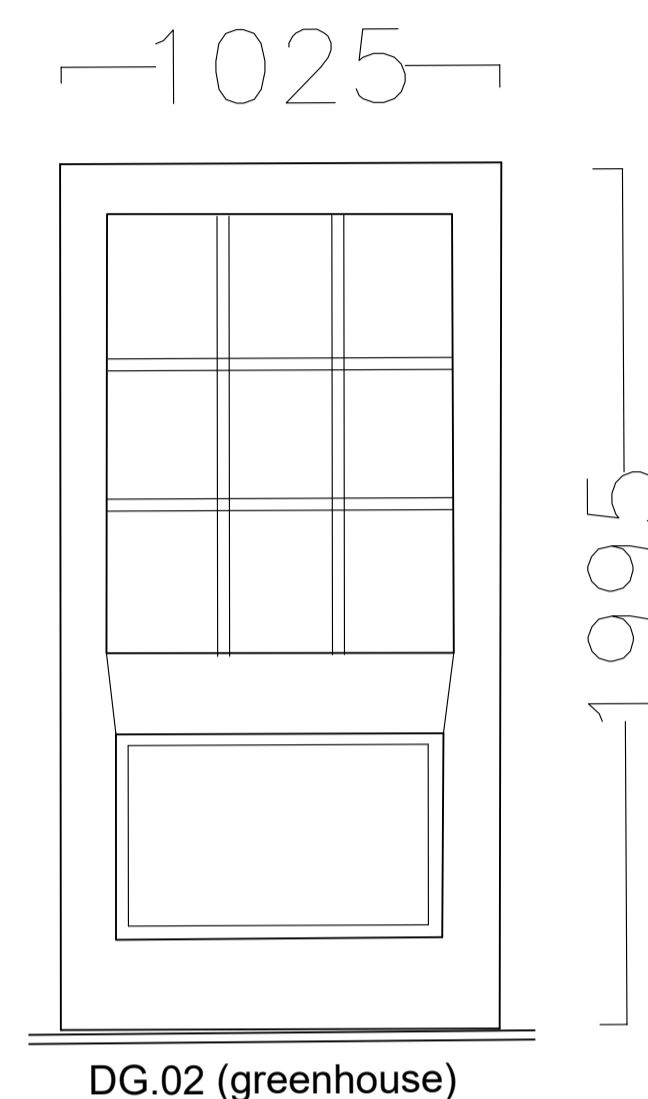
INDICATIVE WINDOW SECTIONS -

DOORS : DG 1 European Redwood for painting (h/w cill)  
 DOORS : DG 2 European Redwood for painting \*\*\*  
 DOORS : DG 3 European Redwood for painting \*\*\*  
 WINDOWS : WG 1 - 3 selected hardwood for painting (h/w cill)  
 Flush casements all equal - with draughtstripped rebated frames  
 Fittings : slotted catches, traditional black metal monkey tail fasteners
