## Detailed UXO Risk Assessment

FIL Reference: 2979R

The site is located at Launton on the former airfield, RAF Bicester in Oxfordshire. The site is centered on the coordinates 459673 E and 223945 N and is approx. 52,000m<sup>2</sup> in size.

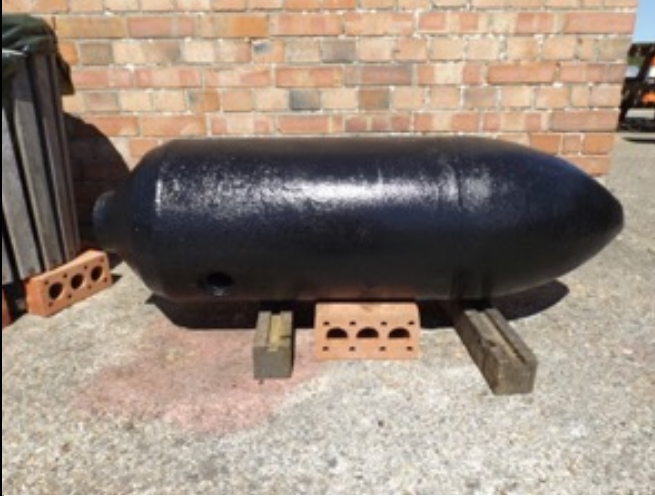
Type	Description	
High Explosive (HE) Bombs

<p>The SC series of HE Bombs were a thin cased general-purpose bomb used as general demolition bombs.</p>
	<p>German SC250 (recovered casing)</p>   <p>German SC50 (London 2015)</p>	<p>Most bombs were 50kg, 250kg or 500kg, although larger bombs of up to 1,800kg were also used. About half the weight of these HE bombs comprised of explosive fill.</p> <p>The SC50 had a one-piece drawn steel body and its total weight was 48 to 55kg.[1] It was dropped on targets across the UK.</p> <p>The SD series of bombs were thicker cased, with a lower charge weight used against hardened targets.</p>

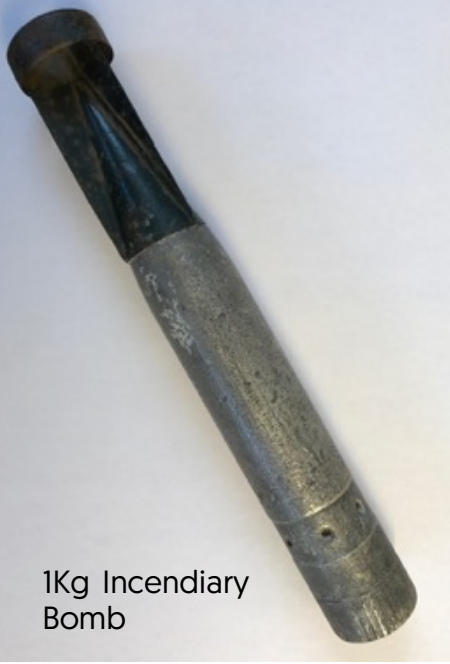
Type		Description
Incendiary bombs

<p>1Kg Incendiary Bomb</p>	<p>The 1 kg BIE incendiary bomb consisted of a cylinder of magnesium alloy, with an incendiary filling of thermite. Rivetted to the body was a steel tail with three fins. These bombs did not explode but were ignited by a small percussion charge, fired upon impact. They were dropped in a variety of containers. Later an explosive head was incorporated into the IB.</p>

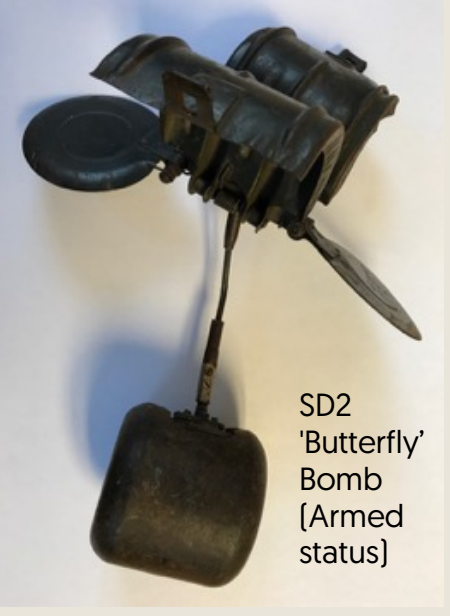
Type		Description
Anti-Personnel (AP) bombs

<p>SD2 'Butterfly' Bomb [Armed status]</p>	<p>A Butterfly Bomb (or <i>Sprengbombe Dickwandig</i> 2kg or SD2) was a German 2-kilogram anti-personnel submunition used by the Luftwaffe during the Second World War. It was so named because the thin cylindrical metal outer shell which hinged open when the bomblet deployed gave it the superficial appearance of a large butterfly. The design was very distinctive and easy to recognise. SD2 bomblets were not dropped individually but were packed into containers holding between 6 and 108 submunitions. These broke open in air and scattered the sub-munitions.</p>

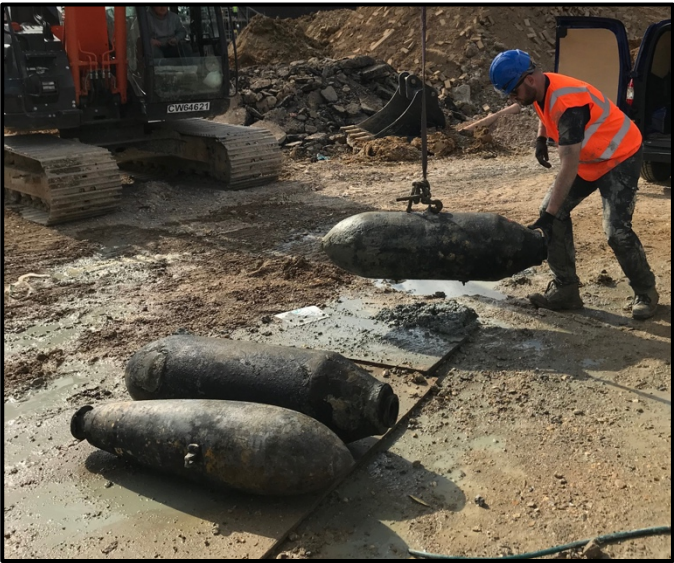
Type		Description
<p>High Explosive (HE) Bombs</p>

<p>Allied 500 lb bombs, Broadbridge Heath, 2019</p>	<p>Allied HE Bombs were usually thin cased general-purpose bombs for use against non-hardened targets.</p> <p>Most allied bombs were produced as 250lb or 500lb, although bombs up to 22,000lb were produced for specific use against hardened military targets.</p> <p>Fill tended to be either TNT or Amatol.</p> <p>The British also produced semi-armour piercing bombs for hardened and military targets, designed to penetrate concrete and buildings. These tended to be tear drop shaped to aid penetration, as seen in the image to the left.</p>

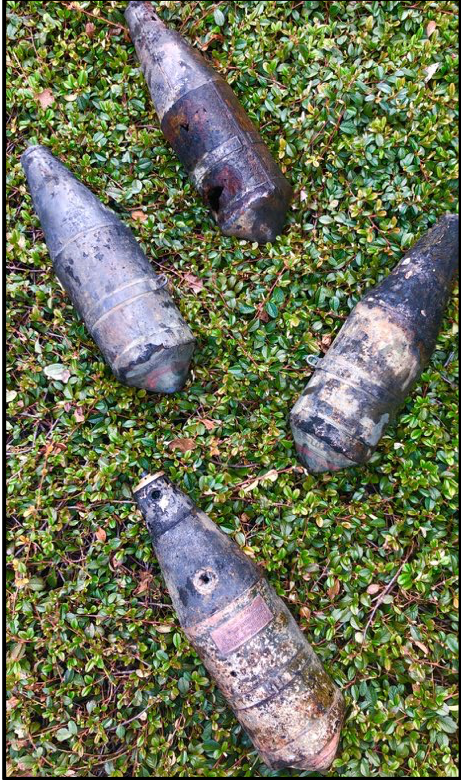
Type		Description
<p>Flares &amp; Pyrotechnics</p>

<p>WW2 Smoke Floats, Dunsfold Airfield 2019</p>	<p>Pyrotechnics and flares are used in a variety of target acquisition roles ranging from marking sites for bombers to search and rescue.</p> <p>All pyrotechnics contain a flash element, although some are designed to disperse in operation.</p> <p>Fill can be varied depending on use, but common fill for the period was white phosphorous, used in a variety of smoke, illumination and tracer munitions.</p>

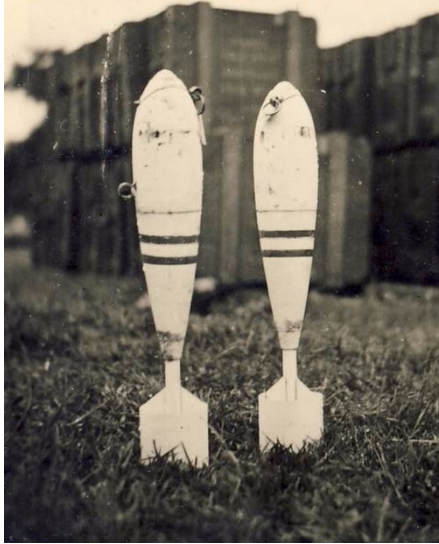
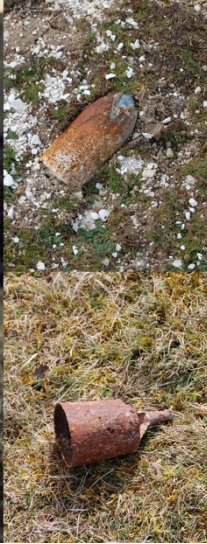
Type			Description
British Practice Bombs

<p data-bbox="379 987 1027 1099">Left: two complete practice bombs. Right top: The front part of a practice bomb. Bottom Right: the tail of a practice bomb.</p>		<p data-bbox="1042 412 1441 775">Practice bombs came in different sizes, but the most commonly used were the smaller versions. They were used for practice bombing purposes and are often found within airfield boundaries where areas were sometimes utilised for practice bombing.</p> <p data-bbox="1042 831 1441 972">A Bomb. 8.5lb. Practice, MK 1, Weighed: 3855g and had dimensions of 76mm x 406mm.</p> <p data-bbox="1042 983 1441 1196">The standard practice bombs contained no HE fill but featured a smoke emission or flash capability to indicate bombing accuracy.</p>
Aircraft Ammunition

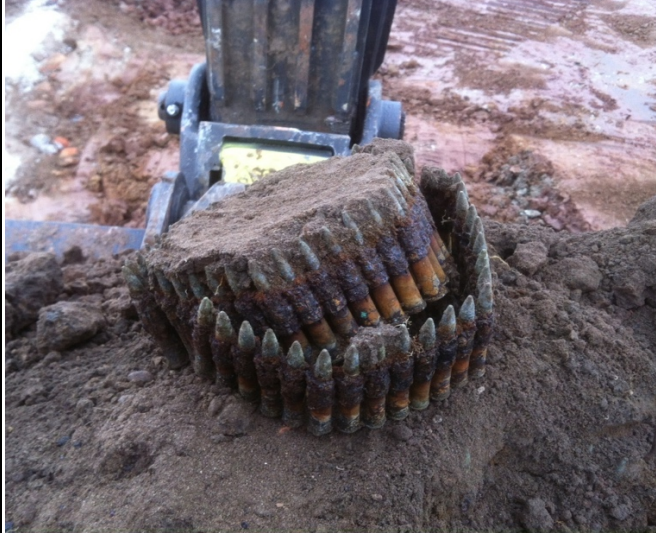
<p data-bbox="1042 1279 1441 1682">British and Allied aircraft were fitted with different types of offensive and defence weapons. The most common ammunition associated with British aircraft is .303" calibre for use in turret machine guns. Pictured left is a belt of .303 ammunition recovered from a UK airfield site.</p>

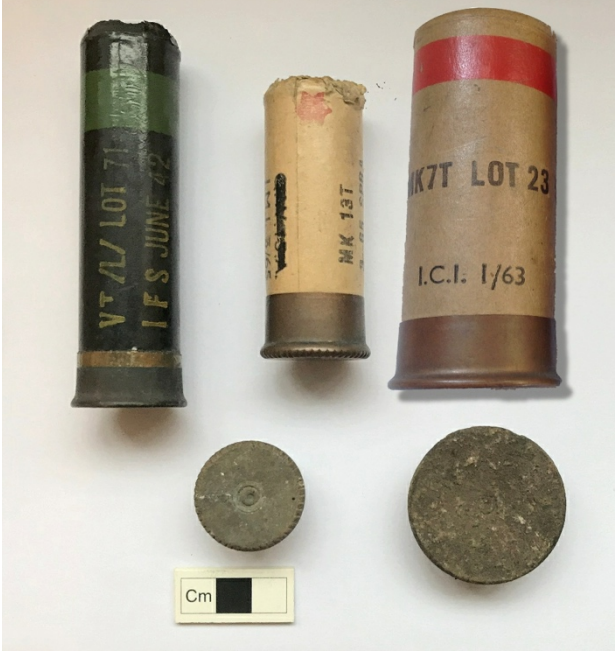
Type		Description
<p>Pyrotechnics (Flare Pistol Cartridges)</p>

<p>Examples of flare cartridges. Left &amp; centre 1" signal pistol cartridges. Right: a 1.5" signal pistol cartridge. Below are examples of brass cartridge bases which is often all that remains if they have been buried in the ground for a long period of time.</p>	<p>Flare cartridges are used in signal pistols. They are used both on the ground as well as in aircraft. When fired, a pyrotechnic flare is launched. These can be used to convey a message from the ground to an aircraft or vice versa. The type of message could be a warning for an aircraft not to land or if fired from an aircraft, indicating an emergency and needing a priority landing. Mostly they comprise of a brass base with a cardboard body. The cardboard body will decay over time often just leaving the brass cartridge base.</p>

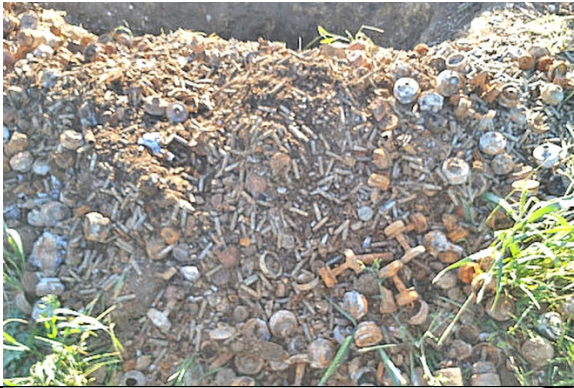
<p>RAF sites commonly disposed of rubbish by burial on site. These rubbish sites often contain ordnance related materiel. The left image shows large quantity of small arms ammunition and bomb fuze (pistols) A large quantity of small arms ammunition and bomb fuze (pistols) components discovered at a former RAF airfield in Northampton.</p>

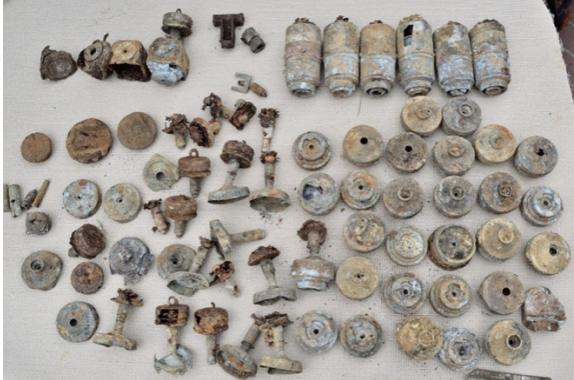
Figure 5 - Details of ordnance related items discovered from RAF airfields in the UK.

<p>Cleaned items recovered from an airfield dump. These comprise of more bomb fuzes (pistols)</p>

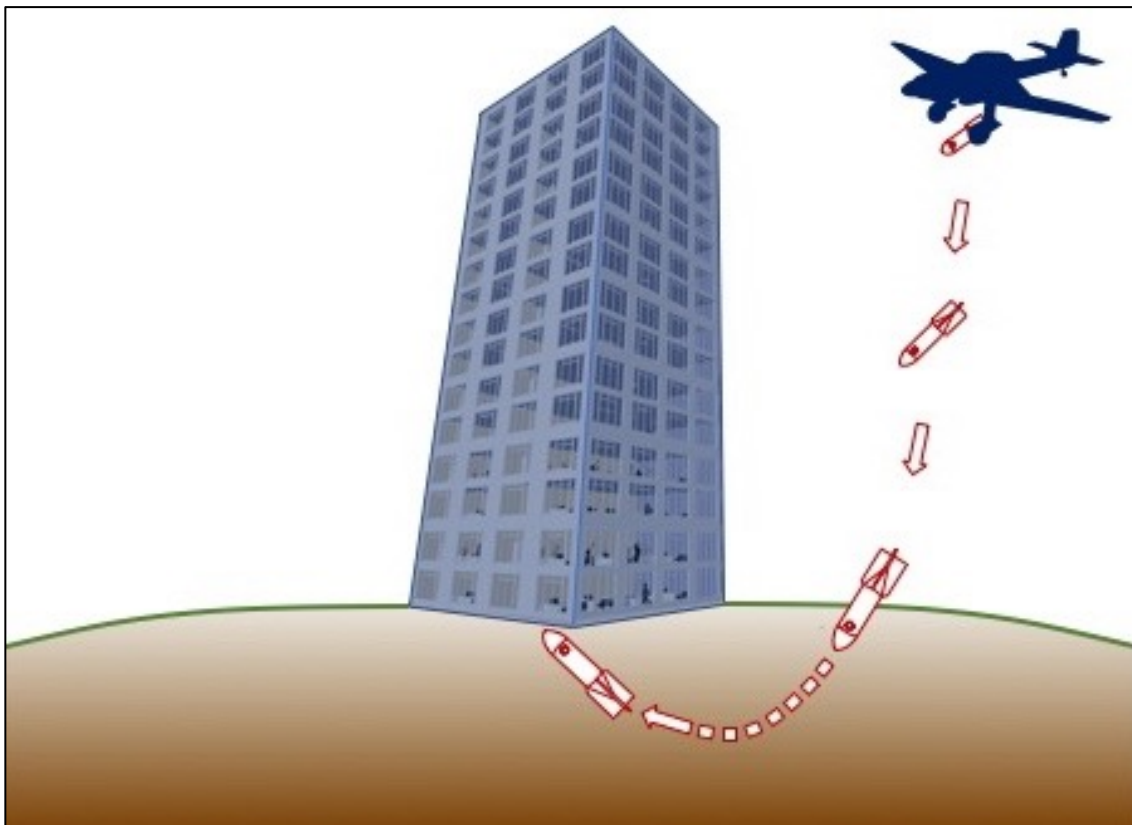
Figure 6. Demonstrating the J-Curve.

J-curve is the term used to describe the characteristic curve commonly followed by an air-delivered bomb dropped from height after it penetrates the ground. Typically, as the bomb is slowed by its passage through underlying soils, its trajectory curves towards the surface.

Many UXBs are found with their nose cone pointing upwards as a result of this effect. More importantly however is the resulting horizontal offset from the point of entry. This is typically a distance of about one third of the bomb's penetration depth but can be up to 15m leading to bombs settling underneath undamaged buildings.

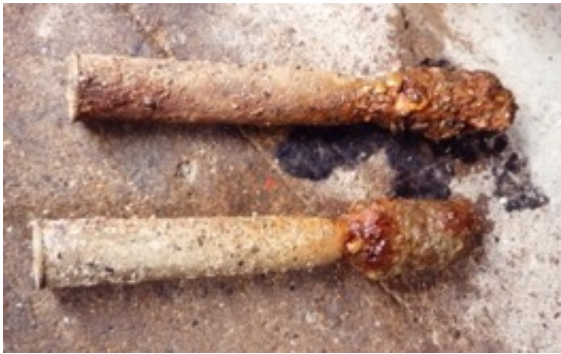
Type	Description
<div style="display: flex; align-items: center;"> <div style="flex: 1;"> <p>Anti-Aircraft Shells</p> </div> <div style="flex: 2;">

<p>40mm AA Shells found at W Sussex site</p> </div> </div>	<p>Fixed (Heavy) Anti-Aircraft batteries were set up all around the country to defend potential targets from aerial attack. Size of guns and shells ranged from small, quick-firing 40mm Bofors guns to larger 3.7 or 4.5inch guns.</p> <p>3.7 Inch = 12.7kg 94mm x 438mm            40mm = 0.9kg 40mm x 311mm            4.5 Inch = 24.7kg 114mm x 578mm</p>

LAA batteries were intended to engage fast, low flying aircraft and were typically deployed around military bases, RAF airfields or important installations. These batteries were mobile and could be moved to new positions with relative ease when required. The most numerous of these were the 40mm Bofors gun, which could fire up to 120 x 40mm HE shells per minute to over 1,800m.

HAA projectiles were high explosive shells, usually fitted with a time delay or a barometric pressure fuze to make them explode at a pre-determined height. If they failed to explode or strike an aircraft, they would eventually descend back to earth.
