CLIENT OXFORDSHIRE COUNTY COUNCIL.

SITE A41 THAME TURN IMPROVEMENT

Geotechnical hazard identification – desk study stage

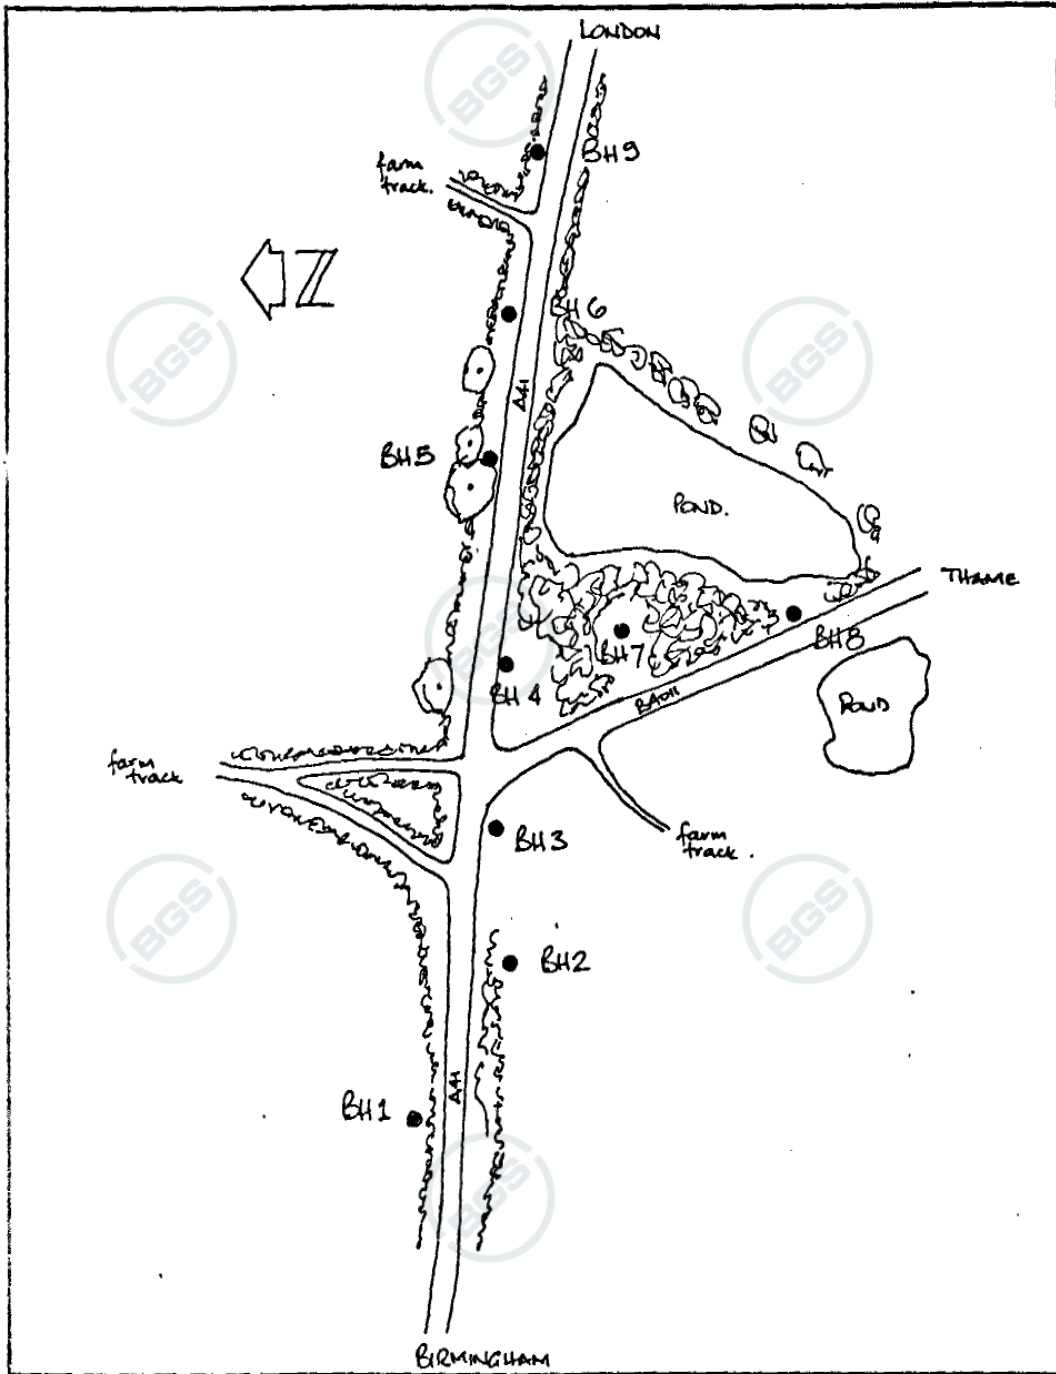
GEL JOB No.	FIGURE
2149	1

SITE PLAN - SHOWING APPROXIMATE BOREHOLE POSITIONS.

SCALE 1 : 2000
(approx.)

TAKEN FROM CLIENT'S DRAWING NOS T72/855a
AND T72/86a, "LONDON-BIRMINGHAM
TRUNK ROAD A41; DETAILED LAYOUT".

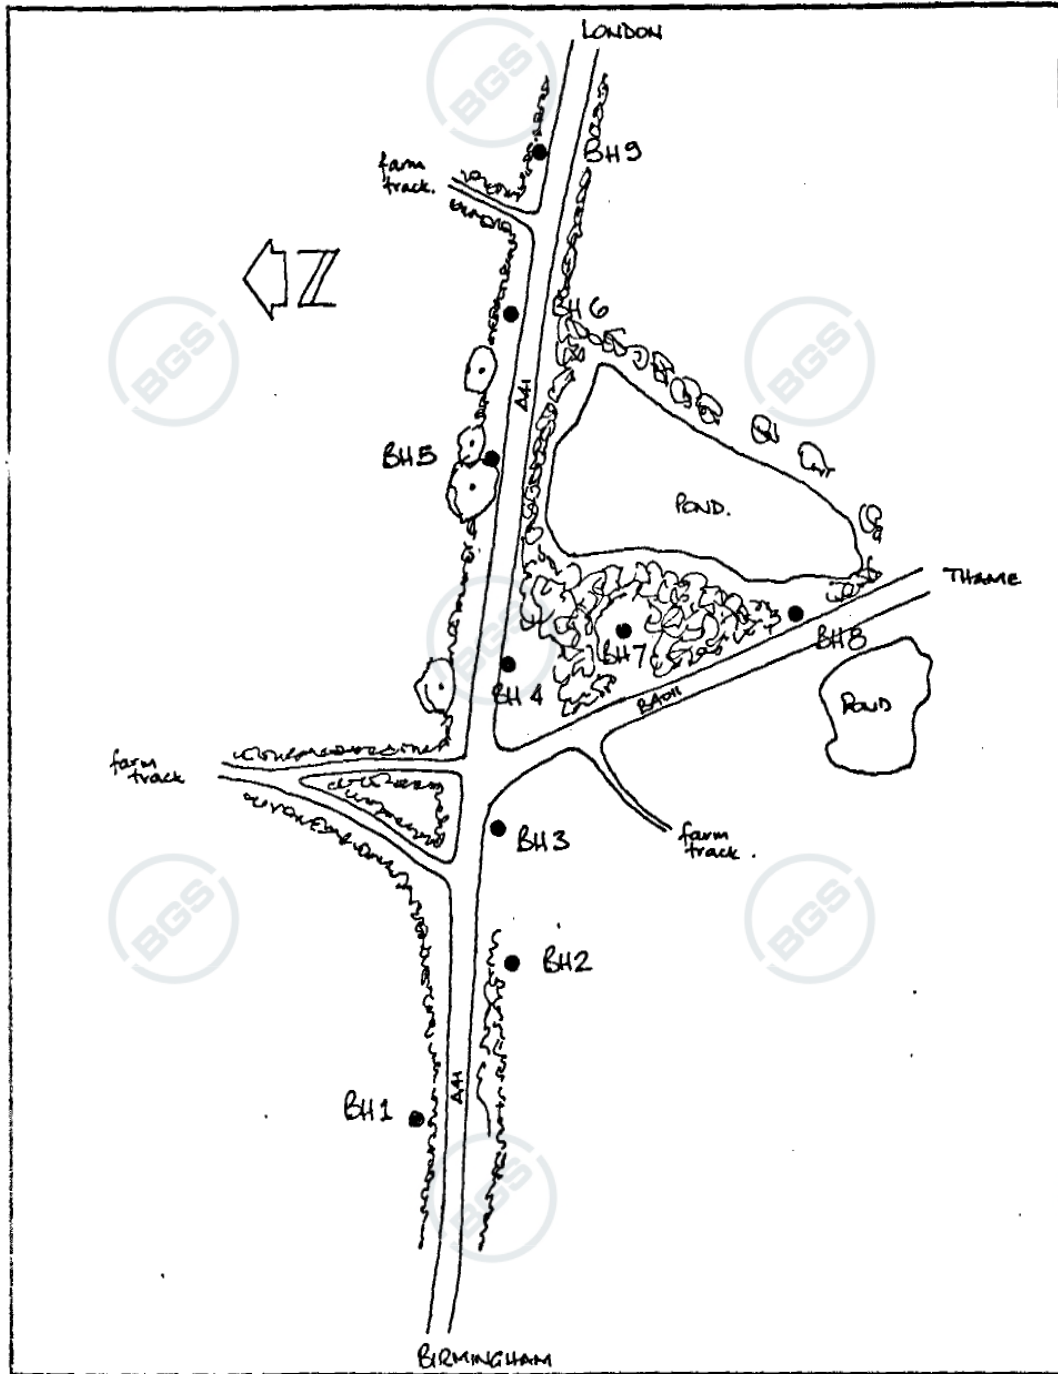
GEL JOB No.	FIGURE
2149	1

SITE PLAN - SHOWING APPROXIMATE BOREHOLE POSITIONS.

SCALE 1 : 2000
(approx.)

TAKEN FROM CLIENT'S DRAWING NOS T72/855a
AND T72/86a, "LONDON-BIRMINGHAM
TRUNK ROAD A41; DETAILED LAYOUT".

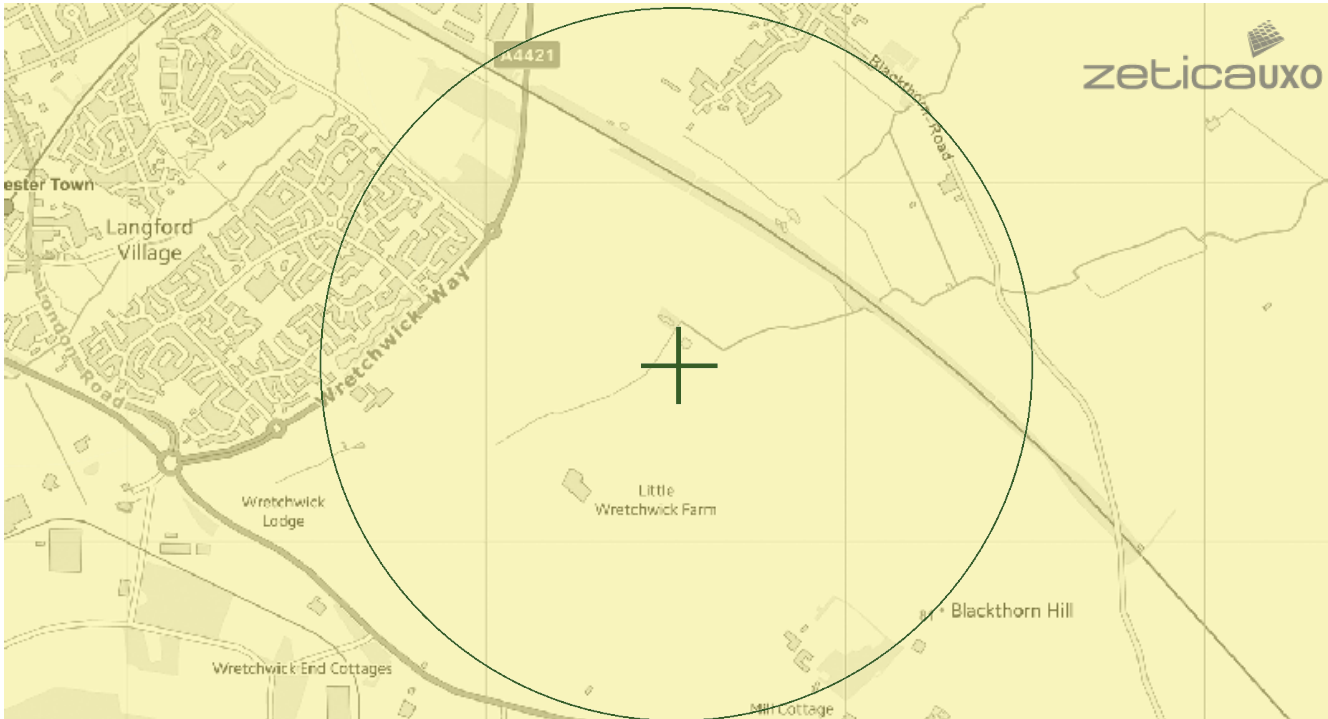
UNEXPLODED BOMB RISK MAP

Location: Little Wretchwick Fm, Oxfordshire
Map Centre: 460500,221500

This map principally indicates a hazard from Unexploded Bombs (UXB) due to WWII bombardment. Other sources of Unexploded Ordnance (UXO) may be present. It should be noted that this map does not represent UXO risk and should not be reported as such when reproduced.
