# NW Bicester Eco development Exemplar

### Arboricultural Method Statement

**Report No** 0516-UA001881-UE21R-04-ArbMS

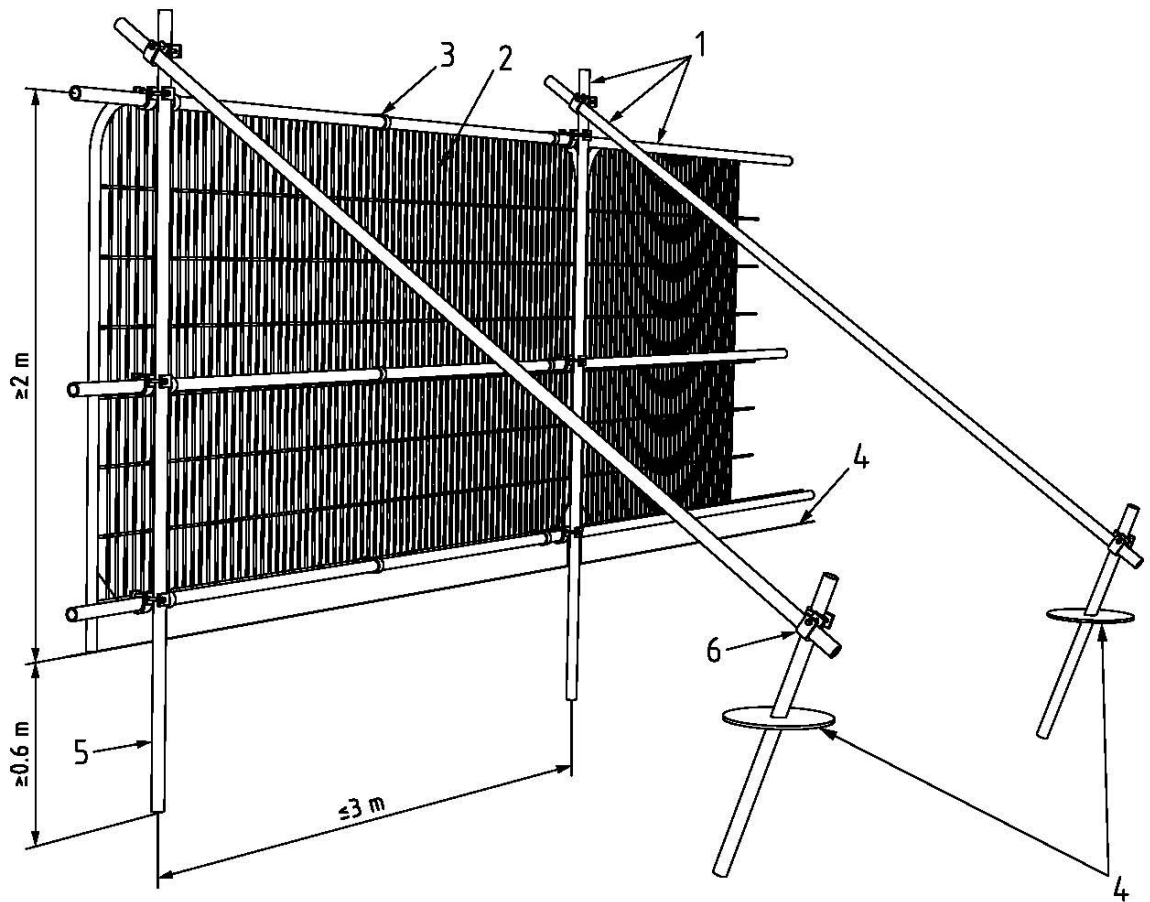
This system involves driving scaffold poles into the ground, onto which are affixed horizontal scaffold poles and diagonal bracing struts (bracing struts are positioned within the protected area). Anti-climb weldmesh panels are secured to this scaffold framework using standard scaffold clips or wire. The system is illustrated in diagram Figure. 2 and is based on BS5837 guidelines. This kind of system is robust enough to withstand occasional knocks by plant machinery.

- 1 Standard scaffold poles
- 2 Heavy gauge 2 m tall galvanized tube and welded mesh infill panels
- 3 Panels secured to uprights and cross-members with wire ties
- 4 Ground level
- 5 Uprights driven into the ground until secure (minimum depth 0.6 m)
- 6 Standard scaffold clamps

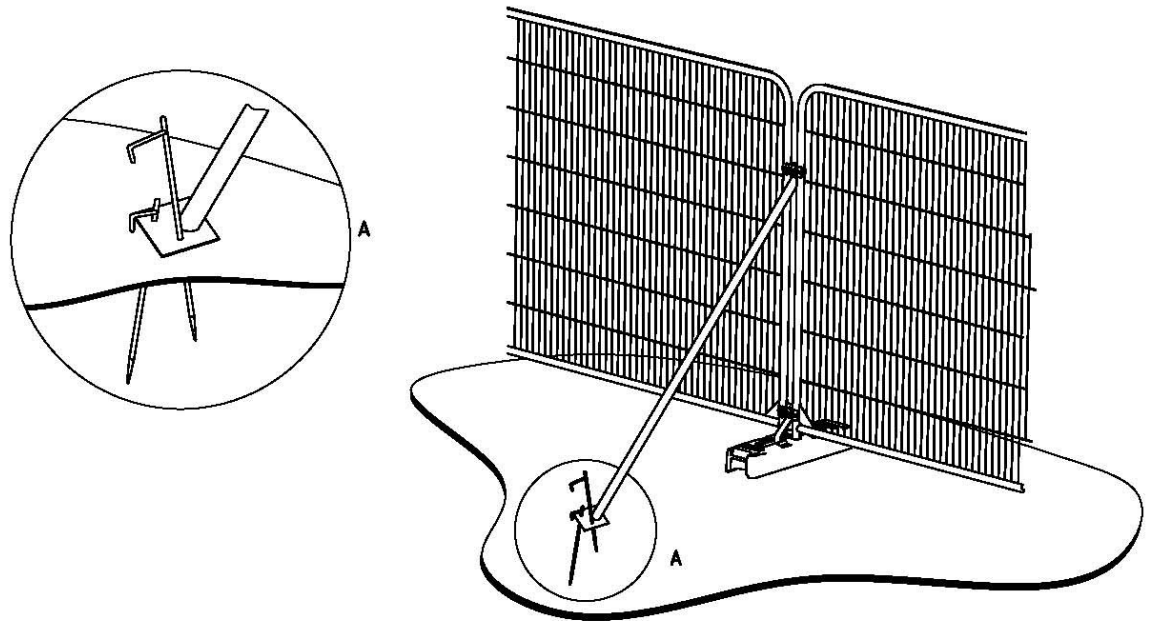
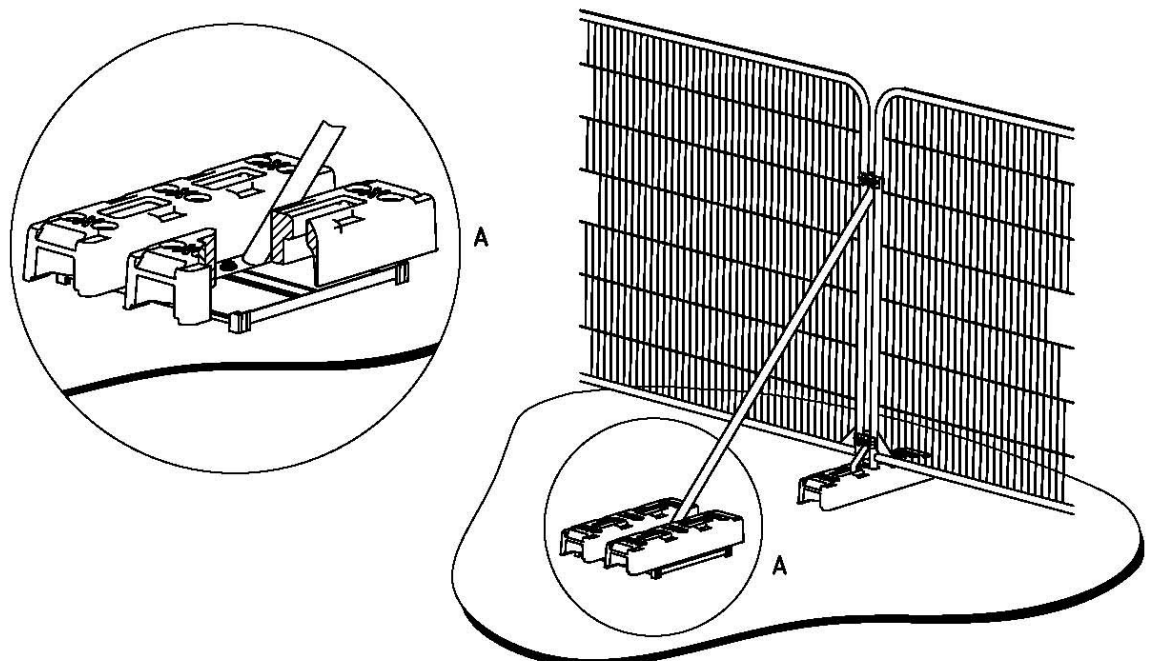
Figure 3. Tree Protection fencing example

This system involves the use of interconnecting anti-climb weldmesh panels. The panels are braced using stabiliser struts which are pinned or weighted to avoid fence movement. The system is illustrated in diagram Figure. 3 and is based on BS5837 guidelines. This kind of system is robust enough to exclude access to protected areas.

a) Stabilizer strut with base plate secured with ground pins

b) Stabilizer strut mounted on block tray
