# Detailed daytime building assessment at Bicester Heritage, Bicester

## Draft Report

January 2017

LC-293	Document Control Box
Client	Bicester Heritage Ltd
Report Title	Detailed daytime building assessment at Bicester Heritage, Bicester
Number	1
Status	Draft
Filename	LC-293_Bicester 4th bat survey_110117JE.docx
Date	January, 2017
Author	JE
Reviewed	
Approved	NJD

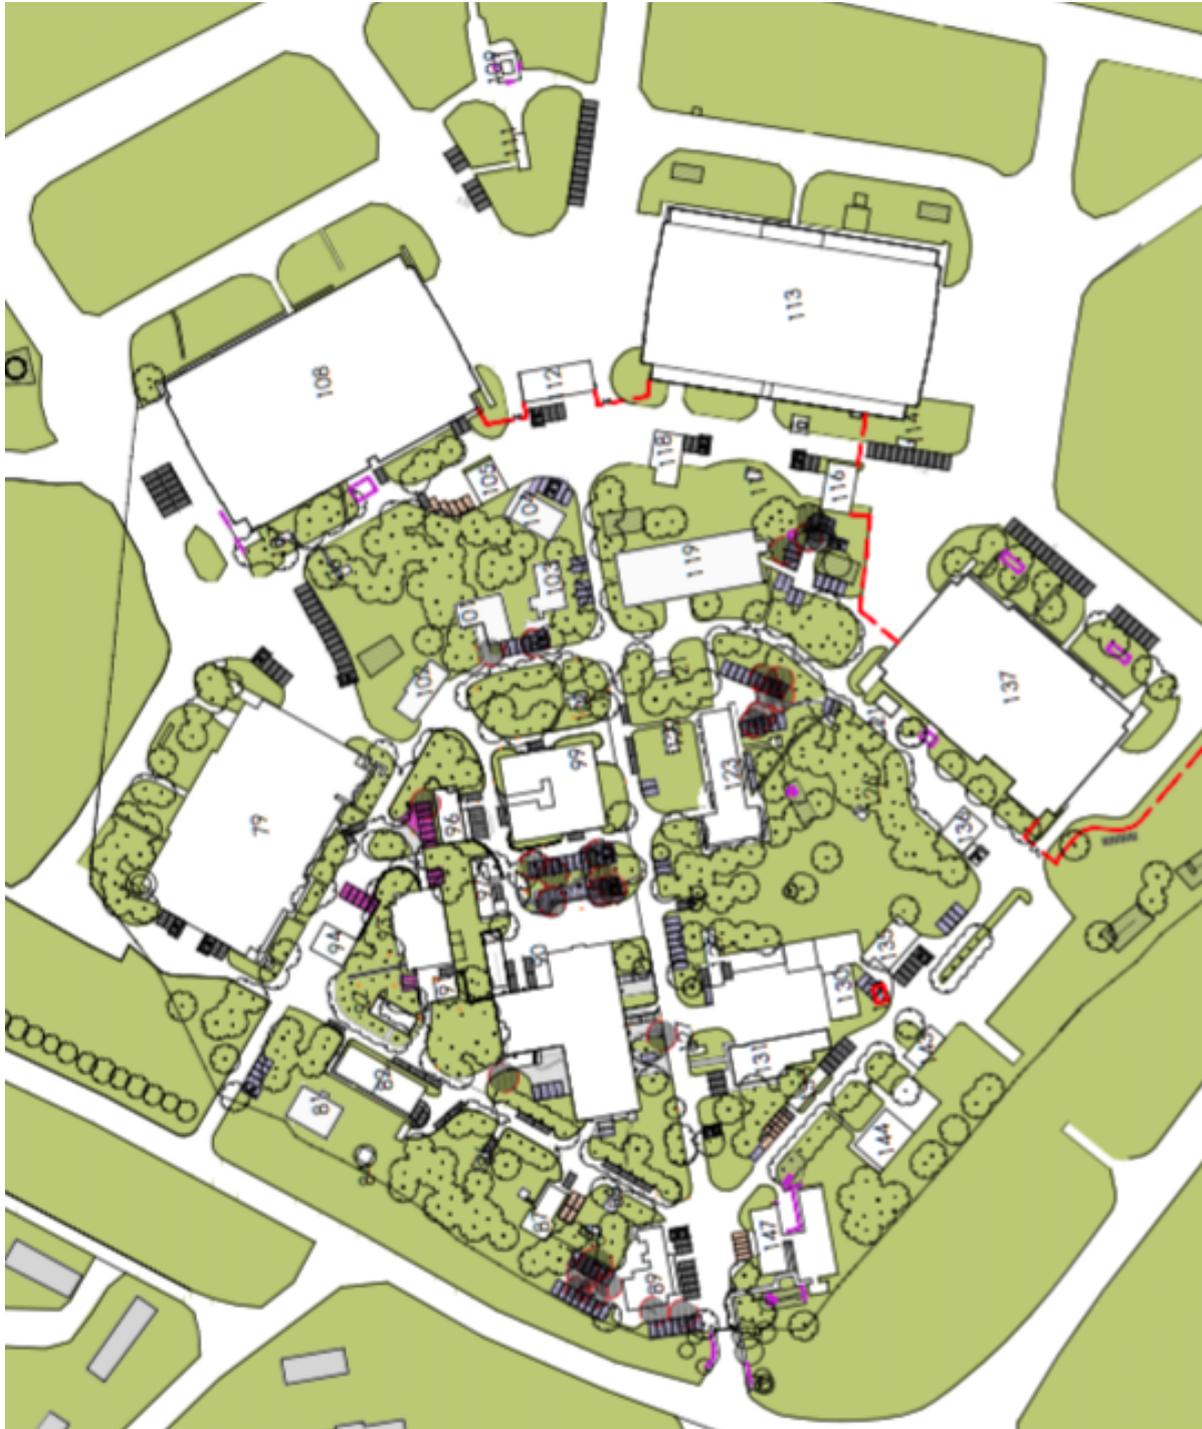
**Figure 1:** Map of the Site (adapted from the Proposed Site Wide Car Parking map received from Bicester Heritage).

### Appendix A Map of the Site
