From: Joyce Christie
Sent: 13 July 2016 16:55
To: Nathanael Stock
Cc: Caroline Roche
Subject: Yew Tree House

16/00247/DISC of 16/00080/F

Discharge conditions

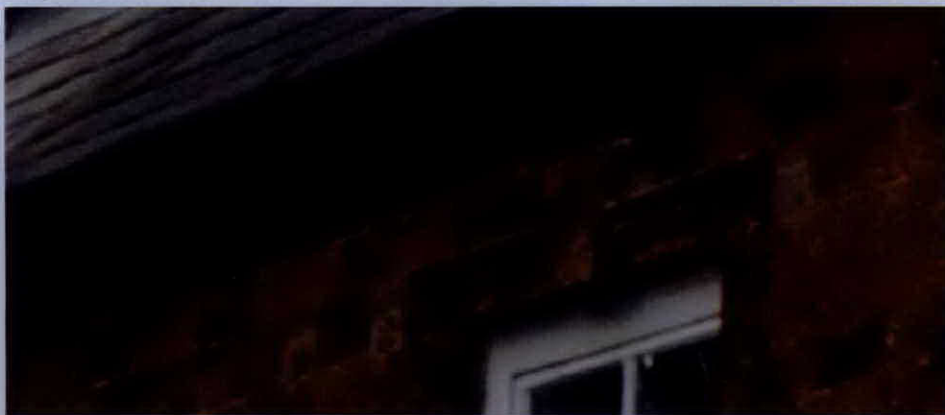
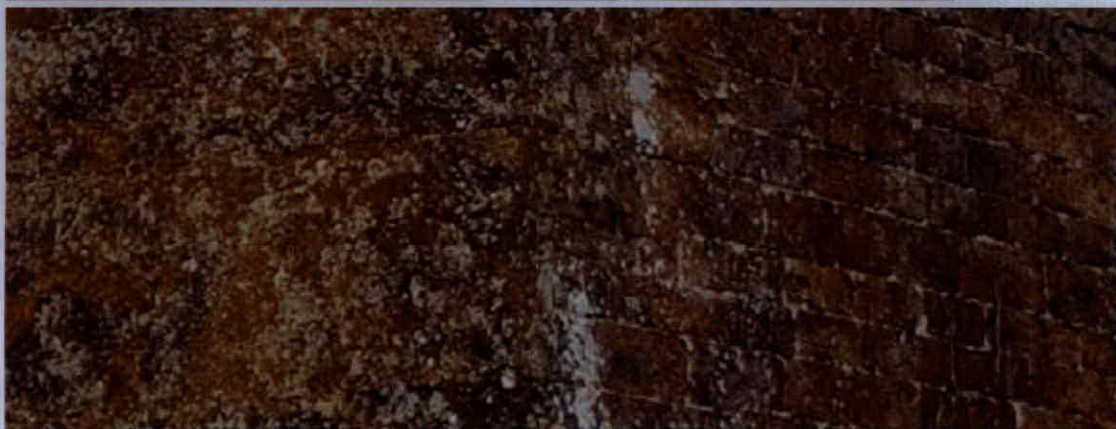
9 (stone sample) – The main house front elevation - the mortar is barely visible as the joints are so tight save for a few creamier joints under the eaves/to the gable the cream mortar is more evident but the joints are still very thin, making the impact of the mortar secondary to the masonry. The joint size of the 1:1:6 cement/lime mix was more

consistent and thin though not as thin as the existing gable, thin joints should be repeated in the lime mortar sample – the latest sample has thicker joints, including the perpends which would make the mortar too dominant – please ensure joint is kept thin. Was the mortar mixed up based on a historic sample as it appears to white - We would suggest that Hornton stone dust is added to the mix to tone it down.

The condition asked for a lime mortar – this could have been lime putty based or NHL 3.5. We note that a lime putty mortar has been used we trust the Applicant has discussed the lime mortar and whether it needs a pozzolan added for the thin stone skin in the new build with the manufacturer. Care should be taken to protect lime mortar to prevent it drying out too quickly, the manufacturer should be able to advise on suitable protection/wet hessian sheets etc. The rebuilt garden wall should have its own sample to match the existing wall NB both faces are different.
