Arboricultural method statement

Cotefield Farm
Oxford Road
Bodicote
Banbury
OX15 4AQ

Report number 431 prepared by:

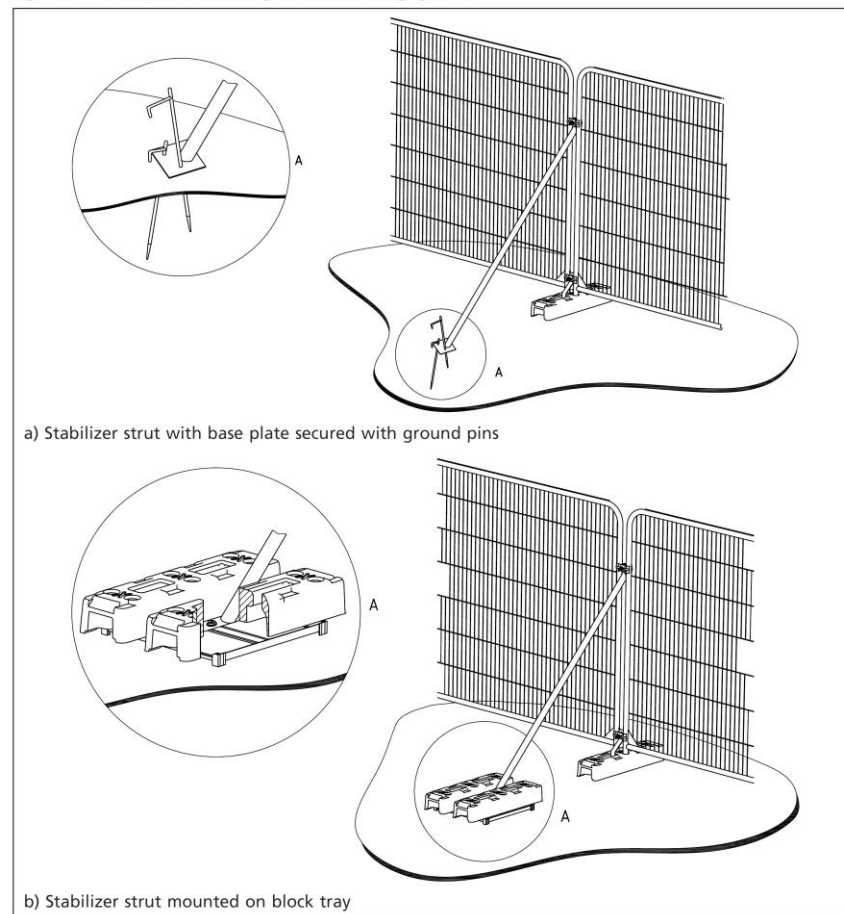
2 m tall welded mesh panels on rubber or concrete feet should be joined together using a minimum of two anti-tamper couplers, installed so that they can only be removed from inside the fence. The distance between the fence couplers should be at least 1 m and should be uniform throughout the fence. The panels should be supported on the inner side by stabilizer struts, which should normally be attached to a base plate secured with ground pins (Figure 3a below). Where the fencing is to be erected on retained hard surfacing or it is otherwise unfeasible to use ground pins, e.g. due to the presence of underground services, the stabilizer struts should be mounted on a block tray (Figure 3b below).

Figure 3 Examples of above-ground stabilizing systems

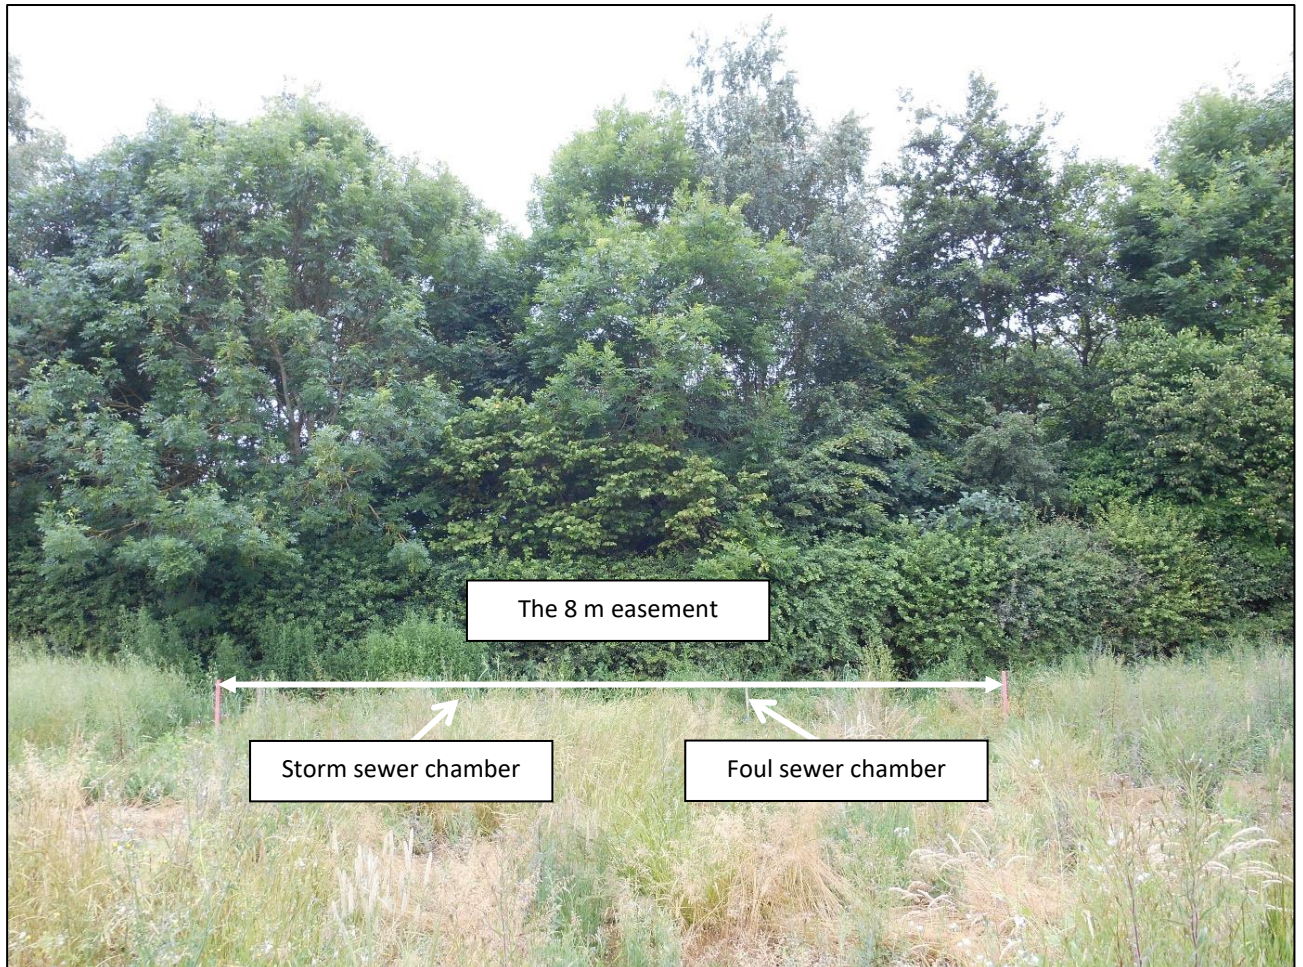
Image 1: the eastern face of the planting belt

- 3.2 The location of the breach in the planting belt has not altered from application reference 17/00316/F and is the same width as the easement that would have been required for the drainage scheme that was approved under application reference 11/00617/OUT. The breach remains as an 8 m wide cordon, identified on the eastern side of the belt by the red pegs seen in image 1 in Appendix 1. The approximate position of the chambers for the foul and storm sewers on the eastern side of the belt are indicated by the un-painted pegs that are also visible in image 1.

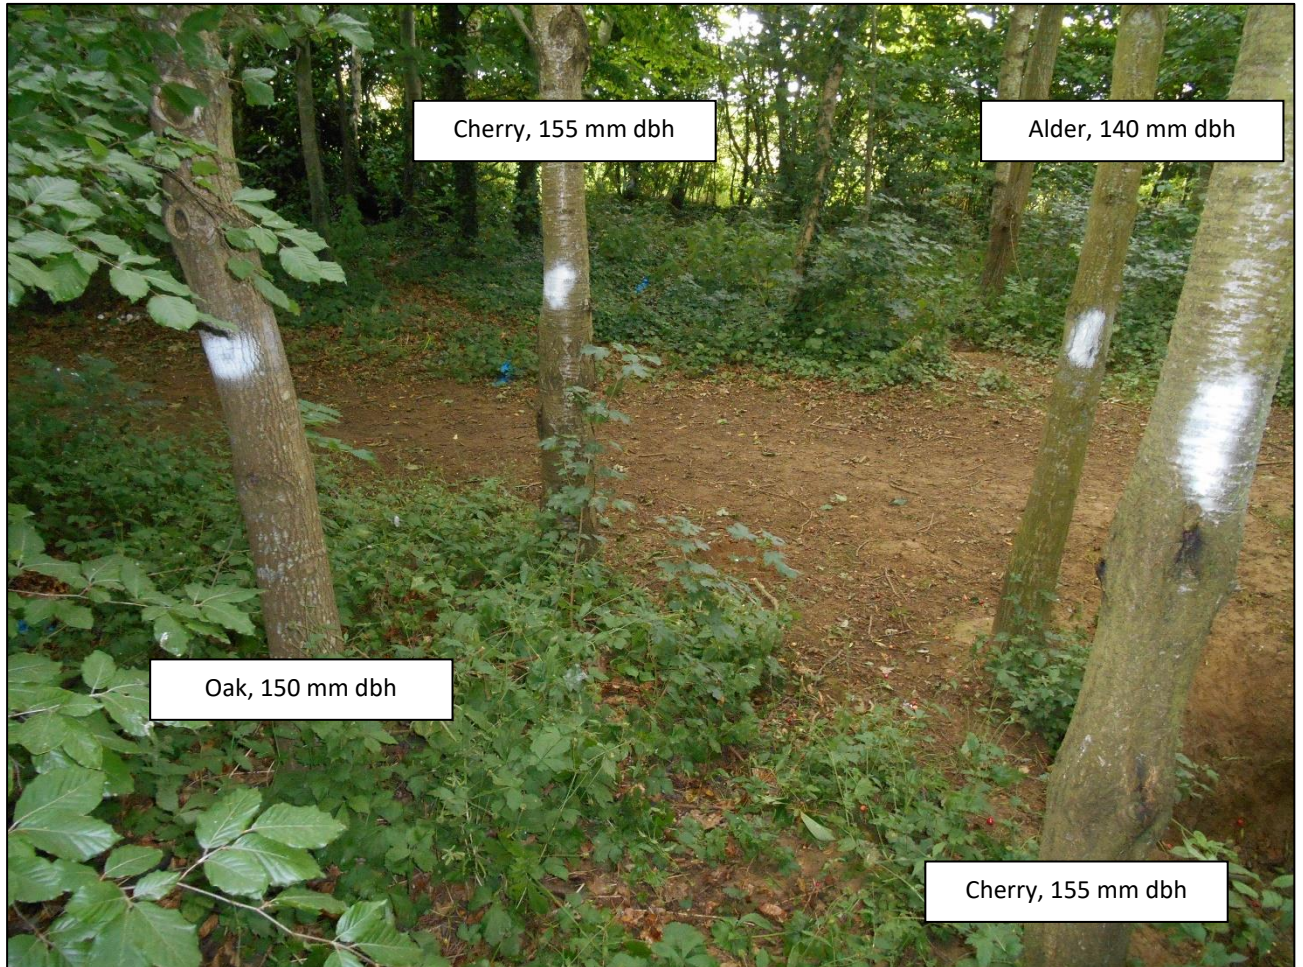
Image 2: some of the trees marked for removal

- silver birch, 200 mm dbh
 - larch, 215 mm dbh
 - beech, 165 mm dbh
 - field maple, 195 mm dbh
- 3.6 To the south of the foul sewer 13 stems were marked with a white spot, see image 2; the trees were, from east to west:

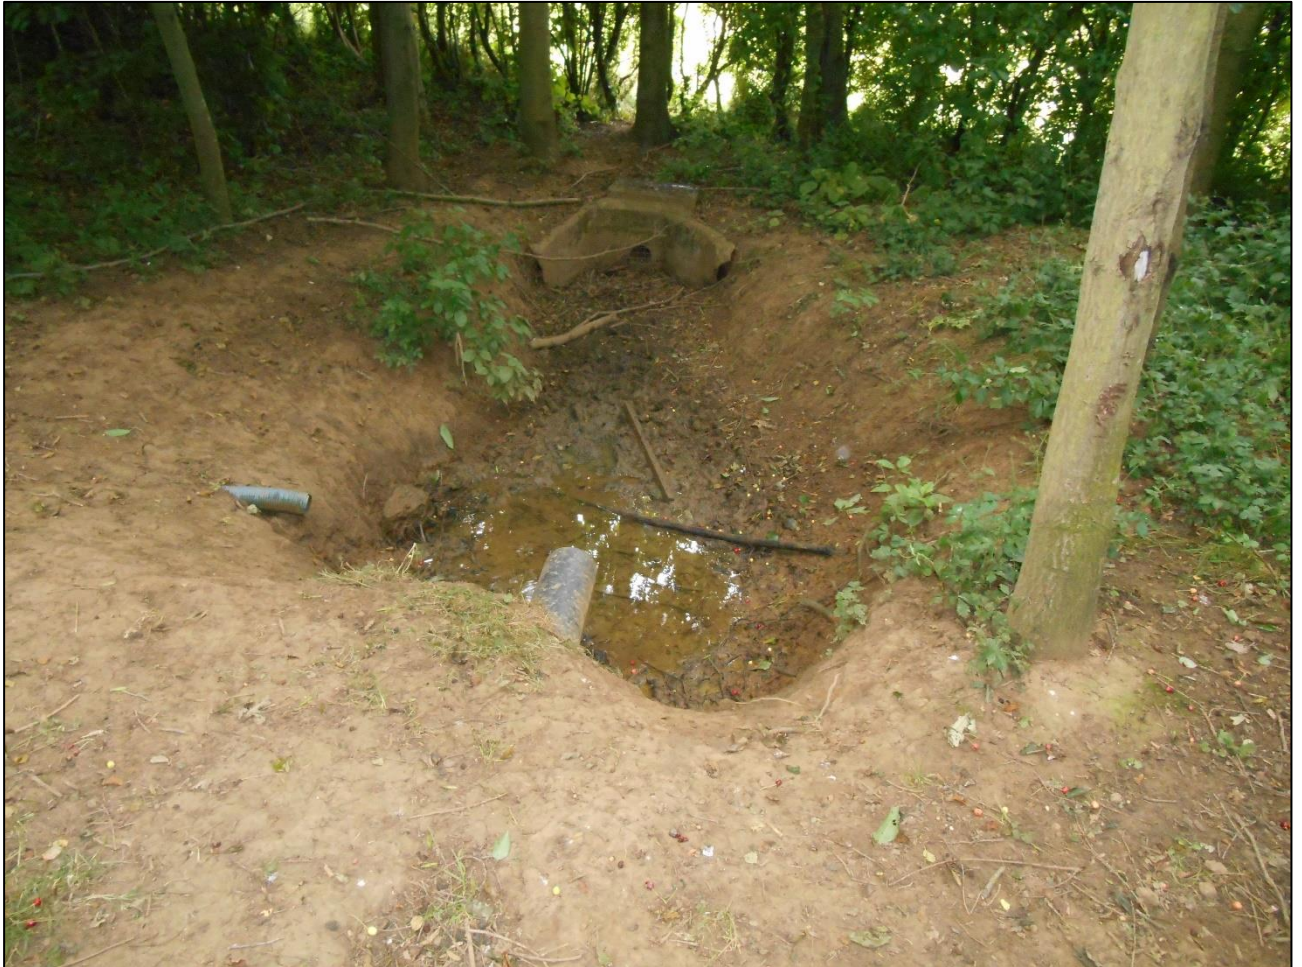
Image 3: part of the existing drainage route across the tree belt

- ash, 250 mm dbh
 - silver birch, 180 mm dbh
 - ash, 260 mm dbh
- 3.7 Part of the southern boundary was defined by the edge of an existing drainage route that ran across the tree belt, which had been built to a very low standard, see image 3.
