WENDLEBURY LODGE, WENDLEBURY, OXFORDSHIRE

HERITAGE ASSESSMENT

PROJECT: Wendlebury Lodge, Wendlebury, Oxfordshire

DOCUMENT TITLE: Heritage Assessment

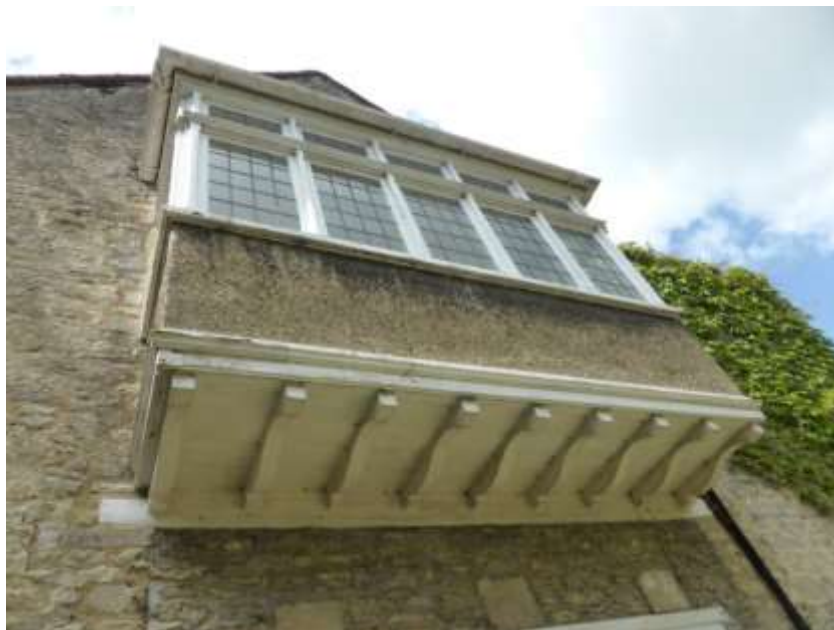
Figure 10: Early 20th century oriel window

- 4.2.1 The east elevation is dominated by an early 20th century oriel window on the first floor. This feature is characterised by side opening leaded timber casements and fixed top lights. The mullions and transoms include chamfers. The lower half of the oriel is finished with pebble dash and the whole is supported on carved brackets.
- 4.2.2 The ground floor includes a long timber window with a row of fixed lights. The top lights are leaded and are wider than the plain fixed casements below. The design and proportions of the openings appear rather odd and internal evidence suggests the window arrangement has been modified. There are clear straight joints and stone rubble infill either side of this window opening. This demonstrates that there was larger opening in this location but it is unclear what

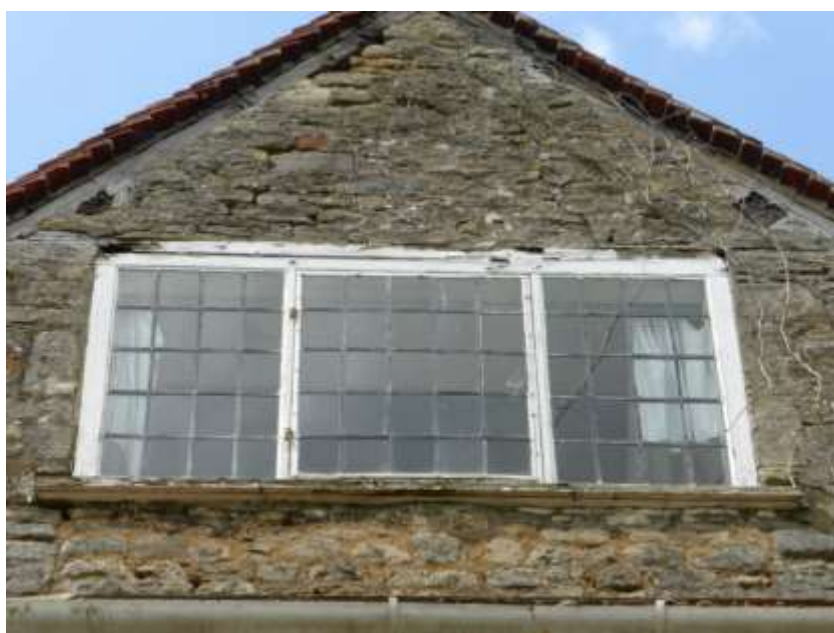
Figure 11: Late 19th to early 20th century metal casements to the attic

- 4.2.3 The Attic window has a wooden frame and contains three metal casements with leaded lights. Window fittings suggest a late 19th or early 20th century date for this window.
- 4.2.4 To the right there is an extension which includes a two storey element with crenelated parapet and a single storey lean-to. These two elements are both pebble dashed and it is not therefore possible to determine whether this represents one or two phases of development. Historic mapping suggests that they had both been built by 1920. This appears to be supported by a butt joint between the rubble stone construction of the lean-to and the brick piers and first floor walling of the two storey crenelated extension. There is a modern door on the left hand side of a brick buttress finished with pebble dash.

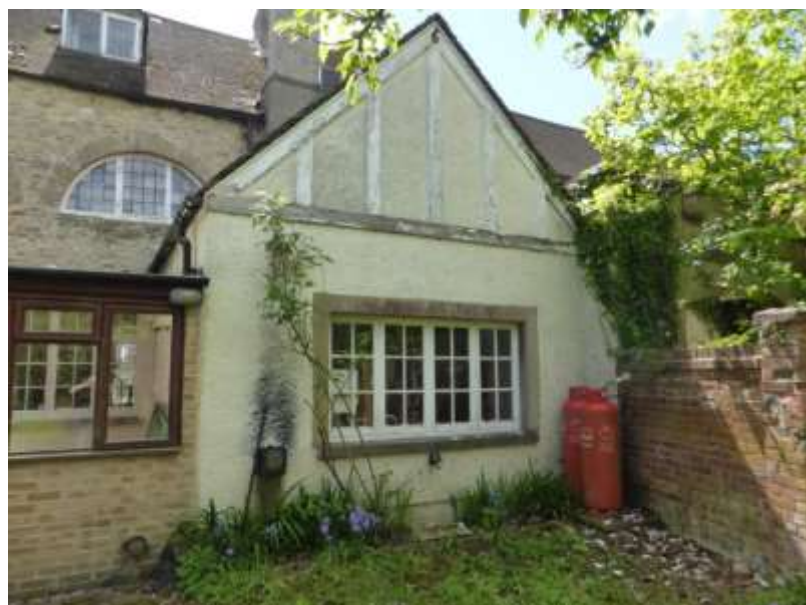
Figure 18: Early 20th century single storey extension on the right hand side of the rear elevation

- 4.3.6 On the right hand side of the rear elevation is a single storey extension with a gabled roof. The wall finish is painted pebble dash. Planks have been applied to the gable end in imitation of timber framing. These are typical early 20th century details. The window surround is cement rendered and the opening contains multi-paned timber casements. At the southern end of

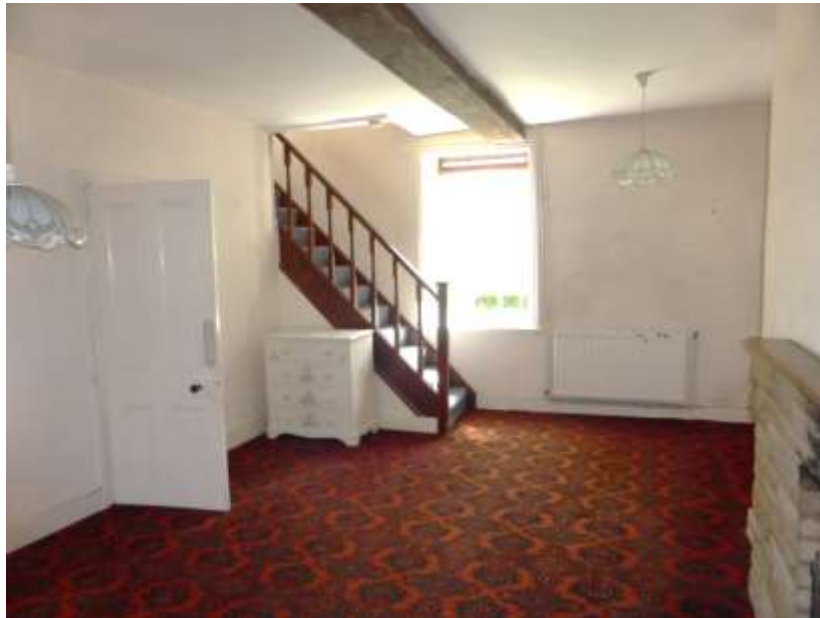
Figure 20: The Dining Room (G1)

- 4.4.3 There is a large chimney breast on the west wall with modern stone fire surround and wood burner. The staircase and enclosure along the front wall of G1 are modern. A transverse beam passes through the centre of the room and appears to rest on a very shallow lintel over the sash window on the front elevation.

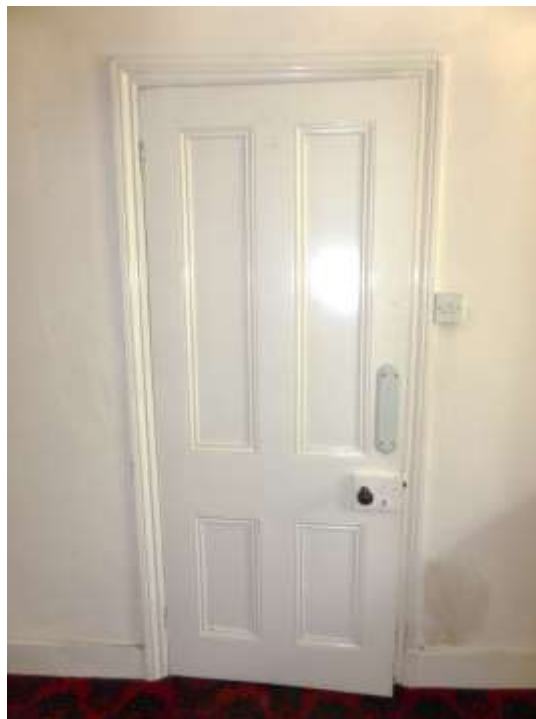
Figure 21: An early 20th century door and architrave between G1 and G2

- 4.4.1 The Dining Room (G1) is accessed from the Hall (G2) through a four panel door. The mouldings around the sunk panels and the door architrave suggest a later 19th or early 20th century date. The door on the rear wall of G1 leading to the Kitchen (G10) is of similar design. The breach through the wall in this location was created in the first two decades of the 20th century and this provides a date for the insertion of the door.

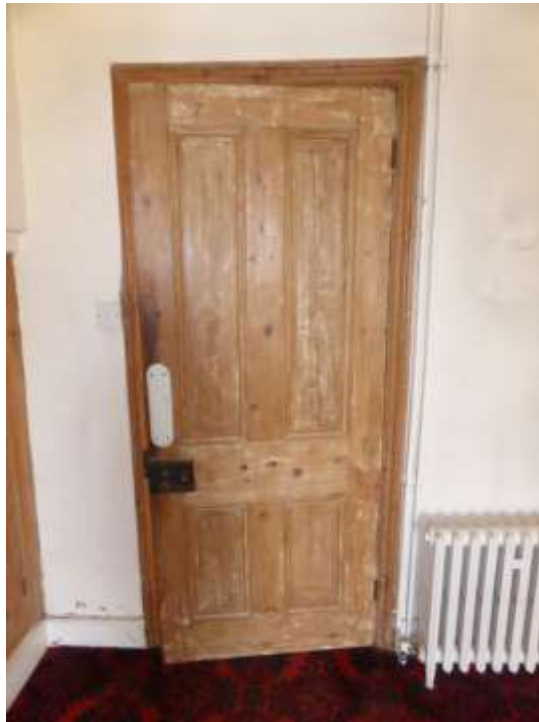
Figure 22: An early 20th century door leading to the Kitchen (G10)

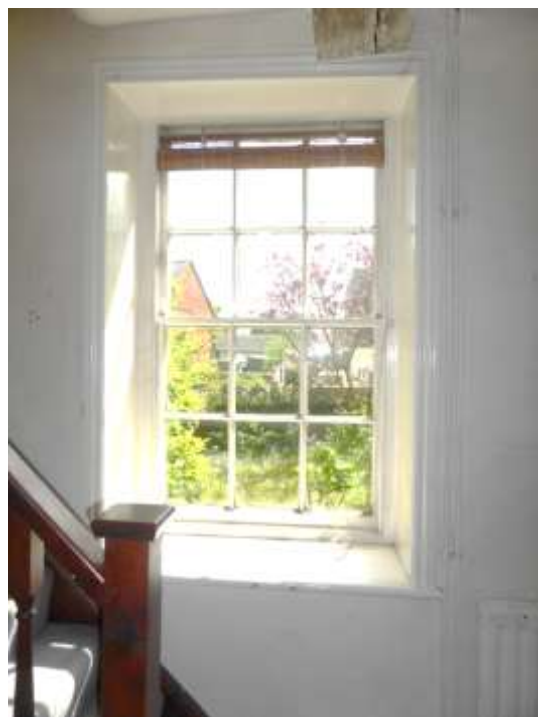
Figure 23: Six over six sash window in G1 with chamfered glazing bars and later 19th century style fastener

- 4.4.2 The sash window on the front elevation includes a sash fastener which was in common use in the second half of the 19th century. The architrave has similar mouldings to the door architraves in G1 and was probably added in the early 20th century. The window opening on the north wall of G1 includes 20th century casements with multi-paned and top hung lights.

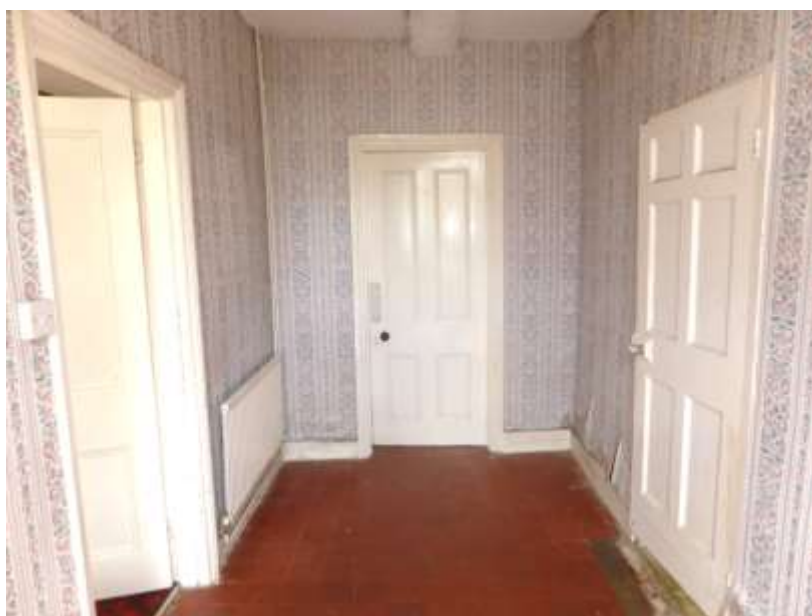
Figure 25: The Hall (G2) looking north

- 4.4.4 The Hall (G2) is accessed externally through a door on the south elevation. This front door possibly dates to the early part of the 20th century as suggested by the three panels below the lock rail. The upper glazed part of the door is probably a modern alteration.
- 4.4.5 The floor is finished with quarry tiles. This is a typical floor finish used for the halls of late Victorian and Edwardian houses and continued to be used in kitchens and sculleries into the 1930s and 40s.
- 4.4.6 A transverse beam crosses through the centre of G2 and, similar to G1, appears to rest on a slender lintel over the front door. The Hall provides access to G3 and G4.

4.4.7 G3 is accessed from the Hall (G2). The door and architrave to G3 are of the same design as the door to G1 from the Hall (G2), i.e. probably early 20th century (see figure 25).

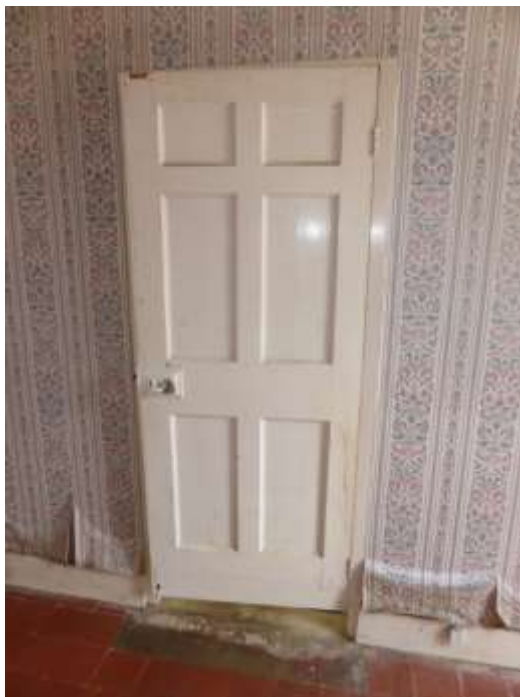
Figure 27: Door to G4 from G2

4.4.8 The Snug (G4) is accessed through a poorly fitted door from the Hall (G2). The door itself appears to be a re-used six panel door. The door frame is plain and not of traditional construction. The chimney breast has been removed from G4 and three metal brackets support the hearth on the first floor.

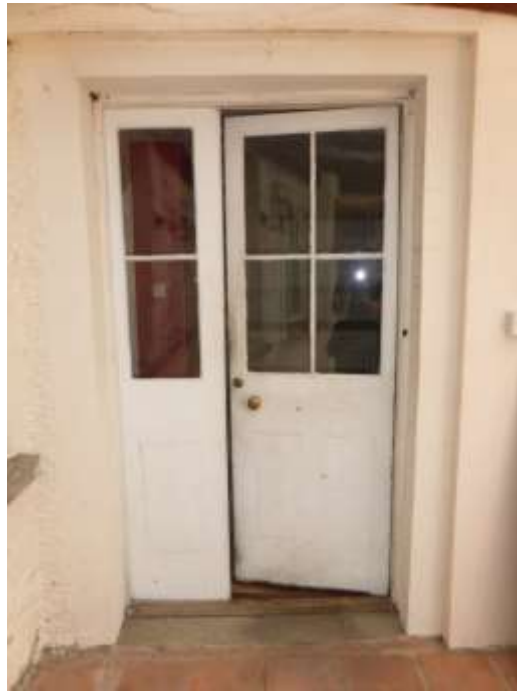
Figure 34: Door to the Kitchen (G10) from the Conservatory (G9)

4.4.14 The Kitchen (G10) is accessed through an earlier 20th century door from the Conservatory (G9). There is a chimney breast with blocked up fireplace on the south wall. The modern suspended ceiling conceals the early 20th century lath and plaster ceiling above. The roof structure, which is common rafter with ridge plank and side purlins can be observed through a ceiling hatch. There is a window opening with 20th century casements multi-pane lights on the north wall.

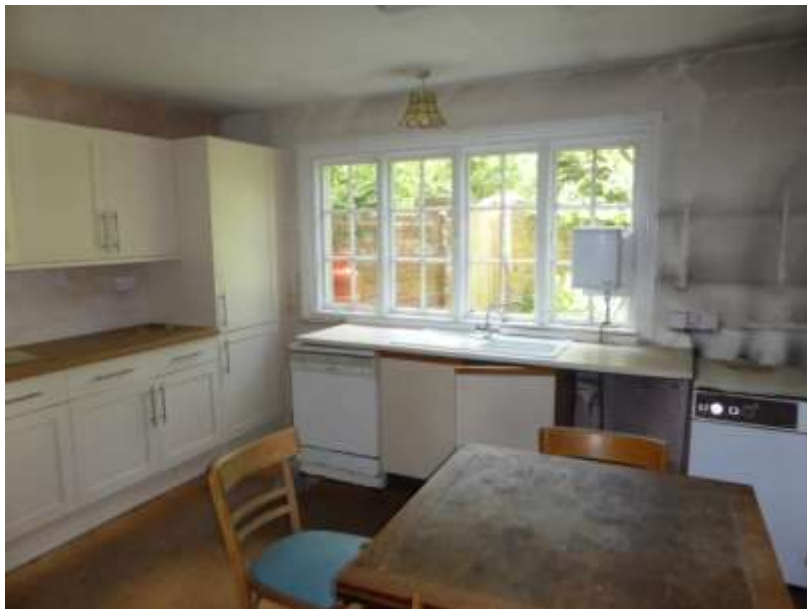
Figure 35: The Kitchen (G10) looking north

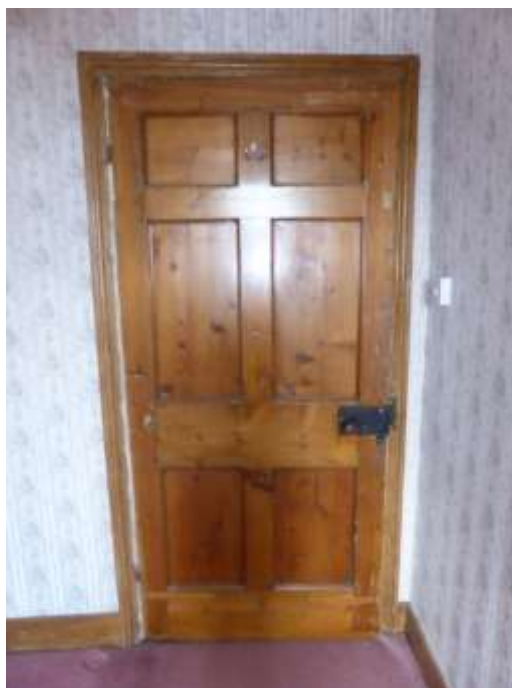
Figure 40: Probable early 20th century door to F1

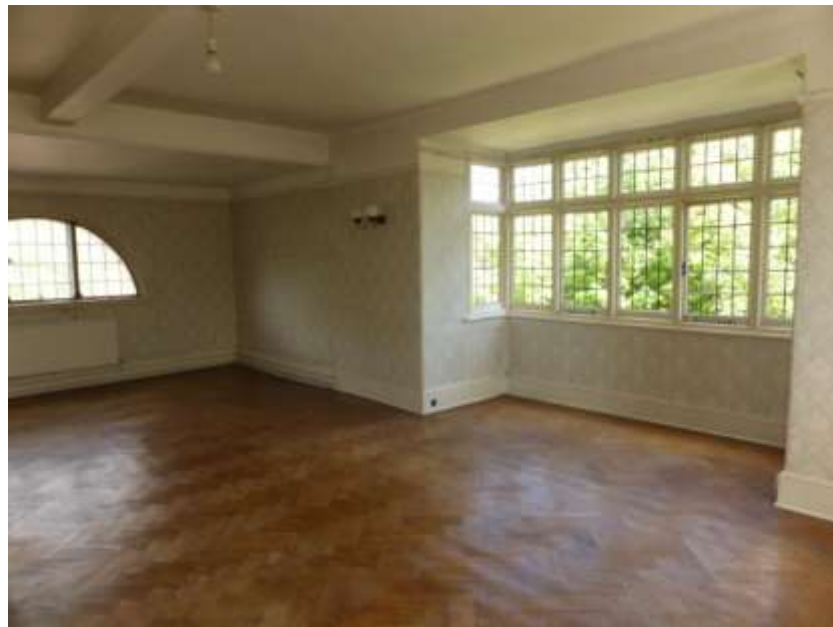
4.5.12 It appears that the thermal window to the rear of F5 was re-set from the original elevation. The casements have a metal frame, the simple L-shaped bar catch may be a later replacement associated with the repositioning of the window.

Figure 49: Re-set thermal window to the left and early 20th century oriel to the right

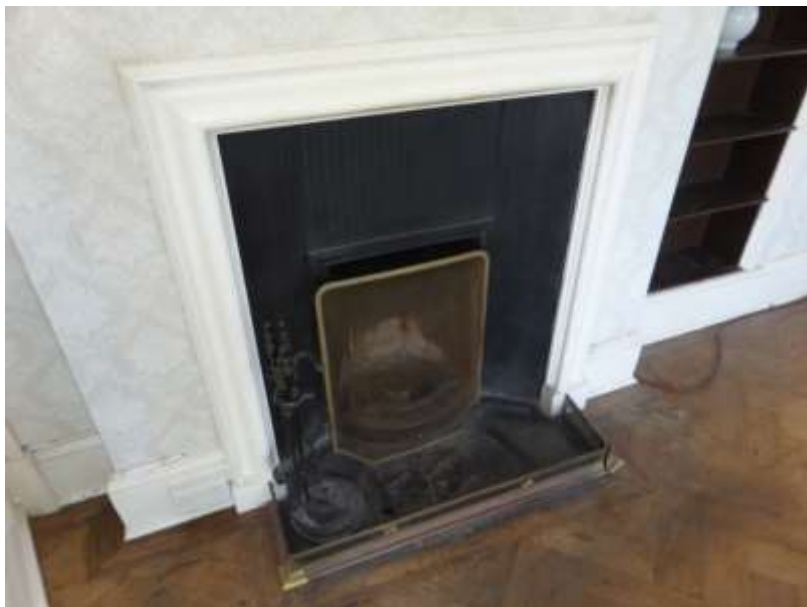
4.5.10 The wooden fire surround includes bolection moulding which appears to be Edwardian in date rather than earlier. The cast iron cheeks of the grate are unusual but appears to also be of early 20th century date, as is the grate itself.

Figure 50: Early 20th century coal grate with bolection moulding surround

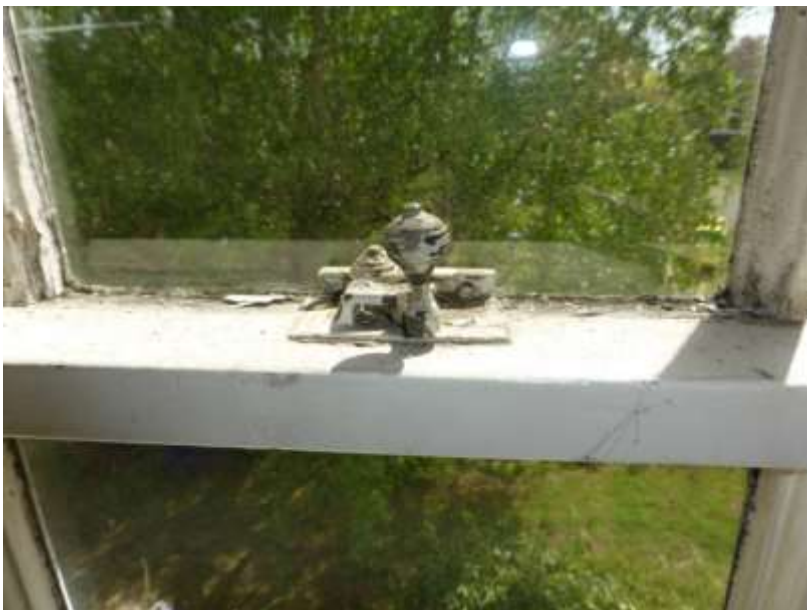
Figure 51: Later 19th century type sash fasteners in F5

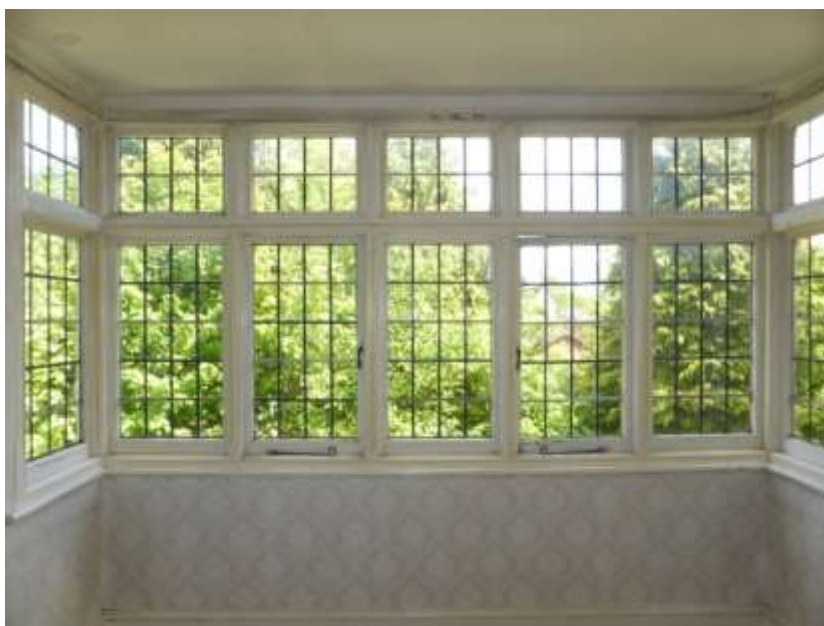
Figure 53: Detail of the early 20th century leaded lights to the oriel window in F5

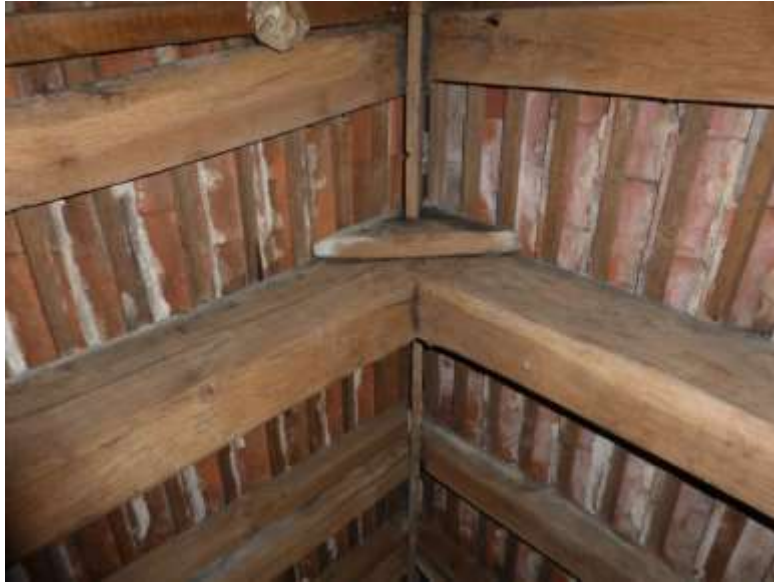
- 4.6.1 The attic is of four bays, the central eastern bay is bisected by a transverse wall. The roof structure throughout includes two purlins on each side of the roof. These purlins include chamfers 35mm wide and simple run-out stops. The purlins are cut back where they are tenoned into the principal rafters. Each truss includes a collar positioned between the purlins and tenoned into the principal rafters and double pegged. The apex of the principal rafters have bridled joints and small plated yokes. Another feature of the apex is a ridge plank. Below the collar there are raking struts which have been nailed to the principal rafters. All of these characteristics are consistent with an 18th century date for construction.

Figure 55: Apex of principal rafters at A1

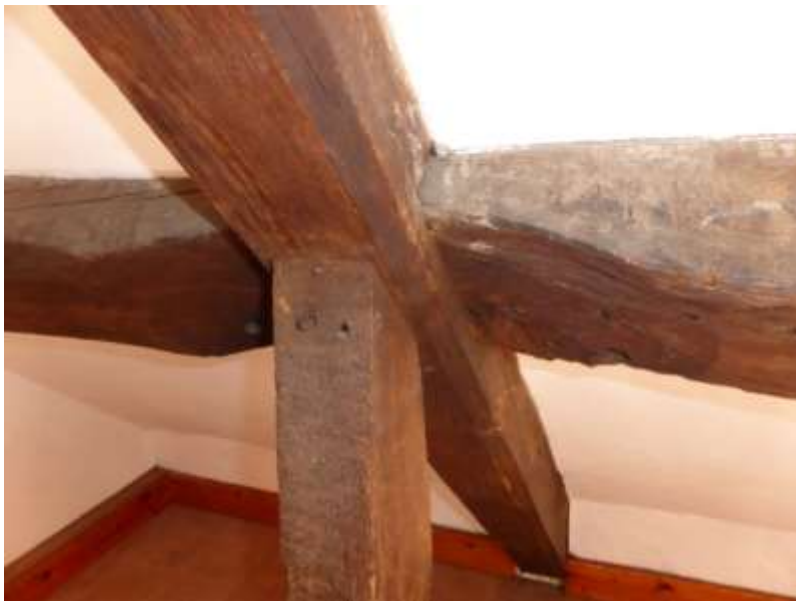
Figure 56: Tenoned purlin in A1

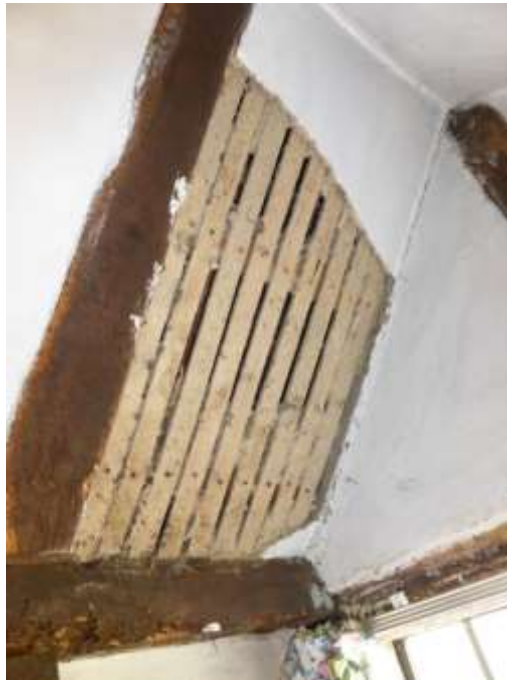
- 4.6.5 By contrast, the dormer window in A5 includes metal framed casements with stanchions and a window catch which is of later 19th or early 20th century design. There are some sawn laths exposed on one side of the dormer, suggesting a 19th century or later date for this finish. There is also a mix of machine sawn and hand sawn timbers with forged nail joints. The window on the east elevation of A5 includes metal framed casements with stanchions and a late 19th to early 20th century style catch. The mullions are timber.

Figure 61: Rear dormer in A5 with sawn laths and plaster finish
