Client	Mr W Sabin		
Project	Temple Mill, Sibford Ferris, Banbury, Oxon. OX15 5DA.

**Planning Conditions (1) Detail Drawings**

Project Ref	Date	Drawing Number	Revision
DDC 2018-498	August 2018	008	D
Scale	Sheet Size	A1	
1:10

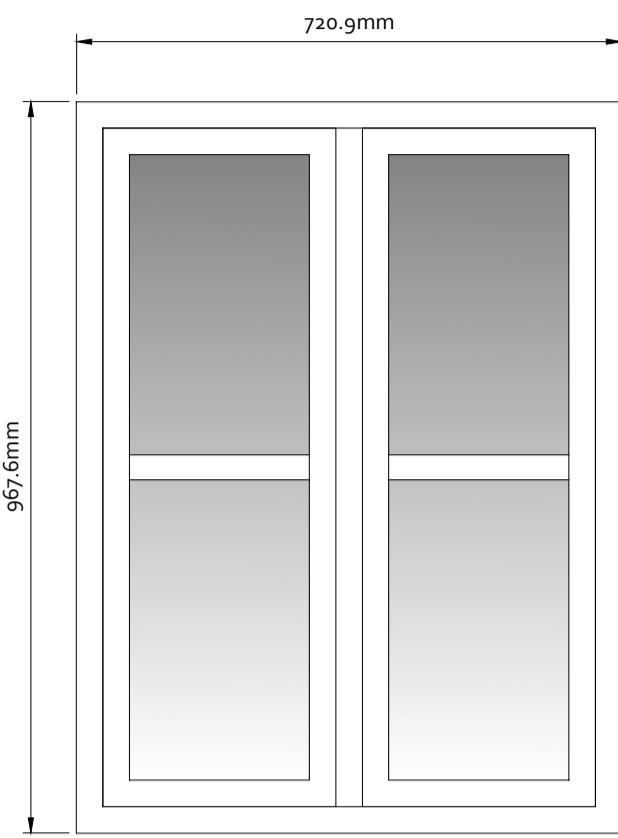
**WINDOW TO GARAGE GABLE**

**Windows**  
 The window should have a true glazing bar, not planted/glued on to glass.  
 Edge spacers should be non-metallic finish - matt black works better if the window is to be painted a non-white.  
 Slimline double glazing (between 10-16mm thick) would look better than standard double glazing.

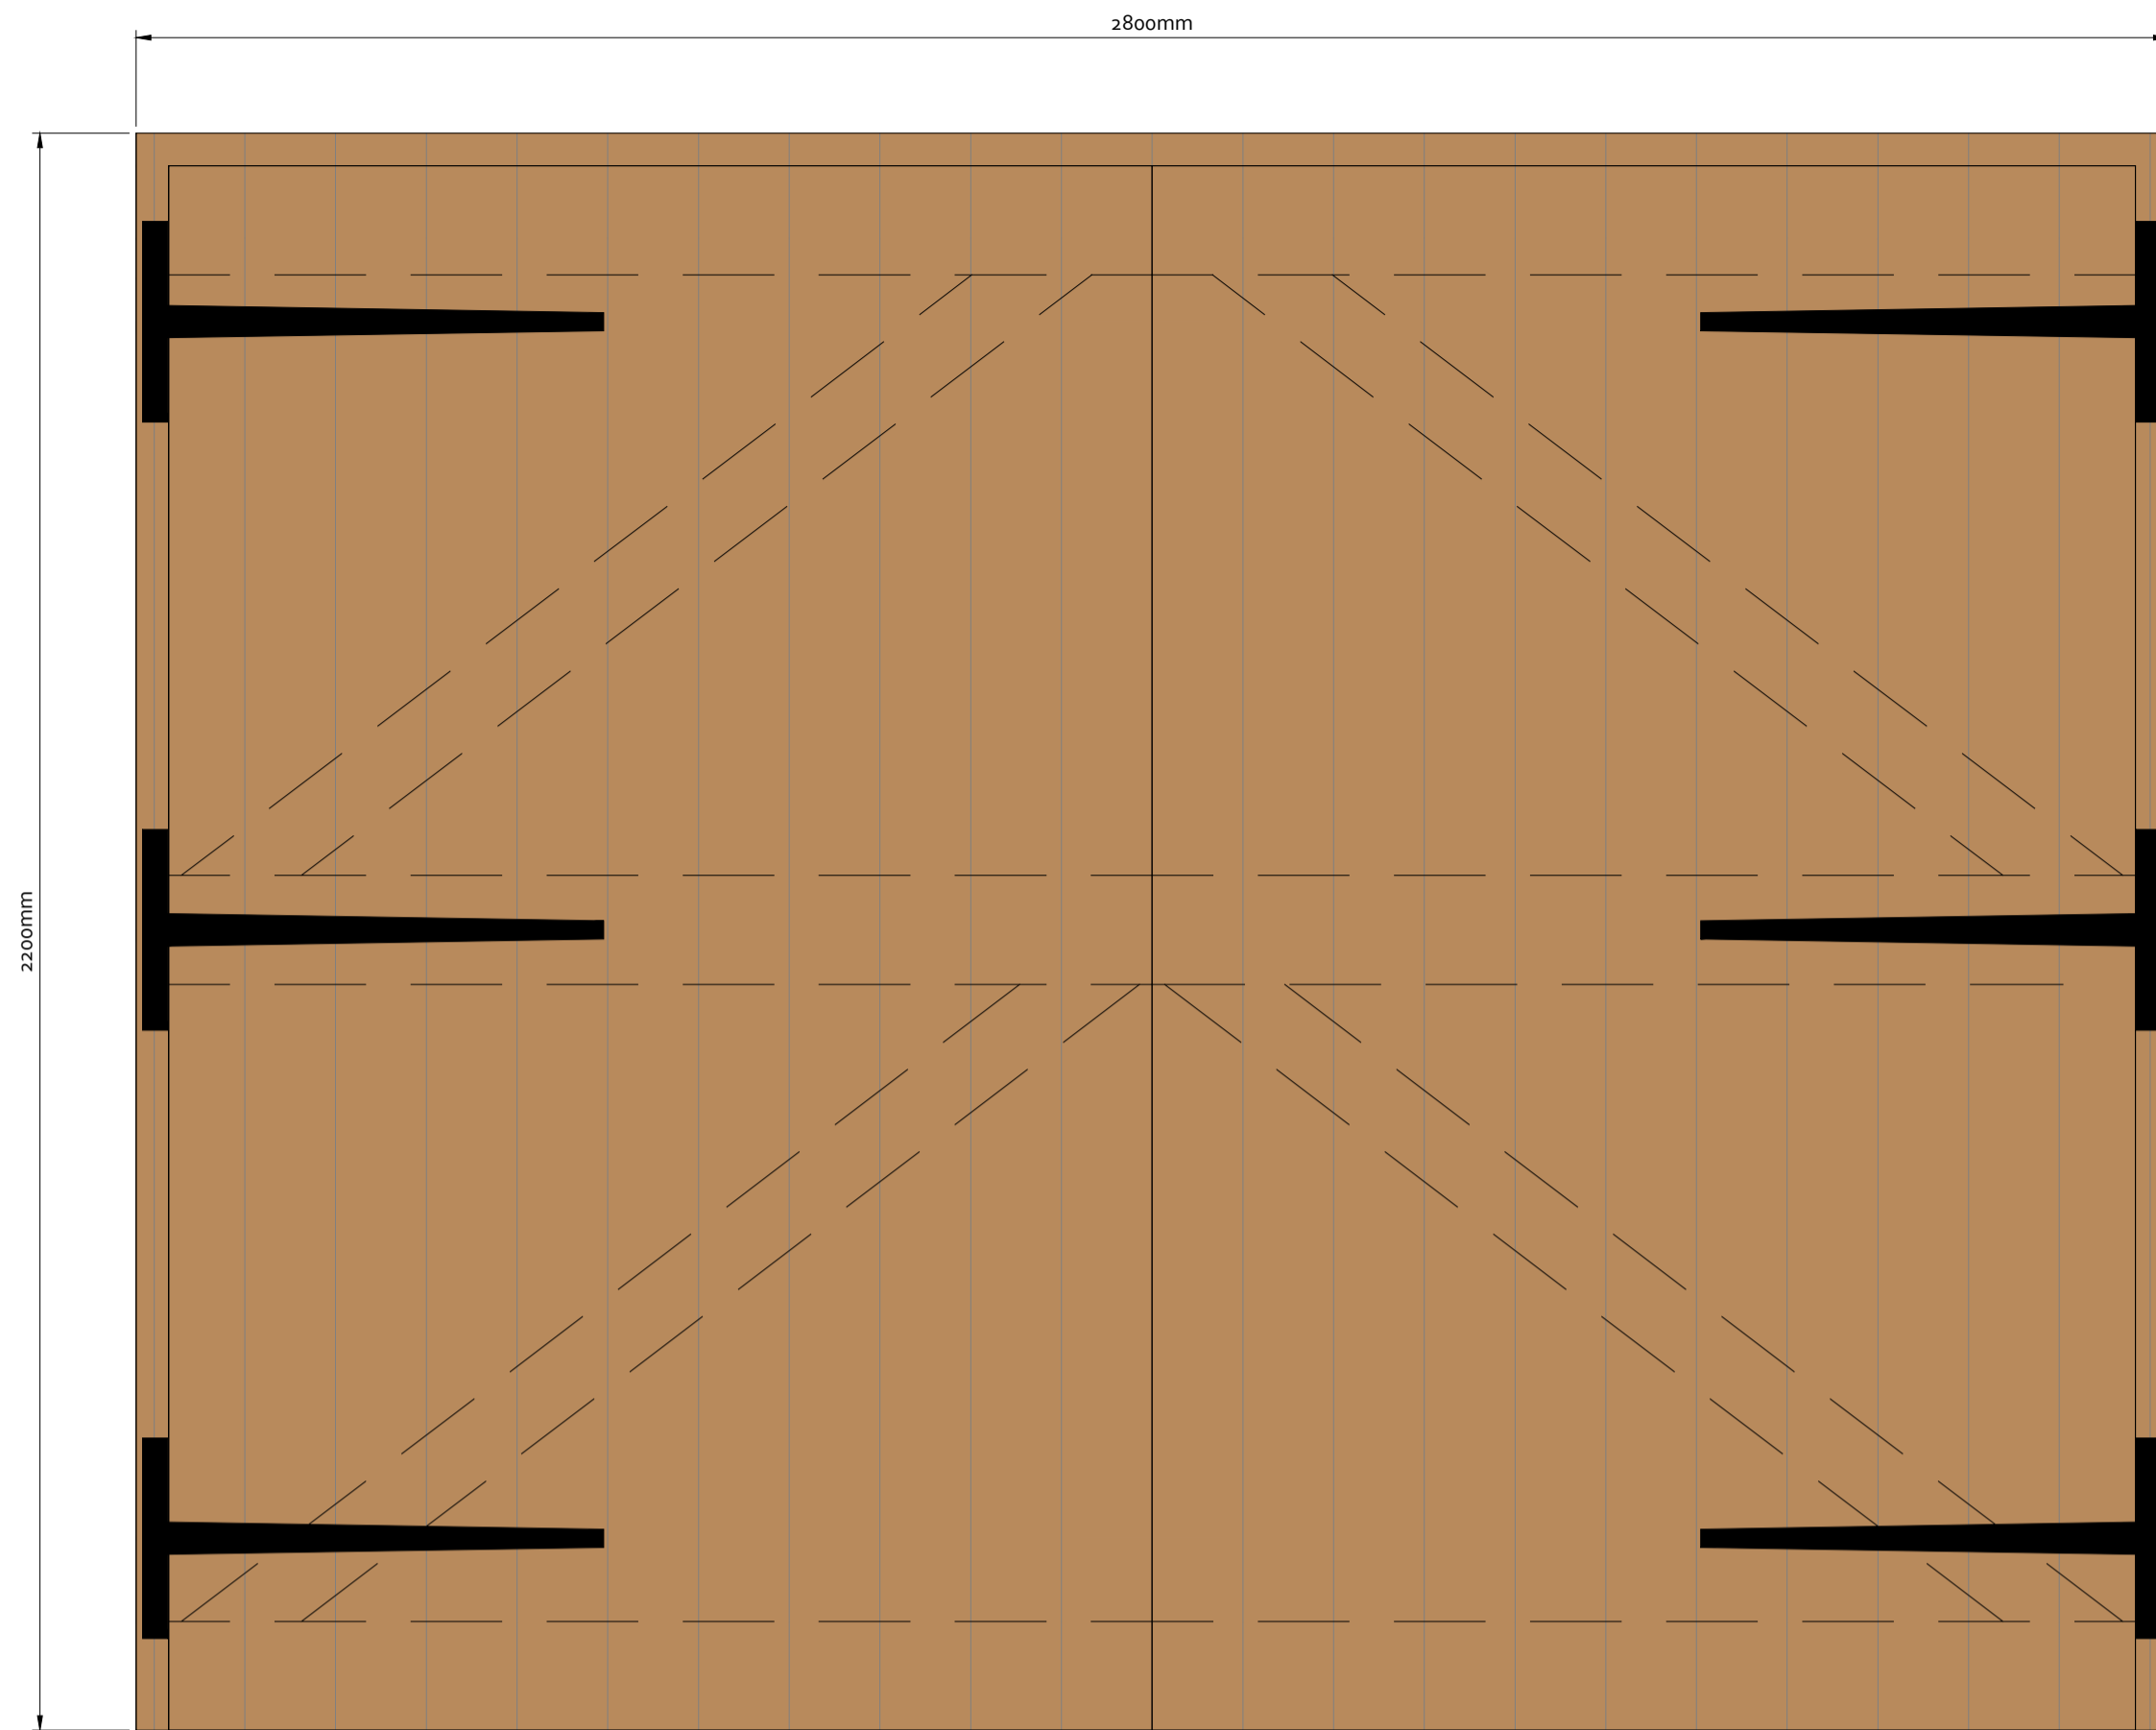
**GARAGE DOORS**

The Garage doors will have internal bolts/bars with no external handles.

Existing strap hinges on site are acceptable, painted black but need to altered in size to suit the door width.

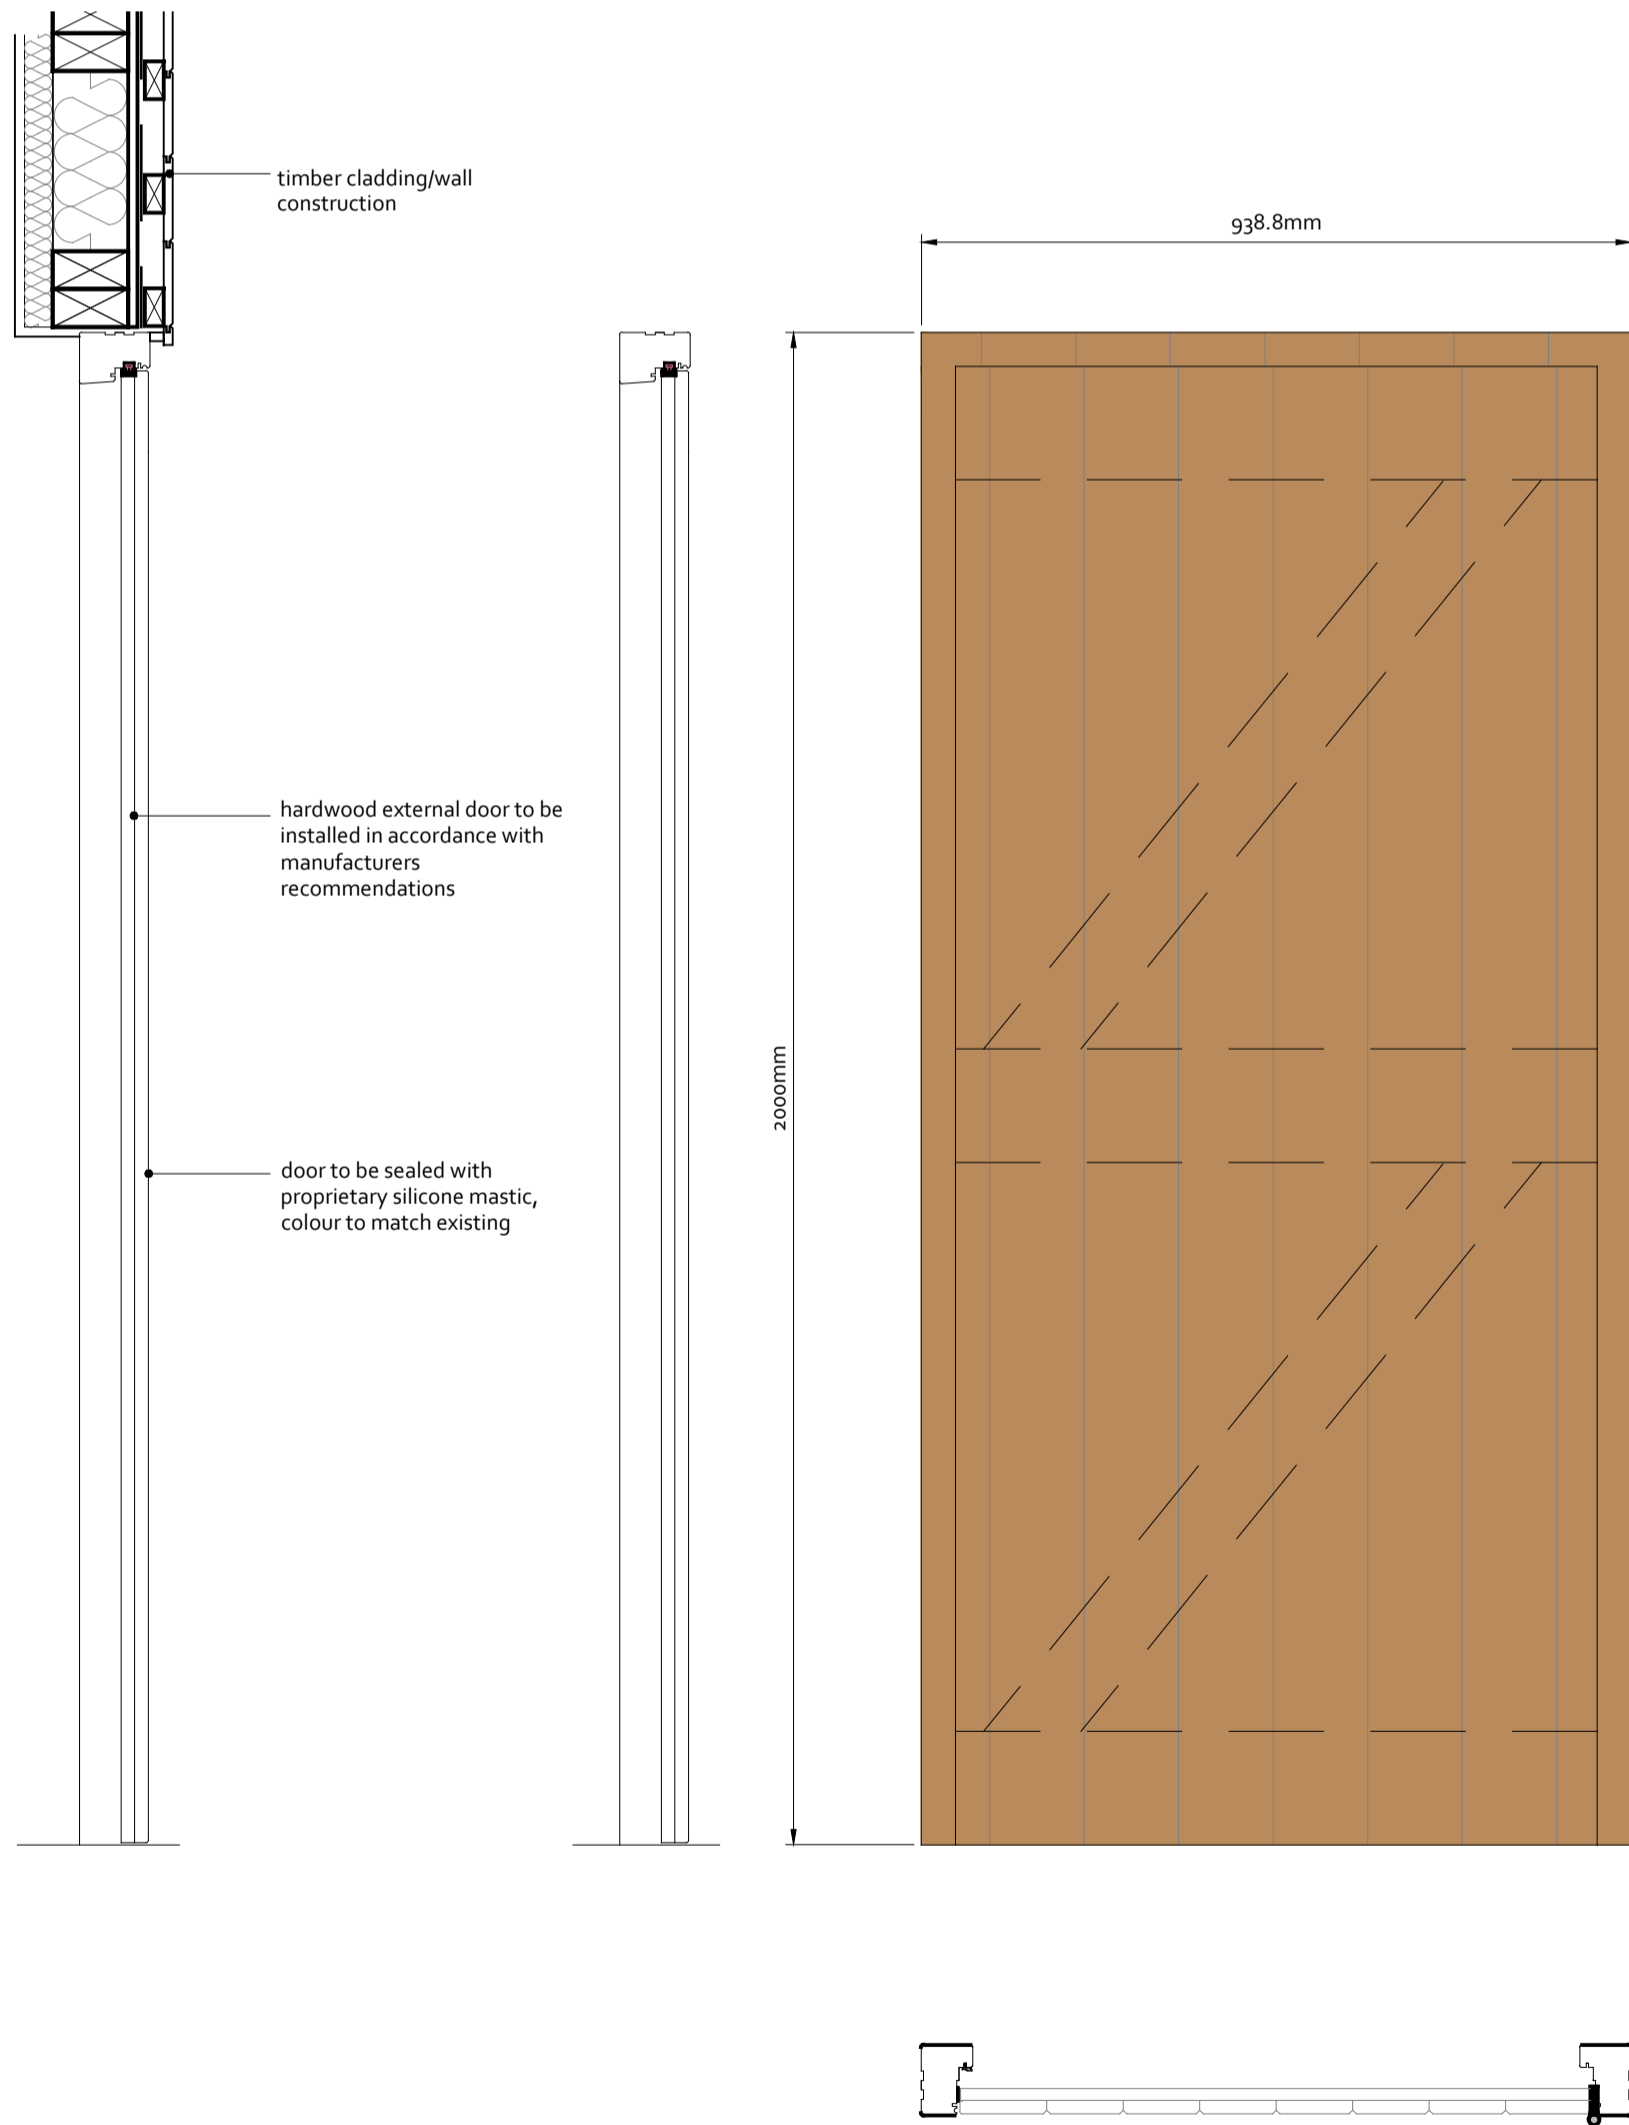
**PERSONNEL DOOR TO WORKSHOP**

**Doors**  
 A cover strip could be attached to the inside of the meeting stile on one of the door leaves to cut down on drafts.  
 The personnel door to the workshop would have a traditional thumb latch, there would be an additional rim lock as is found at the property.
