Revisions			
Client			
Mr W Sabin			
Project			
Temple Mill, Sibford Ferris, Banbury, Oxon. OX15 5DA.			
Drawing			
Planning Conditions (1) Detail Drawings			
Project Ref	Date	Drawing Number	Revision
DDC 2018-498	August 2018	008	A
Scale	Sheet Size		
1:10	A1

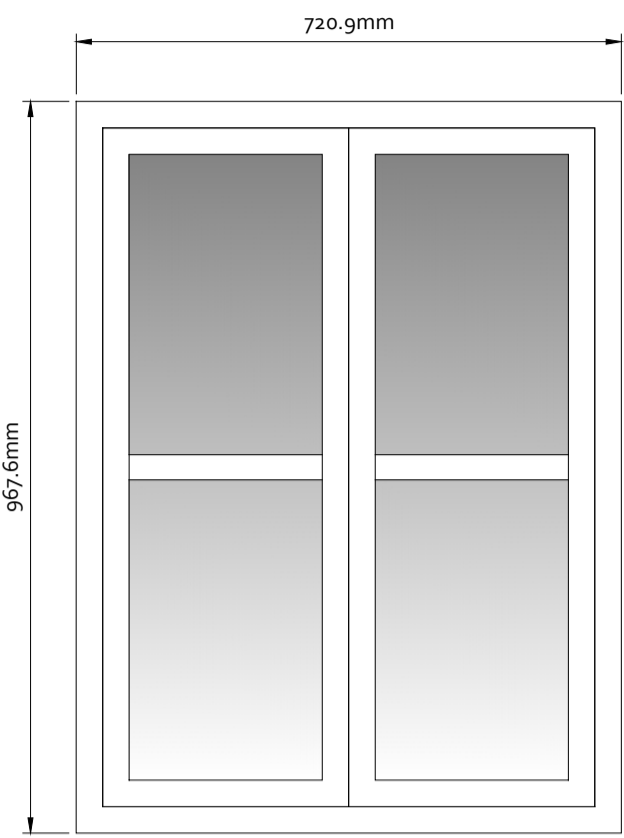
WINDOW TO GARAGE GABLE

Windows
 The window should have a true glazing bar, not planted/glued on to glass.
 Edge spacers should be non-metallic finish - matt black works better if the window is to be painted a non-white.
 Slimline double glazing (between 10-16mm thick) would look better than standard double glazing.

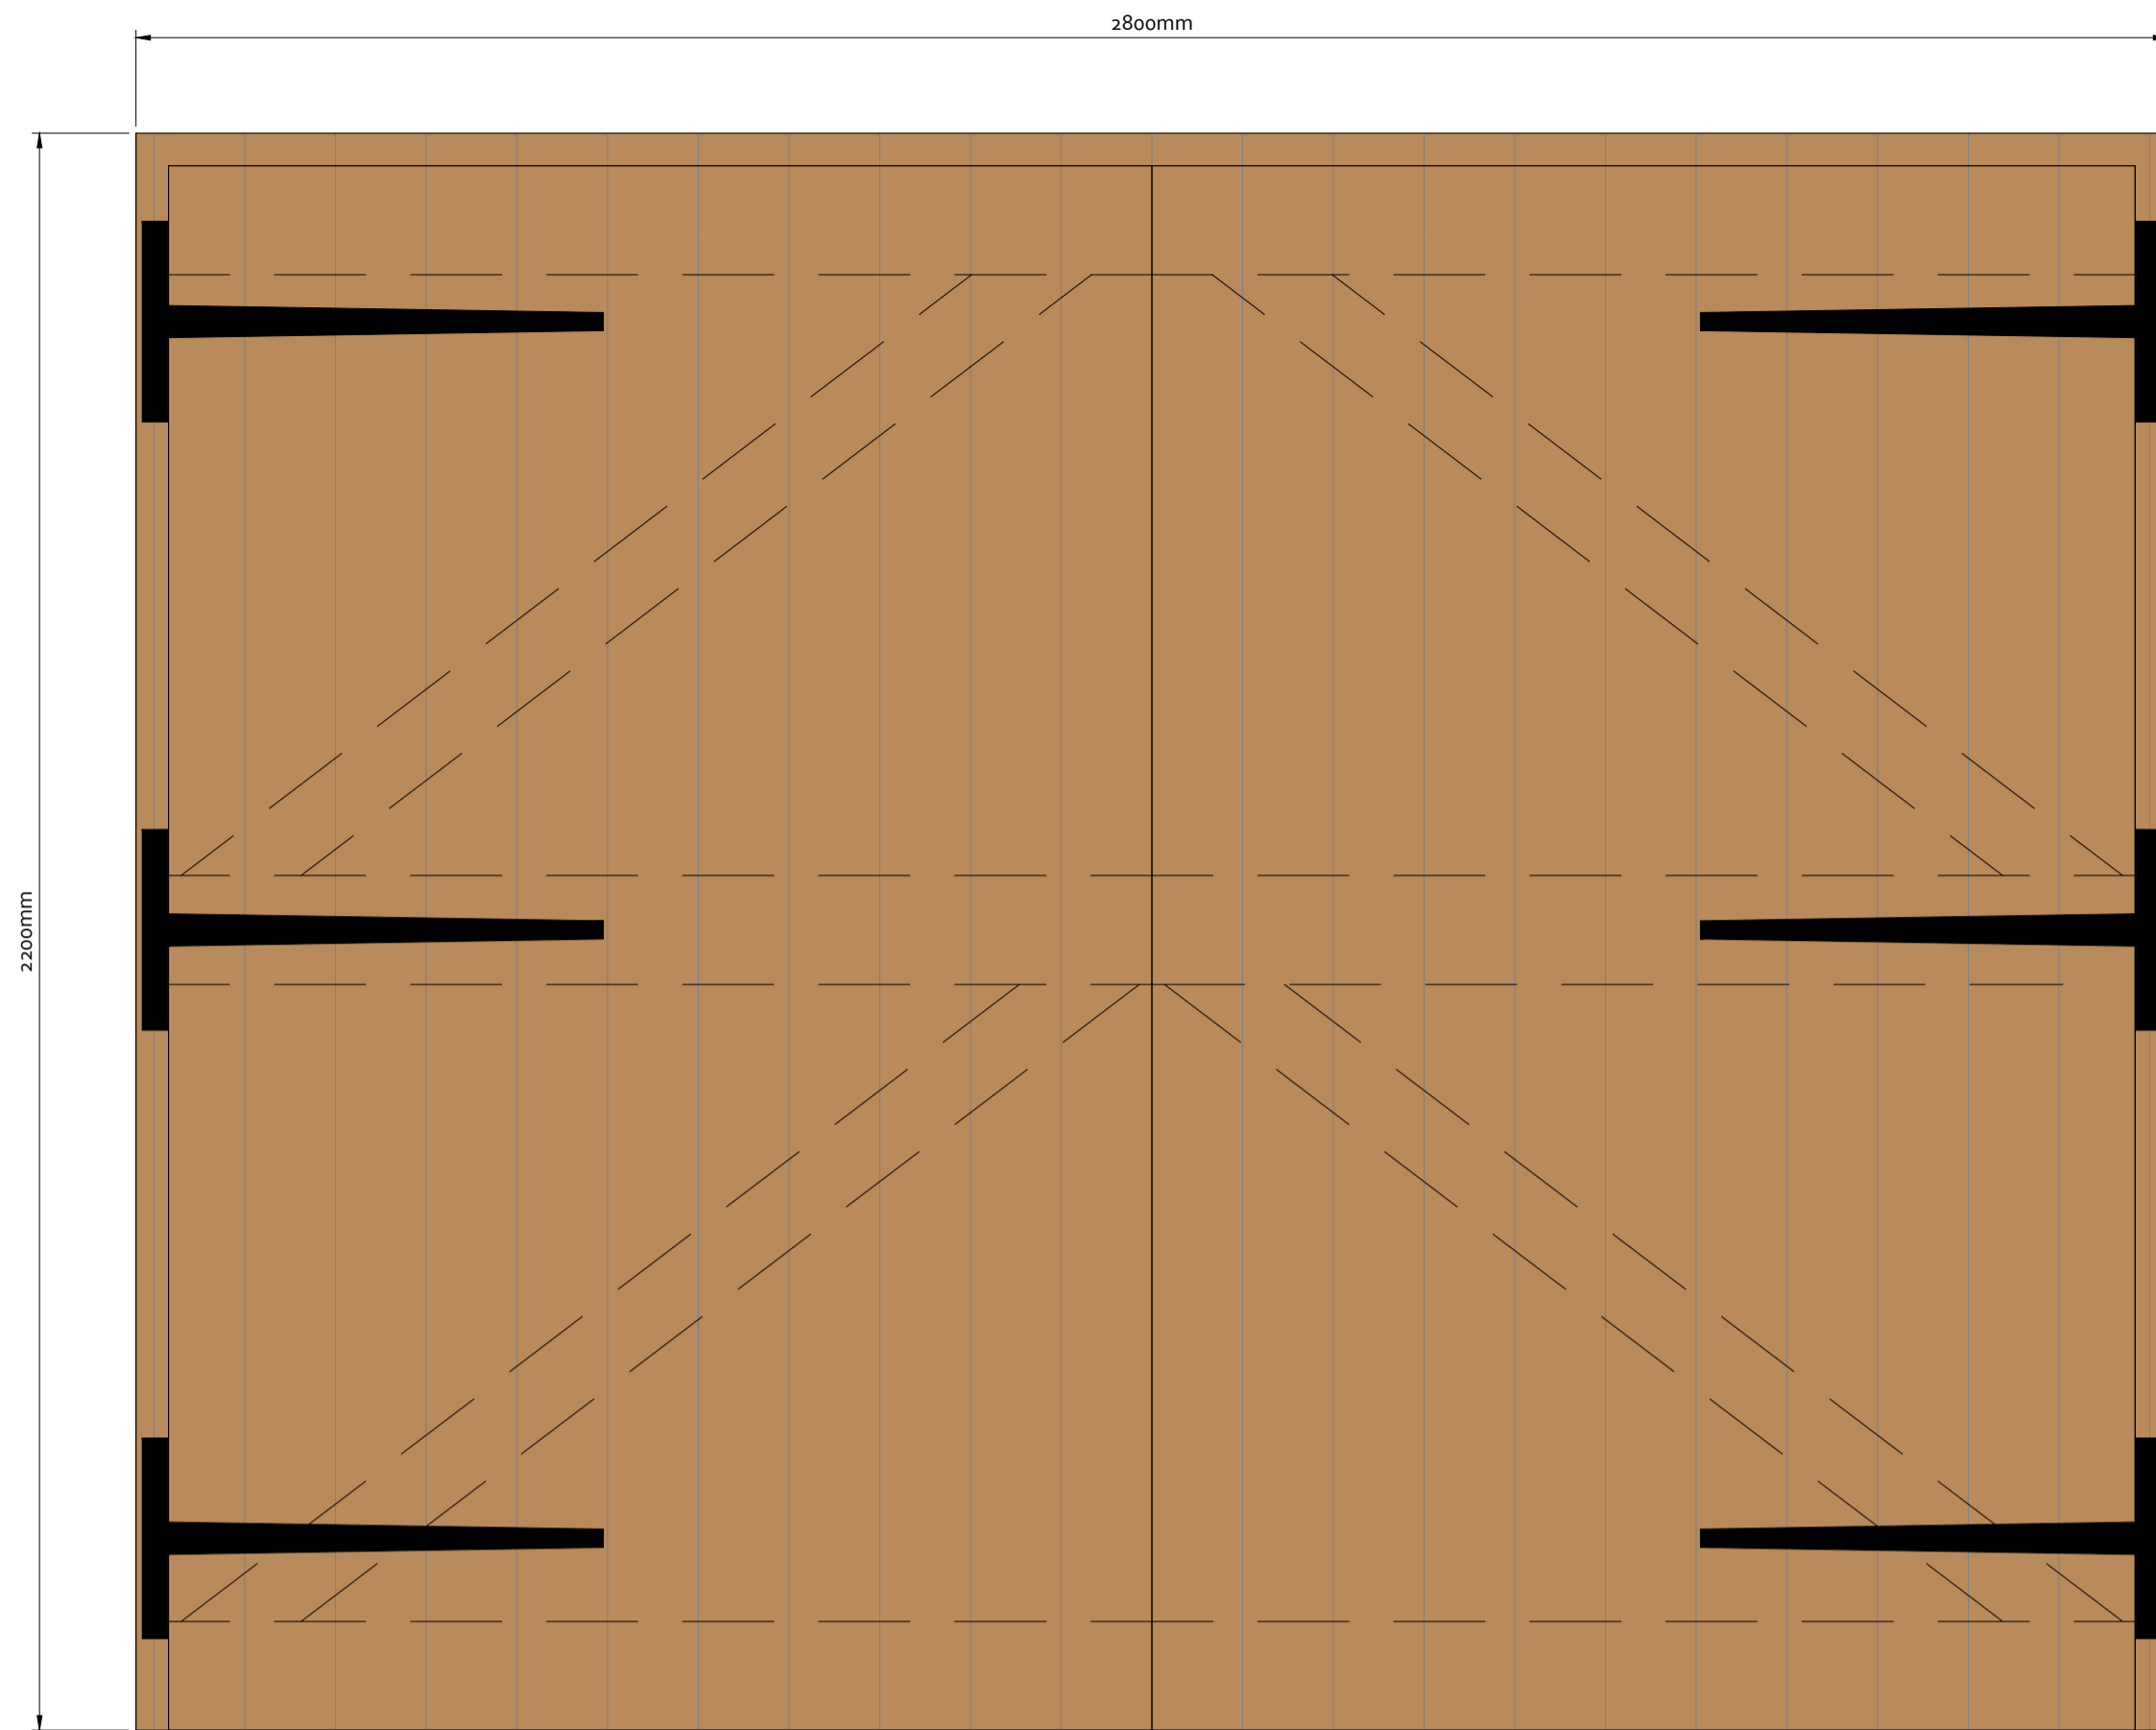
GARAGE DOORS

The Garage doors will have internal bolts/bars with no external handles.

Existing strap hinges on site are acceptable, painted black but need to be altered in size to suit the door width.

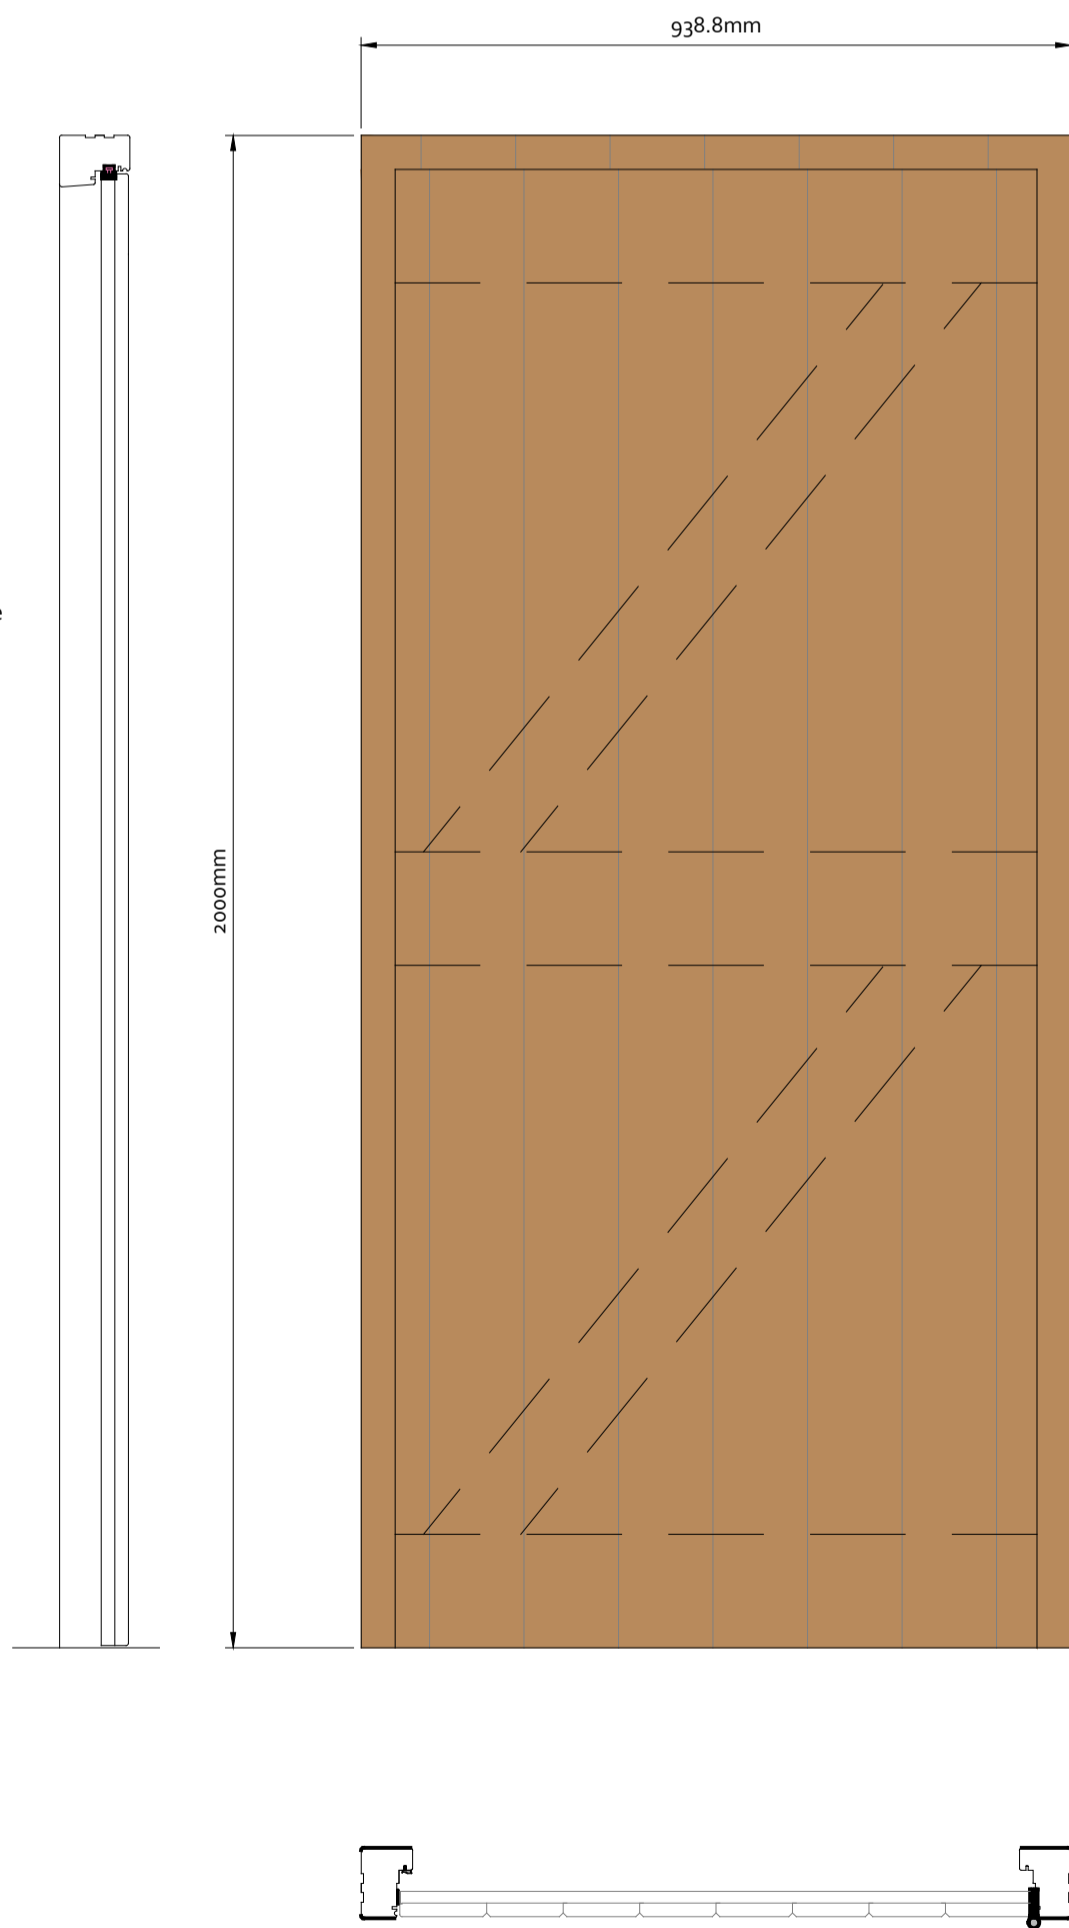
PERSONNEL DOOR TO WORKSHOP

Doors
 A cover strip could be attached to the inside of the meeting stile on one of the door leaves to cut down on drafts.
 The personnel door to the workshop would have a traditional thumb latch, there would be an additional rim lock as is found at the property.
