Arboricultural Statement

Phase 8A, Upper Heyford

On behalf Heyford Park Settlements LP

**BS5837:2012 'TREES IN RELATION TO DESIGN, DEMOLITION AND CONSTRUCTION –
RECOMMENDATIONS'**

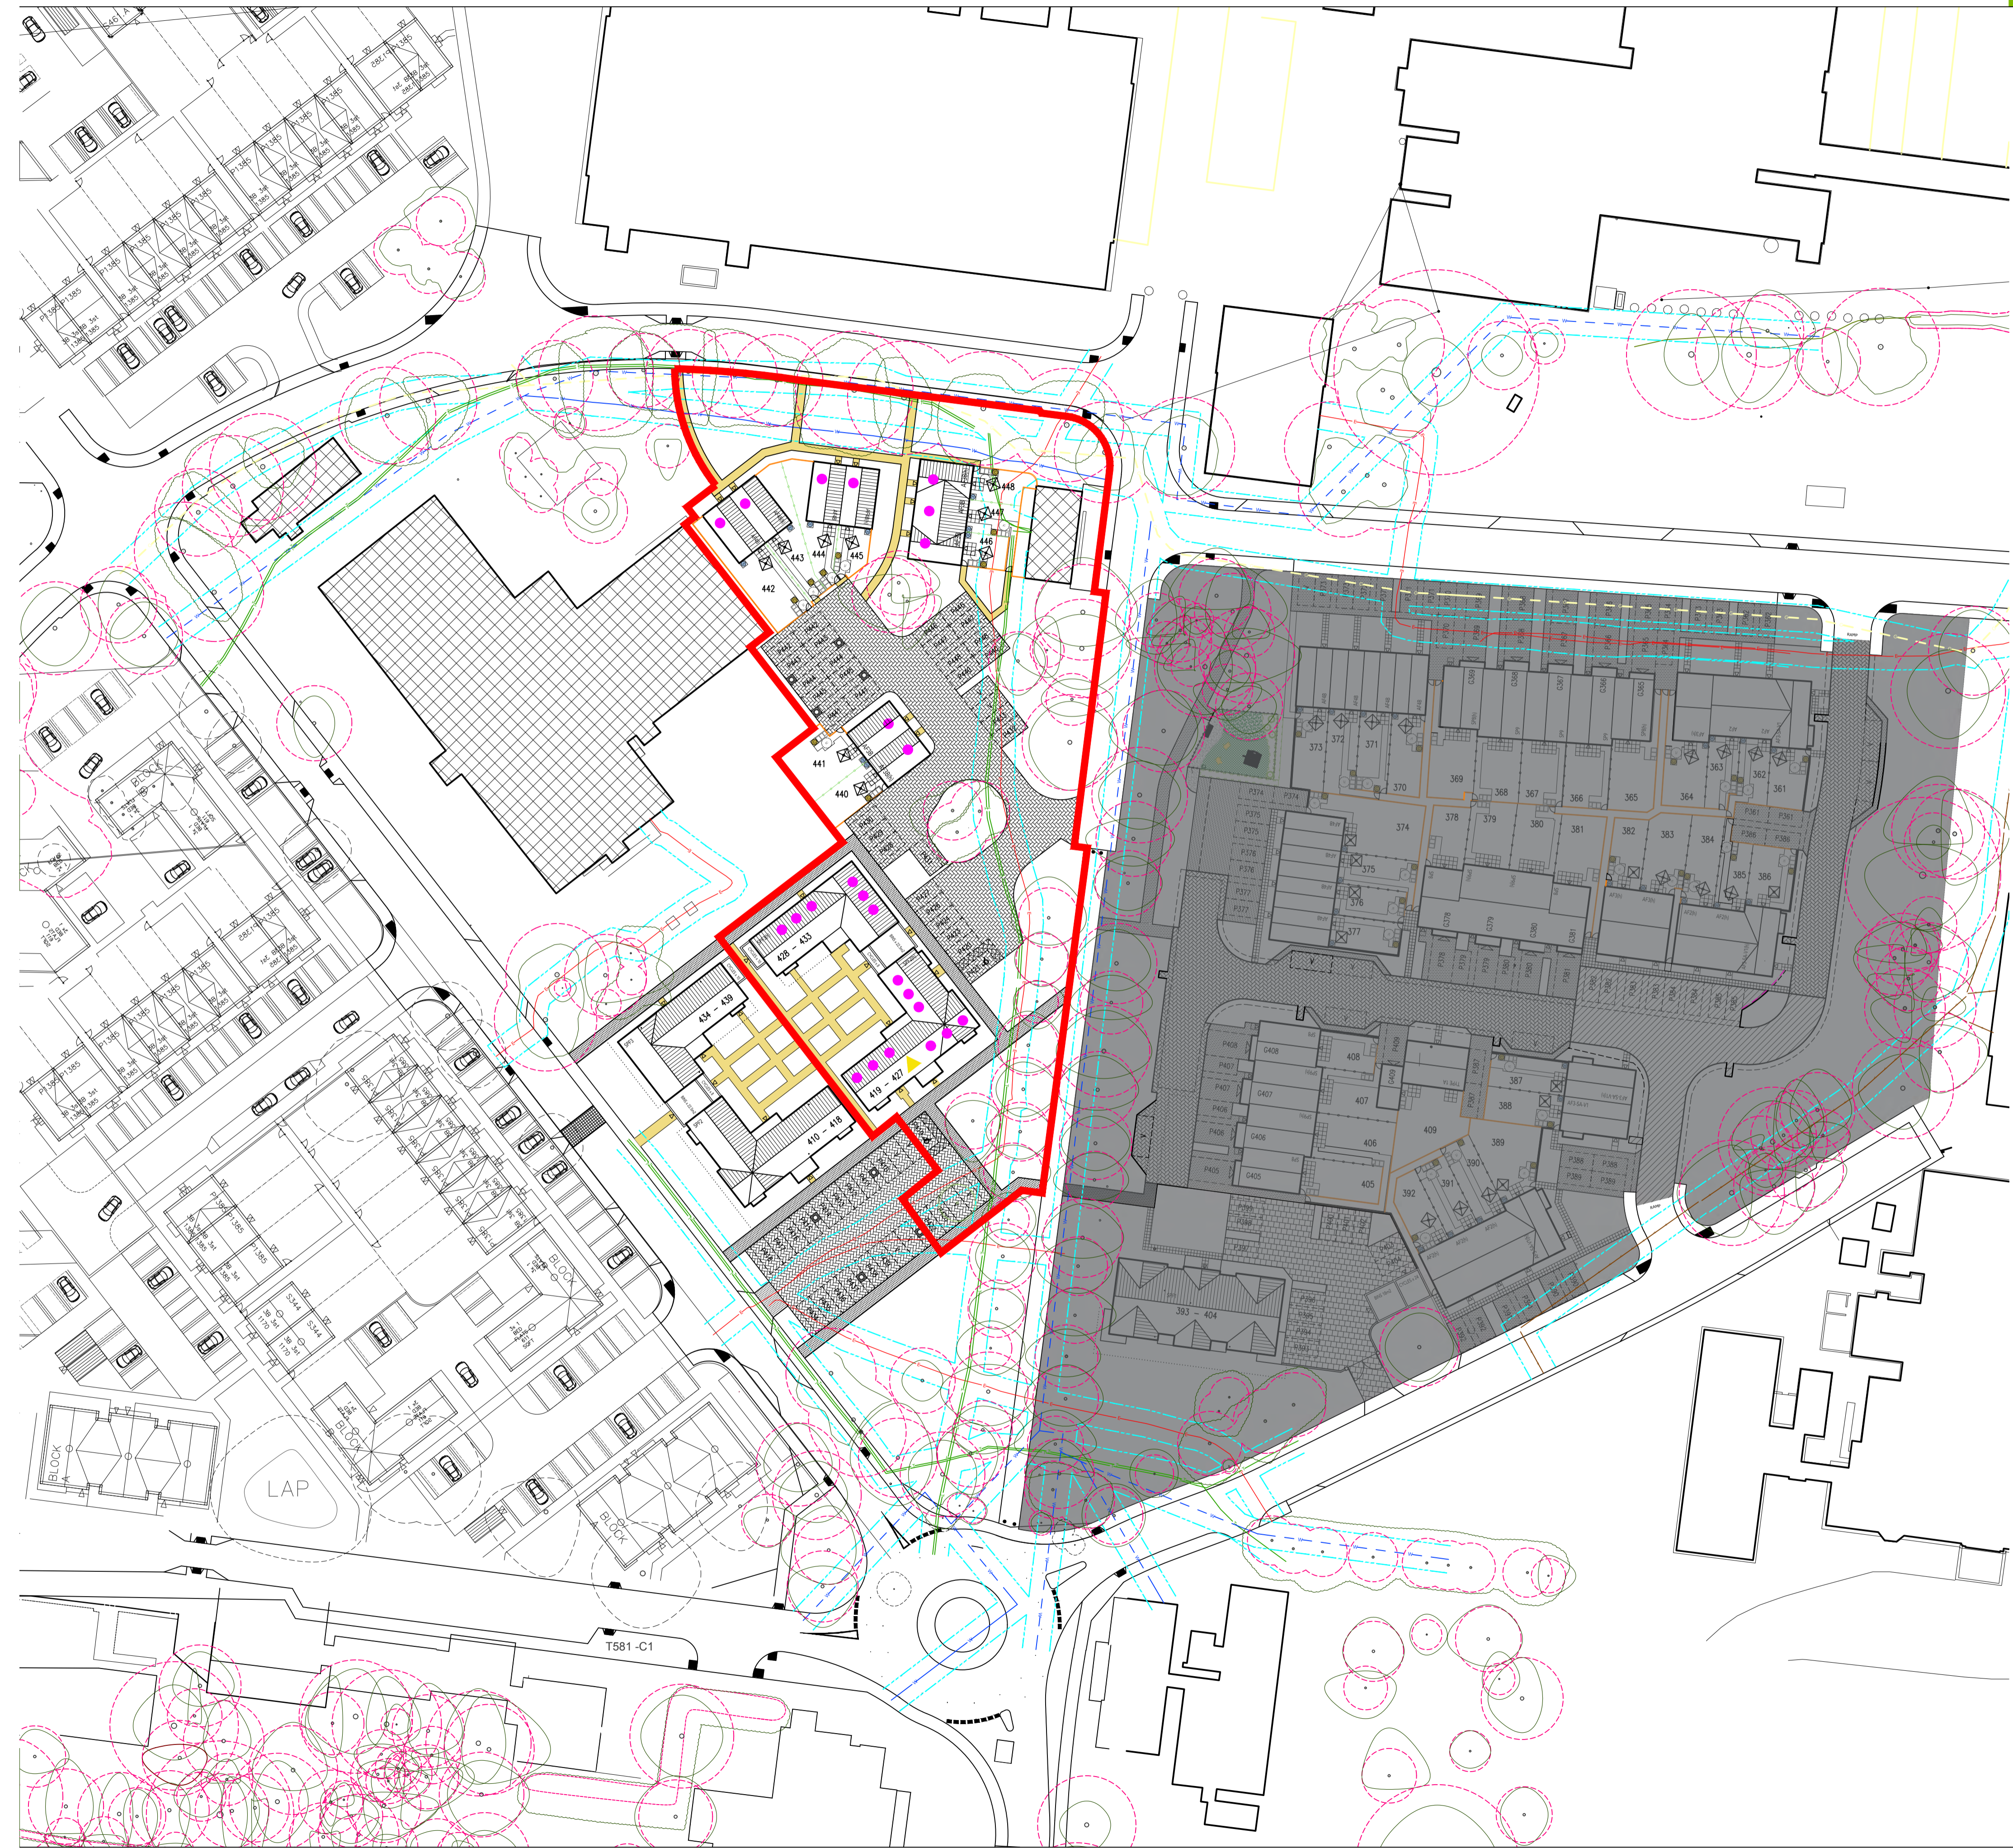
DRAWING TITLE: PLANNING LAYOUT
DRAWING NO: 0521-PH8A-102

PLANNING LAYOUT

SCALE: 1:500 @ A1

- 3.5 Current Phase 8A proposals seek to redesign the approved Phase 8 proposals in this area to replace the two blocks of flats within the northern and central area of the Phase 8A with nine residential dwellings. In addition to the change in accommodation type, proposals re-organise the associated parking arrangements.

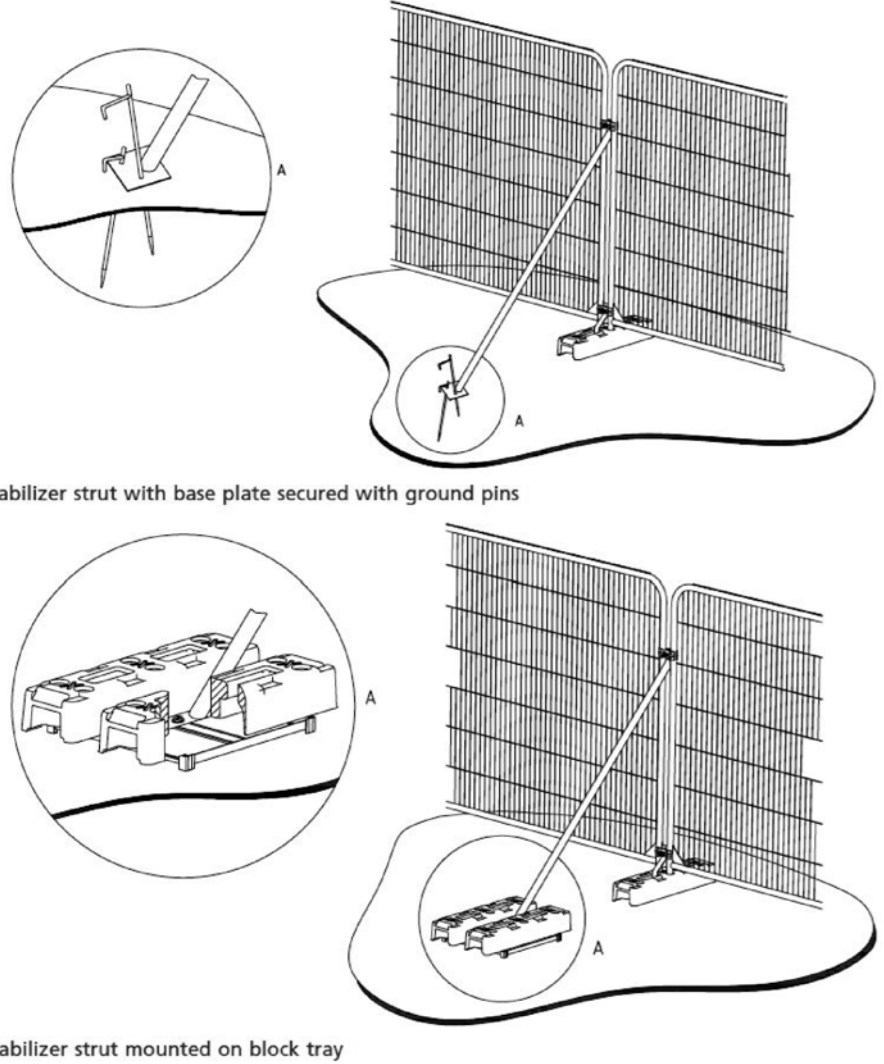
BS:5837:2012 Figure 3 Examples of above-ground stabilizing systems
