Appendix 8.2 Applied Geology Ground Investigation Report (November 2018)

## REPORT ON GROUND INVESTIGATION AT THE PROMISED LAND FARM, BICESTER

Client:	Albion Land Ltd
Report Title:	Report on Ground Investigation at The Promised Land Farm, Bicester
Report Number:	AG2875-18-AF37
Report Status:	Validated Issue 1
Date:	November 2018

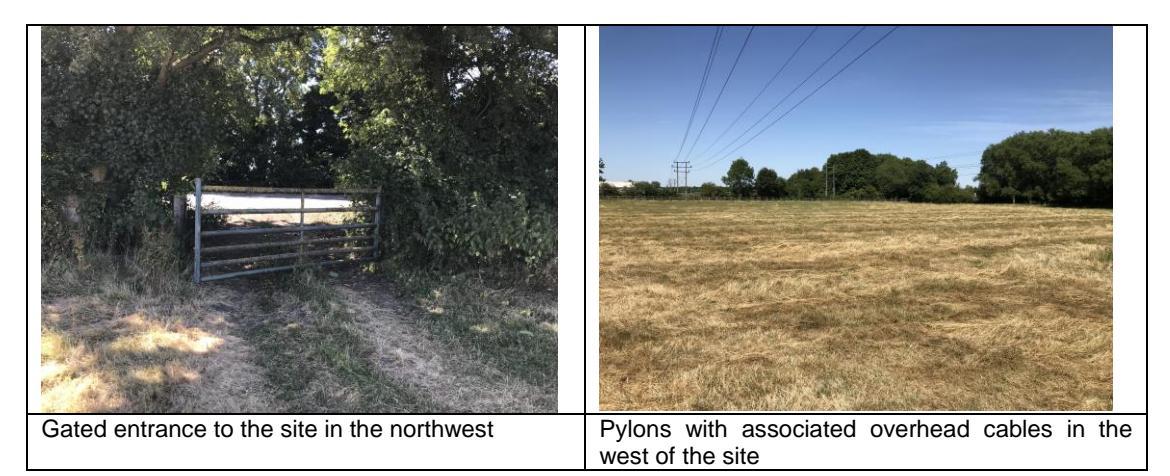
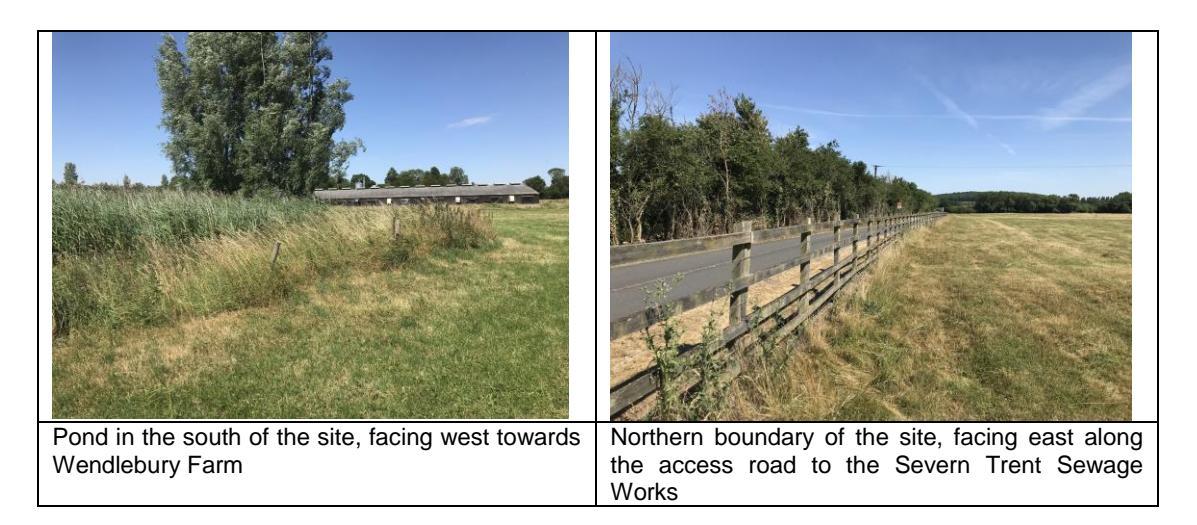
At the time of the walkover the site comprised three undeveloped grassed fields, understood to be used as grazing for cattle. The fields were unoccupied at the time of the walkover; however, it is understood that the farmer had relocated the cattle for the duration of the investigation works. With the exception of the northern boundary of the site and the boundary with Wendlebury Farm in the south, the fields were all lined with hedgerows and semi-mature and mature trees. Electricity pylons with associated overhead cables, orientated north-south were located along the west of the site with two sets also located in the east. A pond, which was almost entirely hidden by overgrown vegetation and reeds, was present in the south of the site, covering an area of circa  $10m \times 20m$ .

The site was bound to the north by an access road to the Severn Trent sewage works, which was segregated by a post and rail fence line, to the east by Langford Brook, to the south by Wendlebury Farm and further fields belonging to the Promised Land Farm and to the west by Wendlebury Road.

No obvious sources of potential contamination or potentially contaminative activities were observed at the site during the investigation.

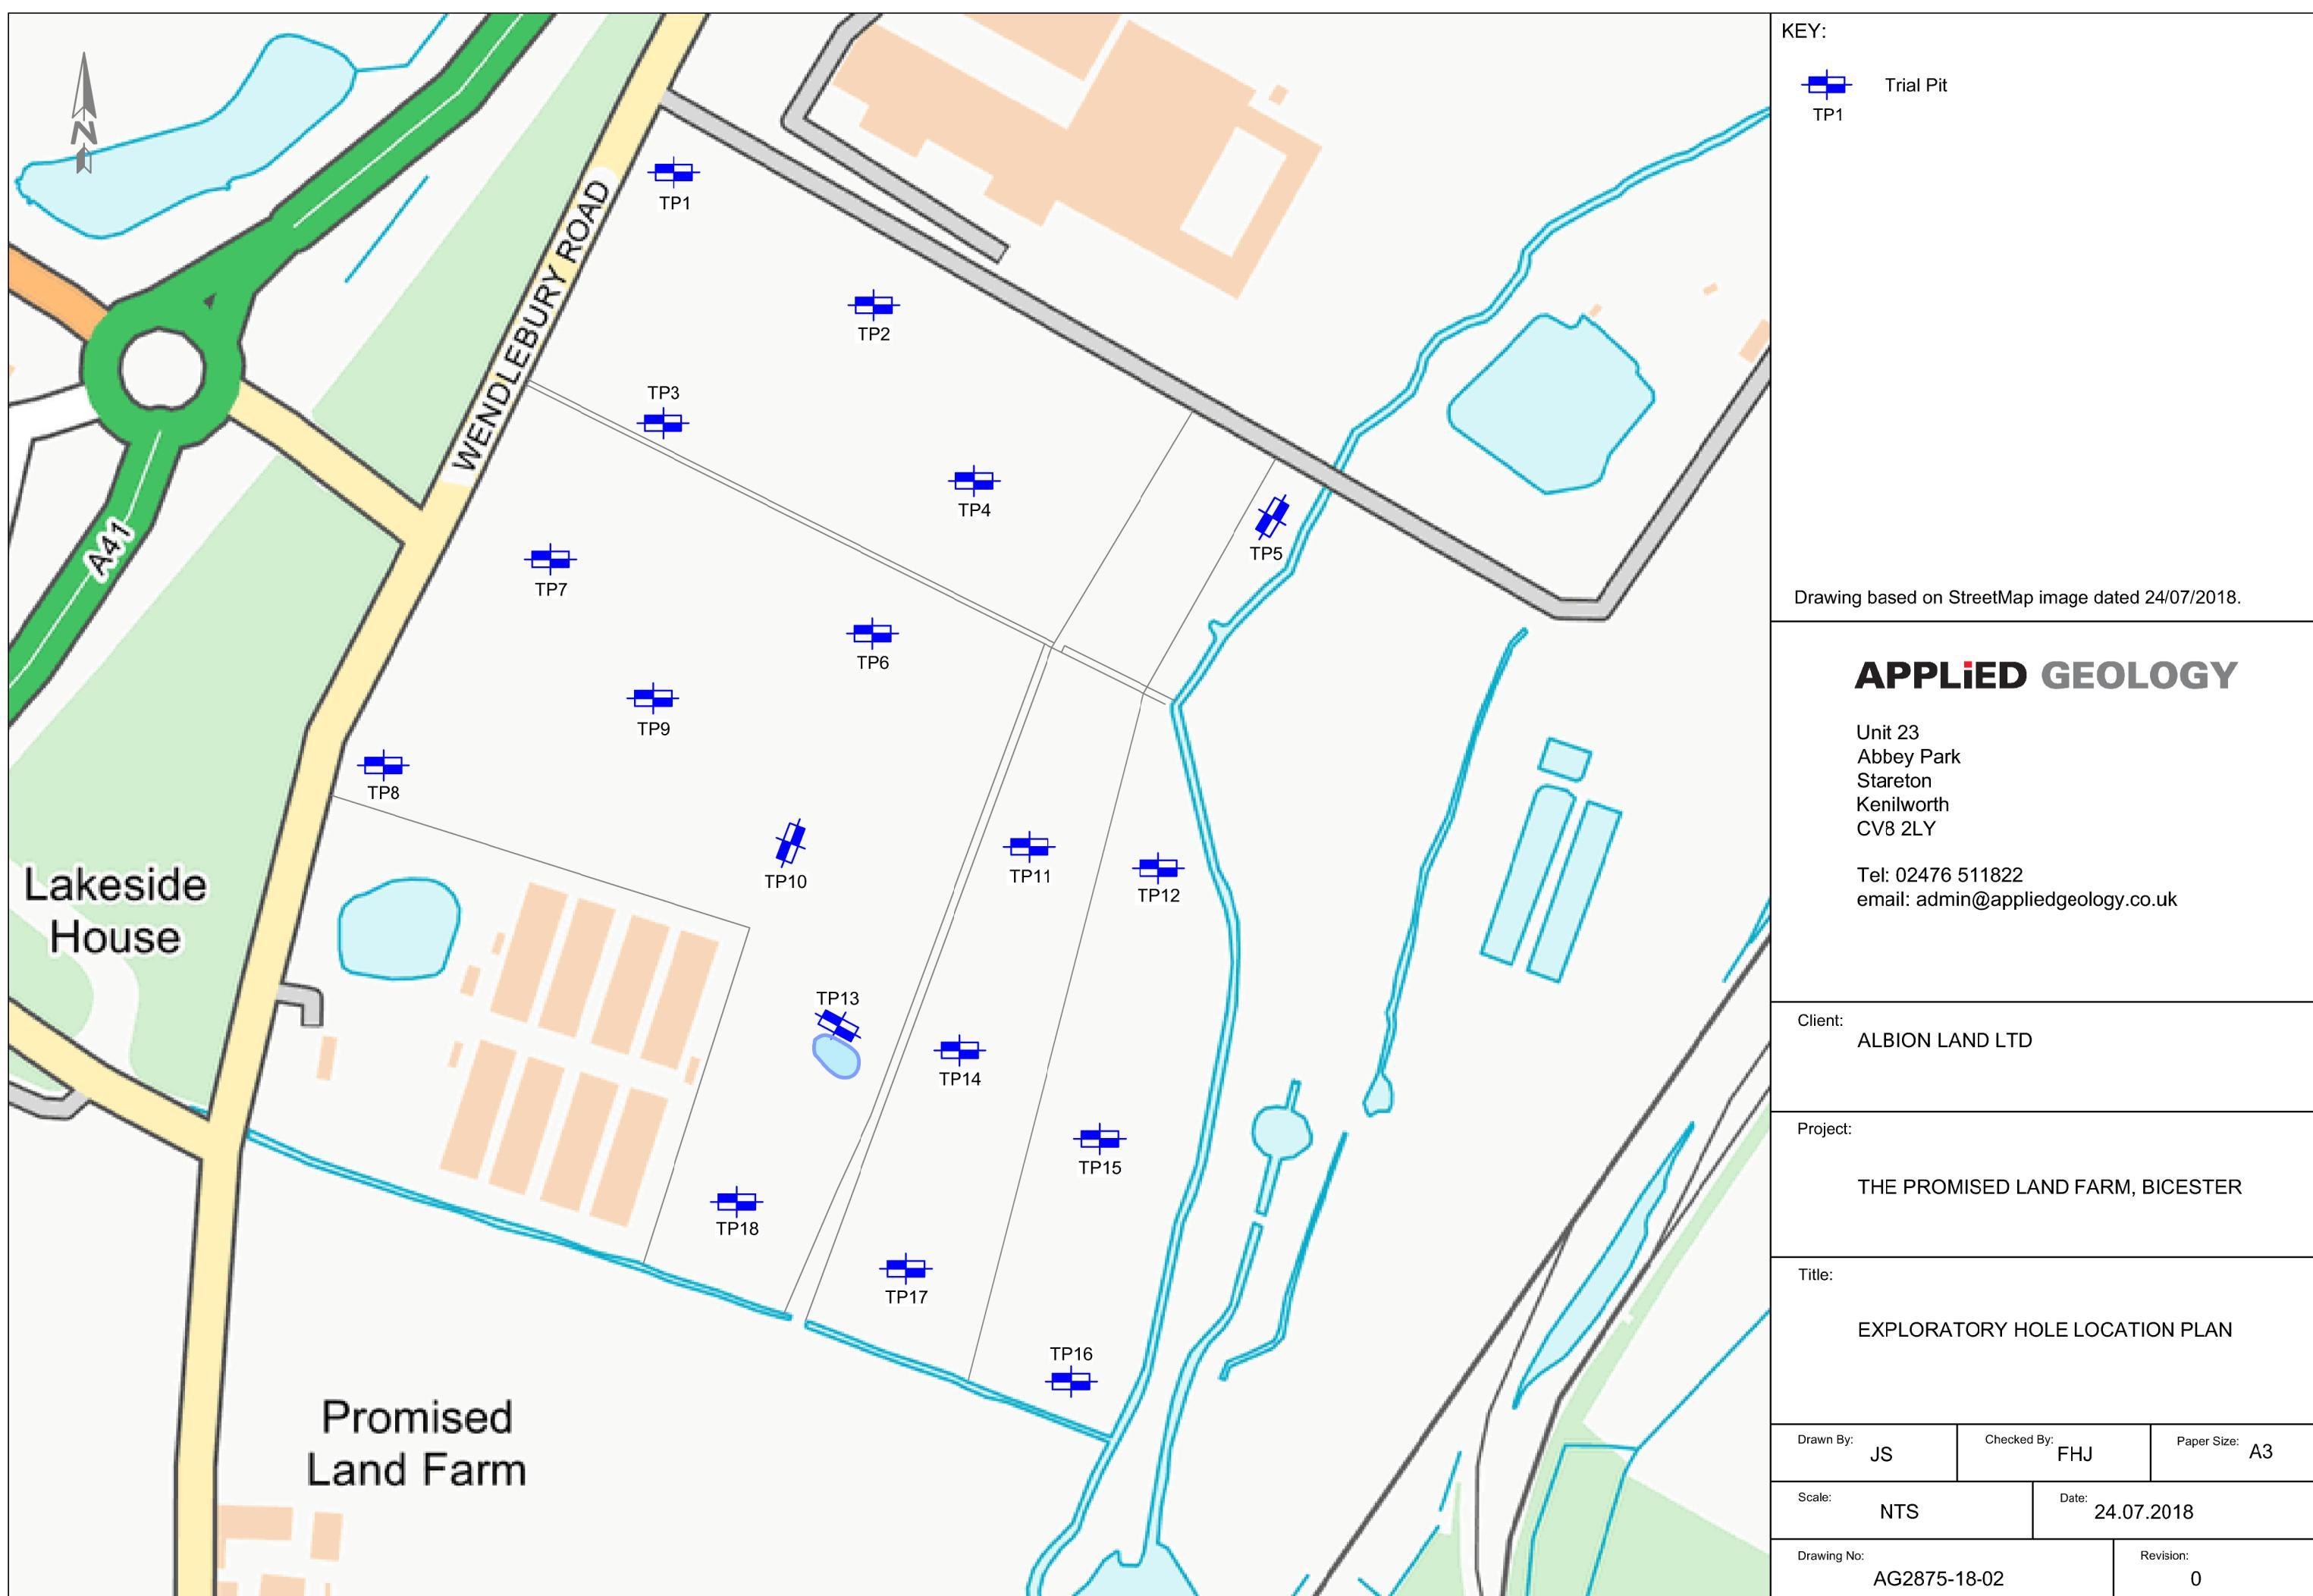
Drawn By: JS	Checked By: FHJ		Paper Size: A3
<sup>Scale:</sup> NTS	Date: 2	4.07.	2018
Drawing No: AG2875-	18-02	R	evision: O

• 18 No Machine excavated trial pits (ref: TP1 to TP18) to depths of between 2.35m and 4.1m below ground level (bgl).

The locations of the exploratory holes were selected in general accordance with the proposed borehole location plan provided by Bailey Johnson Hayes and set out on site by Applied Geology Limited. A number of the positions were constrained by the presence of a sewer, which bisected the site, orientated northeast to southwest and also the pylons and associated overhead cables. The sampling strategy for the exploratory hole locations was to provide best overall coverage. The locations of the trial pits are presented on Drawing No. AG2875-18-02 in Appendix A. The positions are approximated in relation to field boundaries and identifiable features on the site plan.

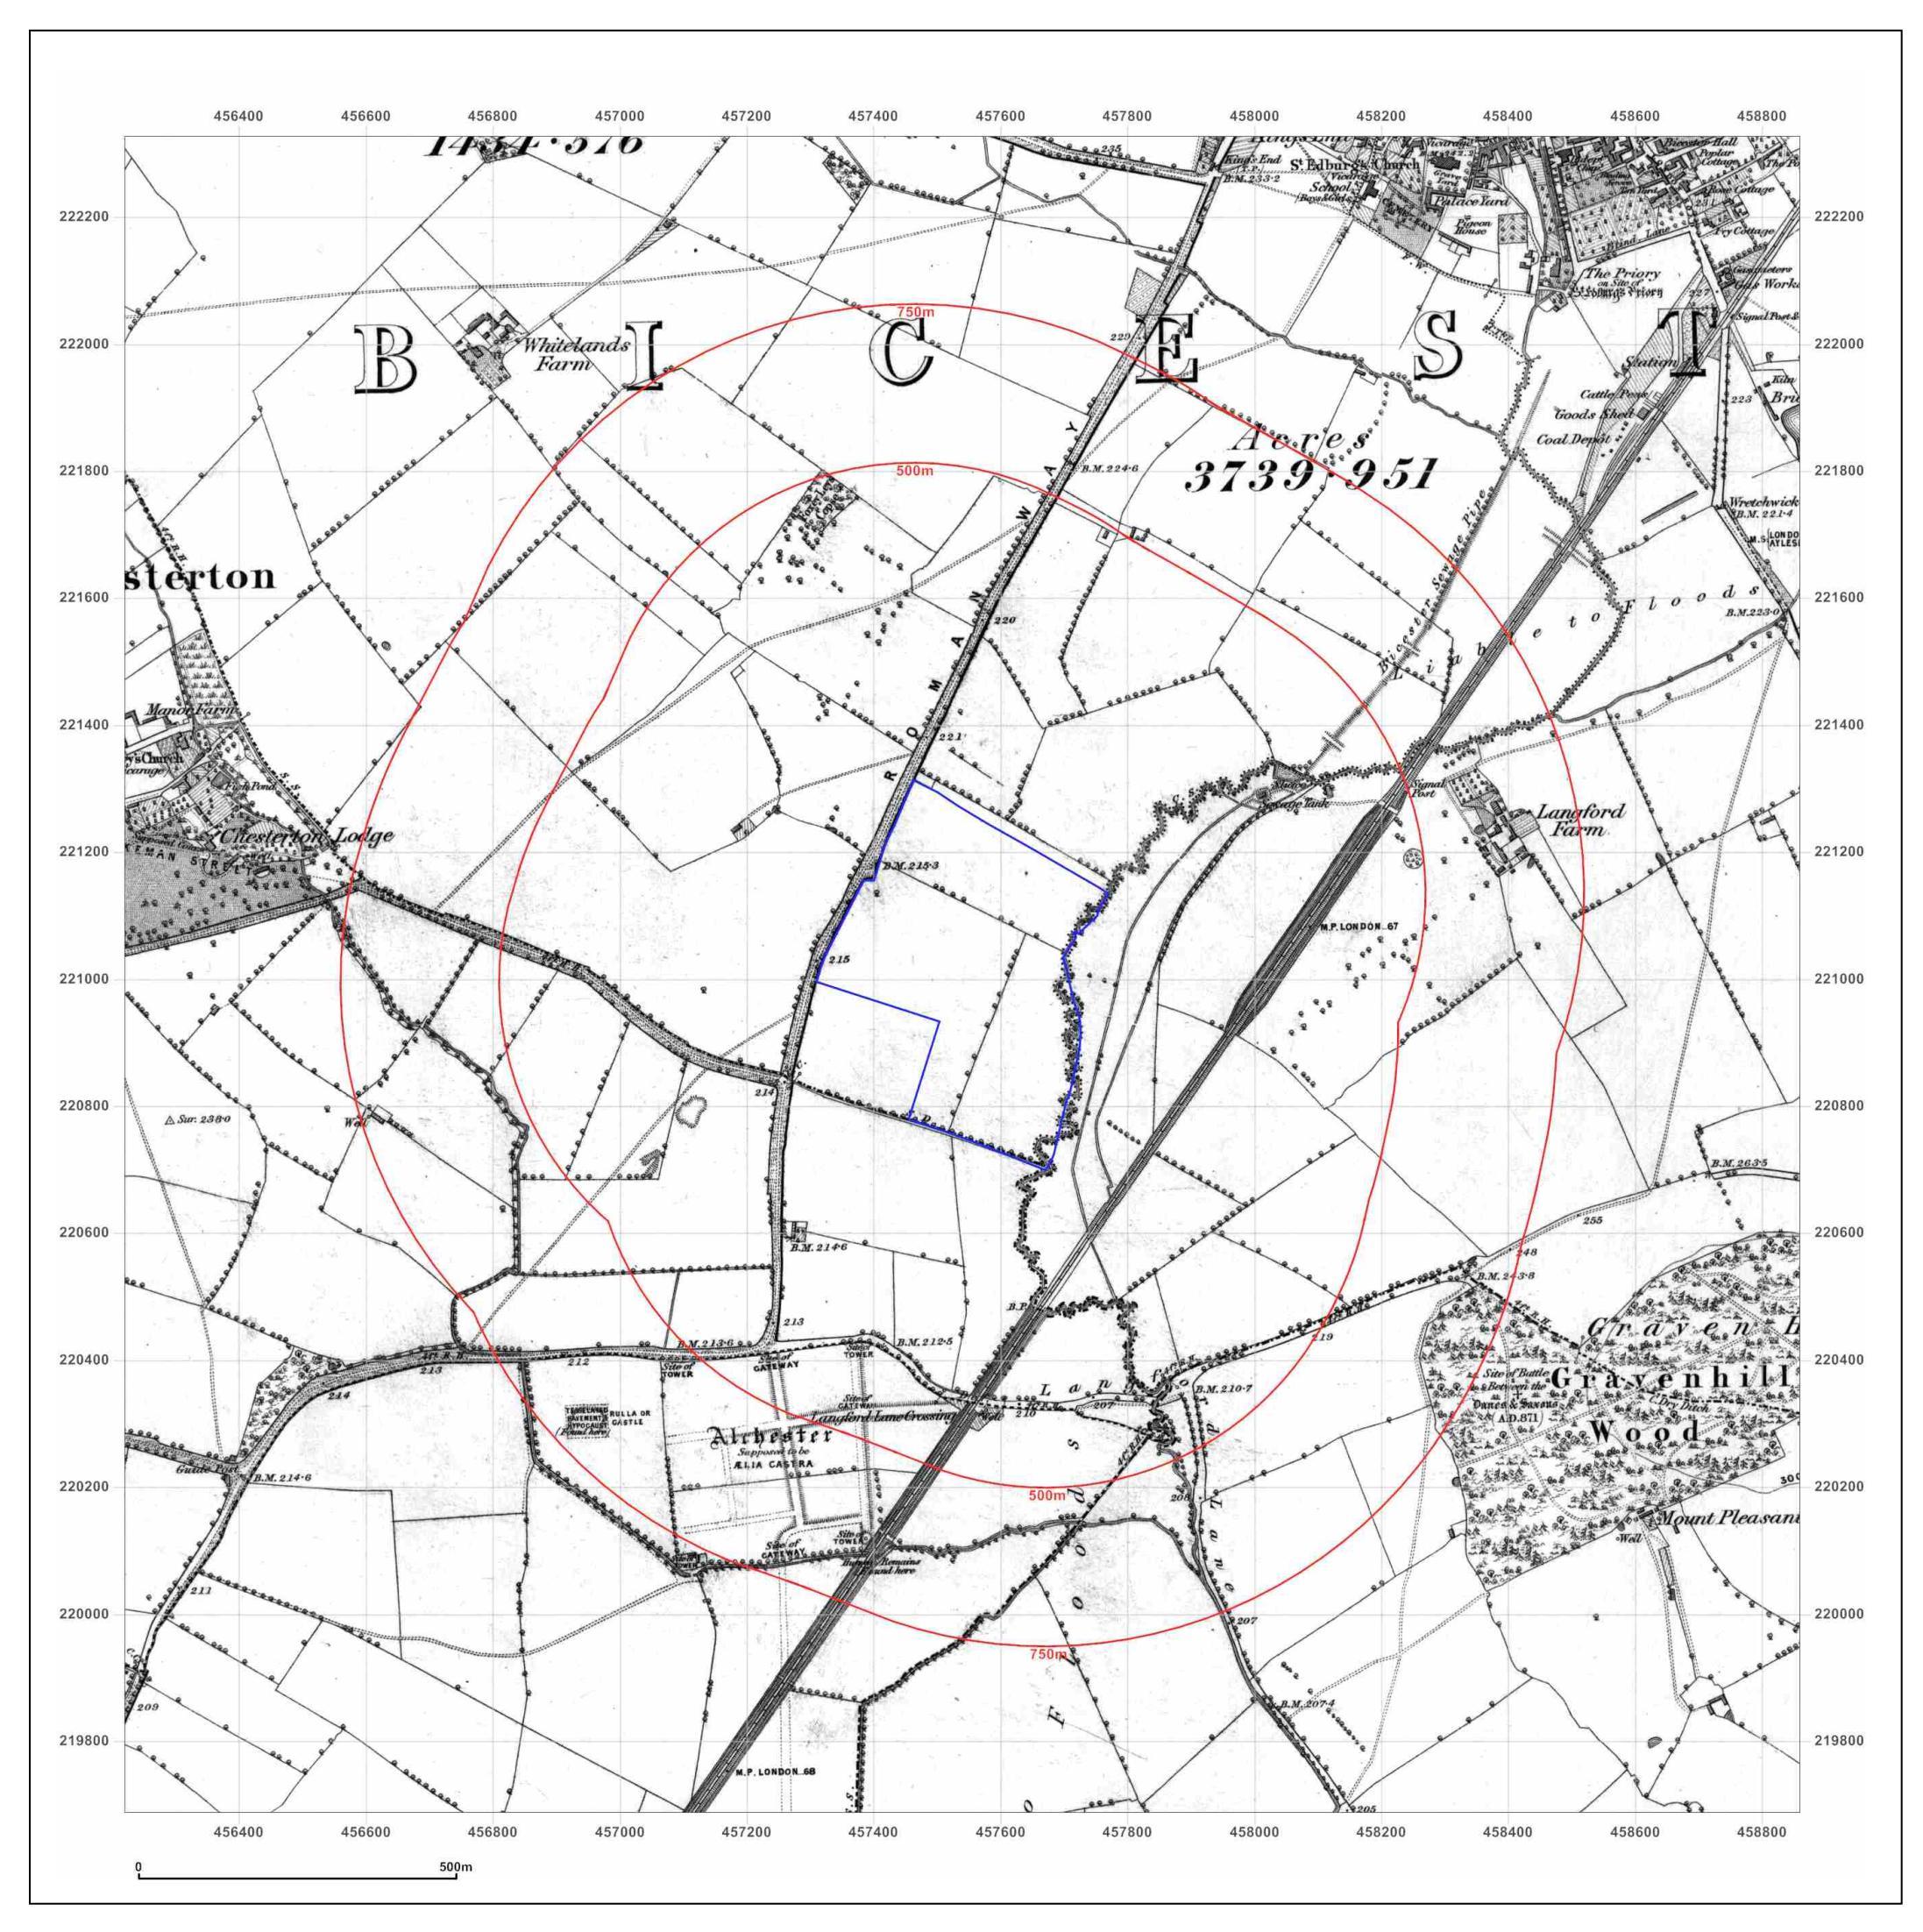
Client Ref: Report Ref: Grid Ref:	EMS_482678_647813 EMS-482678_647813 457539, 221007	
Map Name:	County Series	Ν
Map date:	1885	
Scale:	1:10,560	
Printed at:	1:10,560	S

Site History	<ul> <li>1885 – Site and surrounding area are agricultural fields, the Oxford to Bletchley railway line runs northeast – southwest approximately 105m southeast of the site. Two 'Old Clay Pits' are indicated 225m southwest of the site. Roman Road, orientated north-south bounds the site to the west. Buildings associated with the Promised Land Farm are located approximately 150m southwest. A sewage works is located 200m to the northeast.</li> <li>1950 – The A41 is located 55m to the northwest of the site, orientated northeast – southwest. MOD Bicester, military storage and distribution centre has been developed 400m to the east.</li> <li>1966 – A drain is shown along the southern boundary of the site. The north of the site is bound by an access road, connecting to the sewage works, which has been redeveloped and expanded to approximately 150m east of the site.</li> <li>1983 – Wendlebury Farm is now shown (consistent with the current layout) adjacent to the southwest of the site. A nursery is located 50m to the north of the site.</li> <li>1992-95 – The A41 has been widened.</li> <li>1995 – The nursery to the north is now a garden centre and has expanded south.</li> <li>2002 - Bicester Village Retail Park has been developed approximately 725m to the north and a nature reserve is located 150m to the east.</li> </ul>
