PROJECT No. RML 7118 SITE INVESTIGATION

AT LAND NORTH OF BICESTER ROAD, LAUNTON, BICESTER

ON BEHALF OF CREATED LIFE THREE (BICESTER) LIMITED

MAY 2021

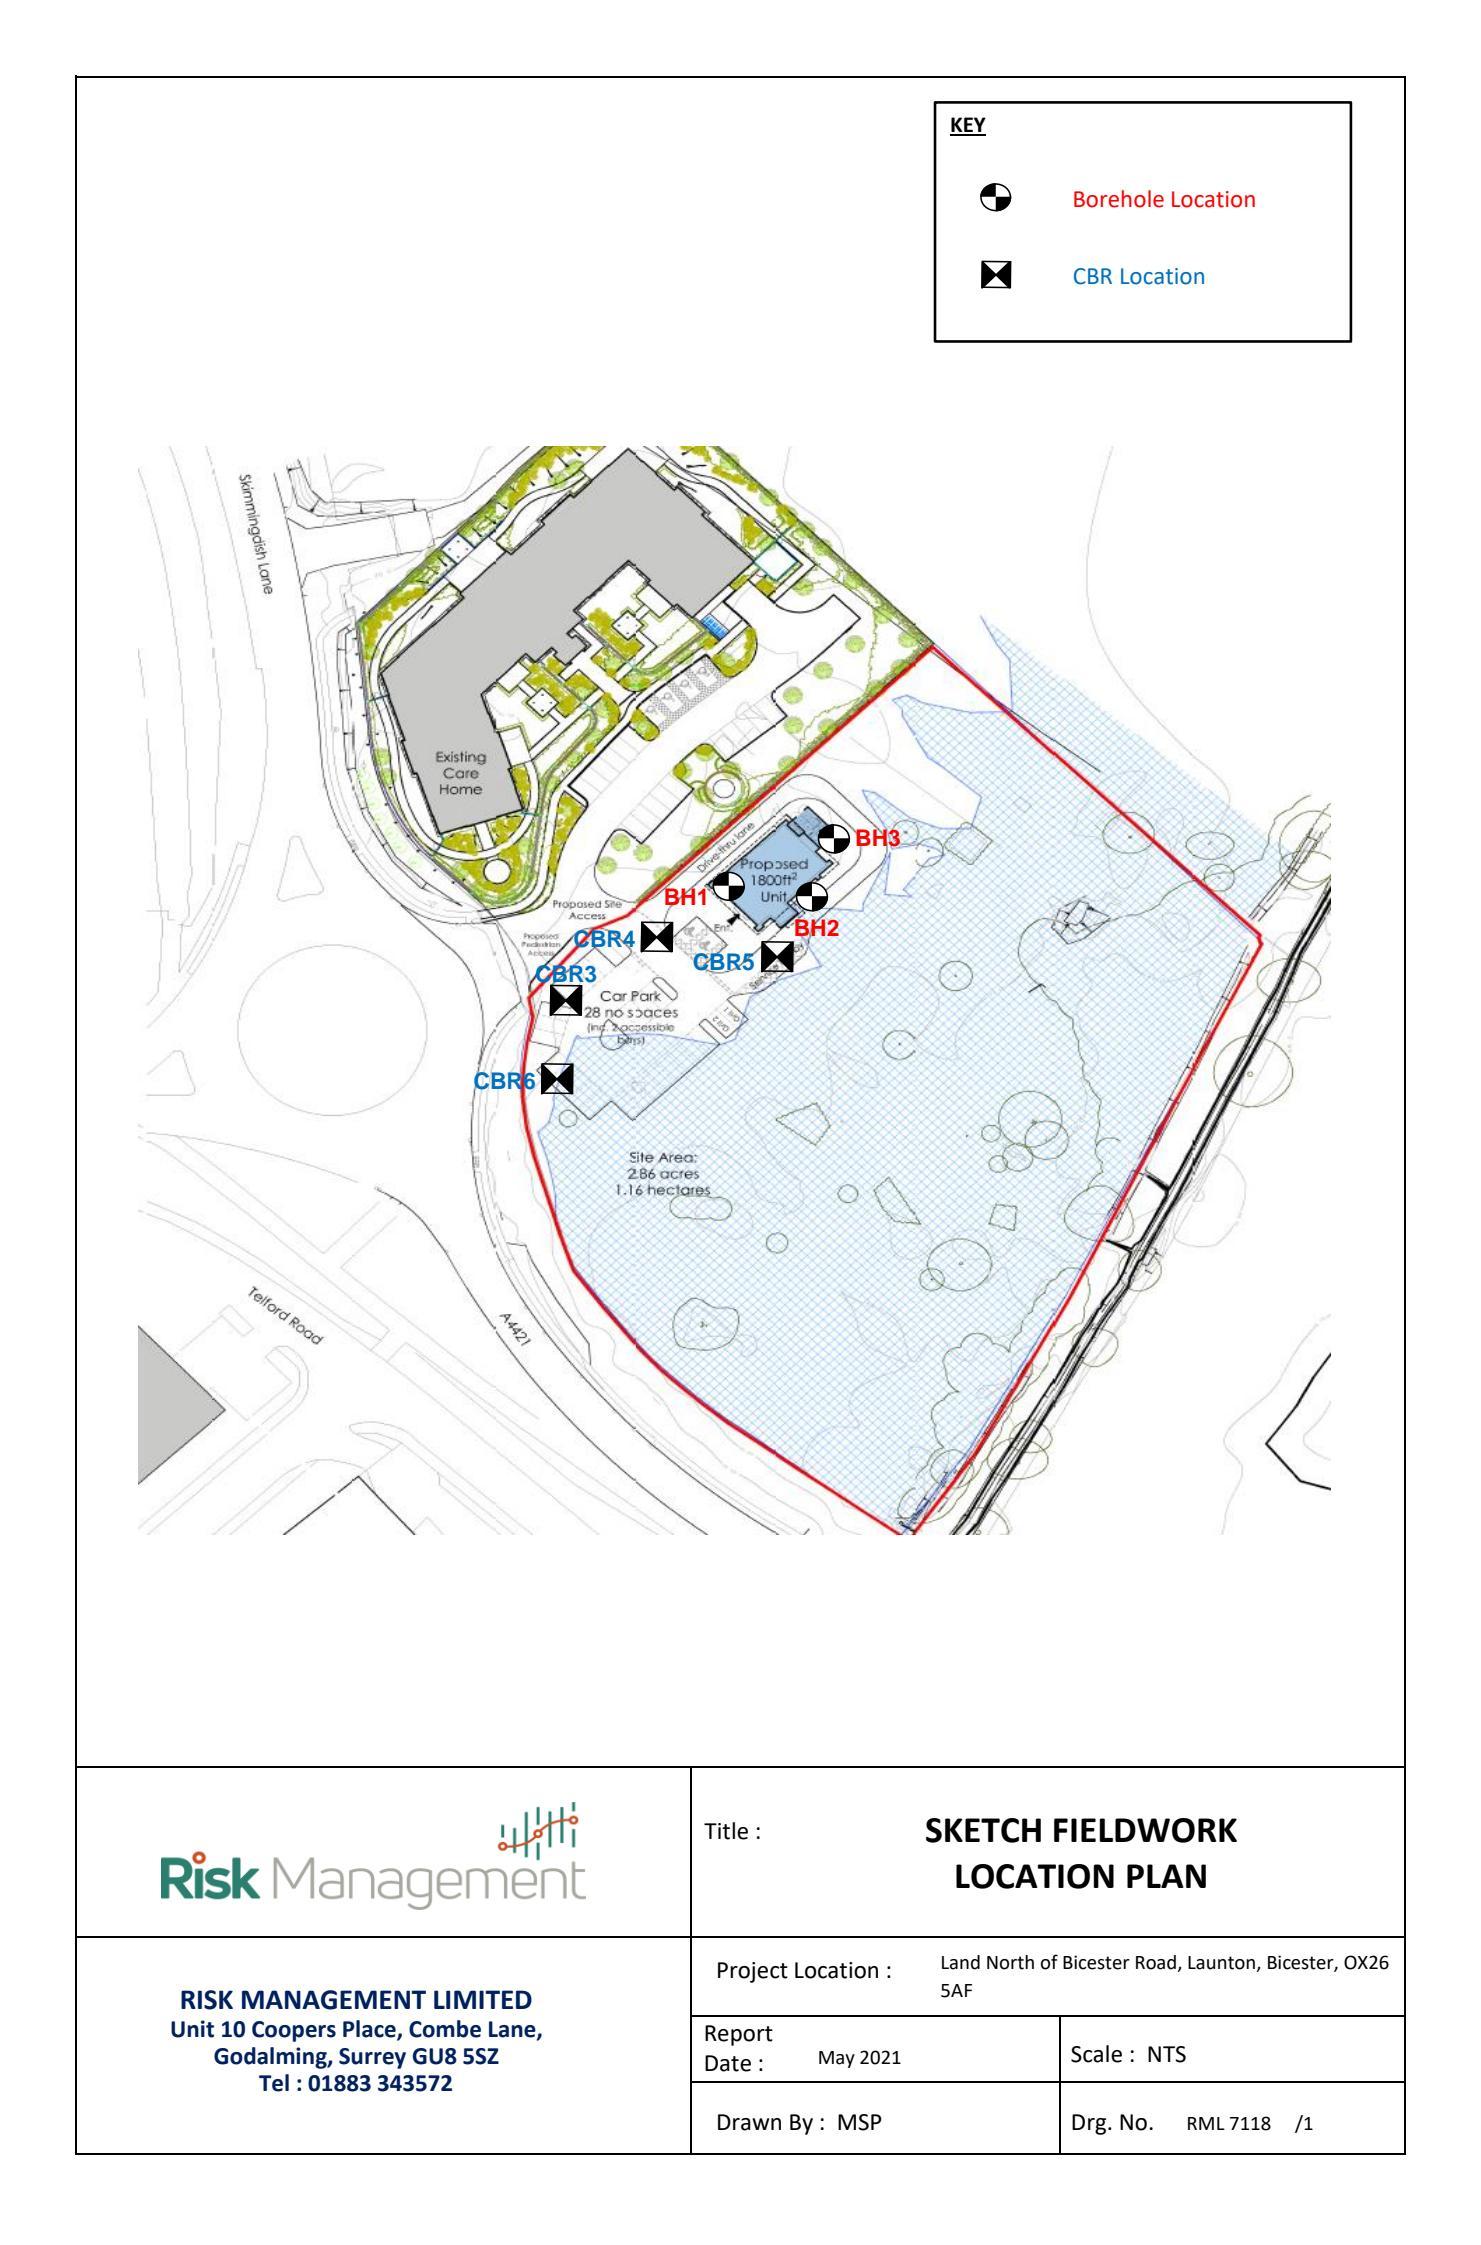
- 2.1 All fieldwork was generally executed in accordance with the recommendations given in British Standard BS 5930:2015, "Code of Practice for Ground Investigations".
- 2.2 The borehole and CBR locations are shown on the appended Sketch Fieldwork Location Plan, Drawing No. RML 7118/1.
- 2.3 Fieldwork was undertaken on Saturday 10th April 2021 and comprised the following:-
