Phase I - II Geo-Environmental Site Assessment

Land at Letchmere Farm, Camp Road, Upper Heyford, OX25 5LS

Prepared for: David Wilson Homes

January 2022

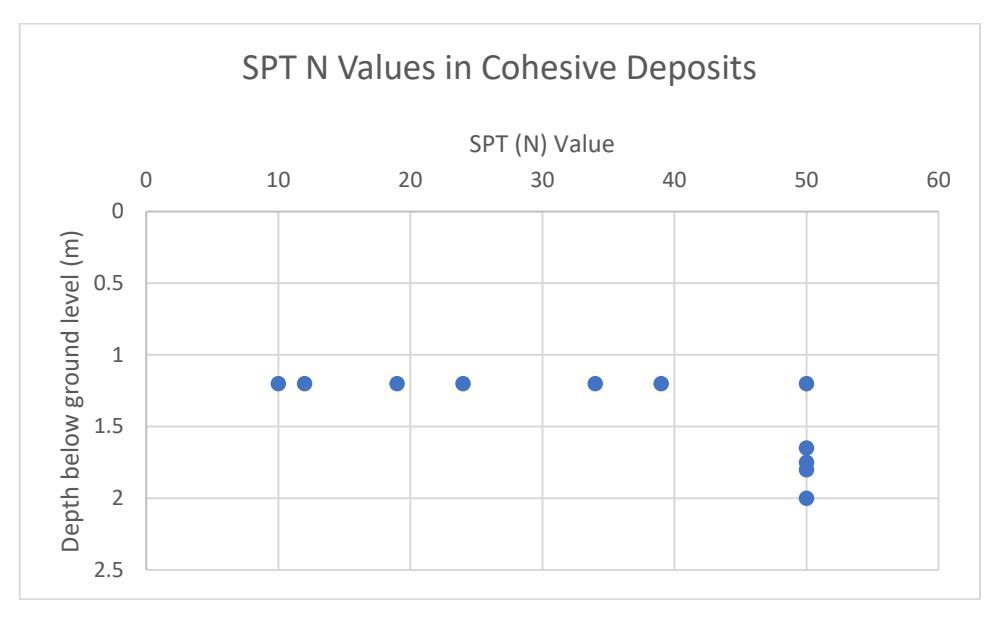
Standard Penetration Testing was undertaken throughout the cohesive fine grained White Limestone Formation. The results are presented in Graph 12-1 below:

The SPT data shows that within cohesive deposits of the White Limestone Formation SPTs varied from N=10 at 1.20mbgl to N=50 at 2.00mbgl.

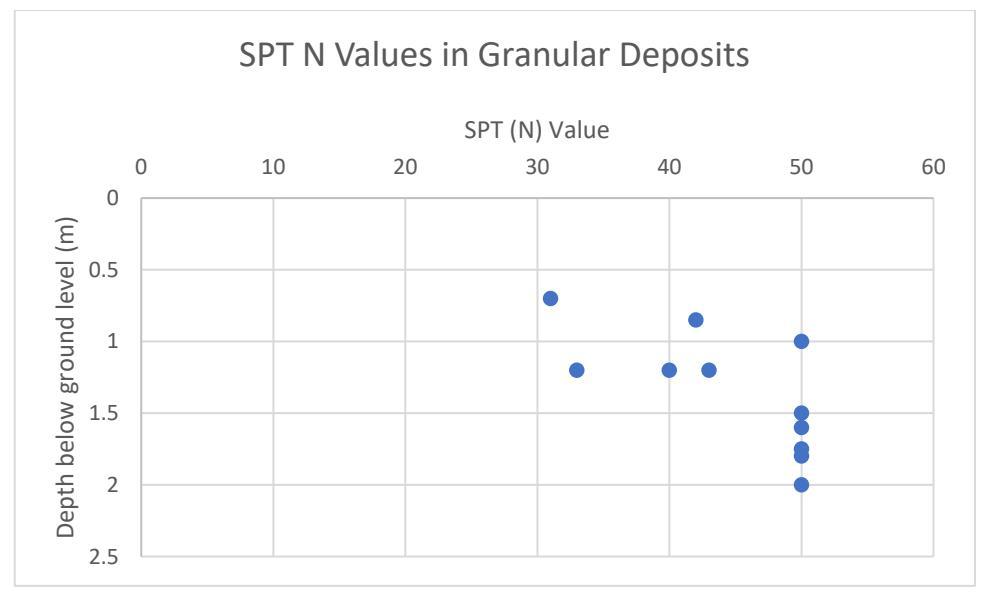
The SPT data shows what within granular deposits of the White Limestone Formation SPTs varied from N=31 at 1.20mbgl to N=50 at 2.00mbgl.

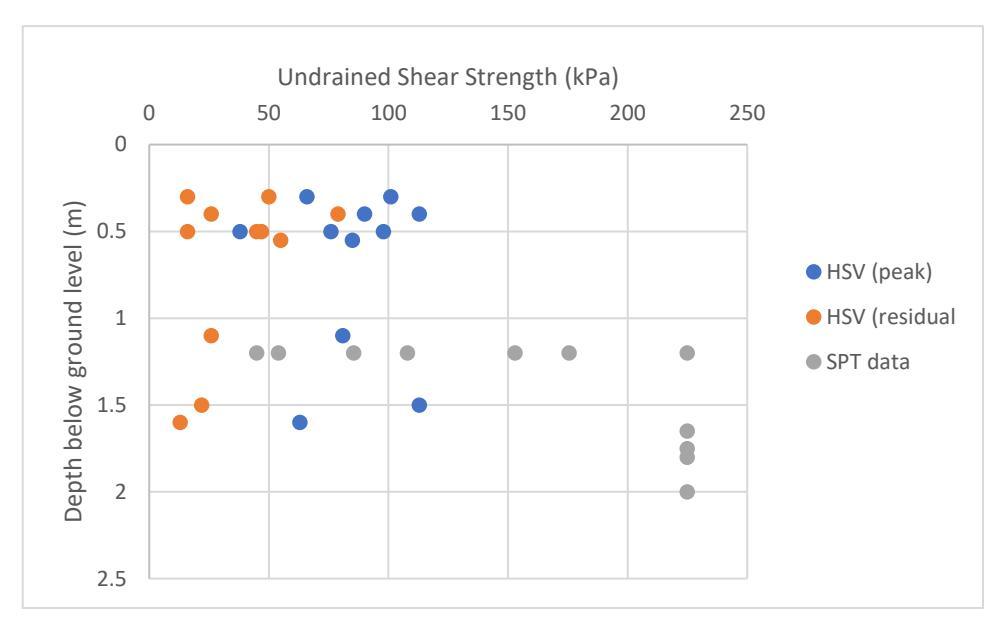
Graph 12-3 Shear Strength vs Depth

Undrained Shear strength was also assessed via in-situ testing with a Hand Shear Vane within hand dug trial pits in window sample locations. Results from in-situ testing and laboratory testing are presented on Graph 12-3.

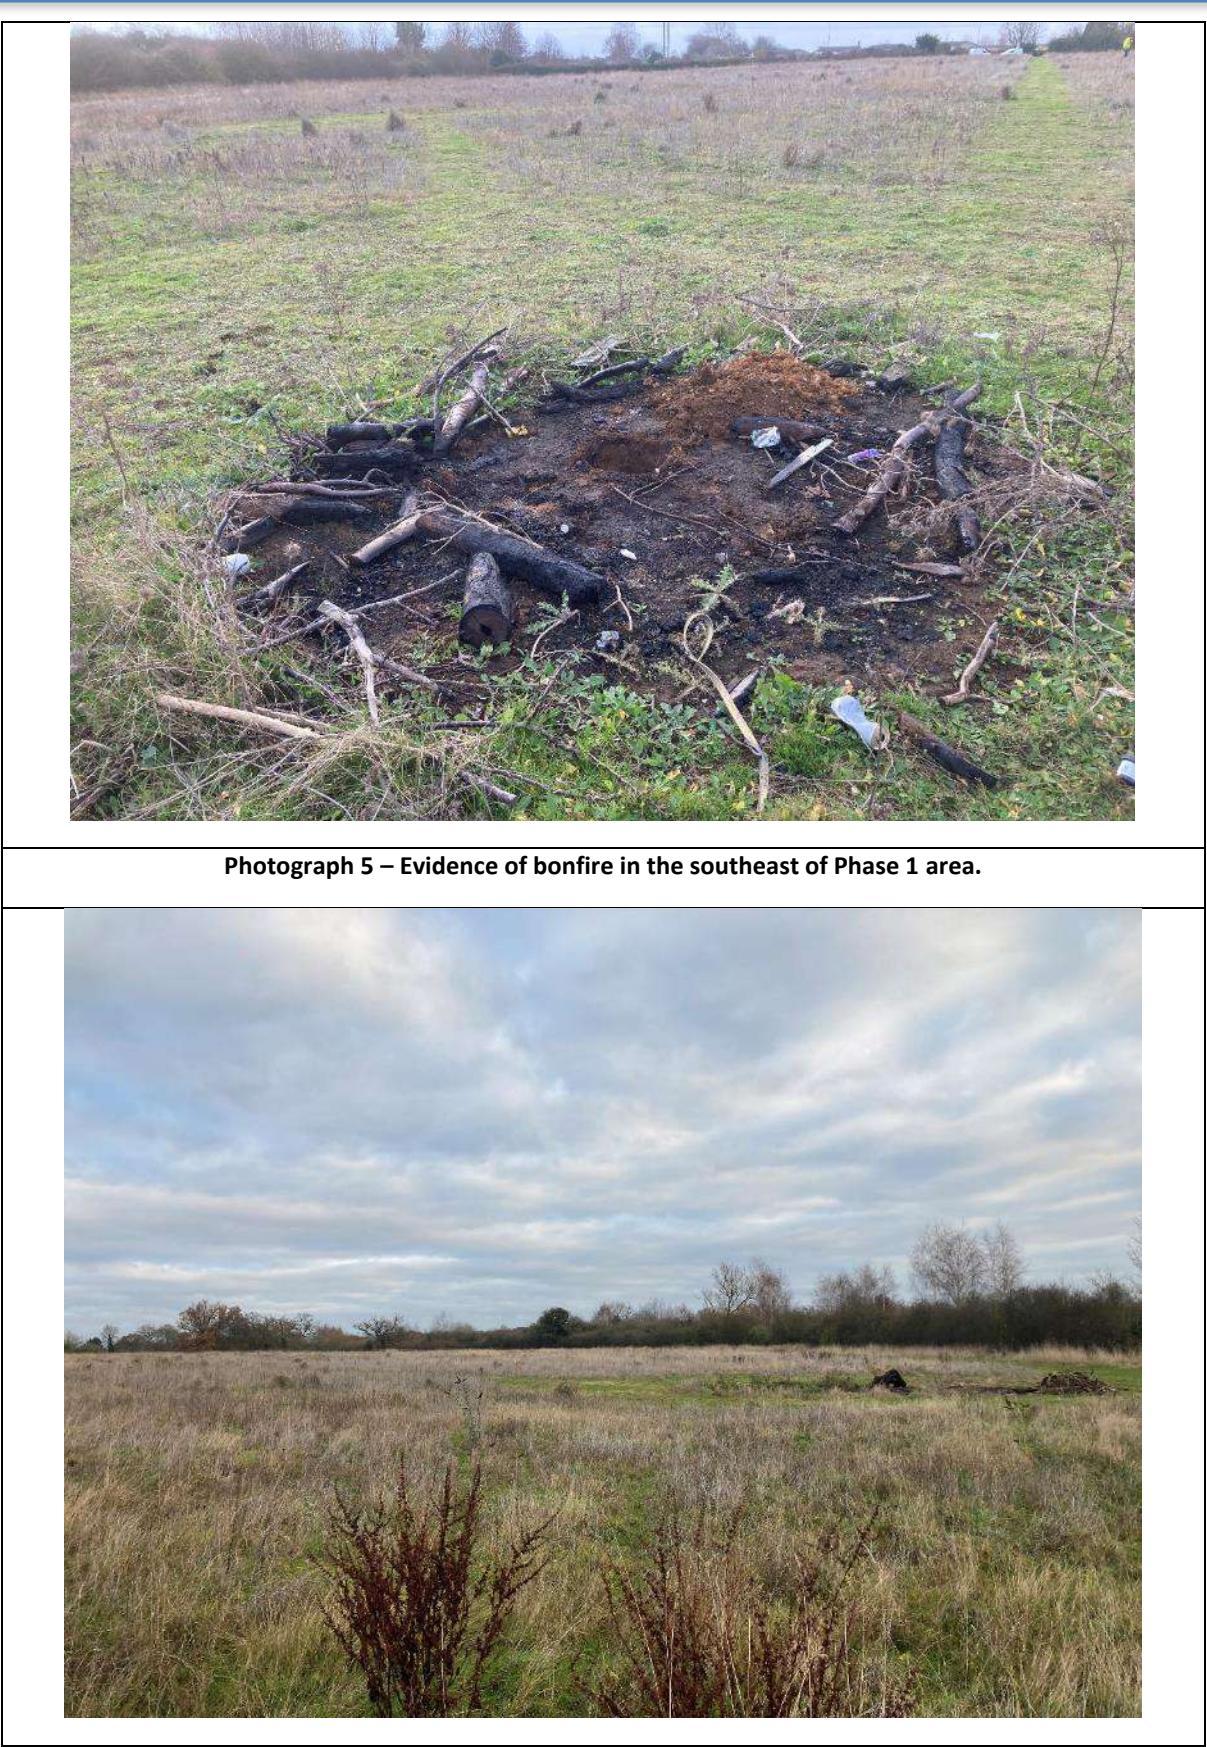
Photograph 6 – Looking north within the Phase 1 area.

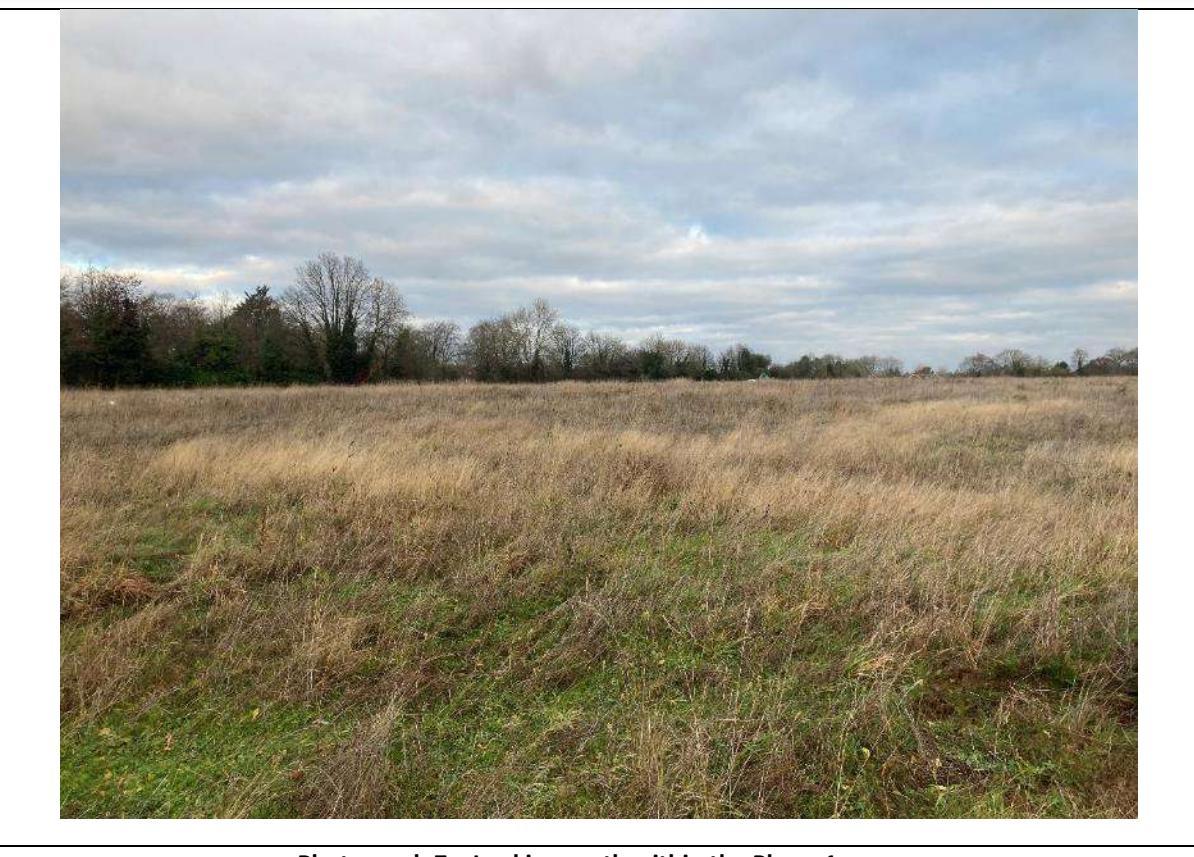
Photograph 7 – Looking north within the Phase 1 area.

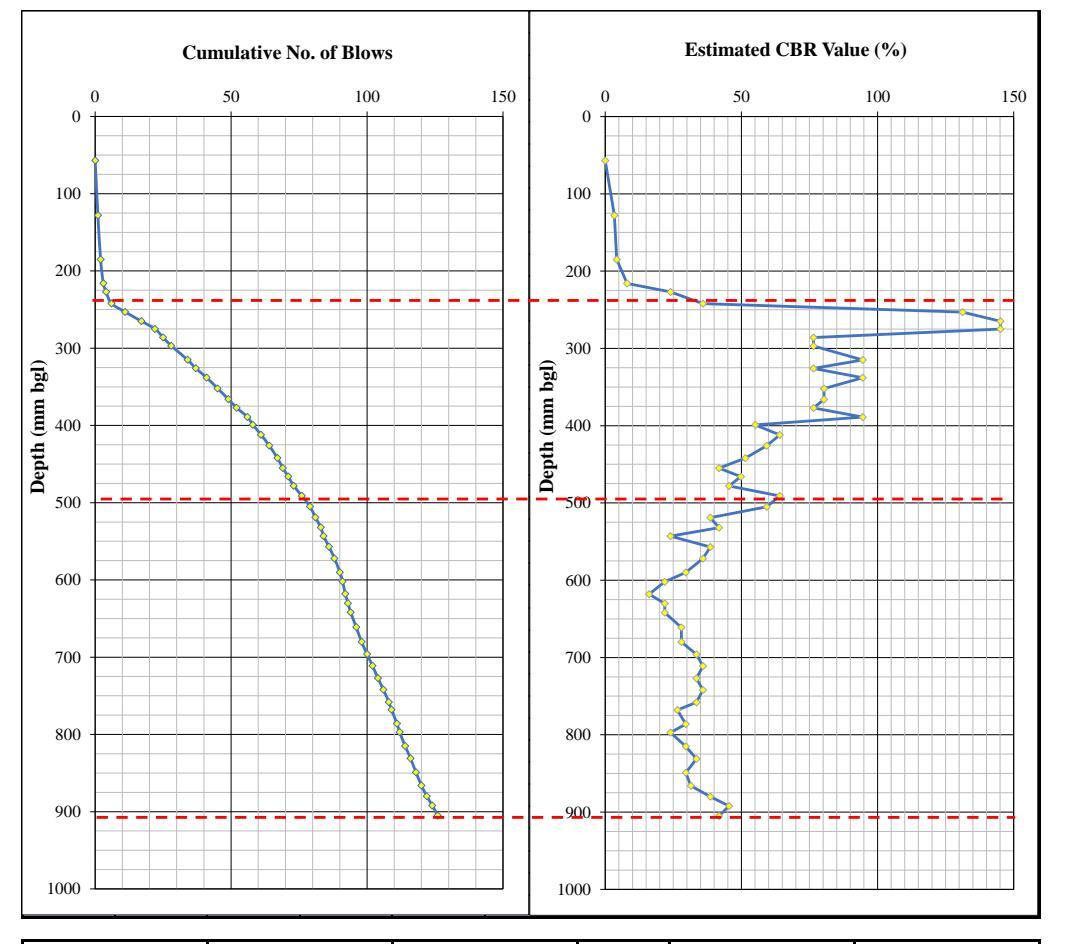
Site Name: Upper Heyford			Test Date:	21/01/2022	
Site Ref:	A11754		ONDUIA	Test Location:	DCP110
Initial Depth:	57	mm bgl	OTHE HE I	Test No.:	1 of 1
Final Depth:	905	mm bgl		Undertaken By:	TH

Start Depth (mm bgl)	End Depth (mm bgl)	Layer Range (mm)	Blows per Layer	DCP mm/Blows per Layer	Average Layer CBR Value (%)
0	245	225	6	41	6.0
245	495	250	70	4	78.6
495	900	405	50	8	33.1
omments					
<u> </u>					
Site Engineer:	Date:	Checked and Appr	oved By:	Date:	Locatio
ТН	21/01/2022	JC		25/01/2022	DCP11

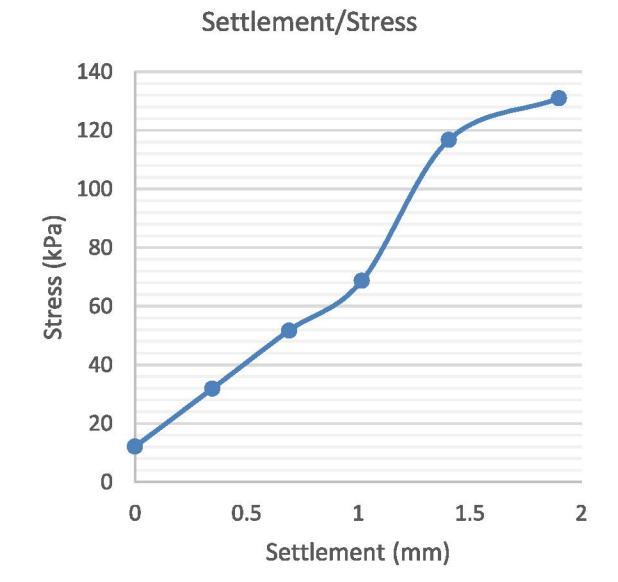
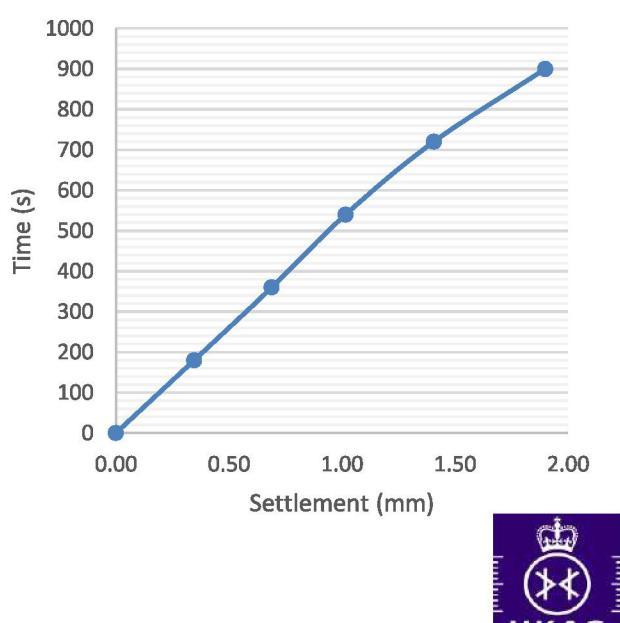
Maximum Applied Stress (kPa):	131
Maximum Settlement (mm):	1.90
Equivalent CBR Value (%):	4
Modulus of Subgrade Reaction, k ₇₆₂ (MN/m ² /m):	34

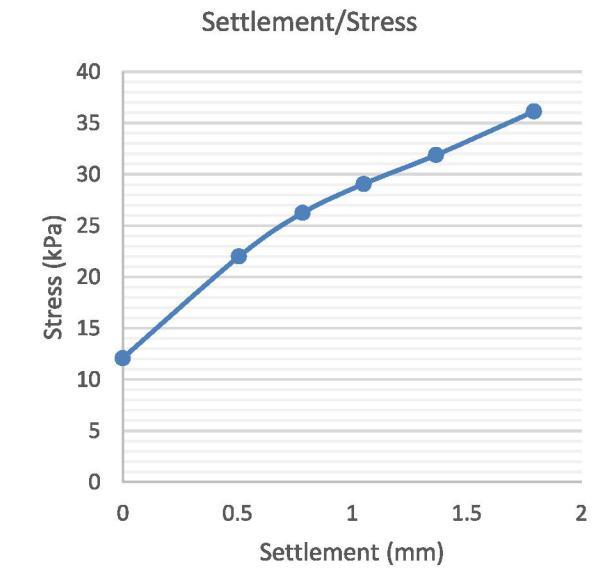
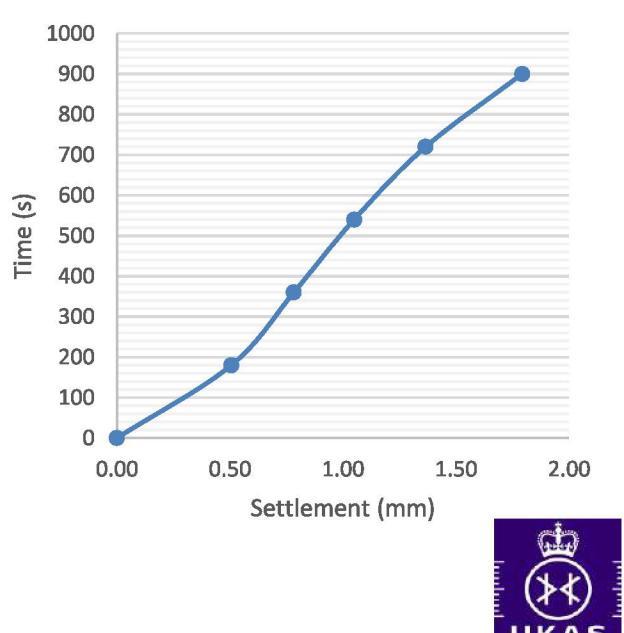
Maximum Applied Stress (kPa):	36
Maximum Settlement (mm):	1.79
Equivalent CBR Value (%):	1
Modulus of Subgrade Reaction, k ₇₆₂ (MN/m ² /m):	11

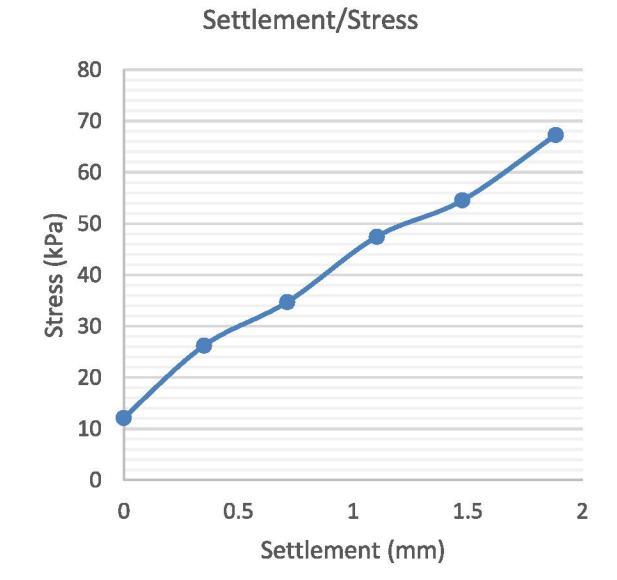
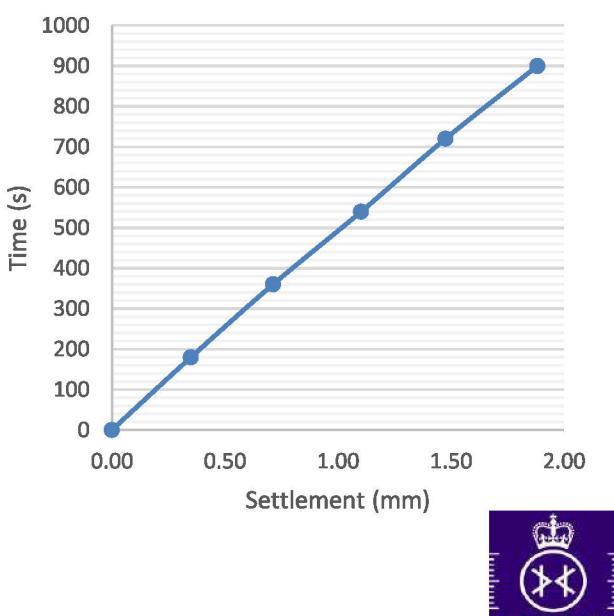
Maximum Applied Stress (kPa):	67
Maximum Settlement (mm):	1.88
Equivalent CBR Value (%):	1
Modulus of Subgrade Reaction, k ₇₆₂ (MN/m ² /m):	18

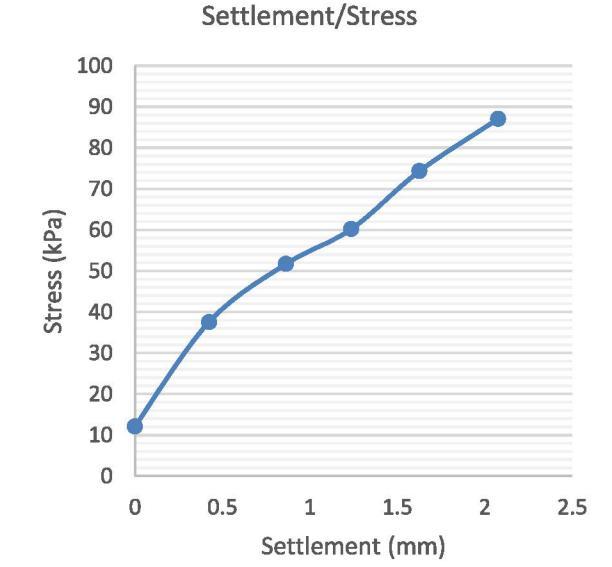
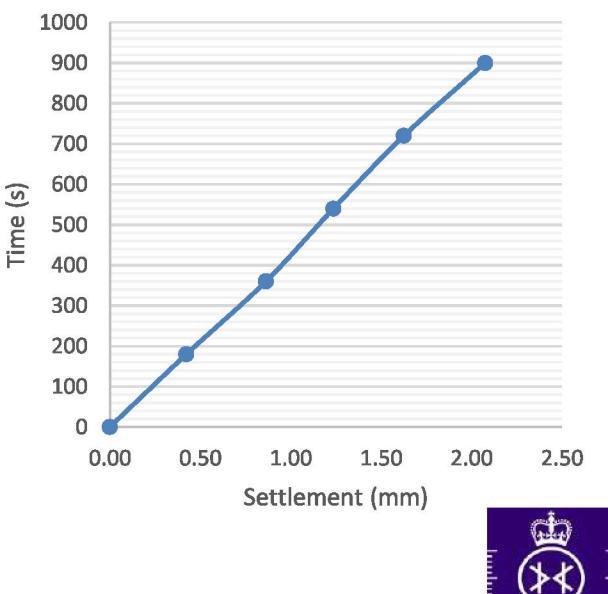
Maximum Applied Stress (kPa):	87
Maximum Settlement (mm):	2.08
Equivalent CBR Value (%):	2
Modulus of Subgrade Reaction, k ₇₆₂ (MN/m ² /m):	21

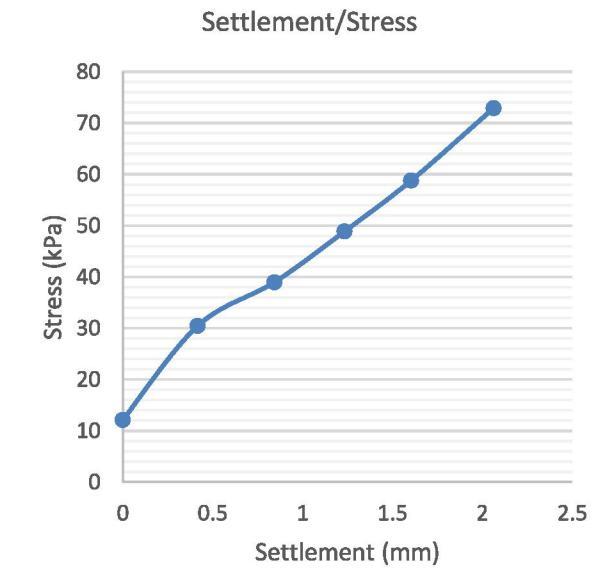
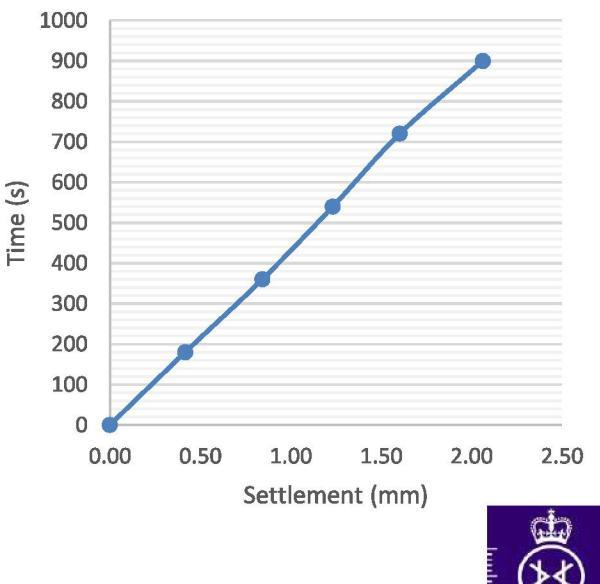
Maximum Applied Stress (kPa):	73
Maximum Settlement (mm):	2.06
Equivalent CBR Value (%):	1
Modulus of Subgrade Reaction, k ₇₆₂ (MN/m ² /m):	17

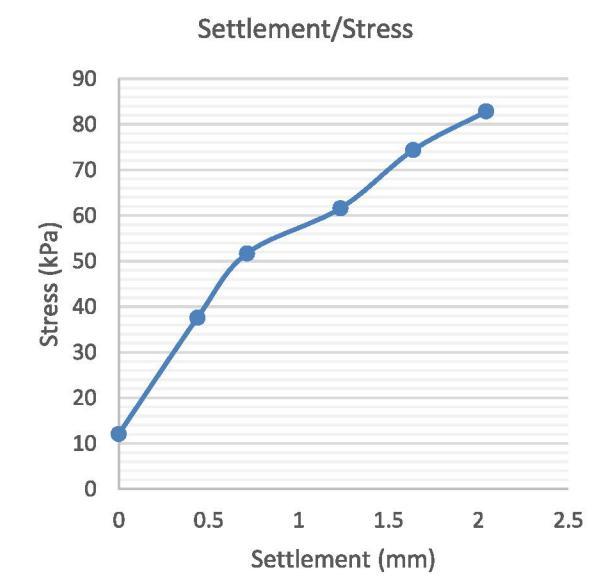
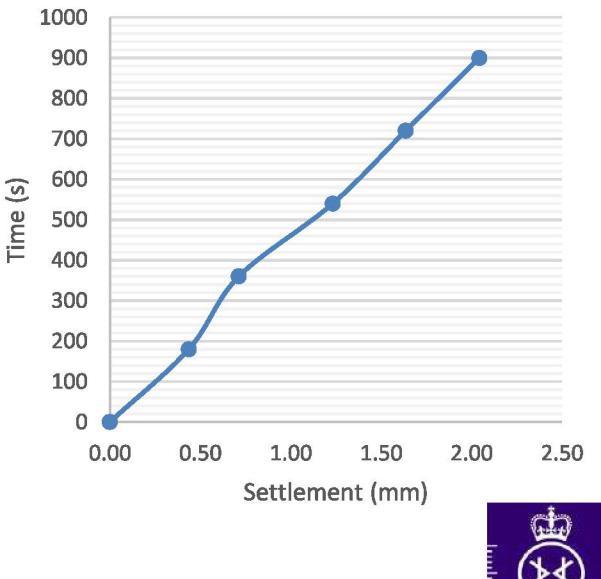
Maximum Applied Stress (kPa):	83
Maximum Settlement (mm):	2.04
Equivalent CBR Value (%):	2
Modulus of Subgrade Reaction, k ₇₆₂ (MN/m ² /m):	22
