Arboricultural Impact Assessment

David Wilson Homes Southern

Land off Camp Road, Upper Heyford

Ref:	22-0773
Version:	5
Date:	April 2024
Author:	Ben Jones BSc (Hons) MSc DipArb TechArborA
Position:	Arboricultural Consultant

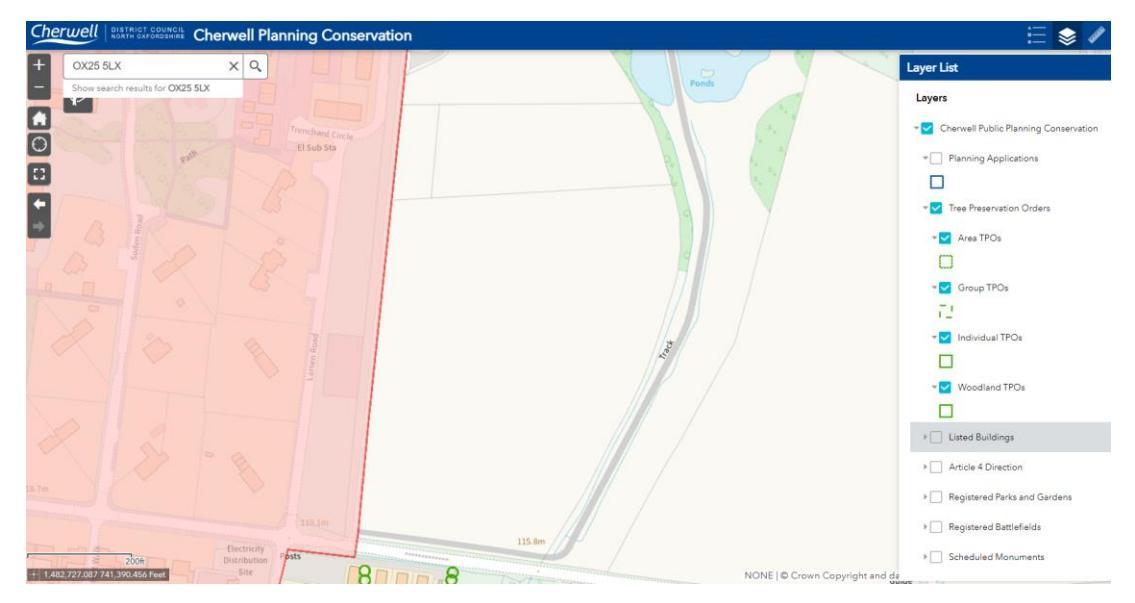
Figure 1: Outcome of online search confirming no TPOs on site, but partial incursion into RAF Upper Heyford Conservation Area, as shown in red (Source: Cherwell District Council).

2.16 The Conservation Area appears to impact upon trees along the western site boundary (i.e. H7-G27 inclusive).
