From: Joyce Christie Sent: 14 October 2019 13:36 To: James Kirkham Subject: 19/01148/F and 19/01149/LB

Joyce Christie Conservation Officer Planning Policy, Conservation and Design Place and Growth Directorate Cherwell District Council

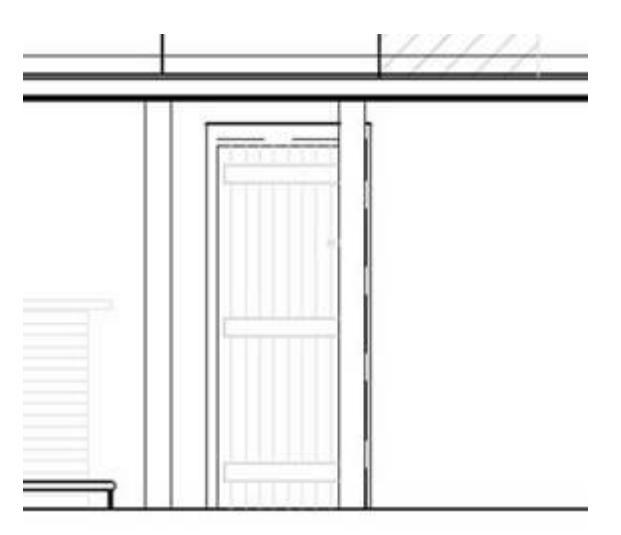
Door to street and inner doors:

I would be happy with a condition for the new screen and inner door, the extract from Section AA shows this draft elevation could be improved upon in relation to the to the two posts, this sould include details of the downstand beams.

The means of escape are a matter for the 'responsible person' under The Regulatory Reform (Fire Safety) Order 2005 and it is noted that the existing double doors prior to blocking up are likely to have formed part of an escape strategy for the pub.

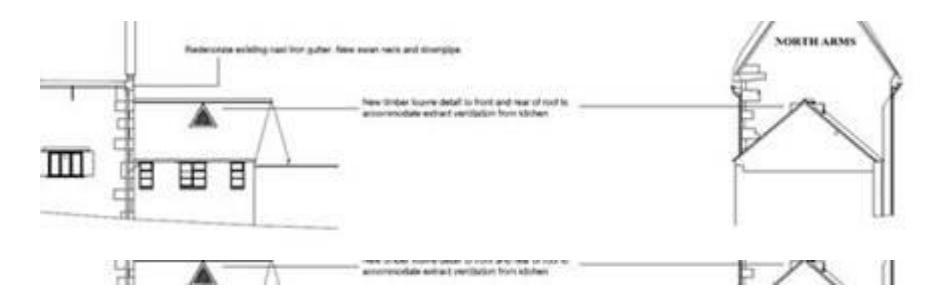
Louvred to roof of kitchen – to detail – they are too close to the ridge as shown. The side elevation and the front elevation appear to be different in terms of size?

To detail.

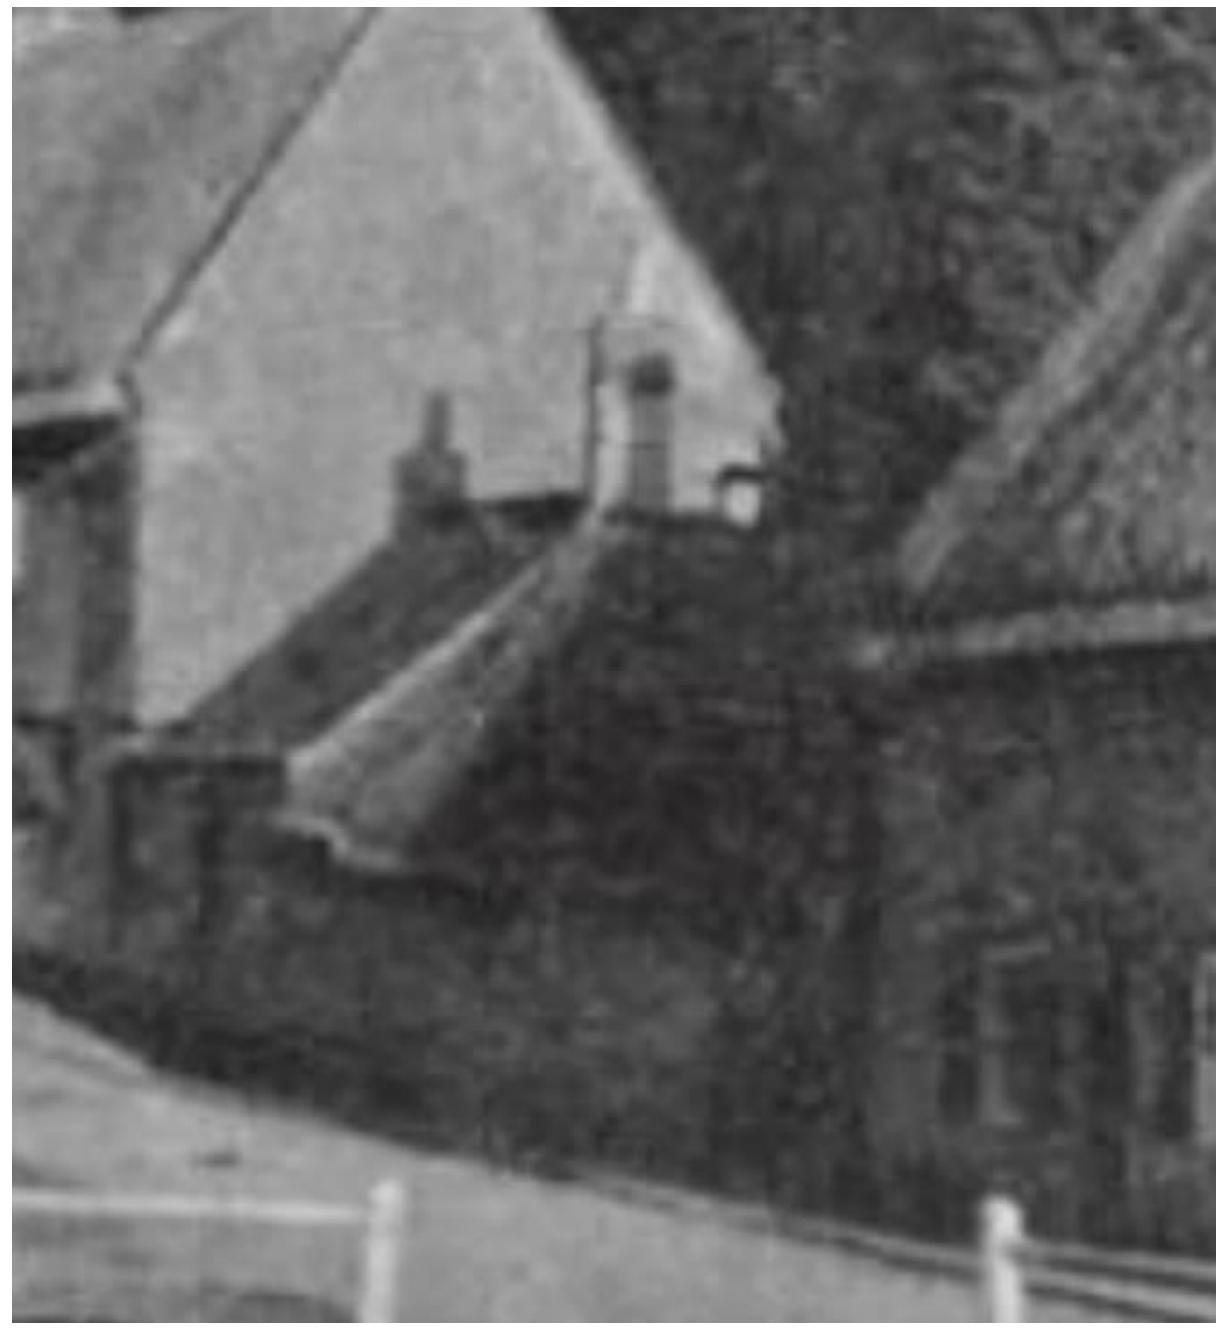
Historic photo of chimney: This shows it was part fo the verge coping to the building that currently houses the toilets and the shadow of the chimney can be seen on the gable of the North Arms. Rock Davidson Associates report Page 23 also mentions the chimney.
