REAR ROOF RB-2 RIDGE DETAIL

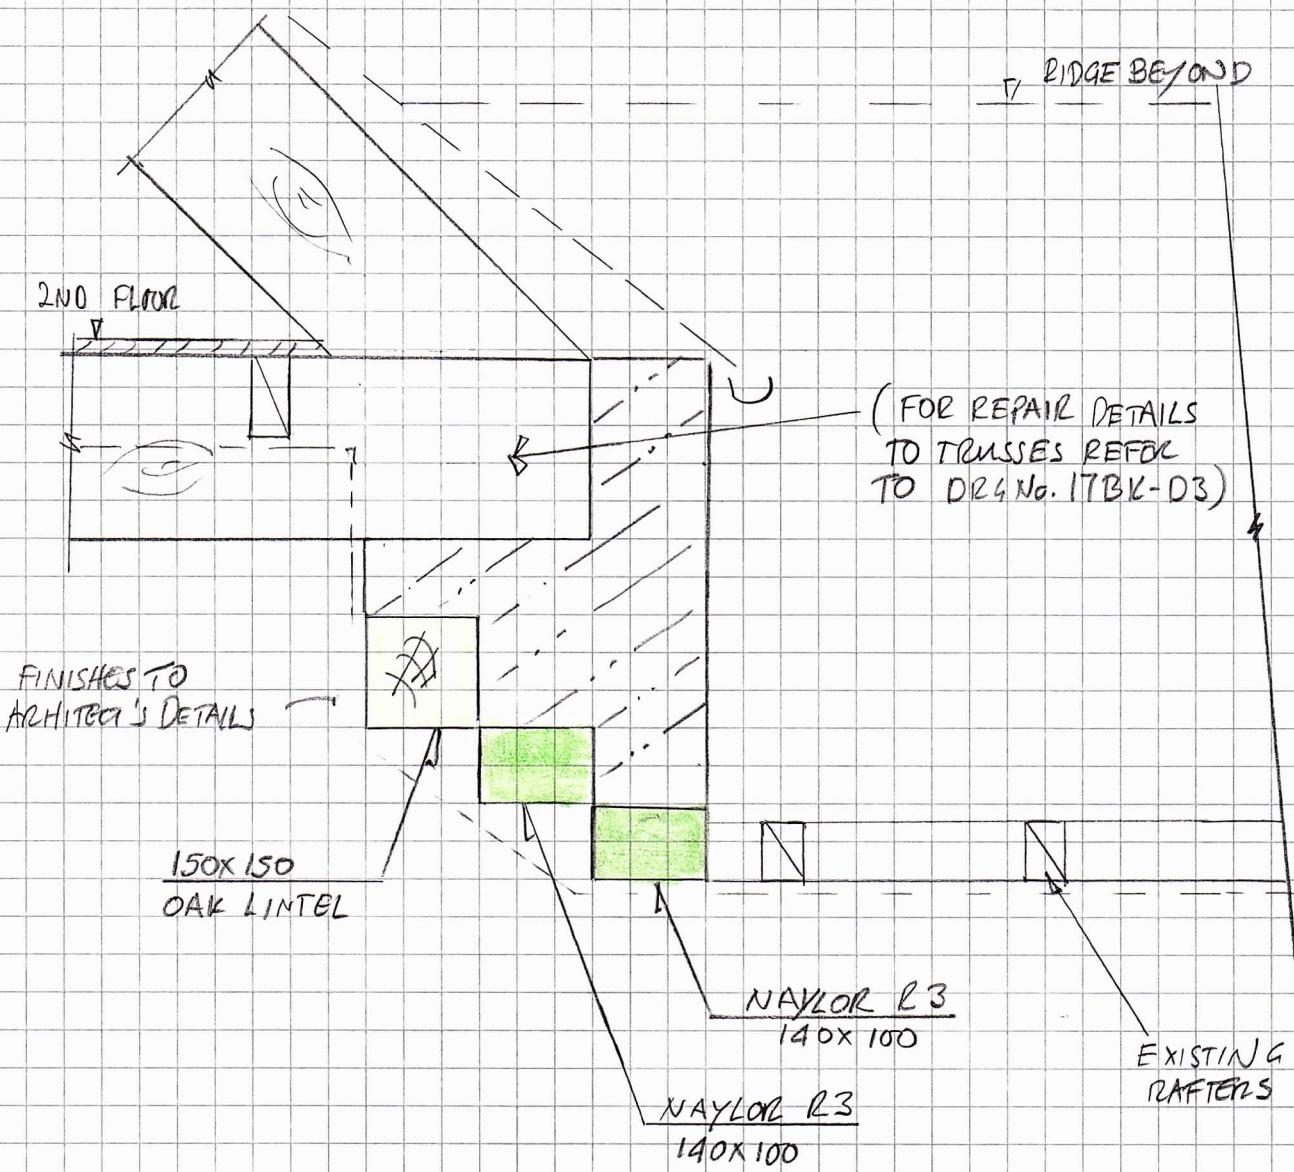
EXISTING RAFTERS
75x50 @ 380°C
DECAYED / ROTTEN
RAFTERS TO BE
REPLACED WITH
NEW TO MATCH
EXISTING.
