Objection 2 from

[with reference to application documents: ES Volume 1 Chapter 14 Flood Risk and Drainage by Mott MacDonald, and the ES Volume 3 Appendix 14.1 Flood Risk Assessment and Drainage Strategy by Mott MacDonald, and Appendix H Site Walkover Technical Note by Mott MacDonald]

Potential Negative Hydrological implications of Proposed Stadium Development on the Triangle

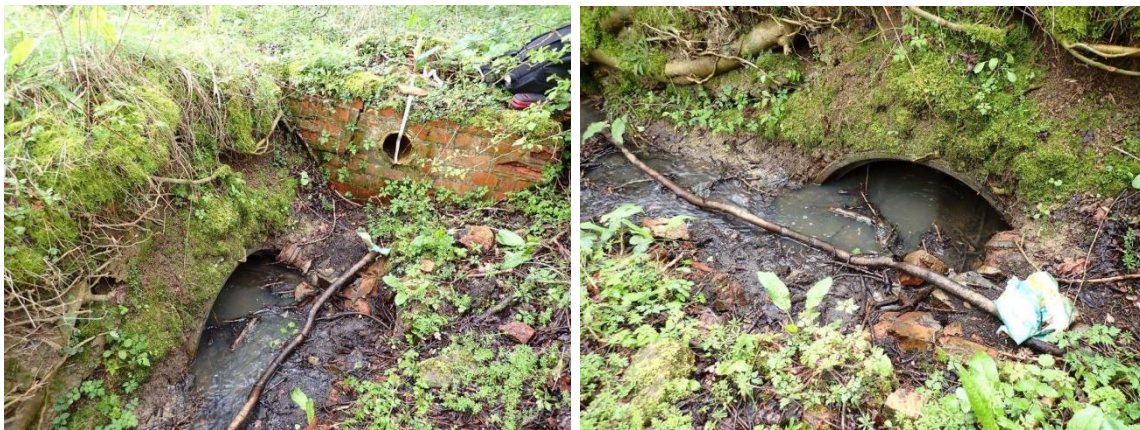
Water has been backing up in that western Frieze Way ditch going south to the culvert position because there is an access causeway to the Triangle field (maybe for agricultural machinery?) from Frieze way crossing that ditch. A drain pipe emerging from the causeway wall 30cm down shows no flow (no explanation for this) BUT I saw water bubbling up from deeper underneath the causeway so water is finding a way underneath, but flow not fast enough to lower ditch water level to north of causeway. See photos below.

Two views of the Triangle/Frieze Way ditch with big culvert to left, set low down which takes ditch water (can be seen flowing) under Frieze Way from the Triangle ditches 29.03.2024 J A Webb photos. Brick wall to access causeway visible with pipe (no water flow). Water is backed up in ditch on the northern side of causeway but emerging from under causeway.

This blockage & backing up (combined with extremely heavy rainfall) in that Frieze Way ditch has meant the lowest area of the Triangle site on the west side has not drained but been

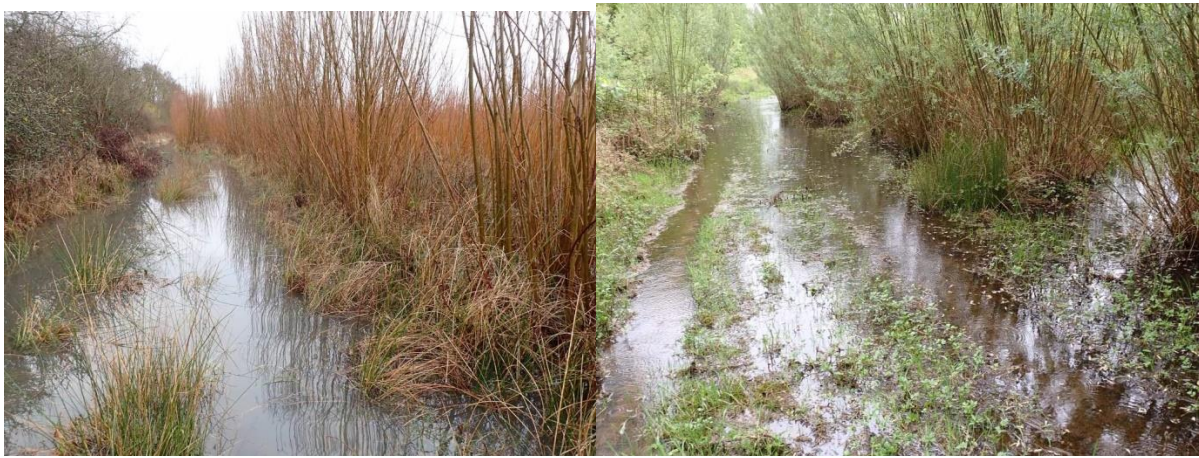
deeply flooded this last very rainy 4 months - to over the top of my wellies at more than 39cm deep at one point.

West side of Triangle in lowest land area adjacent to ditch to Frieze Way. Left view seriously surface water flooded on 02.01.2024. Water deeper than the top of a wellie boot at 39cm. 02.01.2024. Right view on 06.05.2024 still impassibly flooded. Photos J A Webb.

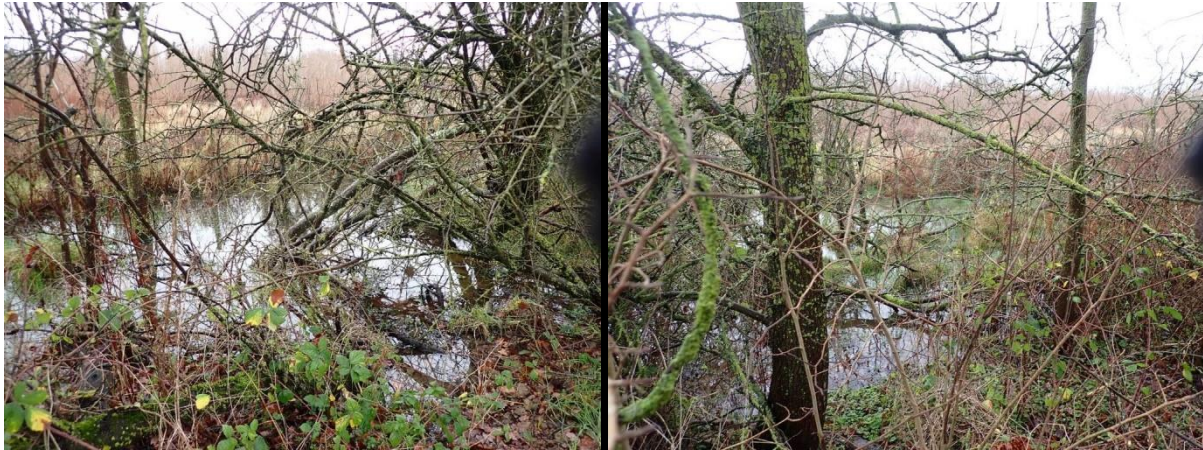
A **surface water flooding map** is available in the documents which clearly identifies this western low area of the Triangle. What it fails to show is the significant surface water pooling on the eastern side of the Triangle as well – probably from the Oxford Road highways ditch (flooding regularly visible from the bus on Oxford Road). This area would probably therefore have to be land-raised as well as this is planned for an access point. **The need to raise this eastern land area (by how much?) not recognised or accounted for in plans.** Even if Highways dug out that ditch, this is still a low site area in the Triangle where water pools. Who knows if cleaning this ditch would solve the issue? Mott MacDonald could not identify an outflow point from this ditch in the south-eastern corner.

Triangle area on the east side extensively flooded on 02.01.2024. Views into the Triangle from the verge on Oxford Road. Photos J A Webb.

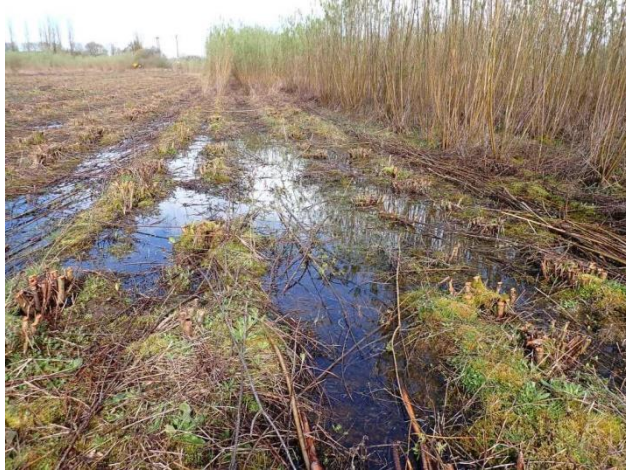
1. **Currently acts as a big rain-water storage area all autumn winter, and spring.** Ruts up to 40cm deep from vehicle access for willow management are all over the site, running NE-SW mean that the site is currently covered in micro-topographical variation which holds back and stores much rainwater. The ruts become essentially a large number of **linear temporary pools** full of water that last all winter into spring (still full of water in May ‘24). In some of these ruts water can be observed very slowly draining southwards towards the ditch, many more ruts were observed to just hold standing stationary water, functioning as mini-ponds, from which water leaves only by evaporation in drier weather. These are thus attenuation features, vastly reducing run-off from the whole site.

Water held stationary in ruts in the site centre, not draining away 29.04.2024, photo J A Webb

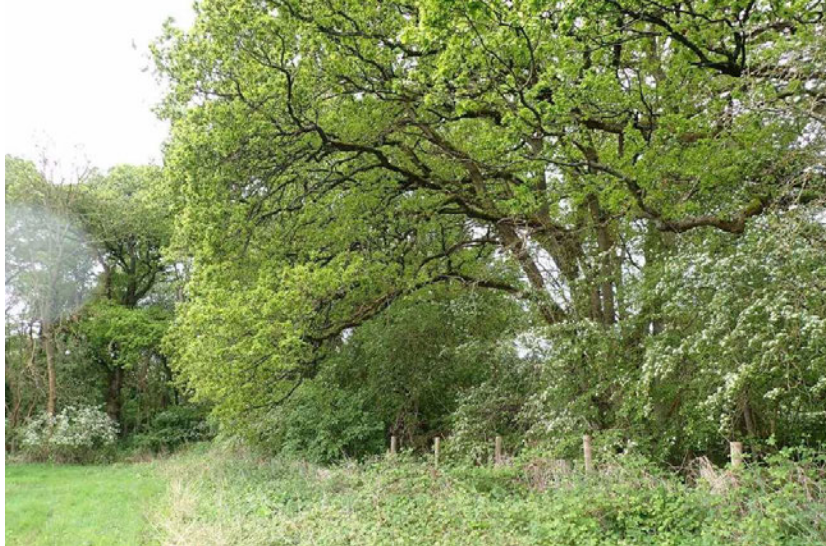
A very large, ancient, 10-trunk oak outgrown coppice stool tree in a nearby section of Stratfield Brake East overhangs the proposed car park area in the south west Triangle corner. Undoubtedly this will contribute detritus to the attenuation ponds, but no cutting back or damage to this historic multi-trunked tree that is many hundreds of years old should be considered.

10 trunk ancient Oak out-grown coppice stool tree rooted in Stratfield Brake East woodland leans out and shades the south west Triangle corner. Over or near proposed car parking area/attenuation ponds. Photo 06.05.2024 J A Webb

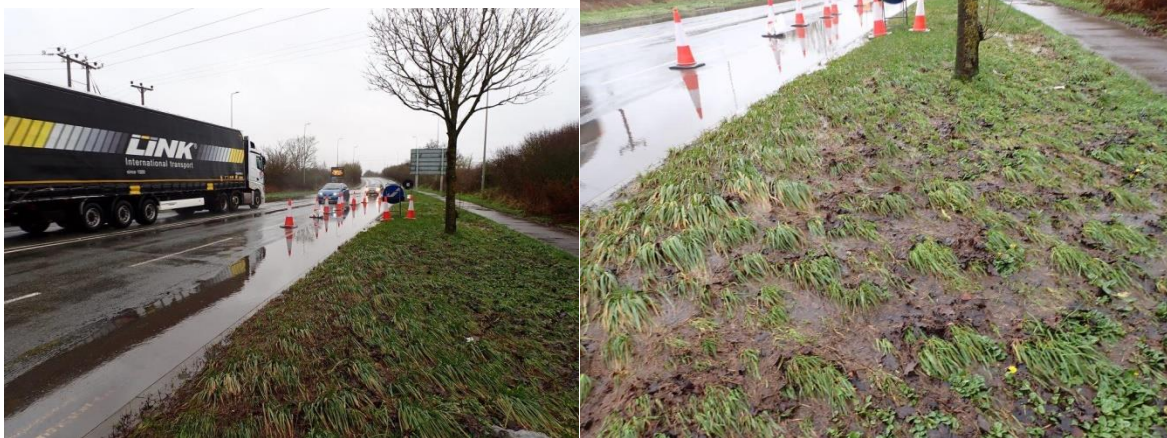
Oxford Road is stated in documents to have its own road drainage gullies leading to a separate drainage system, so in theory should contribute no run-off water to the Triangle site. However on 02.01.2024 after very heavy rain, I observed road water pooling on Oxford Road, restricting traffic flow and there was evidence of it having overtopped the 125mm kerb and having flowed directly over the verge and **into the Triangle drainage ditch on the eastern side**. Would more gully clearing be enough to prevent this in future or will future intense storms overwhelm the road drainage system constantly, with water regularly pouring into the Triangle?

*02.01.2024 Oxford Road next to Triangle partially flooded after very heavy rain, evidence of flood flow over verge (grass leaves direction) and footpath into the Triangle on east side.
Photo J A Webb.*

In the ES section 7.2.2 **Highway Drainage** Mott MacDonald dismiss this possible highway flooding over the kerb and verge to the Triangle as *'not considered to be an issue'*, but the actual evidence of water overtopping the kerb over a substantial section on Oxford Road is in photographs above. It will be an issue in the Climate Change induced deluge rain events to come.

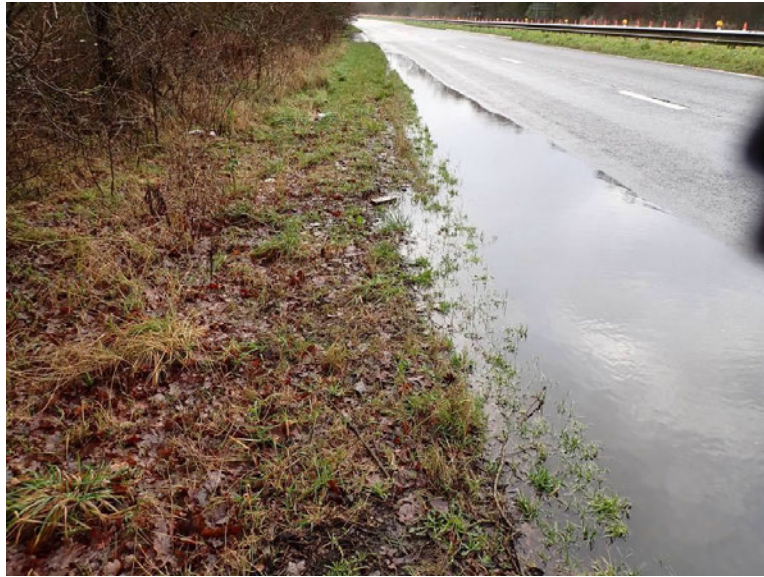
Frieze Way is drained on the Triangle side by linear filter/trench drains in the middle of the verge which likely slow water flow into the main ditch on that side (or exit somewhere else?) but on 02.01.2024 after heavy rain water I have observed water pooling on the road at a low point and **flowing directly over the verge over filter drain and into the main Triangle drainage ditch**. This might be minor, but it all adds to input to a site all, needing to exit via the culvert under Frieze Way.

Pooled water on Frieze Way flowing over verge and directly into Triangle ditch at point in centre of photo on 02.01.2024 after very heavy rainfall. Photo J A Webb.

Maybe the installation of a new cycle track as required by the County Council along this Frieze Way verge will solve this issue, or maybe not; considering there is **not enough width in this verge as it goes through Stratfield Brake woodland** to install the required path width without the death of at least 3 ancient coppice stool oaks, which should receive protection.
