STAGE 3
 BEGBROOKE SCIENCE PARK
 ACADEMIC BUILDING

ZONE B
 EXCEEDANCE FLOW PATH

APPENDIX 3 MICRODRAINAGE (SURFACE WATER) RESULTS

APPENDIX 4 GROUND INVESTIGATION RESULTS

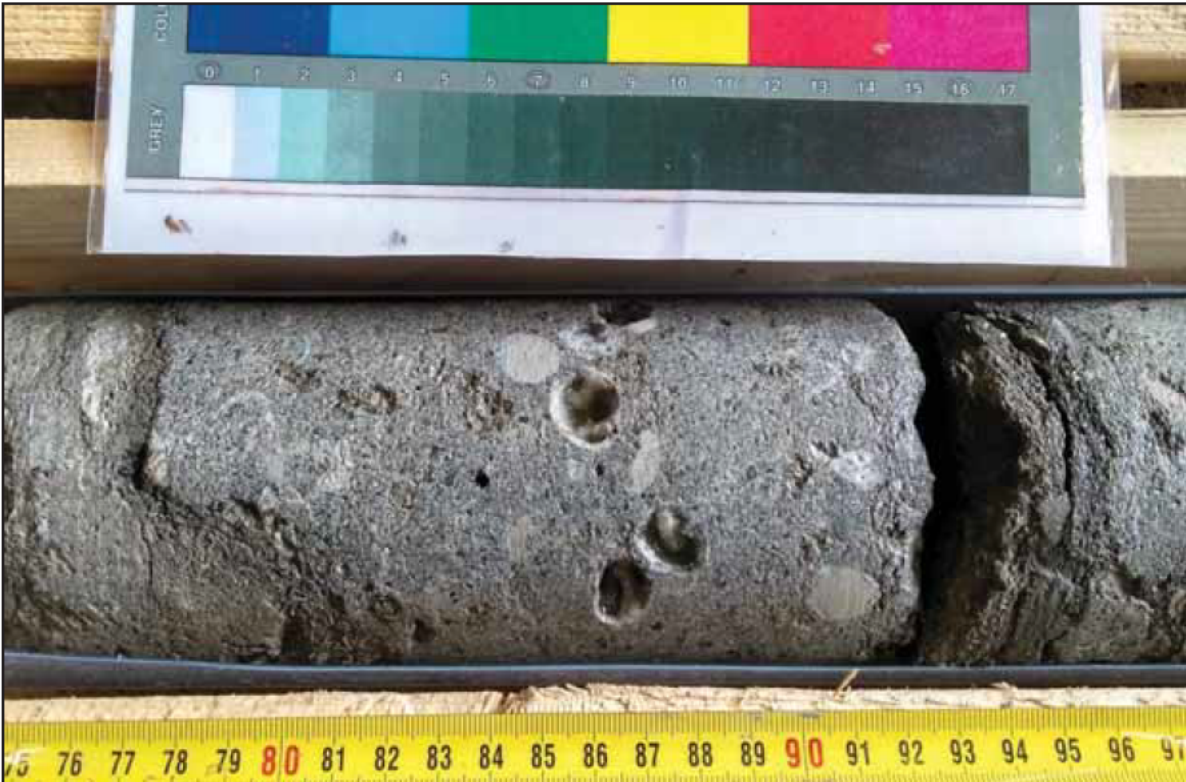
BH1, 9.75-10.00m, example of calcite-filled bivalves in Cornbrash Formation

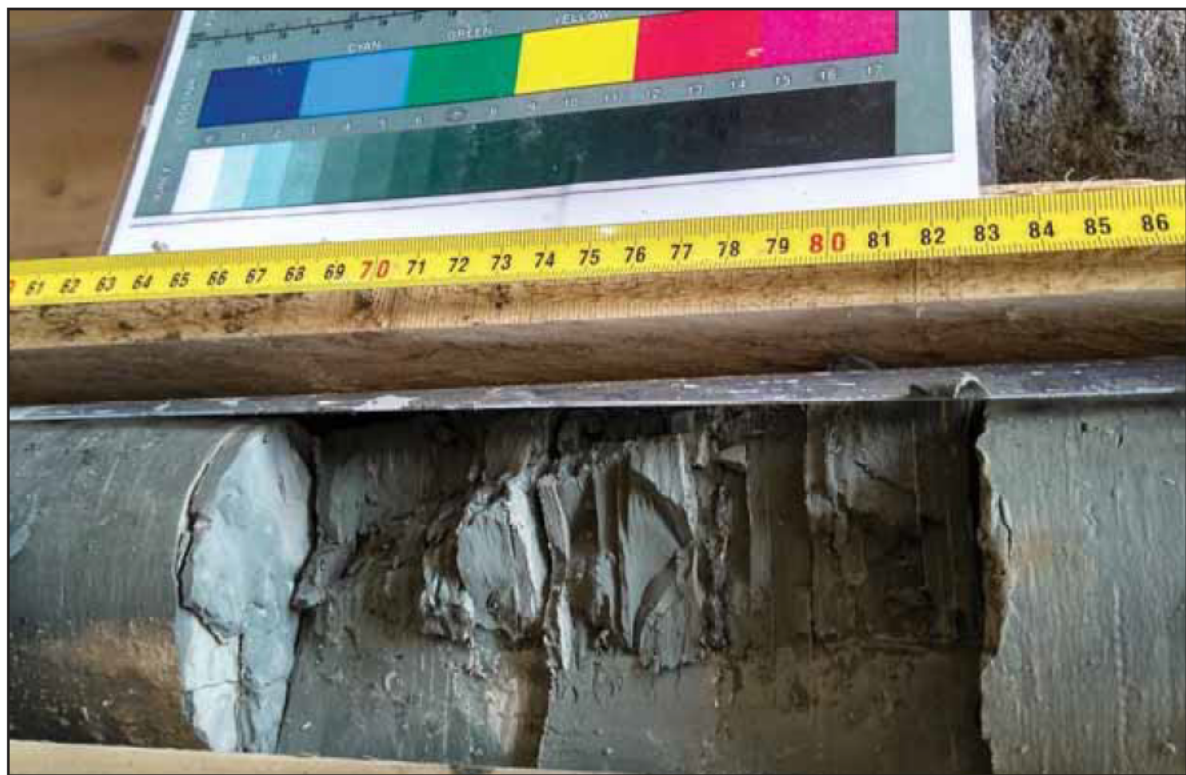
BH1, 11.60-11.85m, example of laminae and 'ripples' of light grey and white silt in very stiff, laminated, green grey clay of the Forest Marble Formation.

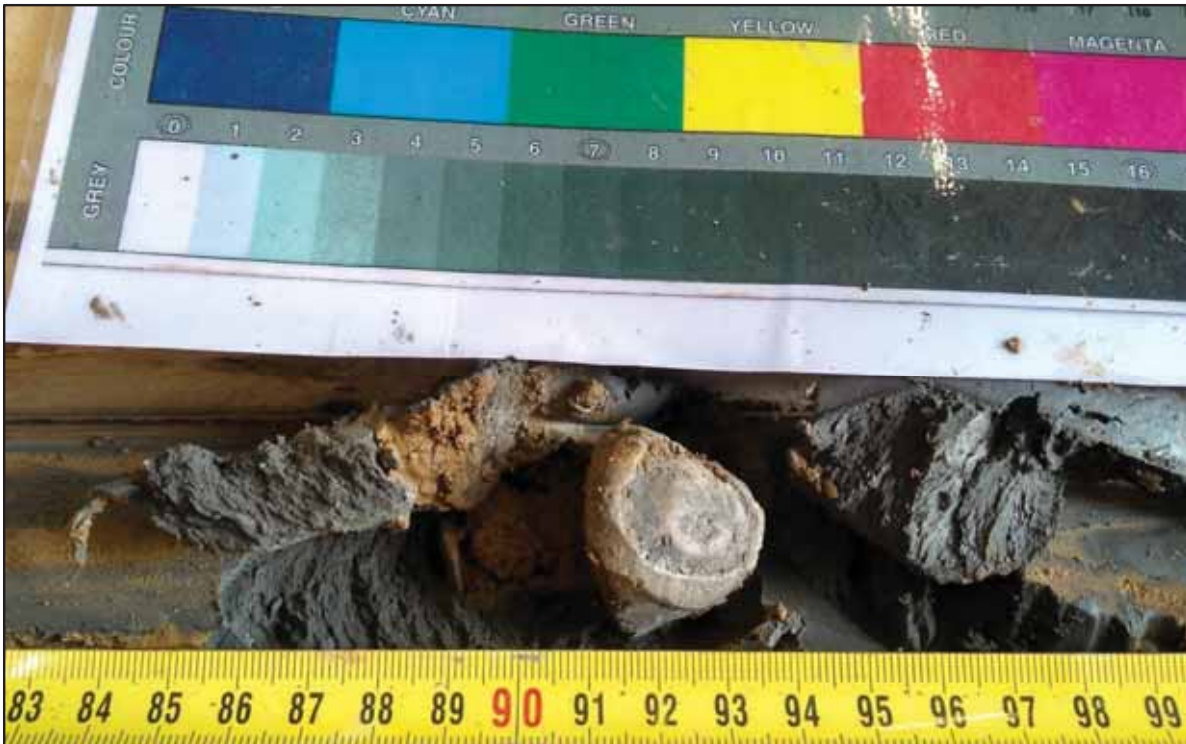
BH2, 5.00m, coarse gravel size concretionary limestone nodule in Kellaways Clay Member

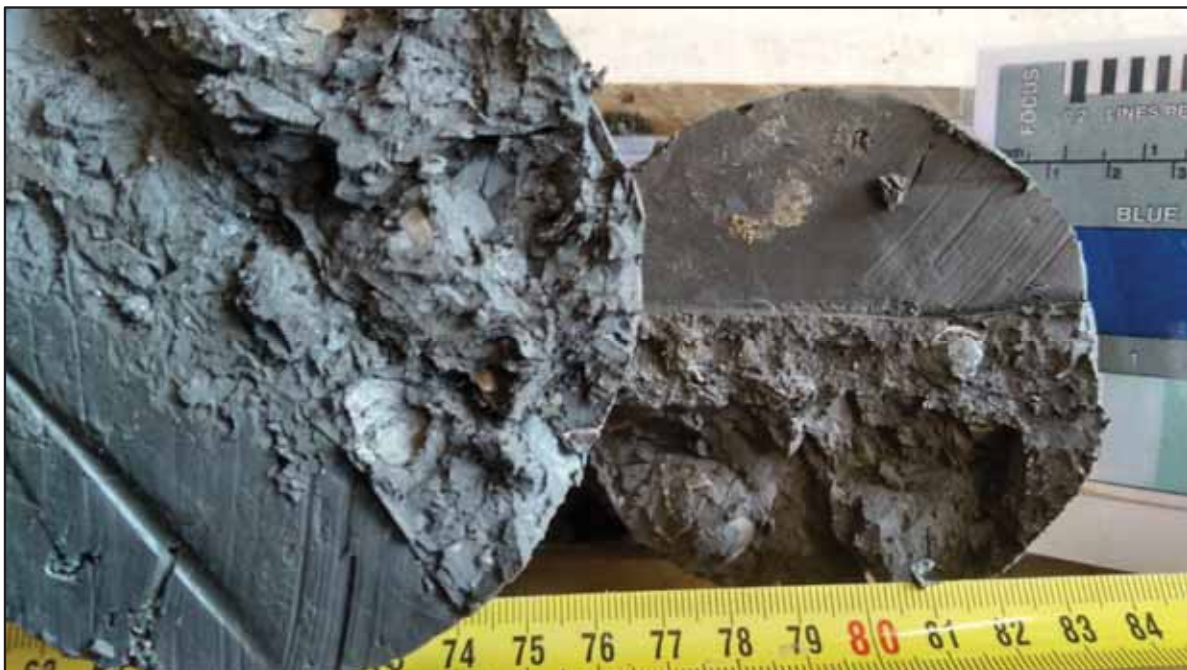
BH2, 7.80, example of bivalve fossil fragments near base of Kellaways Clay Member.

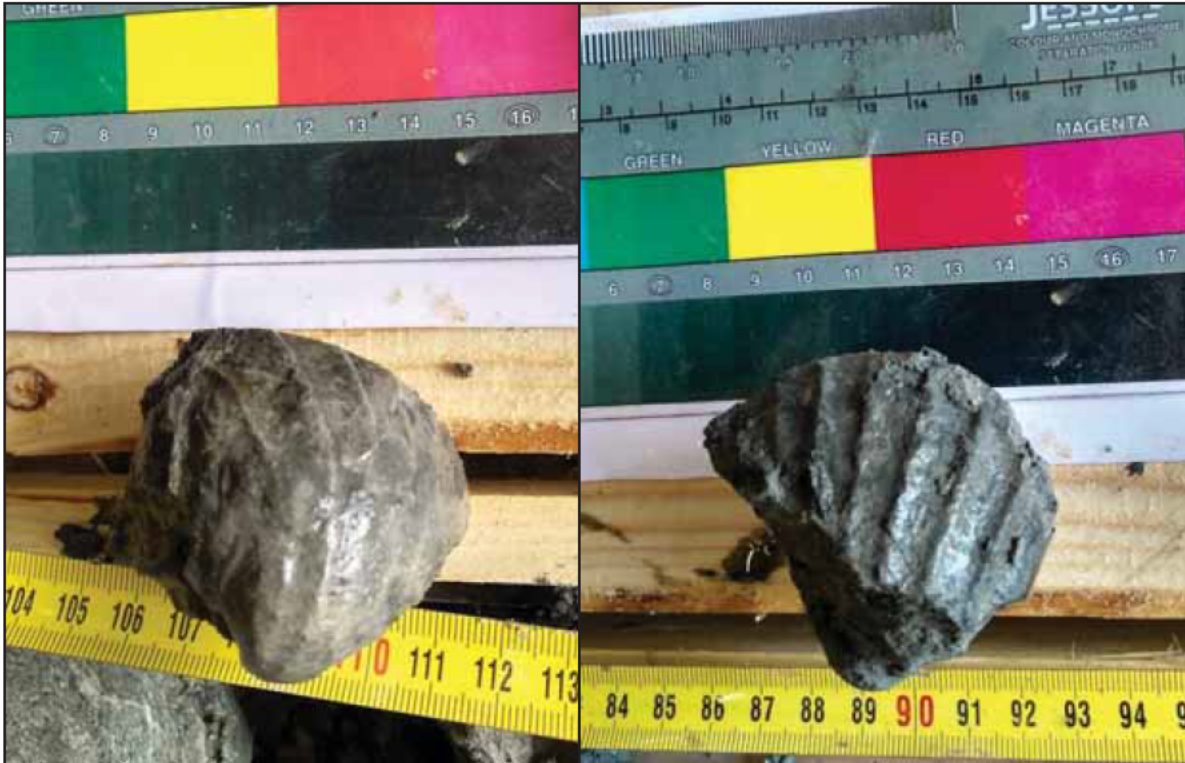
BH2, 9.90m, coarse gravel size cordiid bivalve (with both halves) in Cornbrash Formation.

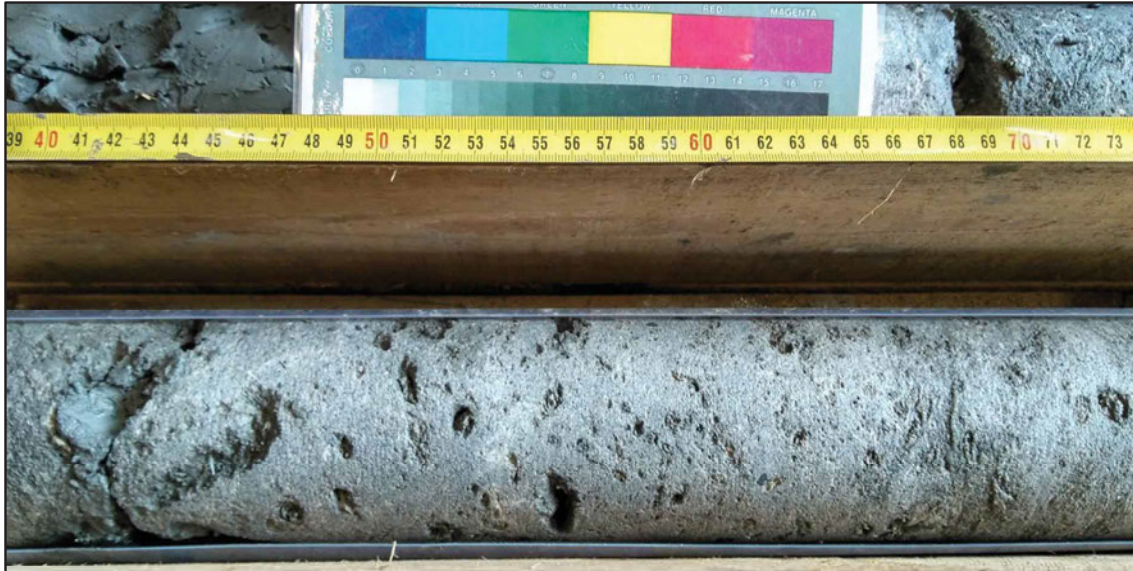
BH3, 10.40m-10.70, bioturbation/bivalve burrows in Cornbrash Formation.

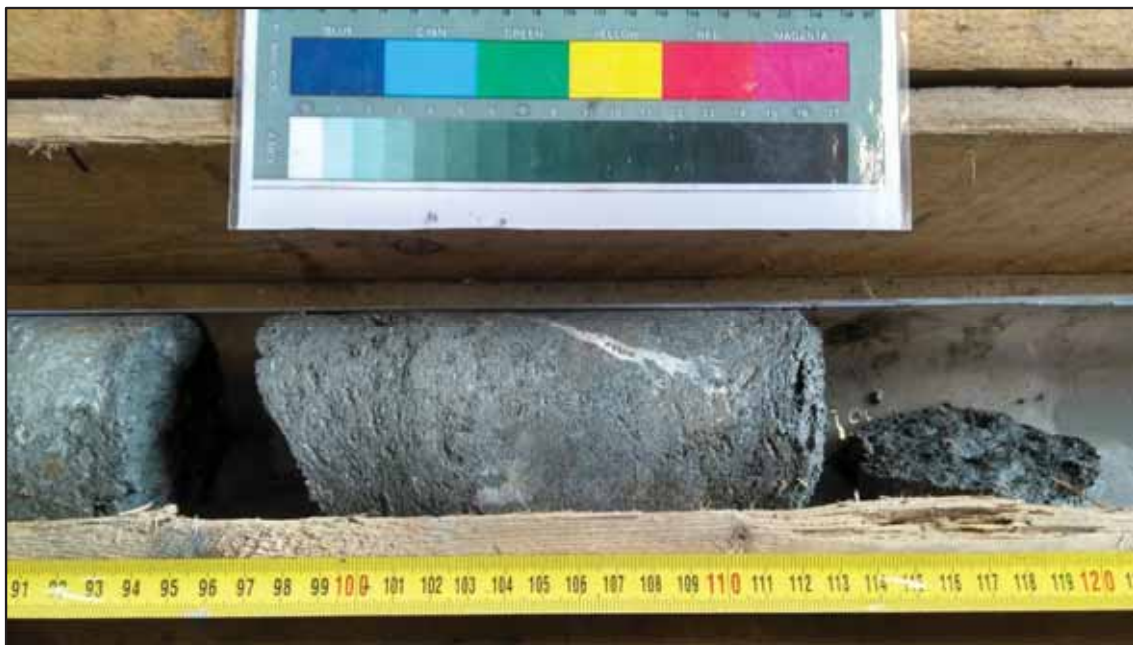
BH2, 10.00-10.10m, calcite veins near base of Cornbrash Formation

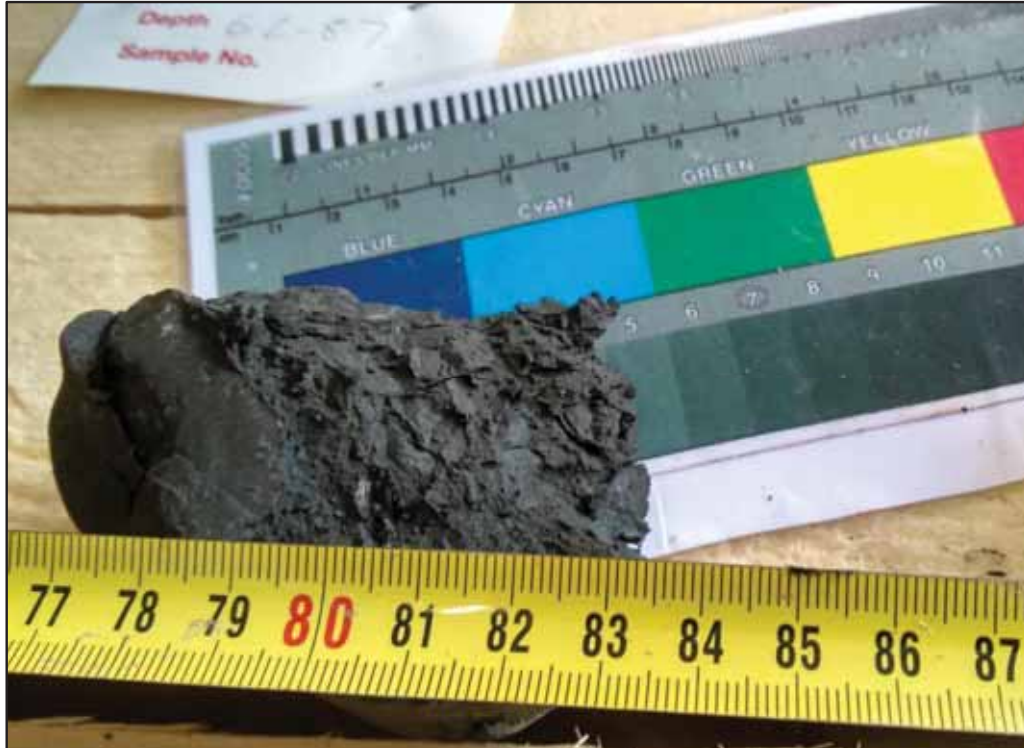
BH4, 6.80m, example of close fissures in Kellaways Clay Member

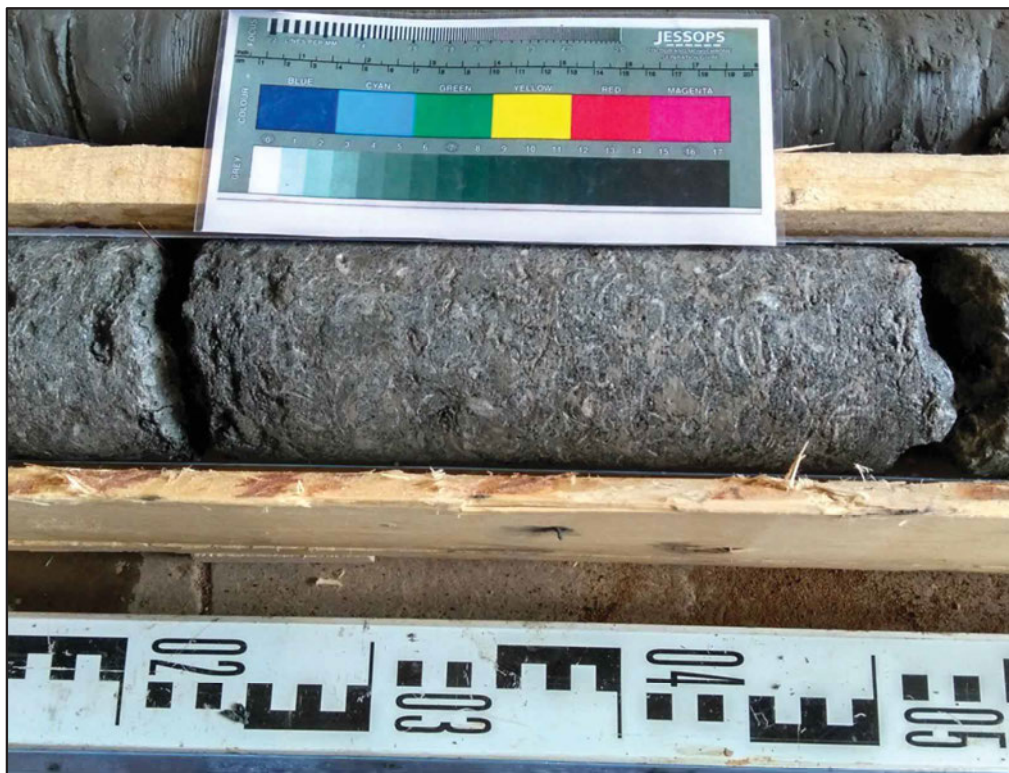
BH4, 8.45-8.70m, abundant bivalves in Cornbrash Formation

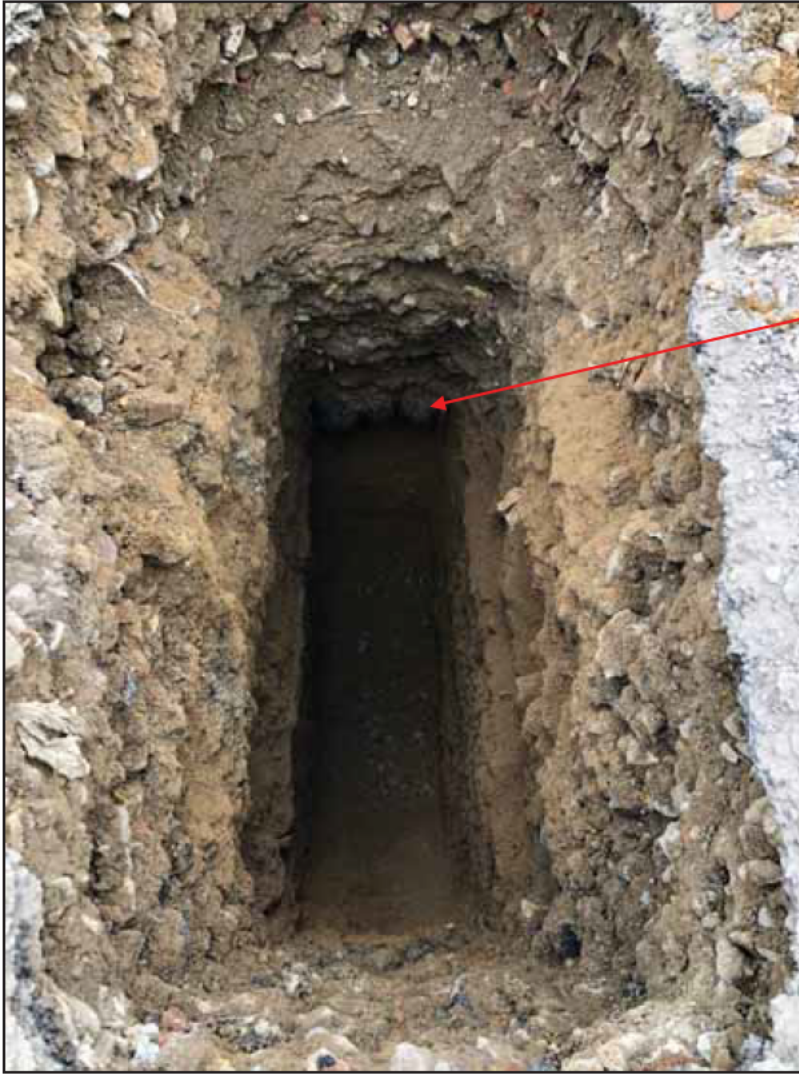
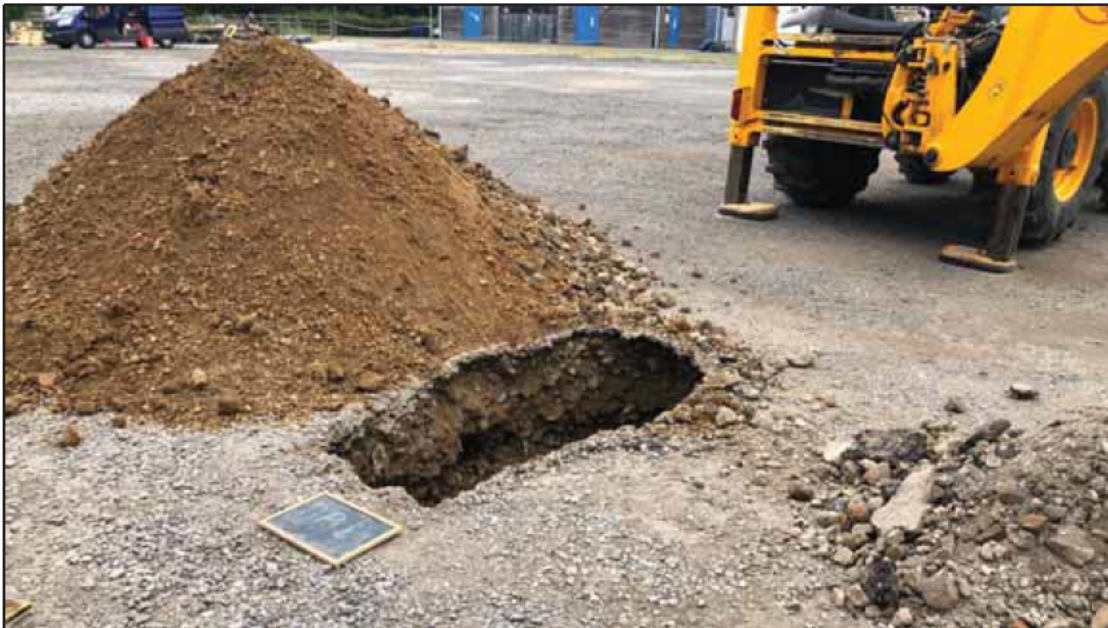
Trial Pit TP1 Photographs

Woven geotextile layer
with thin clay layer
above.

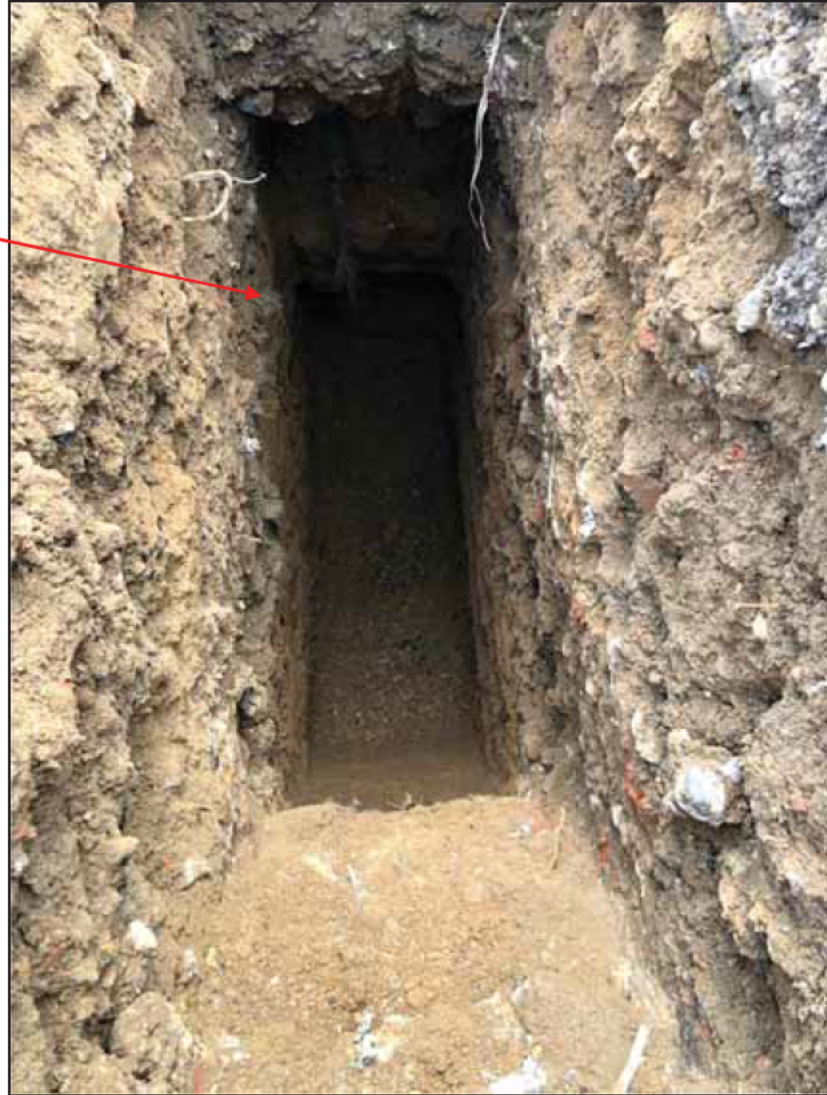
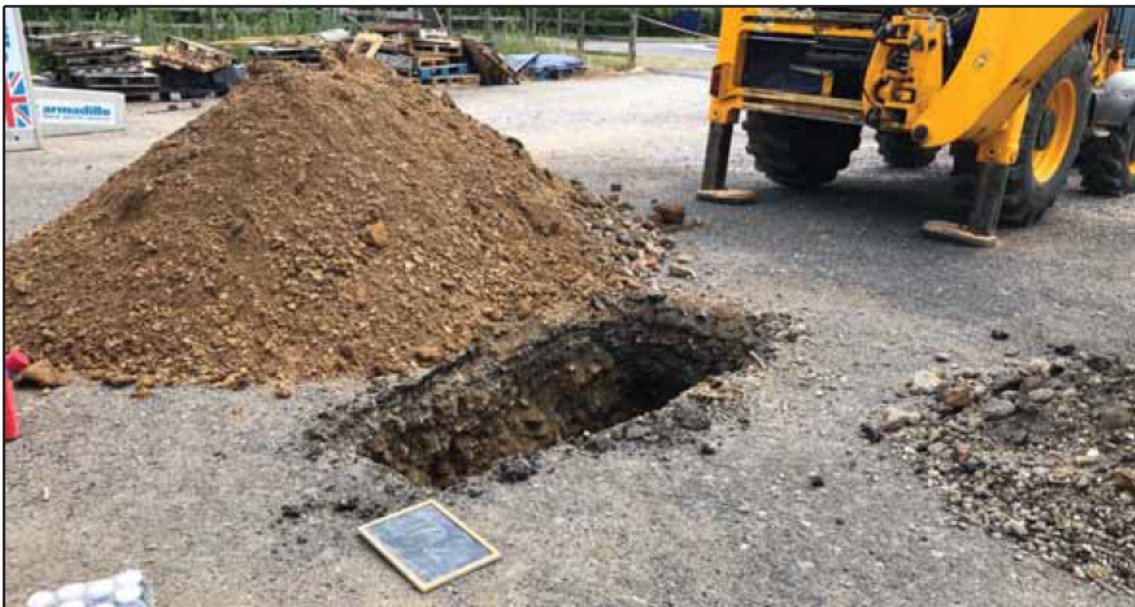
Trial Pit TP2 Photographs

Woven geotextile layer
with thin clay layer
above.

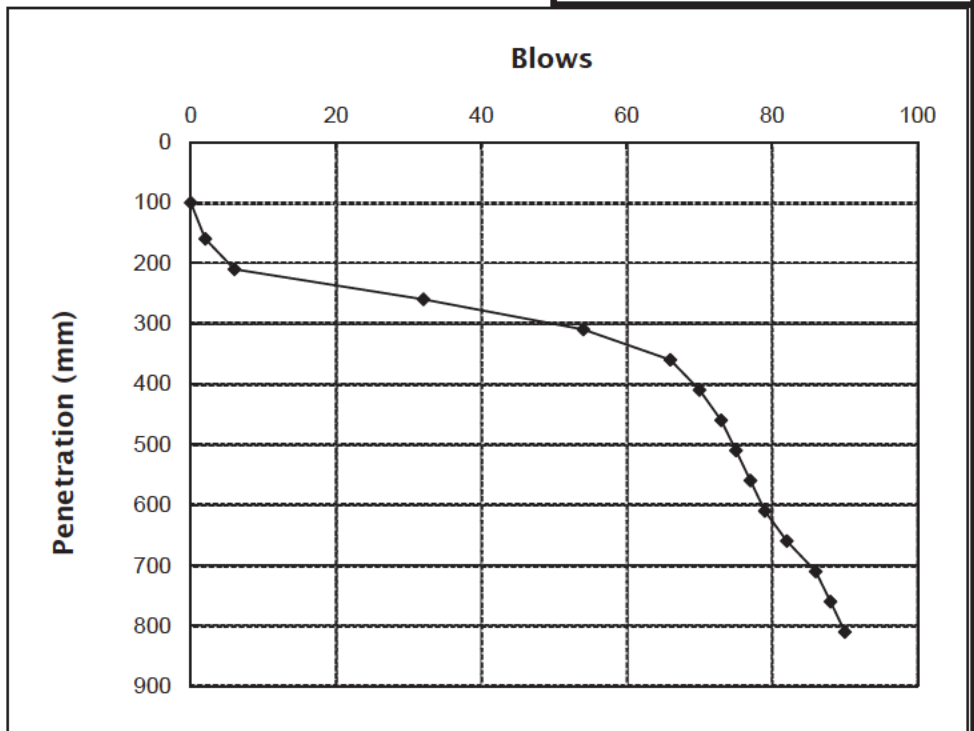
Blows	Pen.
0	100
2	160
6	210
32	260
54	310
66	360
70	410
73	460
75	510
77	560
79	610
82	660
86	710
88	760
90	810
93	860
95	910
97	960
99	990
