# Kirtlington Conservation Area Appraisal September 2011

Planning, Housing and Economy

*Cherwell*  
DISTRICT COUNCIL  
NORTH OXFORDSHIRE

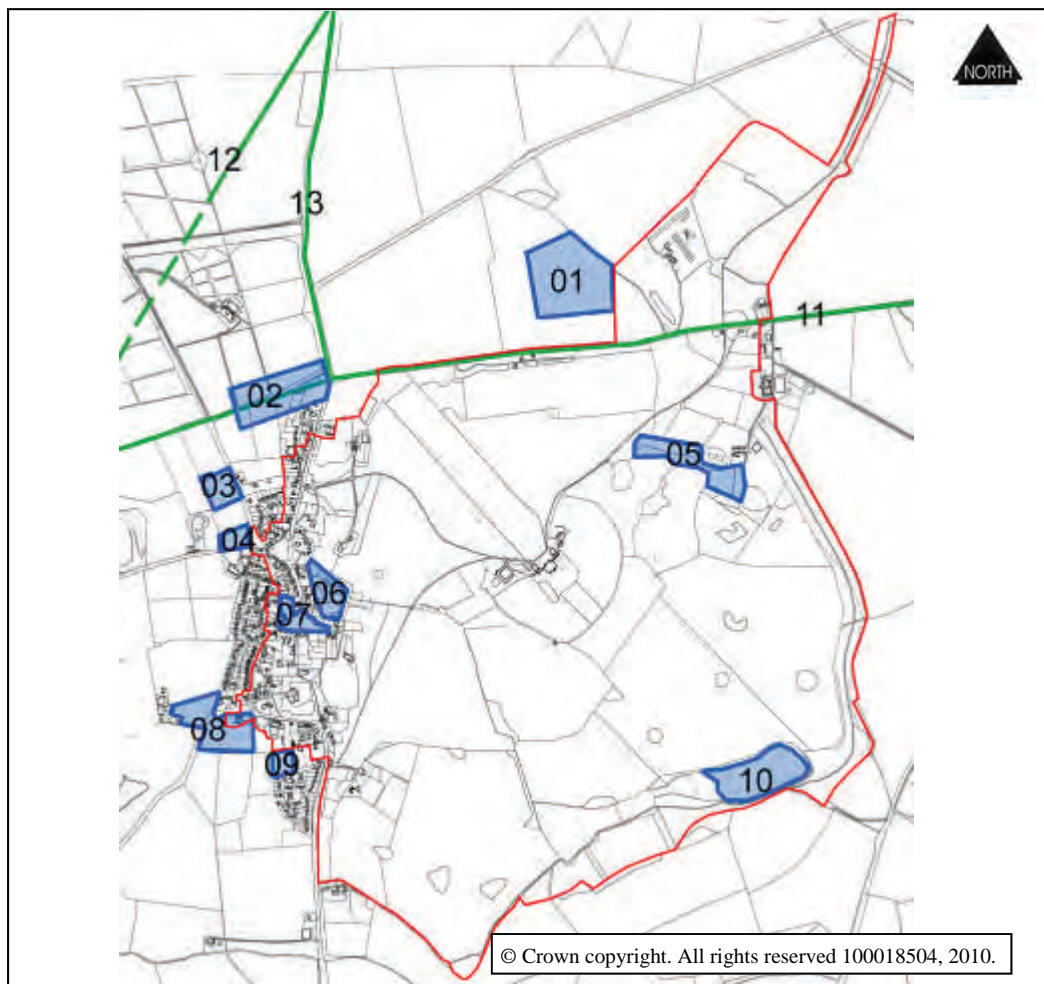
Figure 7: Archaeological Map of Kirtlington

The majority of the conservation area lies in an area of local archaeological interest, which includes the historic village core and Kirtlington Park. The area highlighted as number 6 to the east of the present school is a Scheduled Ancient Monument and contains medieval earthworks, a moat and fishponds. It is thought to be the site of a medieval manor house.

- 01:** Findspot - Neolithic polished stone axe
- 02:** Two Saxon burials, Iron Age settlement and pottery
- 03:** Roman Pottery, Skeletons and Coins
- 04:** Old Quarries
- 05:** Medieval or Post Medieval fishpond, lime kiln and quarry
- 06:** Moated site, supposed site of John of Gaunt's residence
- 07:** Undated ditch and three Post Medieval pits and wall
- 08:** Toll house and Medieval shrunken village
- 09:** Saxon settlement and Roman field system
- 10:** Undated fishpond
- 11:** Akeman Street, Roman Road
- 12:** Portway Roman Road
- 13:** Aves Ditch/ Ash Bank/ Wattle Bank Roman Road

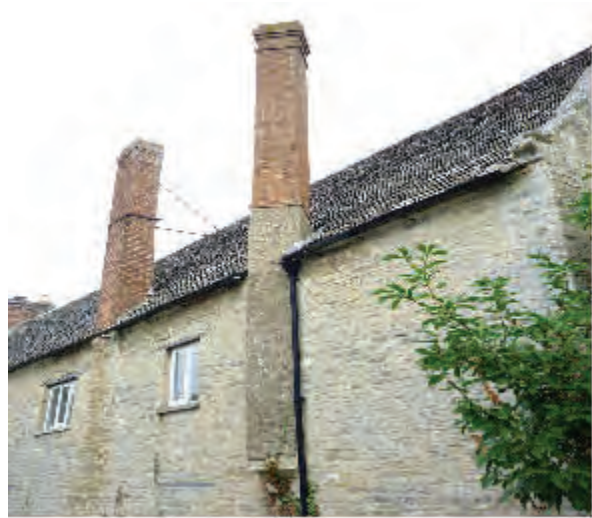
There is great consistency in that all traditional buildings have chimneys and most are red brick on ridge and internal. Some blue brick detailing evident and a few rendered or stone chimneys, but these are rare. There are notable stacks on Dashwood Hotel, indicative of the status of the building.

*External chimney at the Manor House*

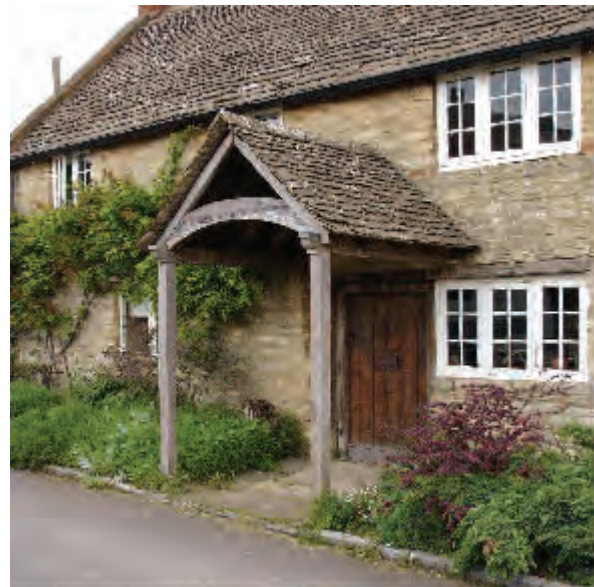
Front elevations lining the main street are generally uncluttered as very few porches are in evidence. Where they do appear both open and closed gables with timber supports are found and there are flat roofed canopies. There are some notable porches of significant size e.g. The Old Bakehouse, which is in a prominent position. Solid storm porches constructed of local stone are generally later additions.

*Porch on the Old Bakehouse.*

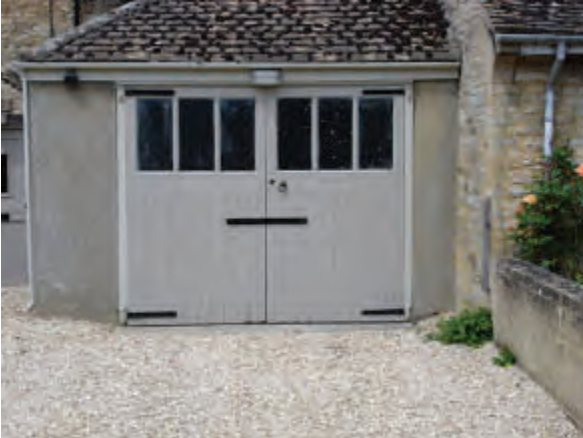
There are some well mannered integral timber garage doors on street frontage, notably adjacent to Rose Cottage on North Green.

*Vertically hung timber garage doors.*

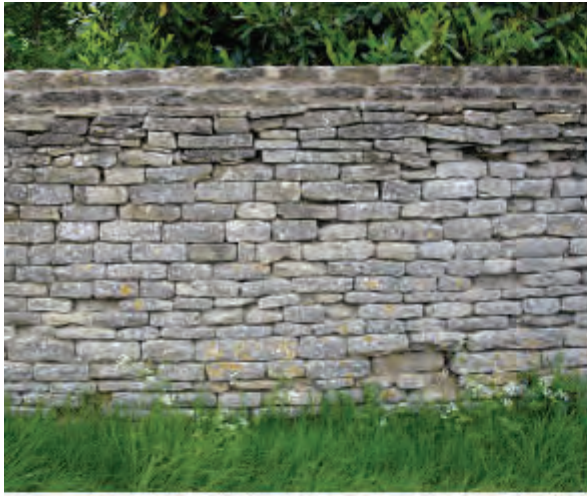
*Mortared stone course forms coping*

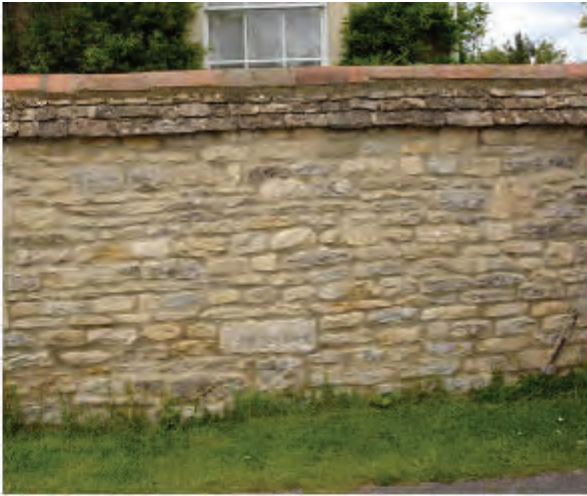
*Tiles and stone slates form coping*

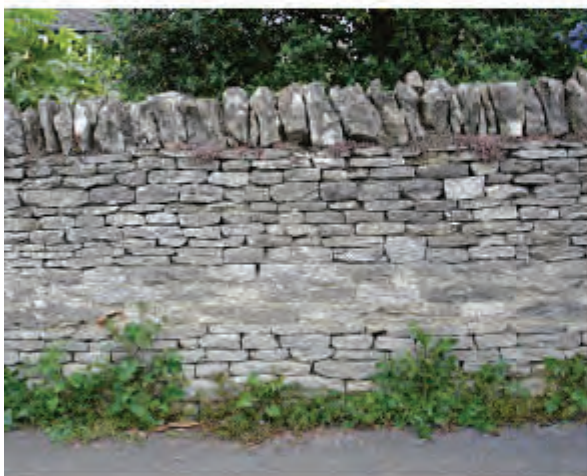
*Stone laid on edge forms coping*

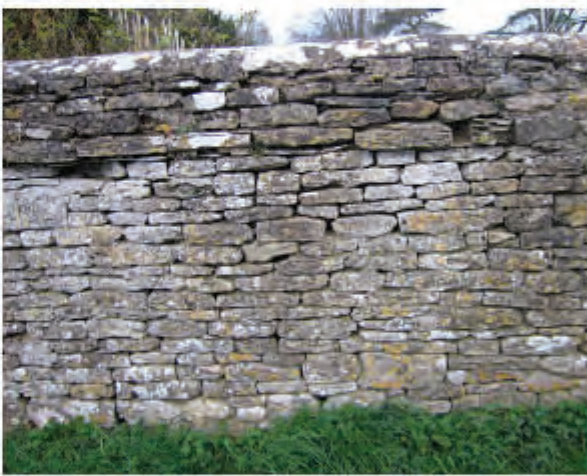
*Heaped mortar forms coping*

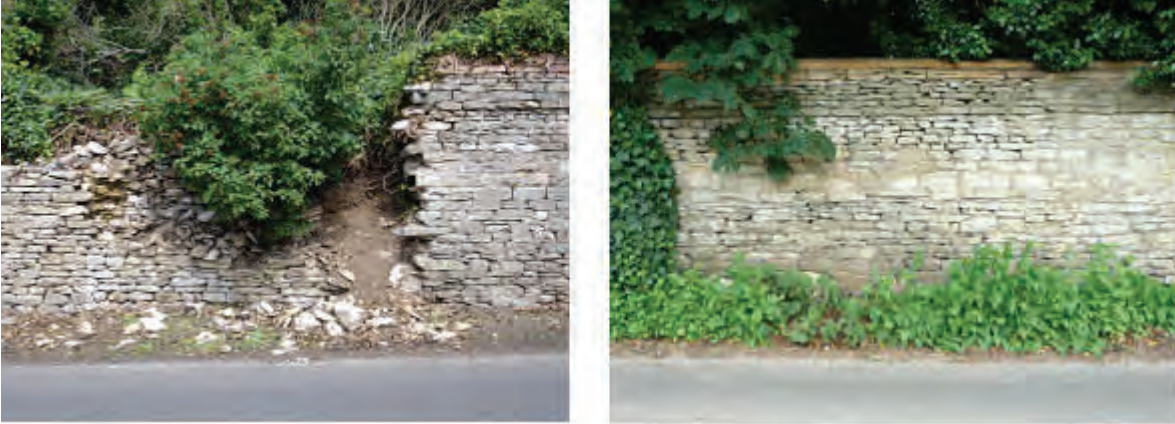
<p><i>Traditional and suitable repair of boundary wall on Bletchingdon Road.</i></p>		
	<ul style="list-style-type: none"> <li>• Encourage owners of historic properties to replace inappropriate modern with the appropriate traditional materials.</li> <li>• Promote tradition styles of pointing and the use of lime mortar.</li> <li>• Only approve new alterations and extensions that are sympathetic to the existing buildings in scale, materials and design.</li> <li>• Require satellite dishes, solar panels, photo voltaic panels and micro turbines be located on rear elevations or within rear gardens.</li> <li>• Exercise a presumption against artificial cladding material, including render on the front elevations of buildings.</li> </ul>	<p>CDC and Property Owners</p> <p>CDC and Property Owners</p> <p>CDC and Property Owners</p> <p>CDC and Property Owners</p> <p>CDC and Property Owners</p>

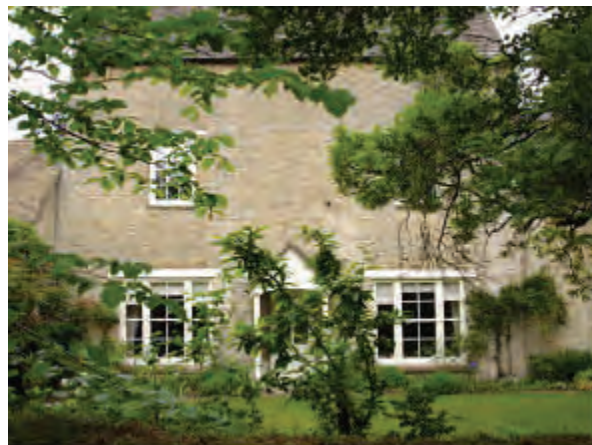
*Foxtownsend Farmhouse*

Farmhouse, now house. Early C17, altered and extended C18. Limestone rubble with squared quoins and wooden lintels; Stonesfield-slate and Welsh-slate roofs. L-plan with subsidiary wings. 2 storeys plus attic and storeys. 2-window front of main range has a central doorway between tripartite sashes and has 12-pane sashes at first floor. Right gable has a leaded attic casement. Roof has rubble stacks to both gables. 2-window C18 service range, to right, is lower with a slate roof and has 2-light casements. Rear wing, returning on left, is as tall as the main range and has a deep plinth, a stone gable parapet to rear, and a further gable facing left from which rises a large rubble stack. Interior: wide ovolo-moulded 4-centre arched stone fireplace with rectangular surround; fine oak dog-leg stair, rising to attics, with moulded handrail, heavy turned balusters, and ball finials.

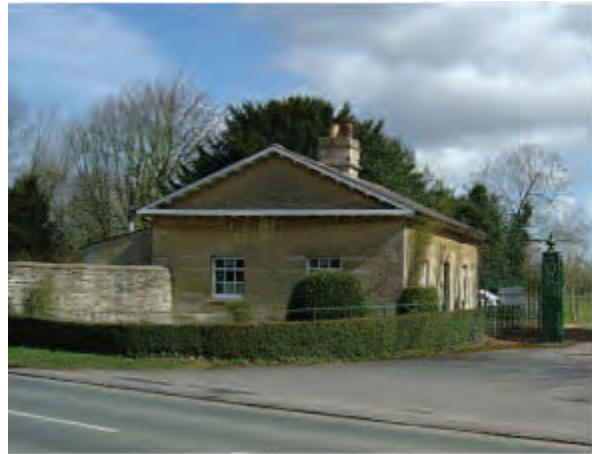
*Lodge*

Lodge and gates. Early/mid C19, extended C20. Limestone ashlar; Welsh-slate roof with ashlar ridge stack. Double-depth plan with small rear addition. Single storey. Symmetrical 2-window front has 6-panel door between 9-pane sashes; both ends have pairs of similar sashes. Shallow-pitched roof has overhanging boxed eaves with wooden brackets, continued across the gables and around the verges to form pediments. Interior not inspected. Cast-iron gates, with quatrefoil bands, have open work piers in ornamental trellis patterns with decorated ball finials, and are linked to lodge by railings and a subsidiary gate.

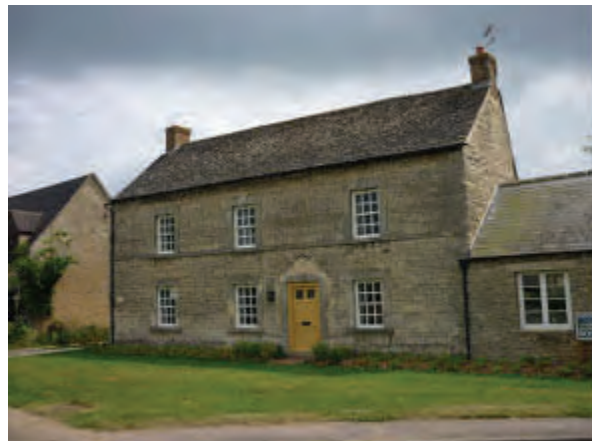
*Myrtle Cottage*

House. Substantially altered in 1759 which is marked by a datestone. Original cottage thought to be earlier. Coursed squared limestone with ashlar dressings: Stonesfield-slate roof with brick gable stacks, 3-unit plan with subsidiary bay. 2 storeys and one storey. Regular 3-window front of main range has a stone-architraved 6-panel door in a glazed porch, to right of centre, and has, at both floors, 3 small 12-pane sashes with wide plain architraves and projecting keyblocks; architraves of upper windows drop below a sill band. Datestone above doorway is inscribed "MY/1759". Remodelled single-storey bay to right is part of an earlier structure. Rear of main range has full-height projection.

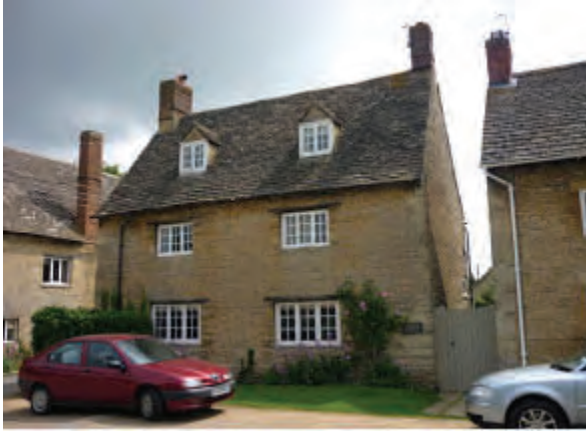
*The Green Cottage/ Church Cottage*

House, formerly subdivided. Mid C17. Coursed squared limestone with wooden lintels; Stonesfield-slate roof with brick gable stacks. 2-unit plan. 2 storeys plus attic. Regular 2-window front has 3-light casements at both floors, the lower wider, all with richly-moulded lintel with carved chamfer stops. Roof has 2 gabled roof dormers. Entrance to rear. Linked to converted outbuilding range to rear. Interior: large open fireplace with moulded stone jambs; winder stair.

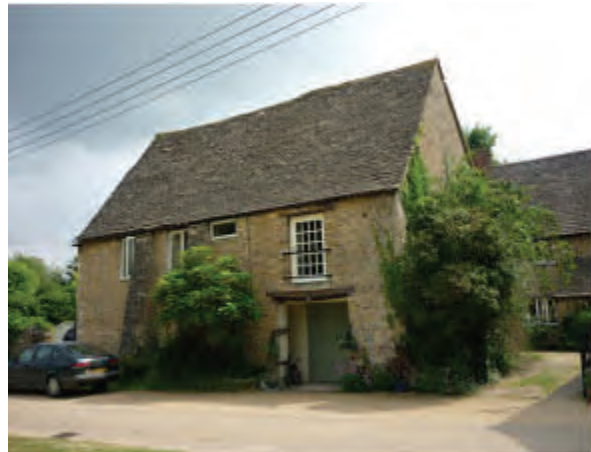
*The Coach House*

Stables, now house. Probably C17. Coursed limestone rubble with squared quoins and wooden lintels; Stonesfield-slate roof. 2 storeys. Front has, to extreme right, a converted loft door above a wide entrance, and there are 2 inserted C20 windows at first floor plus 2 large C20 buttresses. Gable walls have pairs of blocked openings to both floors. Interior not inspected. Building forms fourth side of courtyard to Manor House (q.v.). Included for group value.

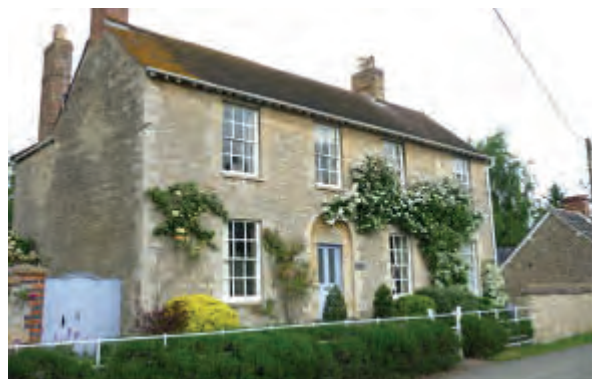
*The Old Vicarage*

Vicarage, now house. Late C18/early C19, extended mid C19. Coursed limestone rubble with ashlar dressings; old plain-tile and Welsh-slate roofs with brick stacks. Central-stair plan, extended. 2 storeys. Symmetrical 3-window front of earliest section has 12-pane sashes below ashlar flat arches, and a central doorway recessed into a shallow semi-circular arch. Added bay to right has a similar sash at first floor. Parallel rear wings with large windows have shallow gable parapets and bear the date 1862. Interior not inspected. Replaced as the vicarage in 1840.

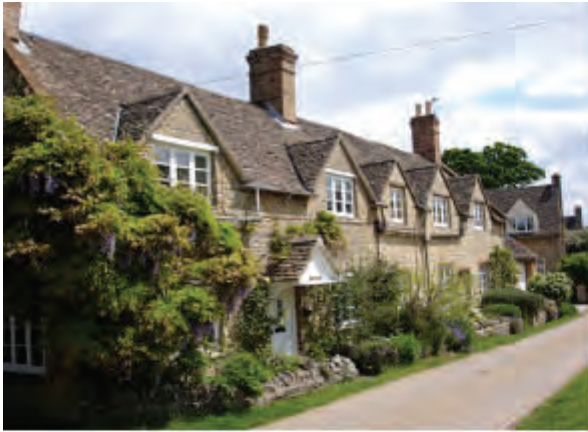
*Gable Cottage and Vine Cottage*

A row of estate cottages, now two residential properties located on south green, with date stone of 1906. The buildings have striking front gables, constructed in stone with slate tiles.
