Arboricultural Implications Assessment and Method Statement

THE OLD VICARAGE, FRINGFORD ROAD, CAVERSFIELD

Report Ref: **191199 - AIA**

Report Date: **13 September 2019**

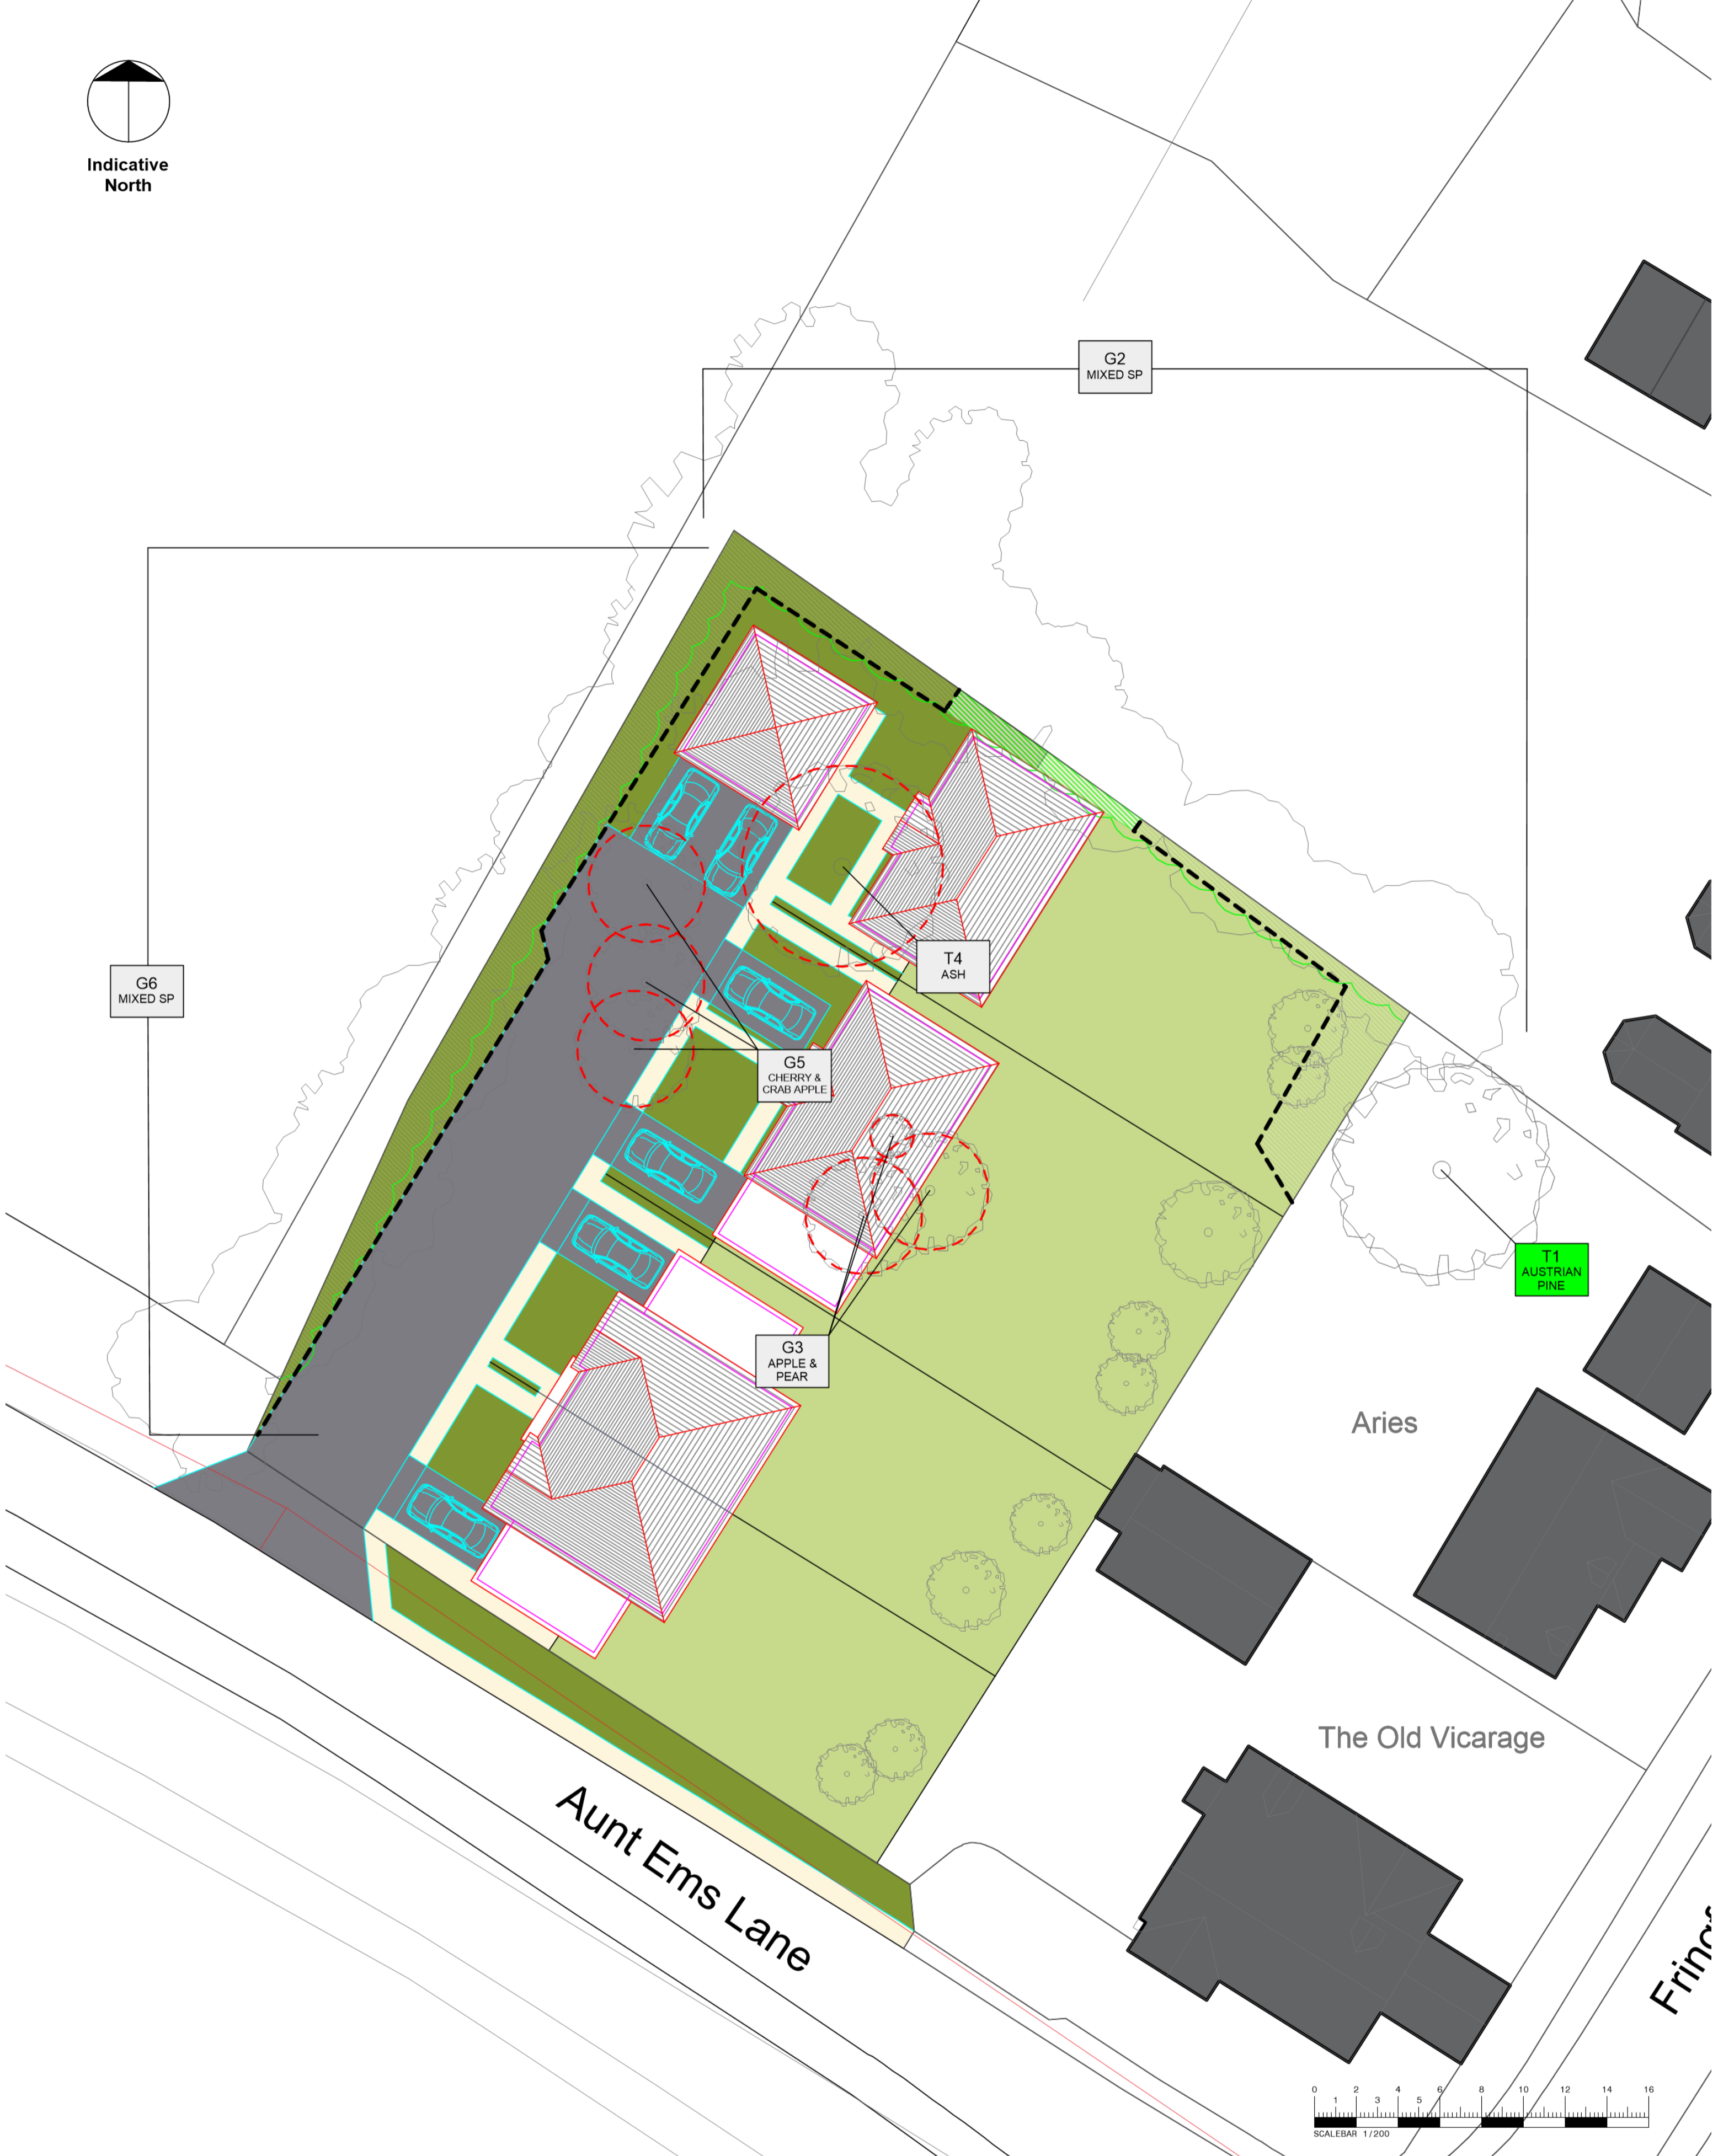
1 A2 plan

- 1.4 **The Tree Protection Plan:** This is included in Appendix 1 and is a composite drawing derived from the information provided. It shows the existing site configuration in grey superimposed over the proposed layout shown in colour. This allows the relationship between the two to be clearly seen and an appropriate analysis of the implications of the proposed site changes to be undertaken. The Tree Protection Plan has also been annotated to show protection measures for the trees that could realistically be affected by the proposed development. It shows any activities in Root Protection Areas (RPAs) and if any trees are to be removed, they are shown with a red dashed crown outline.

ECO 2 - TREE ISSUES AT THE OLD VICARAGE, FRINGFORD ROAD, CAVERSFIELD

COMPOSITE PLAN: CURRENT CONFIGURATION AND PROPOSED LAYOUT

5.1.1 **Tree Protection Plan (TPP):** The plan in Appendix 1 is illustrative, but is based on the layout drawings and topographical survey provided. Therefore, all scaled measurements should be checked against the original design documents. The attached plan and all other information in this report should only be used for dealing with the tree protection issues and all other uses are prohibited, unless authorised by Ecourban Ltd. All the existing trees will have been numbered, with any higher categories (A and B) highlighted in green and blue rectangles and any low categories (C and U) highlighted in grey and red respectively. The plan also shows the locations of the proposed protective measures and any trees to be removed are indicated with a red dashed crown outline. The TPP is an important document and a copy of it should be kept on site for reference whilst the development is under construction.

5.1.2 **Protective barriers:** The approximate location of the barriers is illustrated on the plan in Appendix 1 and information on barrier design based on BS 5837 (2012) guidance is included in Appendix 3. The protective barriers will be erected before any materials or machinery are brought onto the site, and before any clearance or construction activities occur. Once the protective barriers have been positioned, these will stay in situ for the duration of the construction, unless previously agreed with the arboricultural consultant or council's tree officer. There will be no access into the protected areas and the storage of excavated debris and building materials will be prohibited in RPAs, unless authorised by the arboricultural consultant, after discussion with the council's tree officer. No fires or fuel storage will be allowed within or near to protected areas under any circumstances.

5.1.3 **Ground protection measures:** Where the positioning of tree protection barriers is not feasible due to the need for construction access, then ground protection measures will be needed to safeguard RPAs. The position of ground protection is shown on the plan included in Appendix 1, with guidance for ground protection design from BS 5837 (2012) included in Appendix 4. The ground protection will be installed before any materials or machinery are brought onto the site, and before any clearance or construction activities

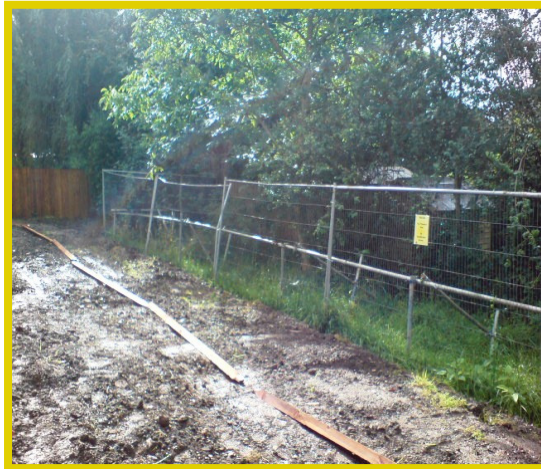
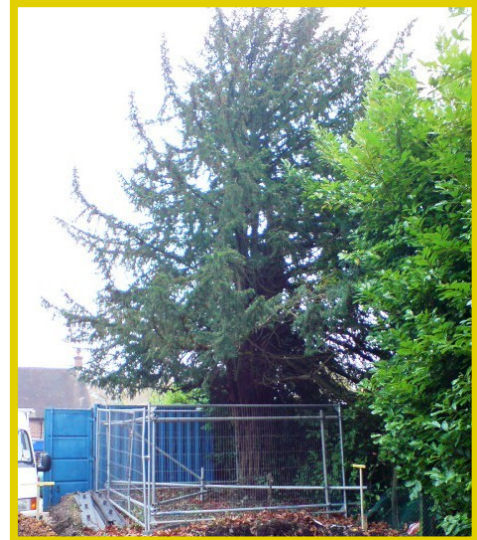
Ref: Tree Protection Barriers (Type 1)	Drawing No. TPB1
Scale: N/A

- 1 Standard scaffold poles
- 2 Heavy gauge 2 m tall galvanized tube and welded mesh infill panels
- 3 Panels secured to uprights and cross-members with wire ties
- 4 Ground level
- 5 Uprights driven into the ground until secure (minimum depth 0.6 m)
- 6 Standard scaffold clamps

The default specification should consist of a vertical and horizontal scaffold framework, well braced to resist impacts. The vertical tubes should be spaced at a maximum interval of 3 m and driven securely into the ground. Onto this framework, welded mesh panels should be securely fixed.

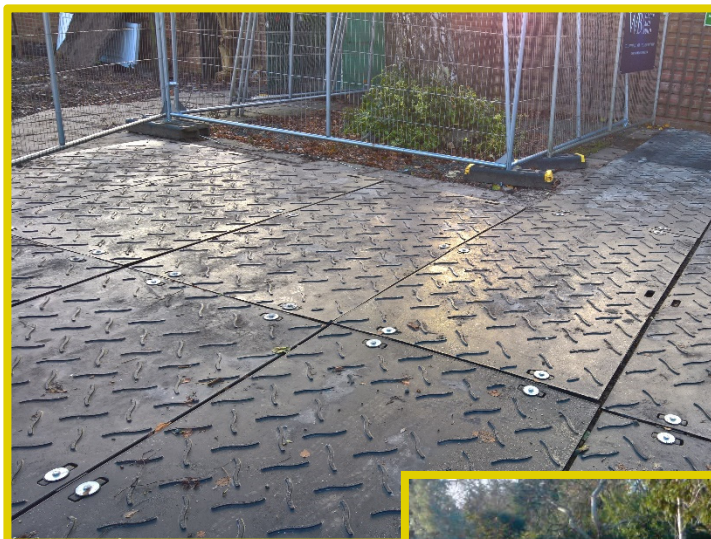
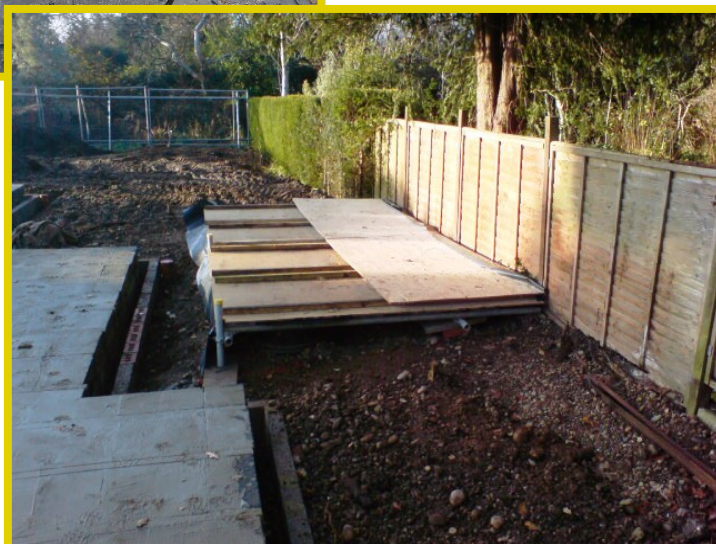
Ref: Ground Protection	Drawing No. GP1
Scale: N/A

New temporary ground protection should be capable of supporting any traffic entering or using the site without being distorted or causing compaction of underlying soil.

- a) for pedestrian movements only, a single thickness of scaffold boards placed either on top of a driven scaffold frame (**Photograph 1**), so as to form a suspended walkway, or on top of a compression-resistant layer (e.g. 100 mm depth of woodchip), laid onto a geotextile membrane;*
- b) for pedestrian-operated plant up to a gross weight of 2 t, proprietary, inter-linked ground protection boards (**Photograph 2**), placed on top of a compression-resistant layer (e.g. 150 mm depth of woodchip), laid onto a geotextile membrane;*
- c) for wheeled or tracked construction traffic exceeding 2 t gross weight, an alternative system (e.g. proprietary systems or pre-cast reinforced concrete slabs) to an engineering specification designed in conjunction with arboricultural advice, to accommodate the likely loading to which it will be subjected.*

occur. In this instance it is proposed that the ground protection will consist of closely spaced scaffold boards over a compressible woodchip layer. Again, once the ground protection has been positioned, it will stay in situ for the duration of the construction phase, unless previously agreed with the arboricultural consultant or council's tree officer.
