**Upper Heyford
New Settlement Area
Development for Residential-led Uses
(Planning Consent 10/01642/OUT)**

REMEDIATION STRATEGY

R1742-R01-v3

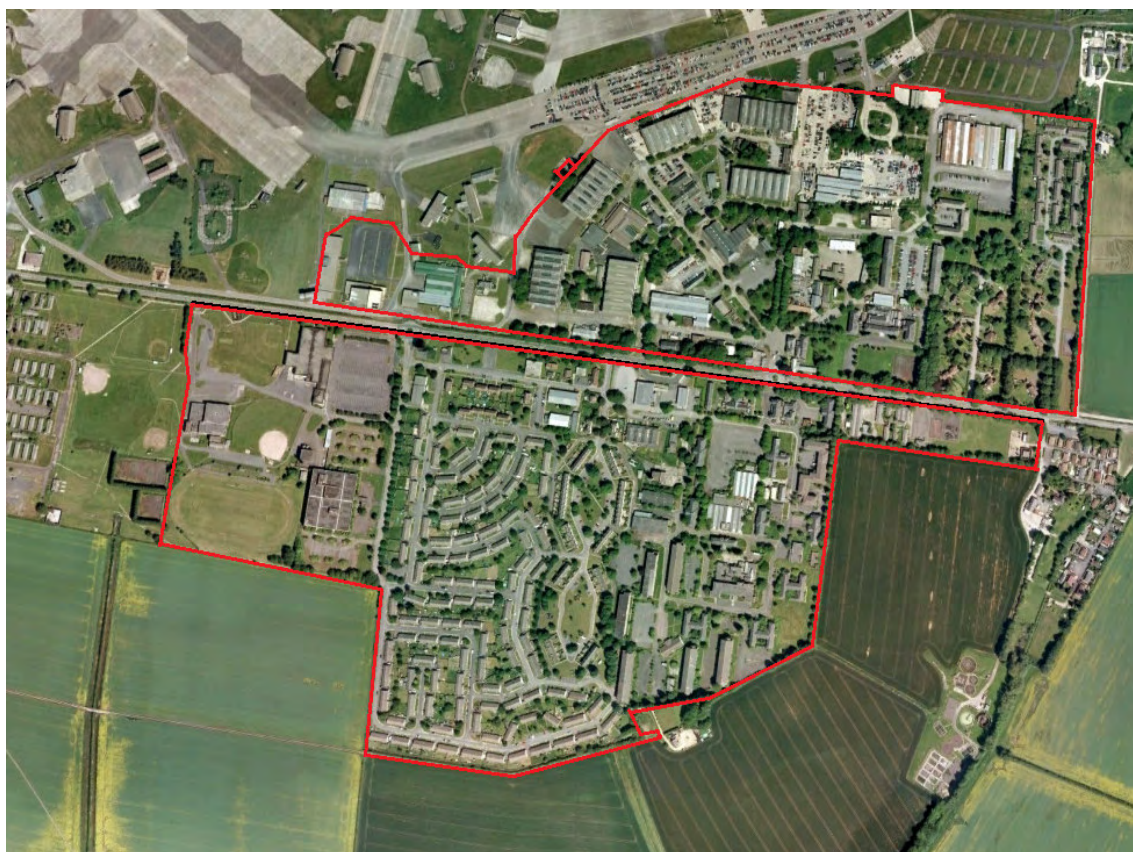
Figure 3.2. Recent Aerial Photograph

3.4.1. The aerial photograph below shows the recent land condition, including a mix of occupied and disused buildings and landscaping / open space.

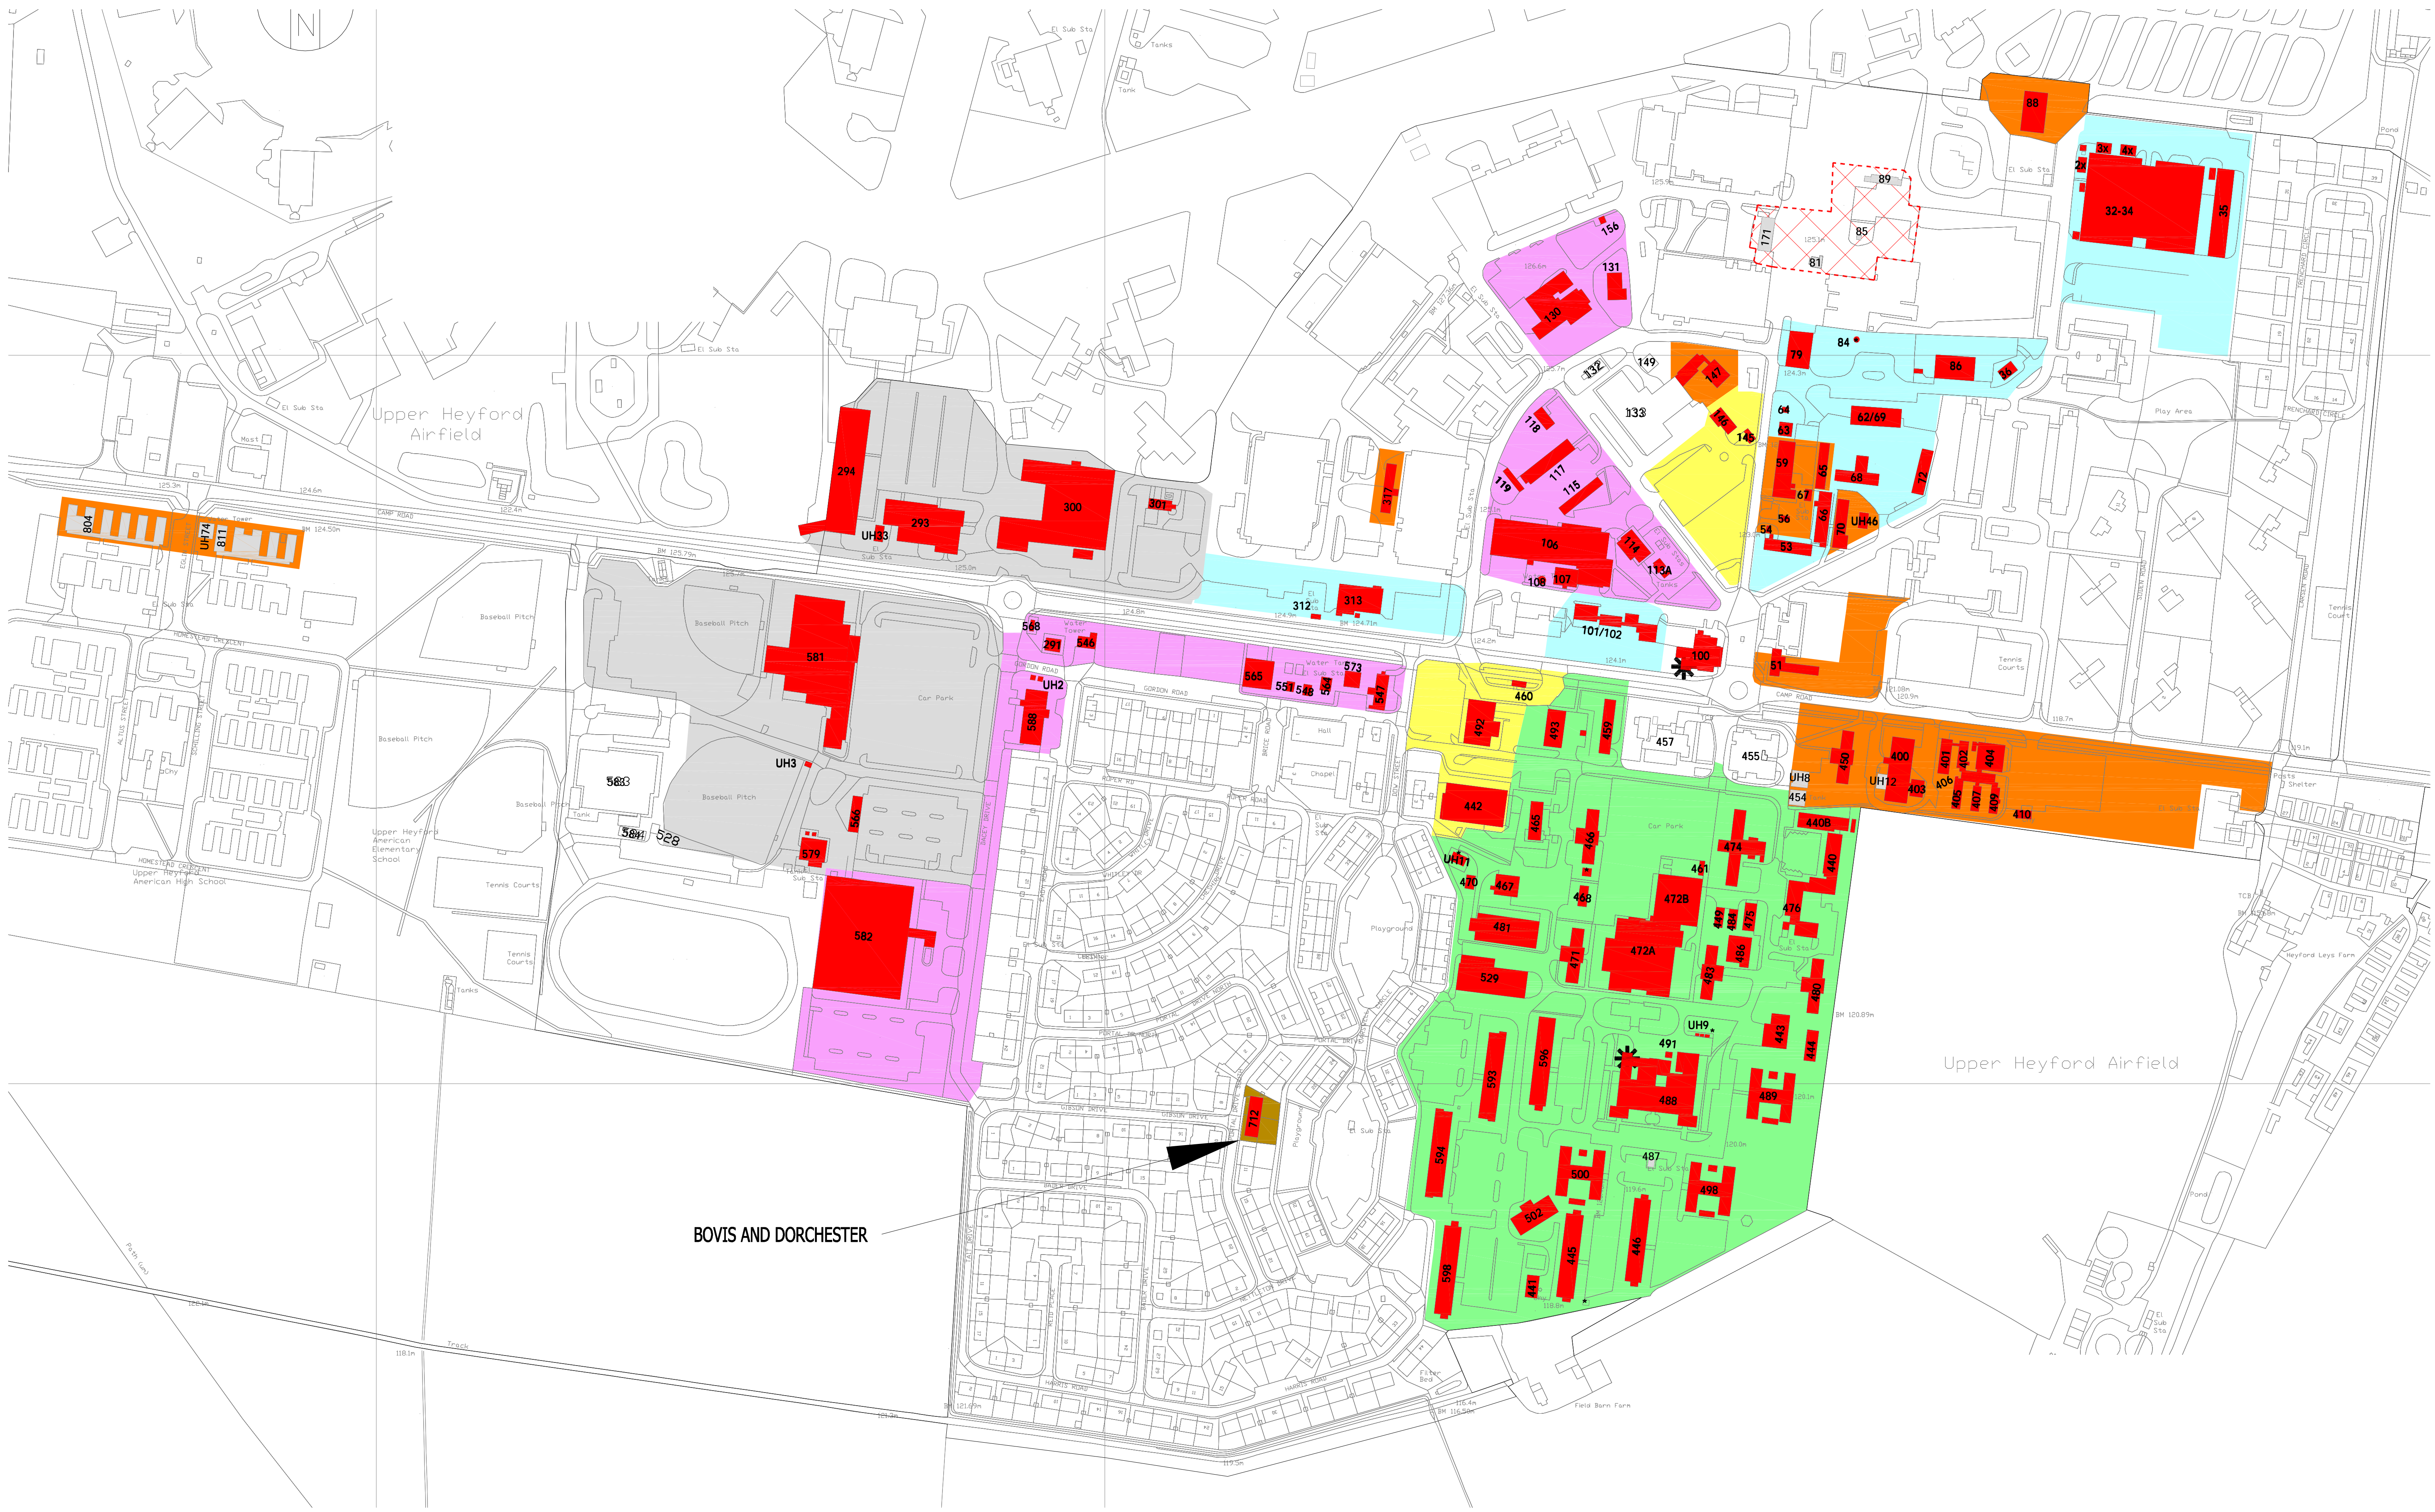
UPPER HEYFORD - DEMOLITION PHASING PLAN

DEMOLITION PHASES

BUILDINGS TO BE DEMOLISHED
