**PROJECT**  
Ivy Cottage  
32 High Street  
Bodicote  
OX15 4BP

**TITLE**  
First Floor Plan Showing  
Proposed Modifications to  
Structure of Attic Floor Above

<b>DRAWING NUMBER</b> 21008/10	<b>REV</b> P4
-----------------------------------	------------------

**First Floor Plan Showing Structure in Floor Above**  
Scale 1:50

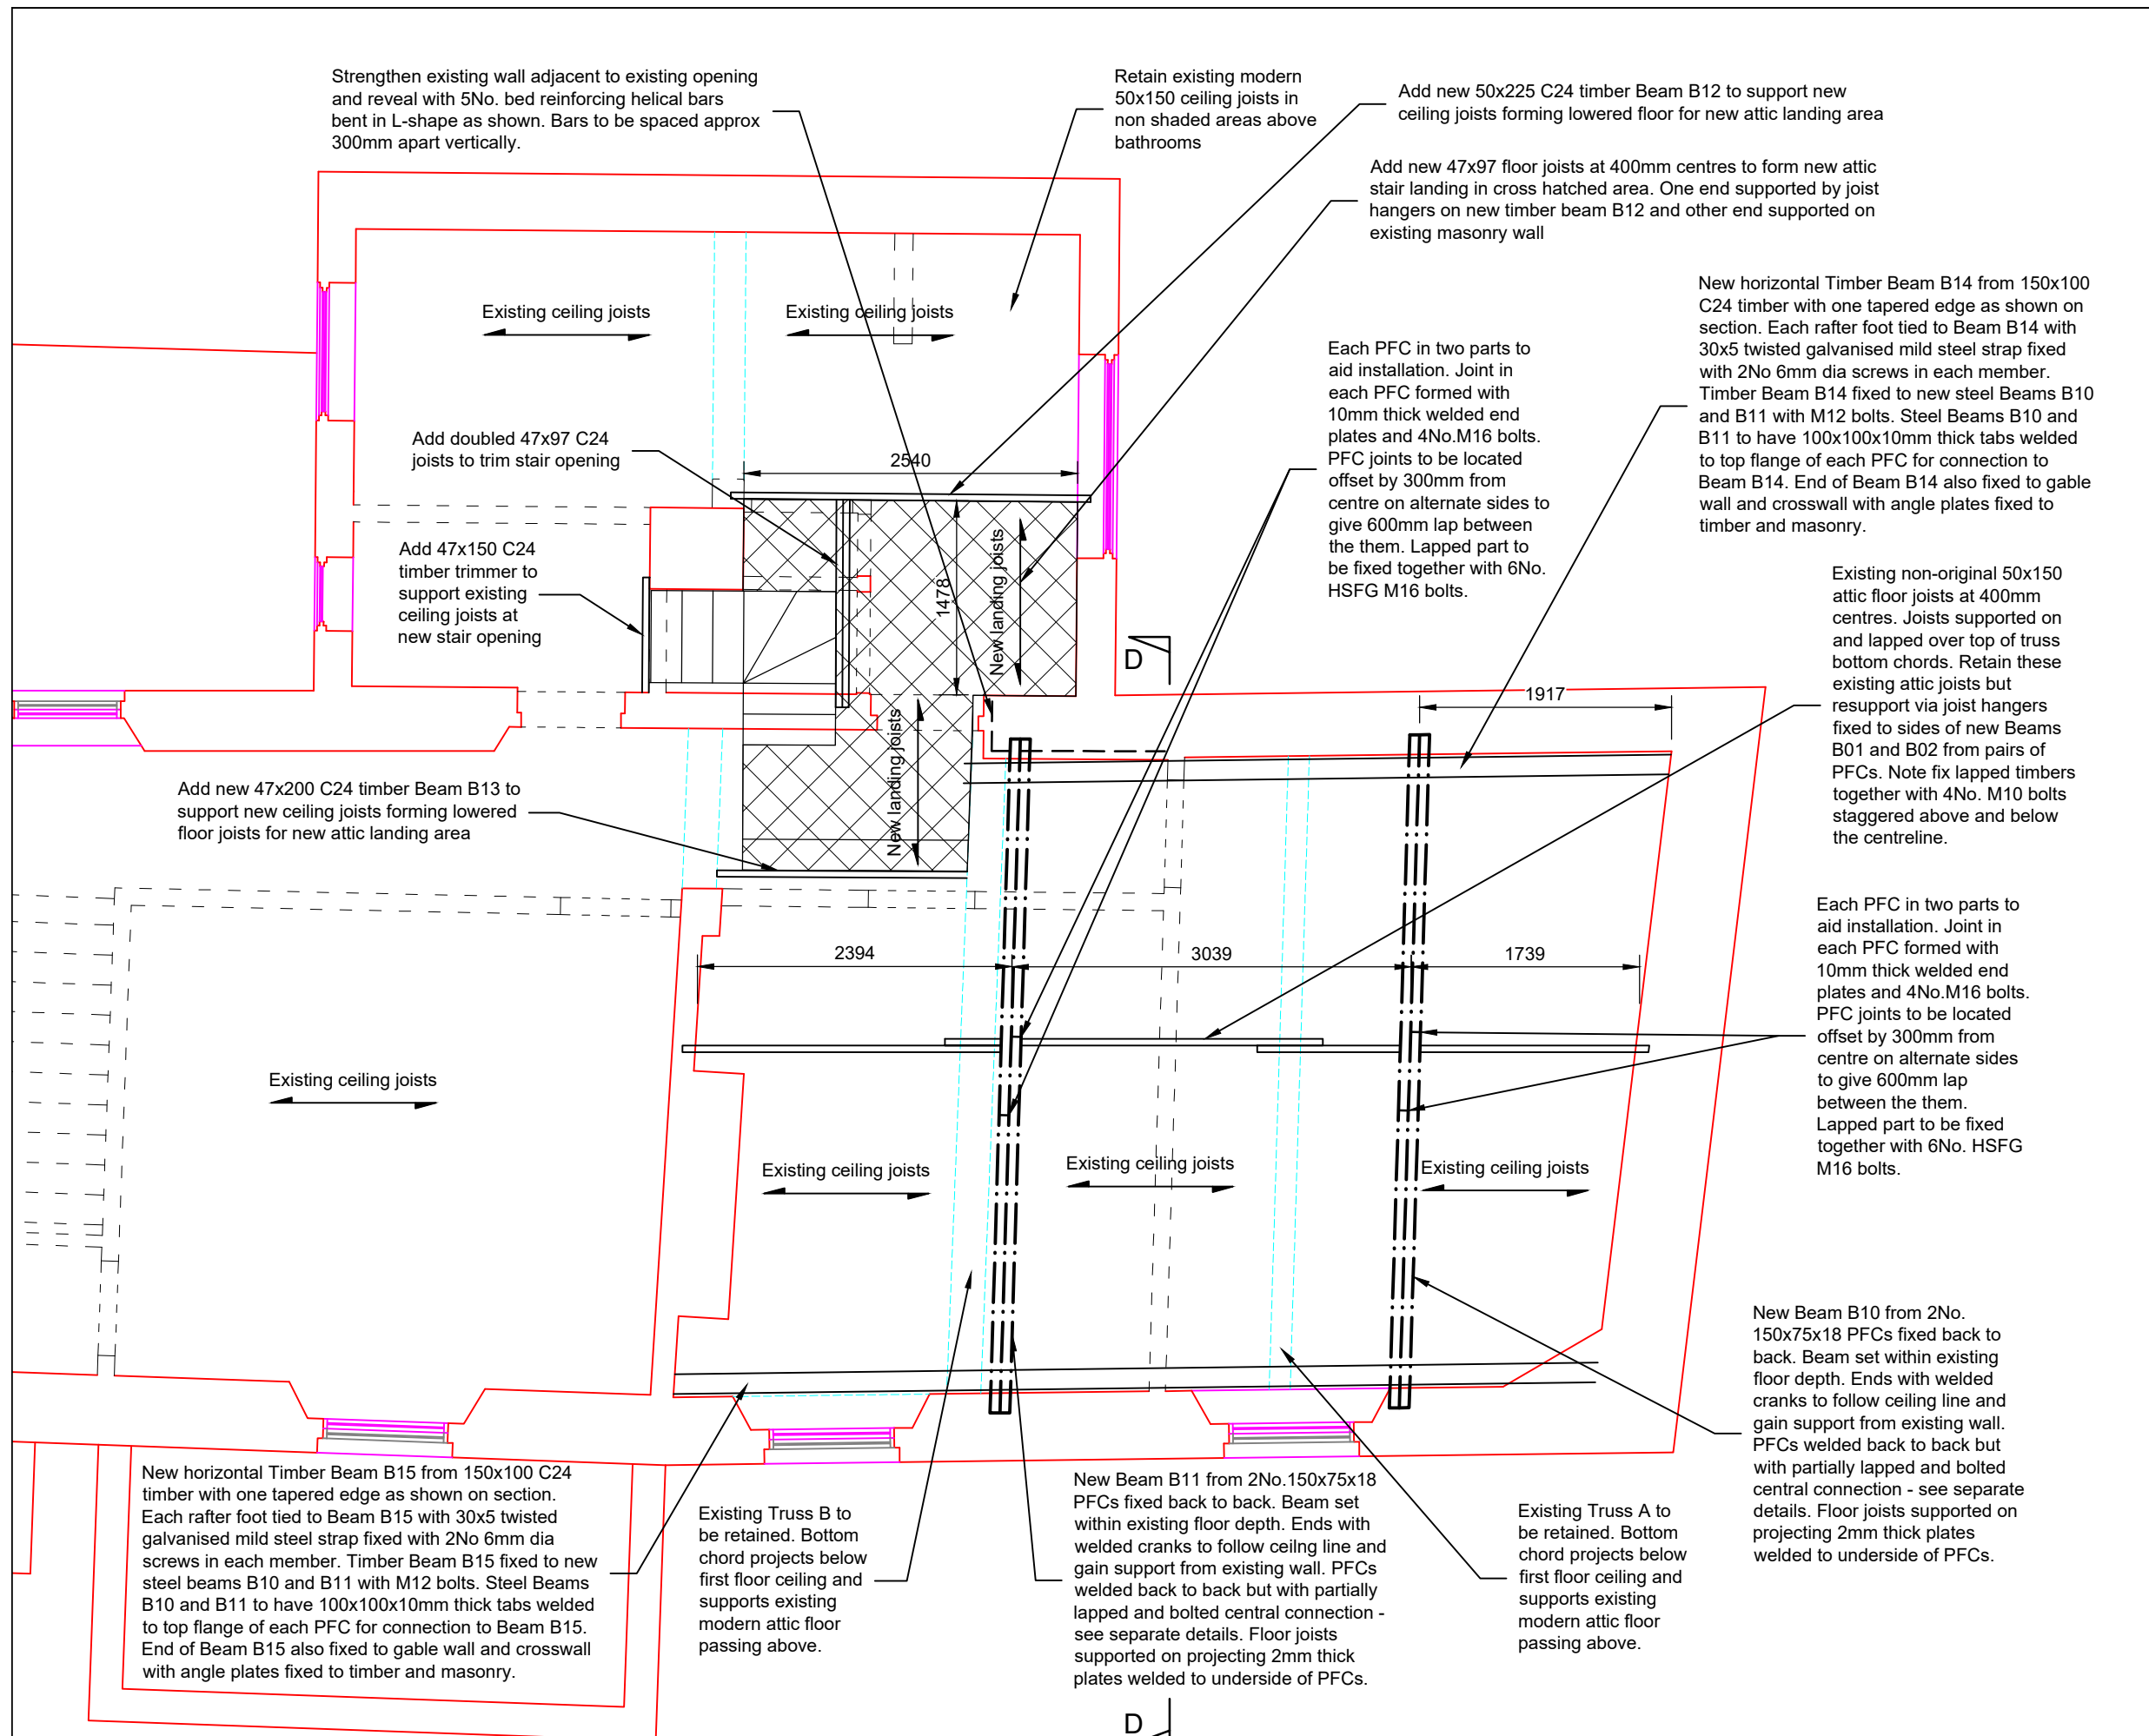
Strengthen existing wall adjacent to existing opening and reveal with 5No. bed reinforcing helical bars bent in L-shape as shown. Bars to be spaced approx 300mm apart vertically.

Retain existing modern 50x150 ceiling joists in non shaded areas above bathrooms

Add new 50x225 C24 timber Beam B12 to support new ceiling joists forming lowered floor for new attic landing area

Add new 47x97 floor joists at 400mm centres to form new attic stair landing in cross hatched area. One end supported by joist hangers on new timber beam B12 and other end supported on existing masonry wall

New horizontal Timber Beam B14 from 150x100 C24 timber with one tapered edge as shown on section. Each rafter foot tied to Beam B14 with 30x5 twisted galvanised mild steel strap fixed with 2No 6mm dia screws in each member. Timber Beam B14 fixed to new steel Beams B10 and B11 with M12 bolts. Steel Beams B10 and B11 to have 100x100x10mm thick tabs welded to top flange of each PFC for connection to Beam B14. End of Beam B14 also fixed to gable wall and crosswall with angle plates fixed to timber and masonry.

Each PFC in two parts to aid installation. Joint in each PFC formed with 10mm thick welded end plates and 4No.M16 bolts. PFC joints to be located offset by 300mm from centre on alternate sides to give 600mm lap between the them. Lapped part to be fixed together with 6No. HSF M16 bolts.

Existing non-original 50x150 attic floor joists at 400mm centres. Joists supported on and lapped over top of truss bottom chords. Retain these existing attic joists but resupport via joist hangers fixed to sides of new Beams B01 and B02 from pairs of PFCs. Note fix lapped timbers together with 4No. M10 bolts staggered above and below the centreline.

New Beam B10 from 2No. 150x75x18 PFCs fixed back to back. Beam set within existing floor depth. Ends with welded cranks to follow ceiling line and gain support from existing wall. PFCs welded back to back but with partially lapped and bolted central connection - see separate details. Floor joists supported on projecting 2mm thick plates welded to underside of PFCs.

New horizontal Timber Beam B15 from 150x100 C24 timber with one tapered edge as shown on section. Each rafter foot tied to Beam B15 with 30x5 twisted galvanised mild steel strap fixed with 2No 6mm dia screws in each member. Timber Beam B15 fixed to new steel beams B10 and B11 with M12 bolts. Steel Beams B10 and B11 to have 100x100x10mm thick tabs welded to top flange of each PFC for connection to Beam B15. End of Beam B15 also fixed to gable wall and crosswall with angle plates fixed to timber and masonry.

Existing Truss B to be retained. Bottom chord projects below first floor ceiling and supports existing modern attic floor passing above.

New Beam B11 from 2No.150x75x18 PFCs fixed back to back. Beam set within existing floor depth. Ends with welded cranks to follow ceiling line and gain support from existing wall. PFCs welded back to back but with partially lapped and bolted central connection - see separate details. Floor joists supported on projecting 2mm thick plates welded to underside of PFCs.

Existing Truss A to be retained. Bottom chord projects below first floor ceiling and supports existing modern attic floor passing above.
