Richborough Estates Heyford Park Oxfordshire Phase 1 Geo-Environmental Assessment

August 2021

| Document Number: | HPO-BWB-ZZ-XX-RP-YE-0001_Ph1 | |

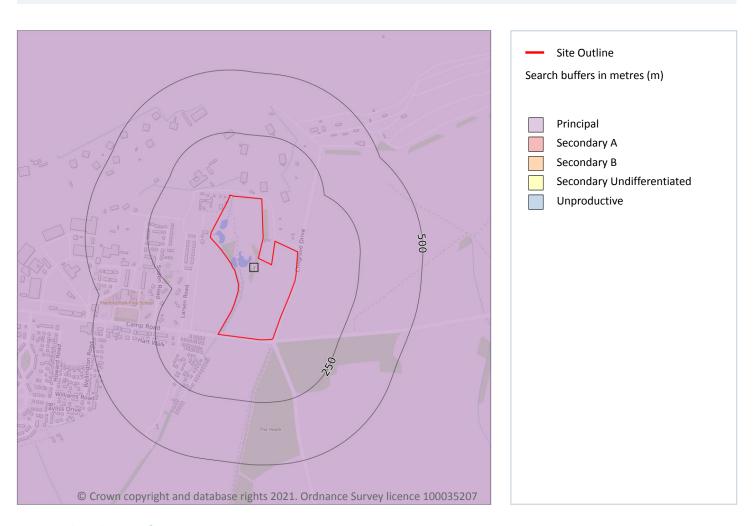
# **Bedrock aquifer**

| ID | Location | Designation | Description |
|---|---|---|--|
| 1 | On site | Principal | Geology of high intergranular and/or fracture permeability, usually providing a high level of water storage and may support water supply/river base flow on a strategic scale. Generally principal aquifers were previously major aquifers |

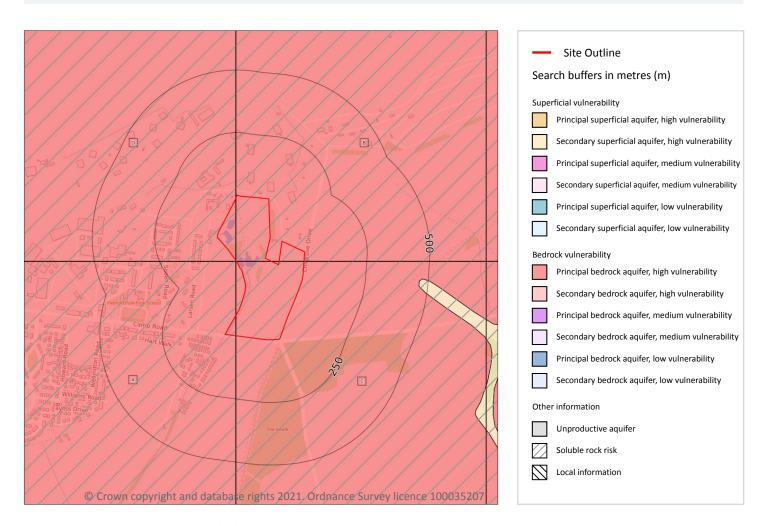
## **Groundwater vulnerability**

| ID | Location | Summary | Soil / surface | Superficial geology | Bedrock geology |
|---|---|--|---|--|---|
| Α | On site | Summary Classification: Principal bedrock aquifer - High Vulnerability Combined classification: Productive Bedrock Aquifer, No Superficial Aquifer | Leaching class: High<br>Infiltration value:<br>>70%<br>Dilution value:<br><300mm/year | Vulnerability: - Aquifer type: - Thickness: <3m Patchiness value: <90% Recharge potential: No Data | Vulnerability: High<br>Aquifer type: Principal<br>Flow mechanism: Well<br>connected fractures |
| В | On site | Summary Classification: Principal bedrock aquifer - High Vulnerability Combined classification: Productive Bedrock Aquifer, No Superficial Aquifer | Leaching class: High<br>Infiltration value:<br>>70%<br>Dilution value:<br><300mm/year | Vulnerability: - Aquifer type: - Thickness: <3m Patchiness value: <90% Recharge potential: No Data | Vulnerability: High<br>Aquifer type: Principal<br>Flow mechanism: Well<br>connected fractures |
| С | On site | Summary Classification: Principal bedrock aquifer - High Vulnerability Combined classification: Productive Bedrock Aquifer, No Superficial Aquifer | Leaching class: High<br>Infiltration value:<br>>70%<br>Dilution value:<br><300mm/year | Vulnerability: - Aquifer type: - Thickness: <3m Patchiness value: <90% Recharge potential: No Data | Vulnerability: High<br>Aquifer type: Principal<br>Flow mechanism: Well<br>connected fractures |
| D | On site | Summary Classification: Principal bedrock aquifer - High Vulnerability Combined classification: Productive Bedrock Aquifer, | Leaching class: High<br>Infiltration value:<br>>70%<br>Dilution value: 300-<br>550mm/year | Vulnerability: - Aquifer type: - Thickness: <3m Patchiness value: <90% Recharge potential: No | Vulnerability: High<br>Aquifer type: Principal<br>Flow mechanism: Well<br>connected fractures |

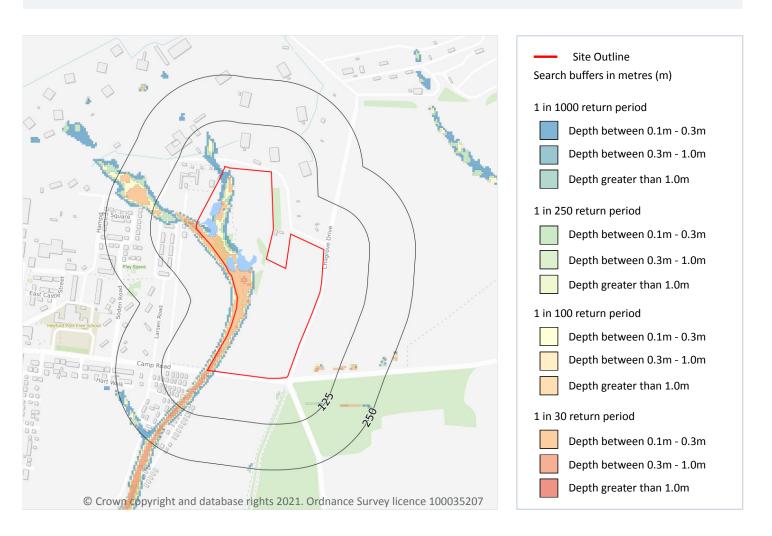
# 8 Surface water flooding

| Highest risk on site | 1 in 30 year, 0.3m - 1.0m |

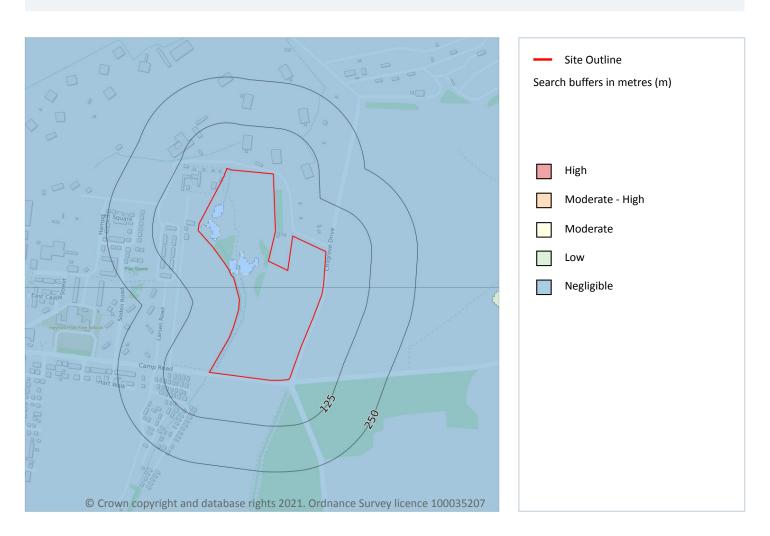
# 9 Groundwater flooding

| Highest risk on site | Negligible |

Groundwater flooding is caused by unusually high groundwater levels. It occurs when the water table rises above the ground surface or within underground structures such as basements or cellars. Groundwater flooding tends to exhibit a longer duration than surface water flooding, possibly lasting for weeks or months, and as a result it can cause significant damage to property. This risk assessment is based on a 1 in 100 year return period and a 5m Digital Terrain Model (DTM).

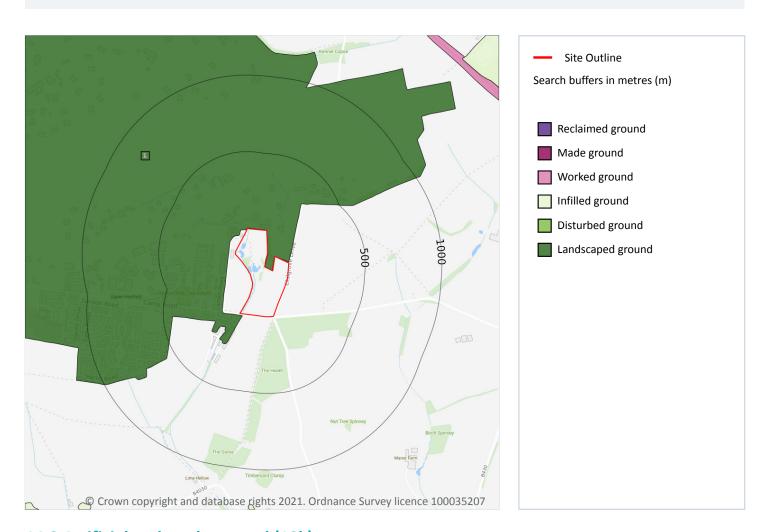
# Geology 1:10,000 scale - Artificial and made ground

Details of made, worked, infilled, disturbed and landscaped ground at 1:10,000 scale. Artificial ground can be associated with potentially contaminated material, unpredictable engineering conditions and instability.
