**Upper Heyford – Trenchard Circle (Planning Ref. 16/00196/F)  
In-Situ Formation Soil Validation**

Drawing:  
 Formation Sampling Locations

Checked: BJT  
 Scale: 1:1,250 @ A4  
 Drg No: L20200717-D01

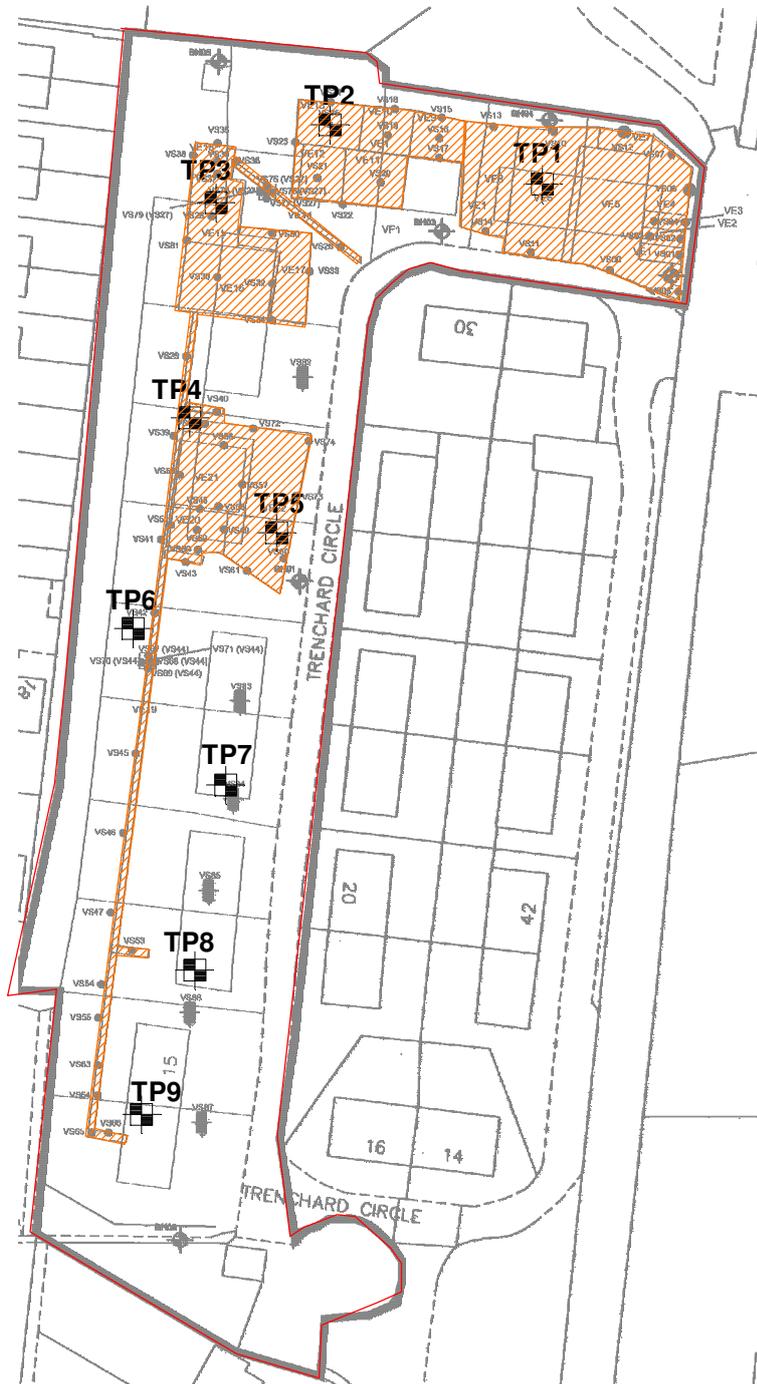
A site location plan including the location of validation entries is provided within Drawing D01. SGP understand that redevelopment proposals for this phase is for residential use with private gardens, drives and areas of soft landscaping although a proposed layout has not been provided.

AAe Remediation Excavation & Backfill Area

Formation Sampling Trial-Pit

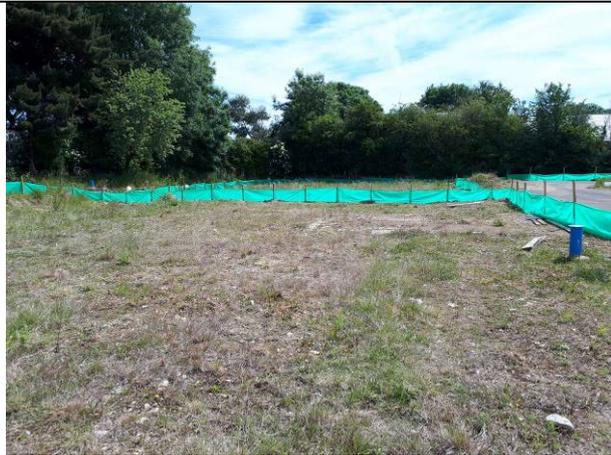
02.06.20 – Eastern view across the northern part of the site

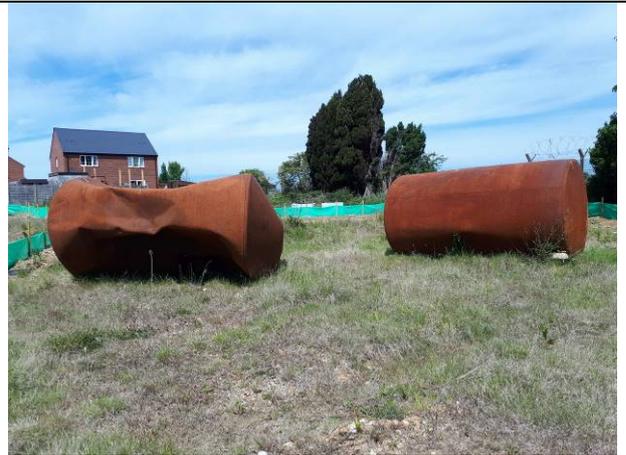
02.06.20 – Removed USTs as part of remedial works awaiting off-site removal for recycling

During the remedial works, 2 previously unidentified 4,500 litre below ground oil tanks were encountered, these were removed, and the surrounding soils inspected and tested. No further detail was provided such as the contents of the tanks and their decontamination status prior to removal.

Removed impacted soils were reportedly relocated within the wider Heyford Park area for bio-piling or off-site disposal, it is uncertain whether treatment or disposal took place. If it was the latter no waste transfer tickets were provided in the report, similarly no detail as to storage of impacted soils for treated soil was provided. Metal pipework and tanks were reportedly disposed of off-site for recycling.

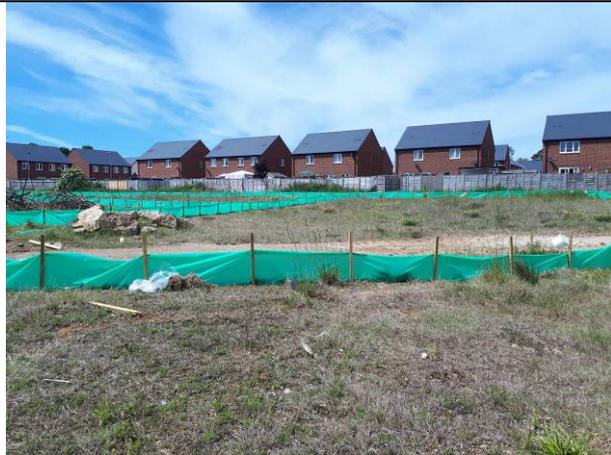
02.06.20 – Site surface occupied by light vegetation. Ecological fencing up during on-going survey work

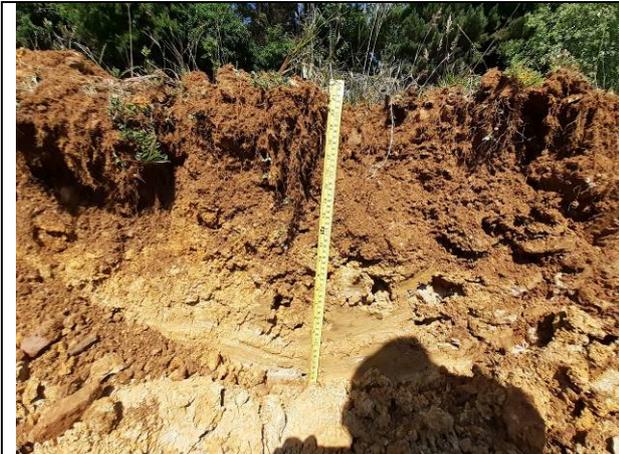
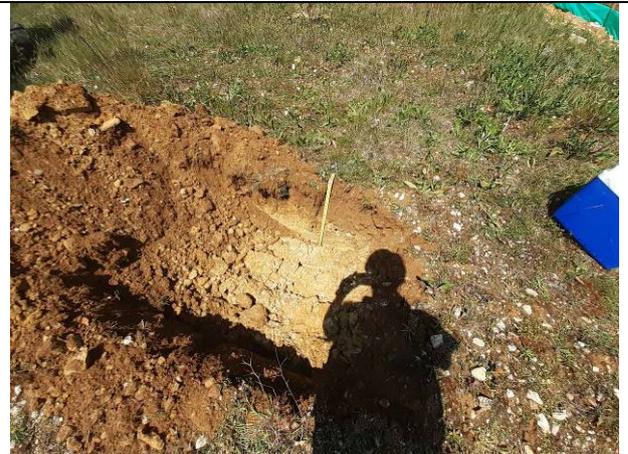
24.06.20 – TP1

Nine in-situ samples were collected from the exposed formation level soils across the site with depth validation photos showing the 0-400mm depth range appended to this report; a site location plan indicating the approximate location of in-situ validation entries is provided within Drawing D01. Assuming an approximate area of 11,250m<sup>2</sup>, the total volume of validated soils is effectively 4,500m<sup>3</sup>. With 9 samples collected, the specified sampling rate of 1 sample per 500m<sup>3</sup> has been achieved.

Five of the samples (TP1, TP2, TP3, TP & TP5) were collected from areas where re-worked natural backfill soils were present and the remainder from undisturbed natural strata.
