**PROJECT** Stratfield Farm  
OX5 1DL Kidlington

**DWG TITLE** Block E  
Existing Plans

**STATUS** Planning and LBC

**JOB/DWG No.** 219-112

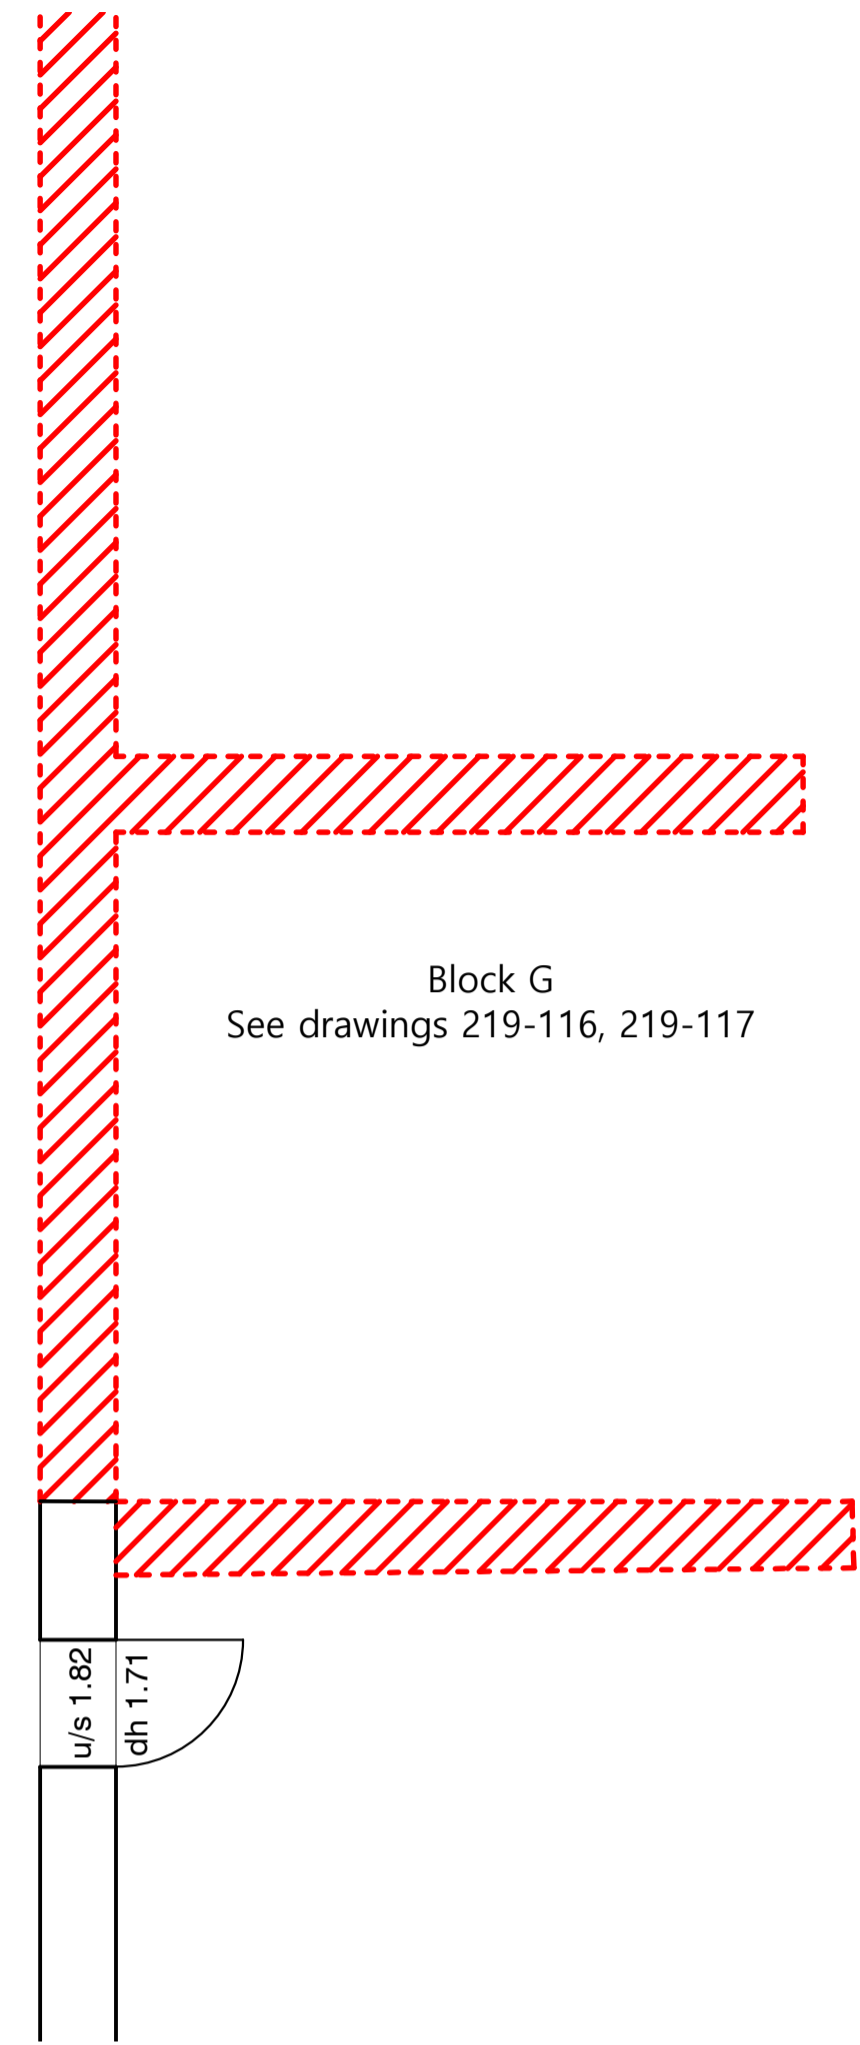
### 1.0 Ground Floor Plan

Gapping repair to drystone wall, take down and rebuild

Carry out gapping repairs to wall, removing incongruous sections / cement capping and renewing with new limestone capping to match existing

Small section of wall to be taken down to ground level and rebuilt straight
