PROJECT Stratfield Farm
 OX5 1DL Kidlington

DWG TITLE Block E
 Existing Elevations and Section

STATUS Planning and LBC

JOB/DWG No. 219-113

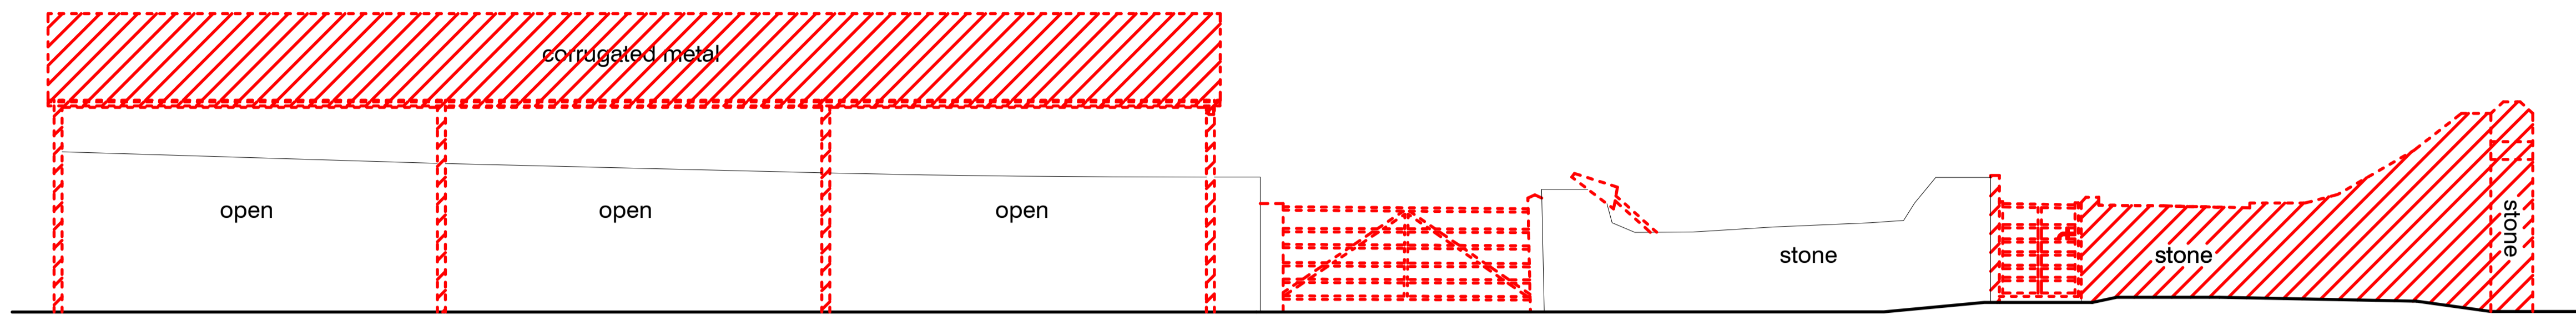
1.0 North Elevation

Retained wall as part of block G, see drawing 219-117

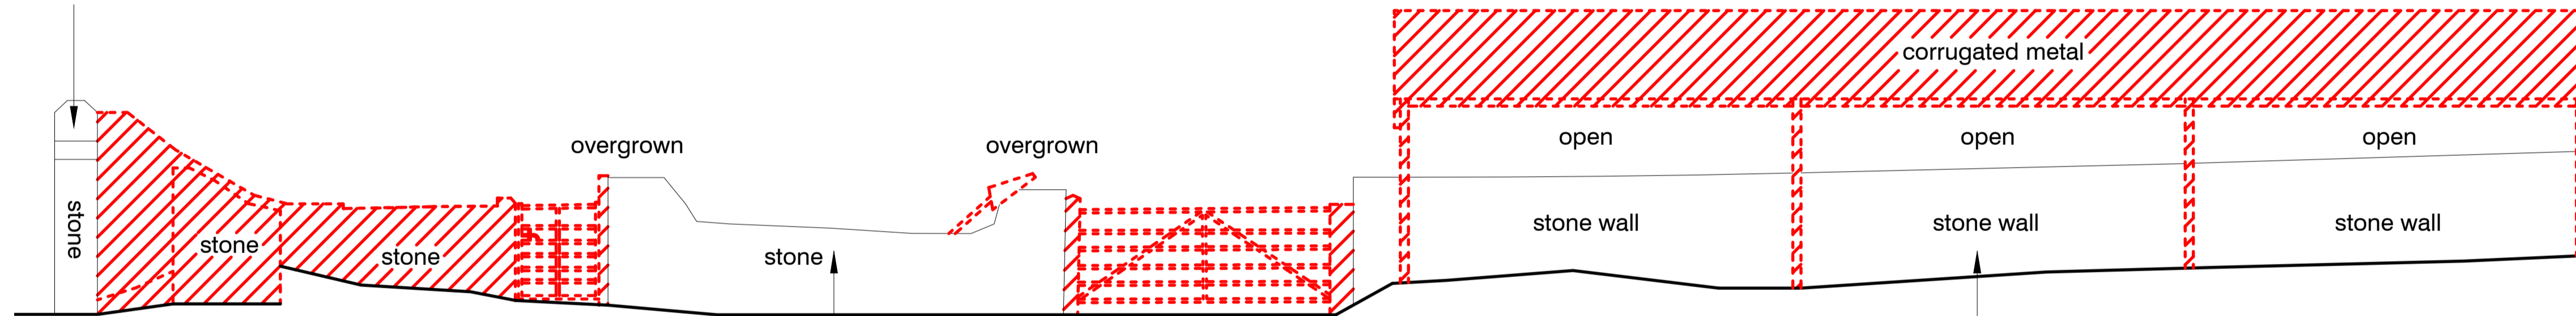
2.0 South Elevation

Gapping repair to drystone wall, take down and rebuild

Carry out gapping repairs to wall, removing incongruous sections / cement capping and renewing with new limestone capping to match existing
