**PROJECT** Stratfield Farm  
OX5 1DL Kidlington

**DWG TITLE** Block F  
Existing Plans

**STATUS** Planning and LBC

**JOB/DWG No.** 219-114

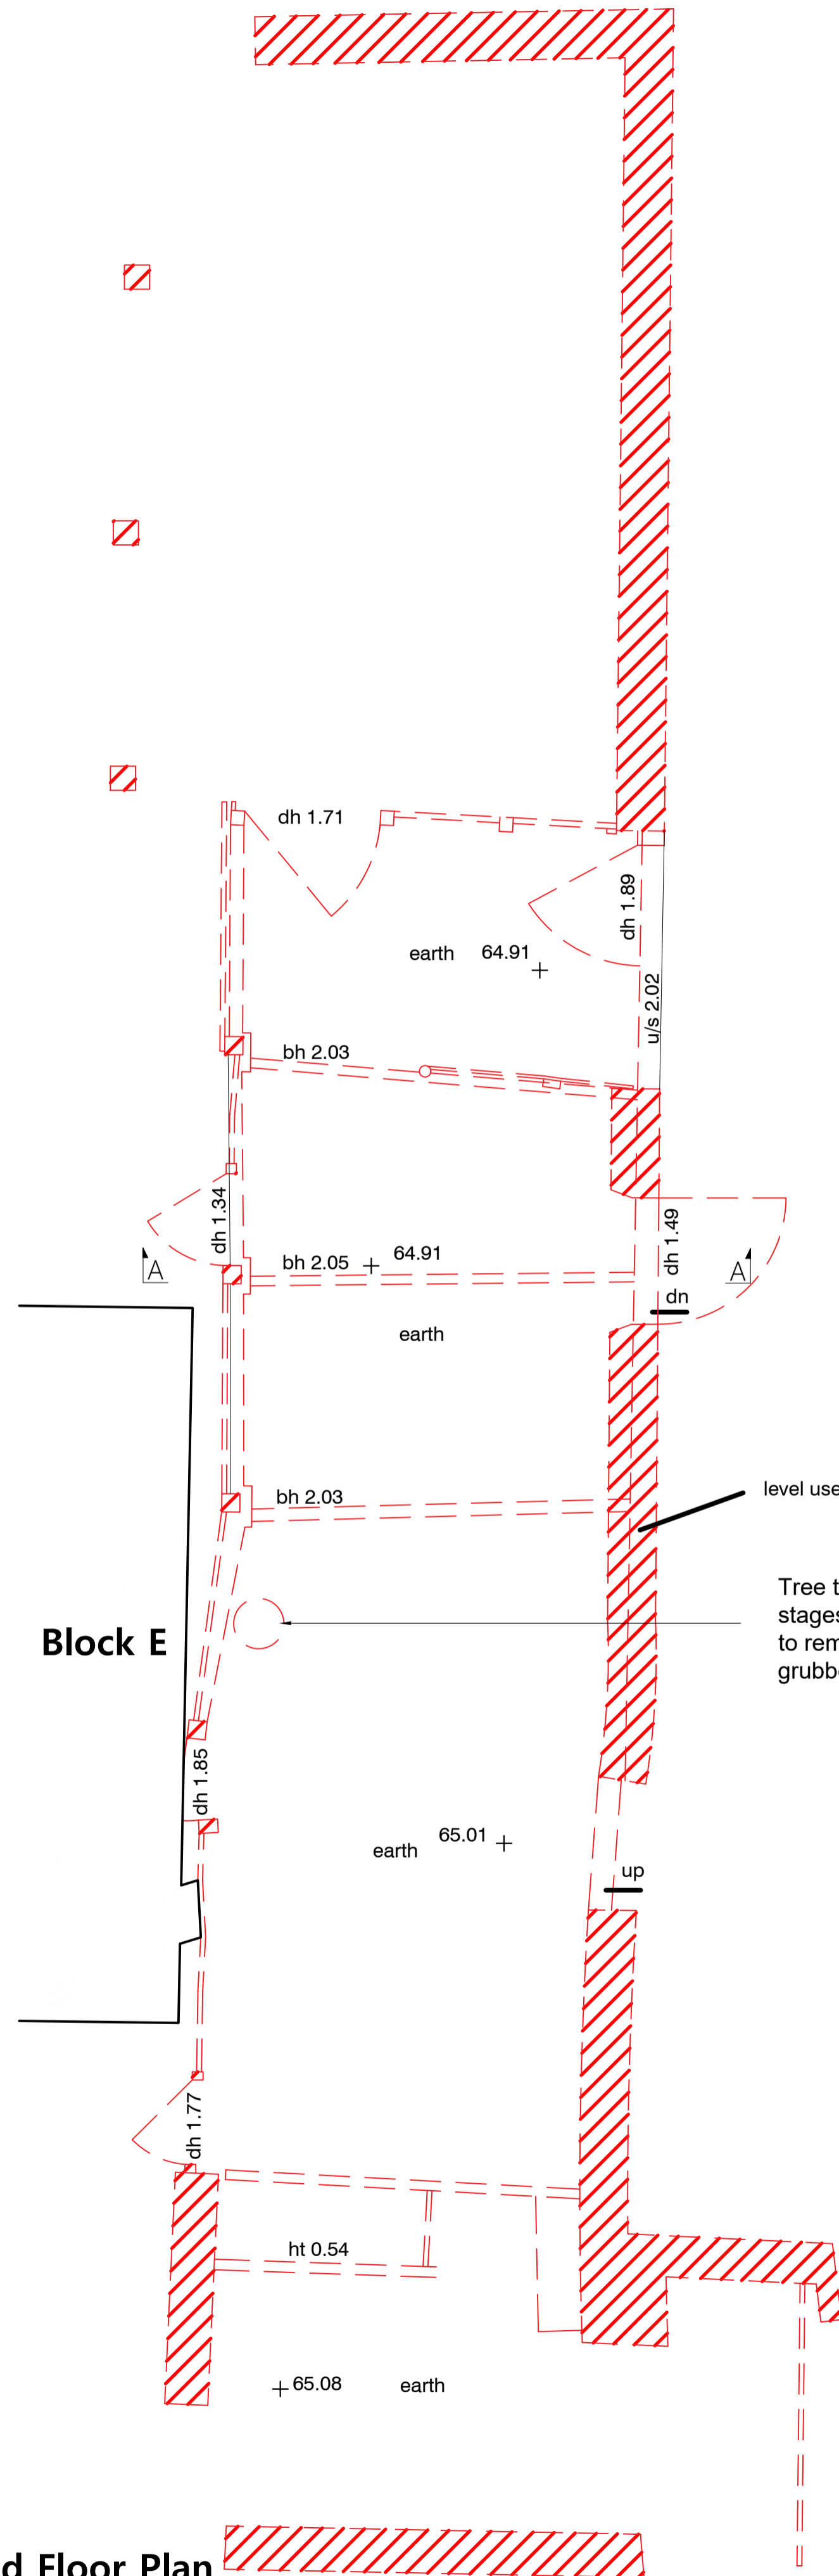
**1.0 Ground Floor Plan**

**R1** Roof structure of Block F appears to be raking east. Remaining 3 bays of the roof (from north) are in fair condition and are proposed to be preserved and reused. Structural engineer will be required to advise.

Generally, remove all vegetation. Retain limestone rubble walling stone from demolished walls to be reused for new walls.
