**PROJECT** Stratfield Farm  
 OX5 1DL Kidlington

**DWG TITLE** Block H  
 Existing Elevations

**STATUS** Planning and LBC

**JOB/DWG No.** 219-118

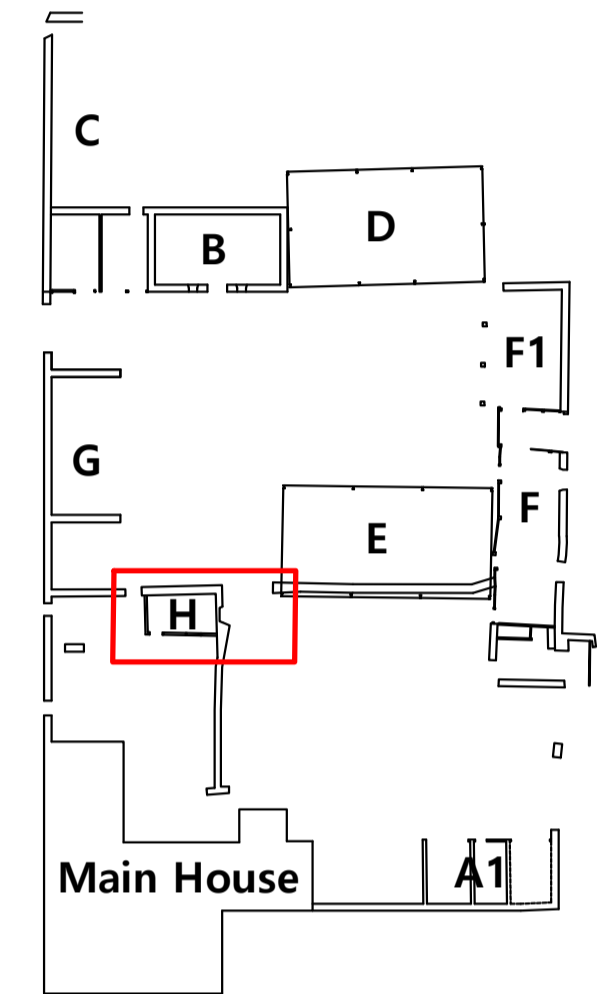
### Repairs

**R1** Carry out gapping repairs to wall, removing incongruous sections/cement capping and renewing with new limestone capping to match existing
