PROJECT Stratfield Farm, Kidlington
OX5 1DL Kidlington

DWG TITLE Site Plan
As Proposed

STATUS Planning and LBC

JOB/DWG No. 219-200

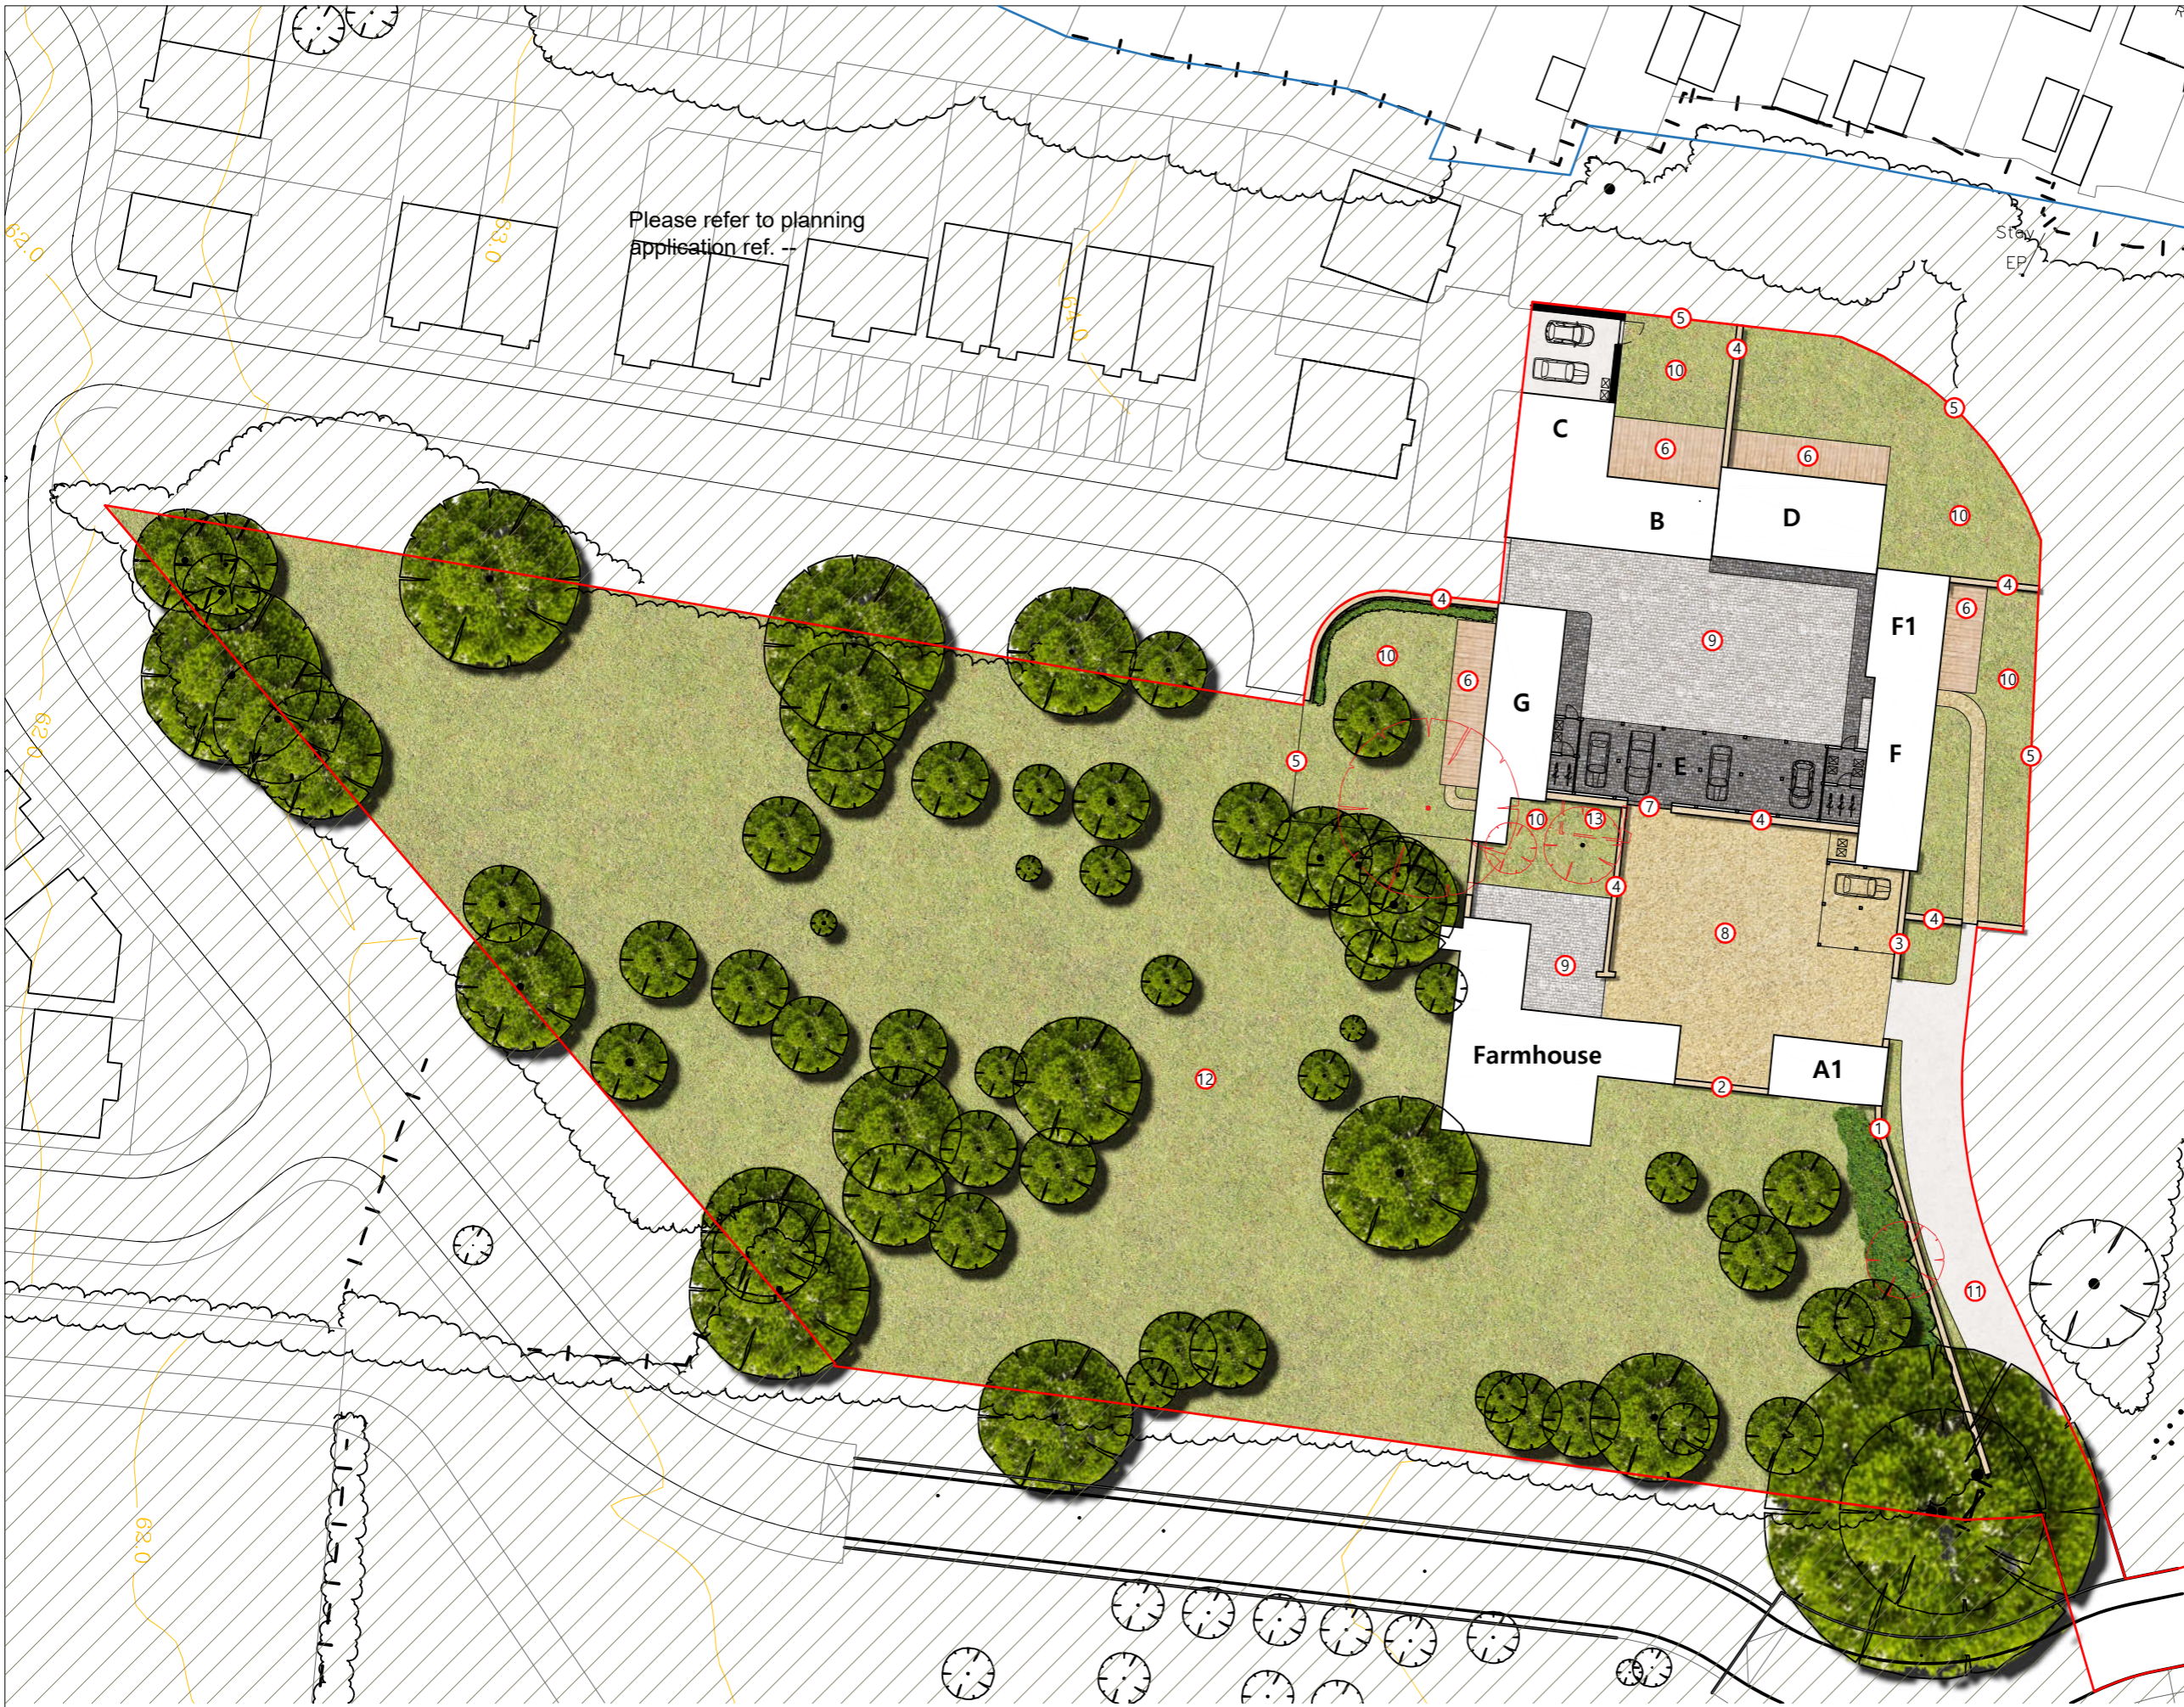
1.0 Site Plan
1:500 @ A3

- ① Existing dry stone wall cracks to be repaired. New movement joint to be added between wall and Block A1
- ② Existing coursed rubble limestone wall to be repaired and repointed. Capping to be replaced with stone slates.
- ③ Existing coursed rubble limestone wall to be rebuilt. New capping to be added with stone slates. Existing brick quoins to be tied into the wall around opening.
- ④ New 1.4m high dry stone walling with mortar capping.
- ⑤ New 1.2m high timber post and rail fence.
- ⑥ New timber decking.
- ⑦ Existing metal gate replaced with a fixed timber gate.
- ⑧ Gravel.
- ⑨ Stone sett cobbles in two shades to demarcate pedestrian areas.
- ⑩ New lawn area.
- ⑪ Existing road to be tarmacked.
- ⑫ Existing orchard to be retained.
- ⑬ Block H to be demolished.
