Client: Adderbury Parish Council  
 Project Title: Community Centre and Sports Facility  
 Land off Milton Road, Adderbury  
 Topographic Survey

drawing no. 9735 Milton Rd  
 date 18th Jan 2022

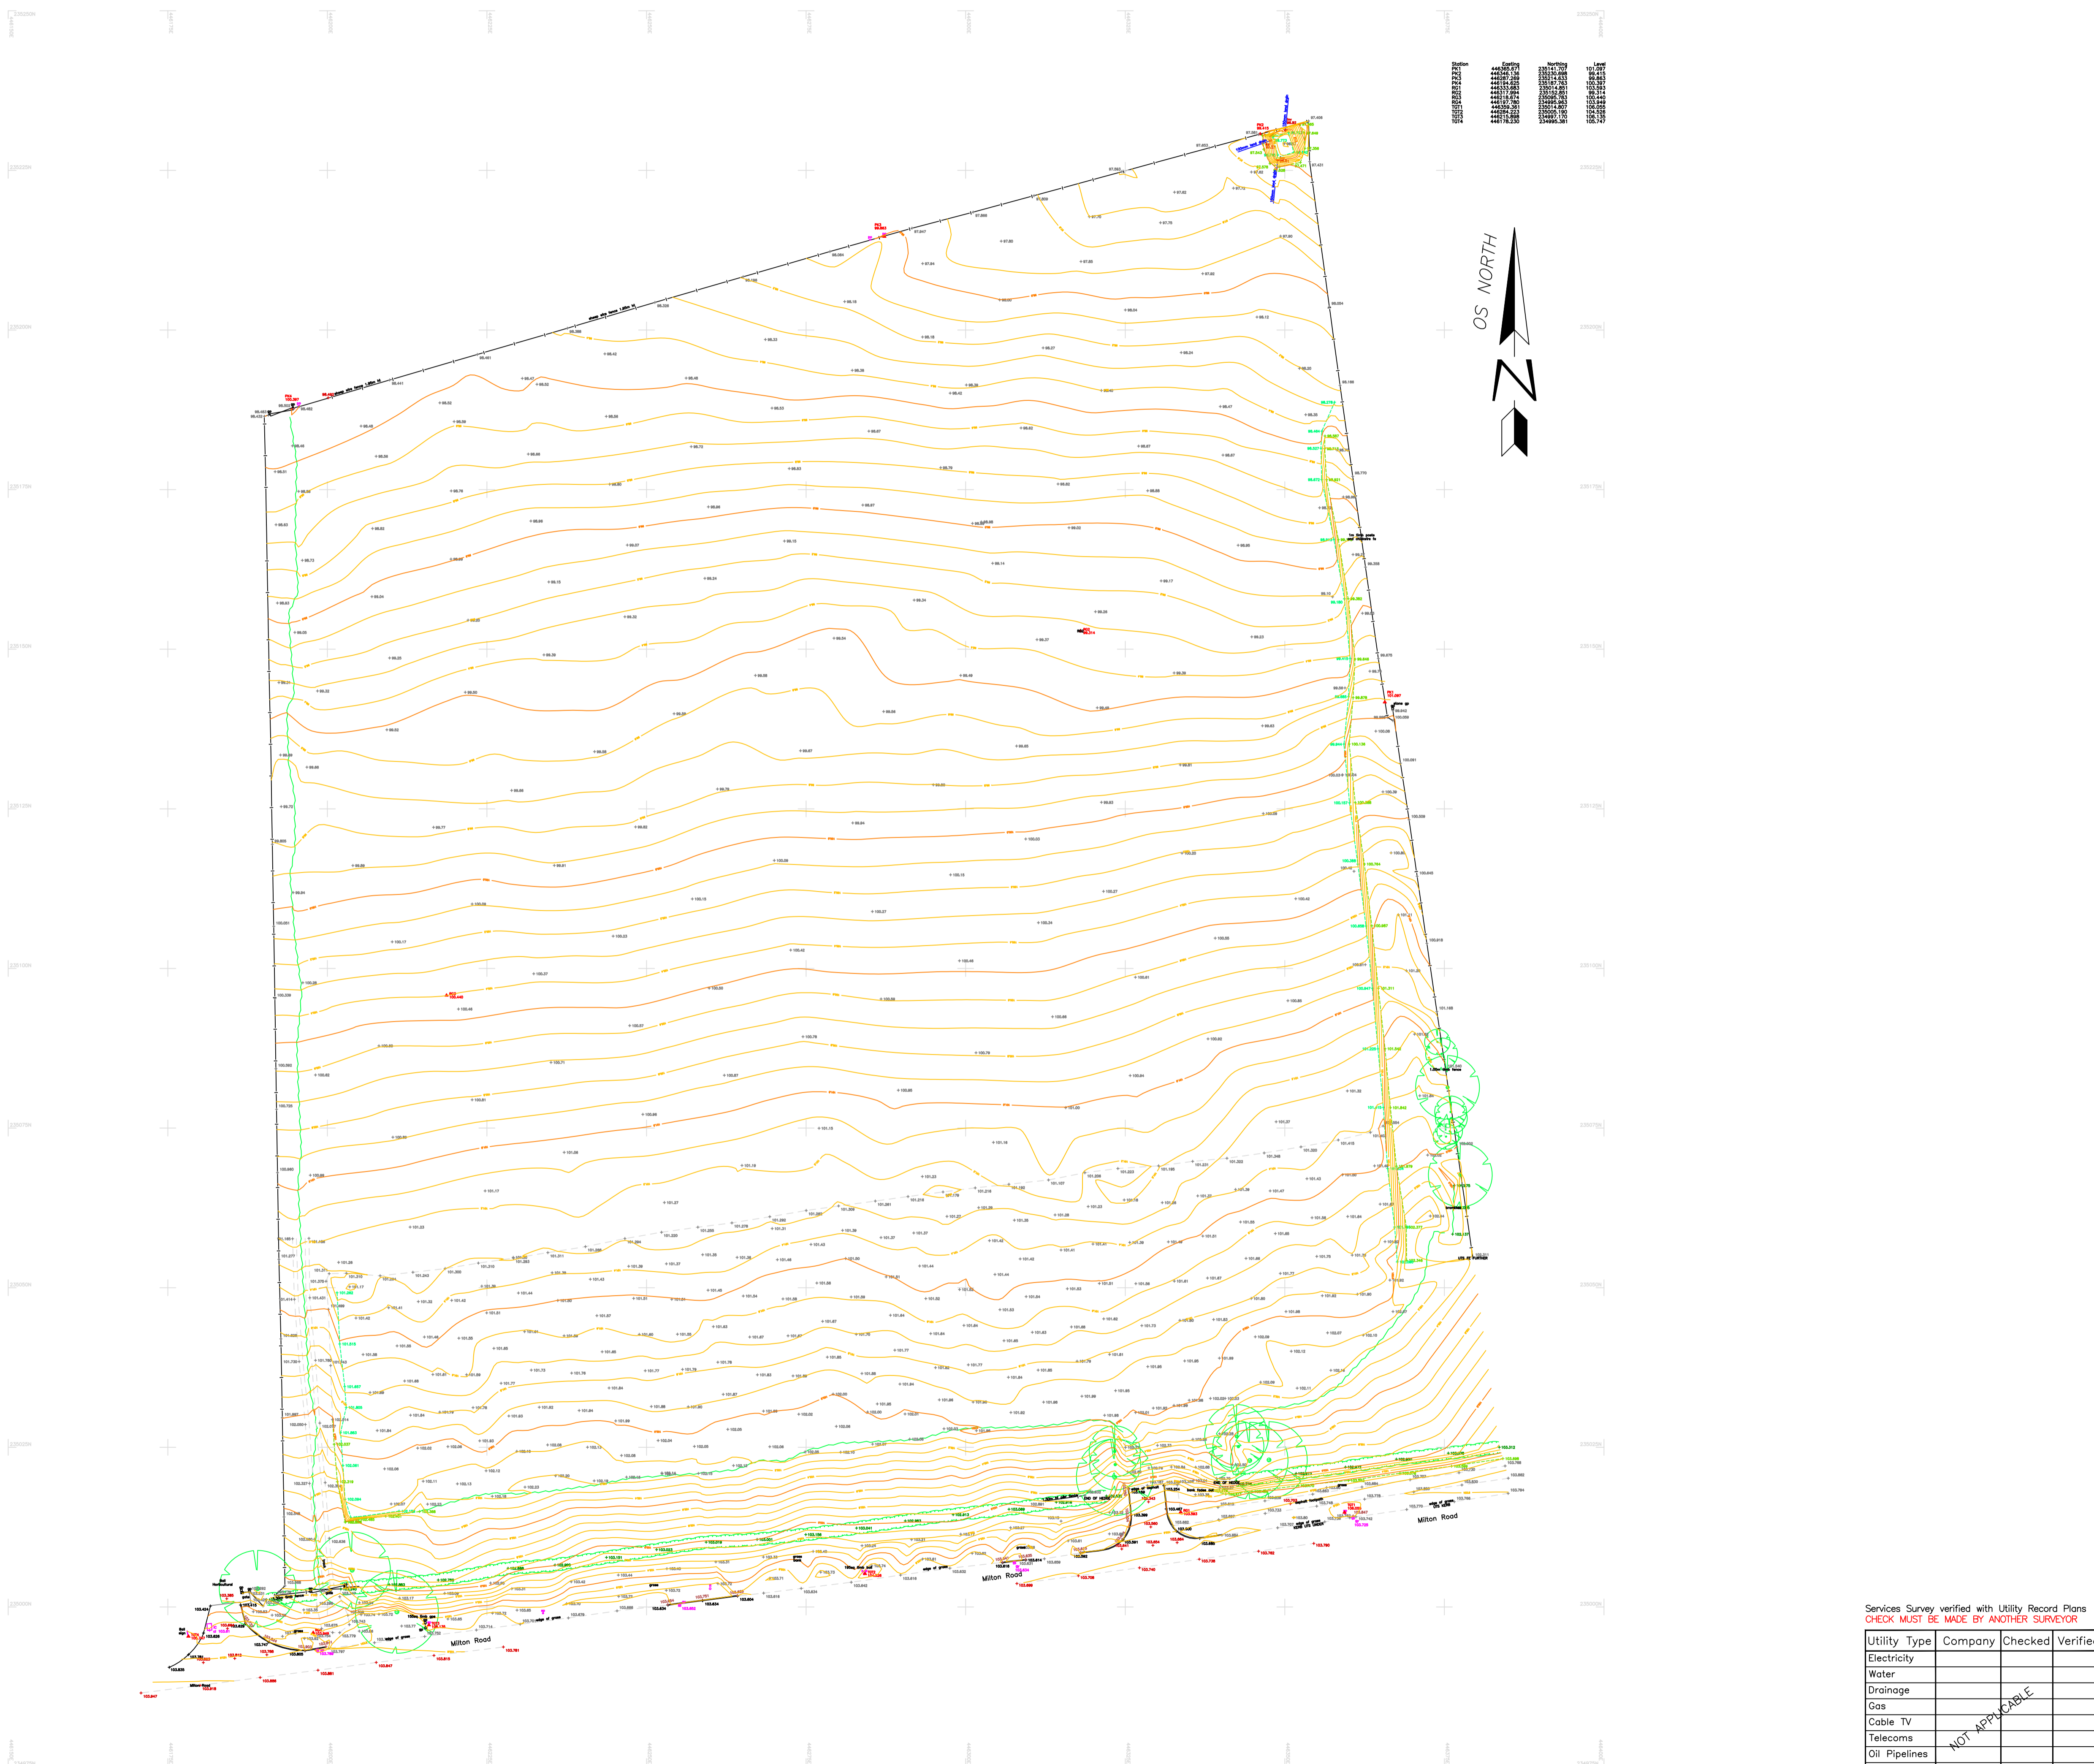
Services detection including electromagnetic location (EML) and ground probing radar (GPR) have been used to locate underground services. RGI Surveys have successfully used these methods since our establishment in 1989. Identification of services is only possible through confirmation with record drawings & with surveyor's experience in the field. Please be aware that results are not flawless and where critical we advise confirmation of services by trial excavations.

The services survey should be read in conjunction with utility record drawings. Single cable lines may represent multiple cables and ducts.
