IAN O'BRIEN STUDIO

Mawles Cottage

New pedestrian access gate

Design and heritage
statement

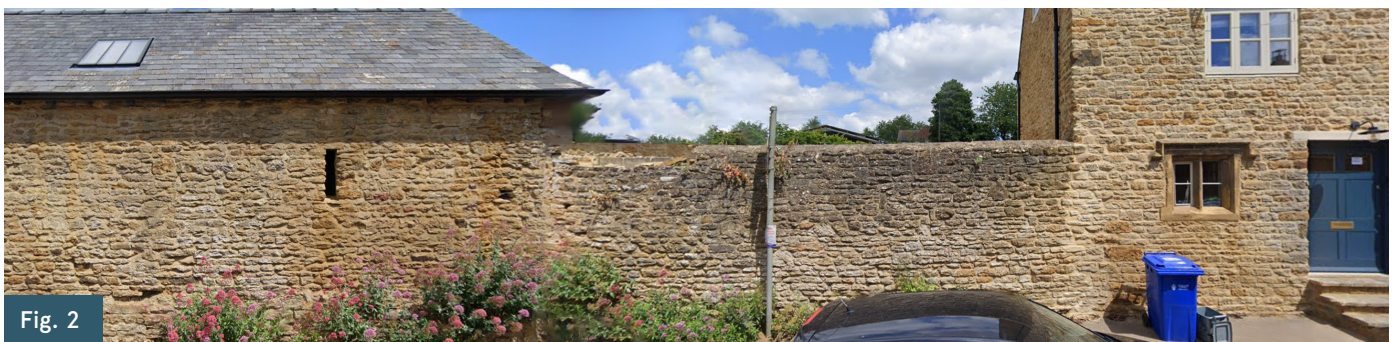
Fig. 2 — Photo of the street elevation of the boundary wall

The concerning existing boundary wall [figure 2], is an ironstone wall that continues the line of the adjoining stone buildings. The wall and buildings form the boundary of Main Street. Inner concrete blockwork faces the wall, with the boundary wall serves as a retaining structure between the level change of the properties garden and Main Street. The wall is currently in a poor state of repair. Works will provide opportunity to carry out local repairs and improve appearance, including rebuilding the collapsed section.

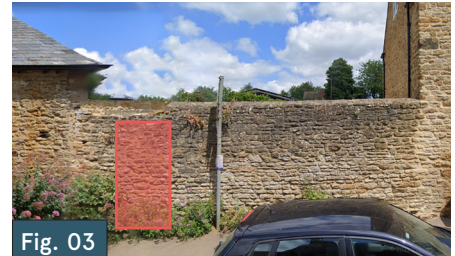
The existing wall will be partially demolished to create an opening for the gate access [figure 3]. Remedial stonework repairs will be undertaken in a complementary manner, using traditional materials and techniques used on the existing wall. Local ironstone will be laid using traditional pointing techniques and lime mortar [figure 4].

Fig. 03 — Location of proposed opening in wall

The boundary wall at Mawles Cottage, continuing the line of adjoining properties, is characteristic of the conservation area. The proposed opening does not alter the general form or massing of the boundary wall. It is a modest scale in a large expanse of wall and does not break the top line of the wall, maintaining the visual image of a continuous wall.

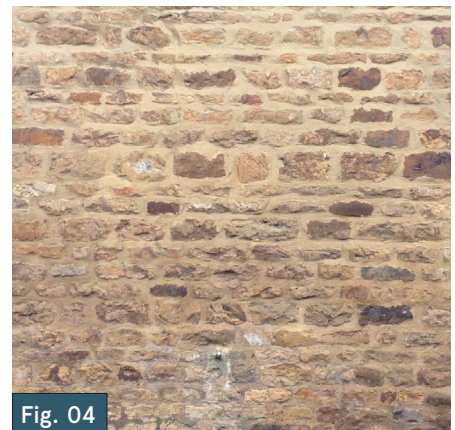
Fig. 04 — Local ironstone with lime mortar pointing

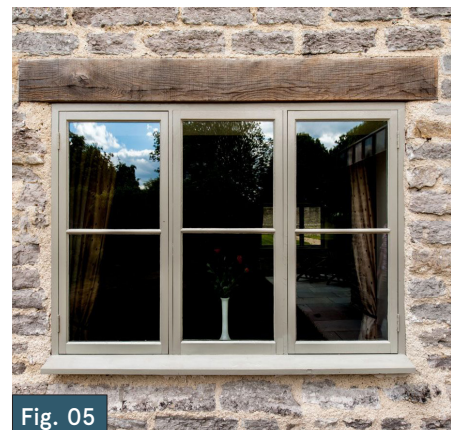
The proposed opening will be supported using an exposed timber lintel, finished to match others found on the building [figure 5].

Fig. 05 — Example traditional exposed timber lintel
