Arboricultural report
Land at The Beeches,
Heyford Road,
Steeple Aston,
Oxfordshire

A tree report for planning purposes to build 1 dwelling :

Ref: 21/02147/OUT

23/01273/F – variation of condition 1 of 22/01613/REM

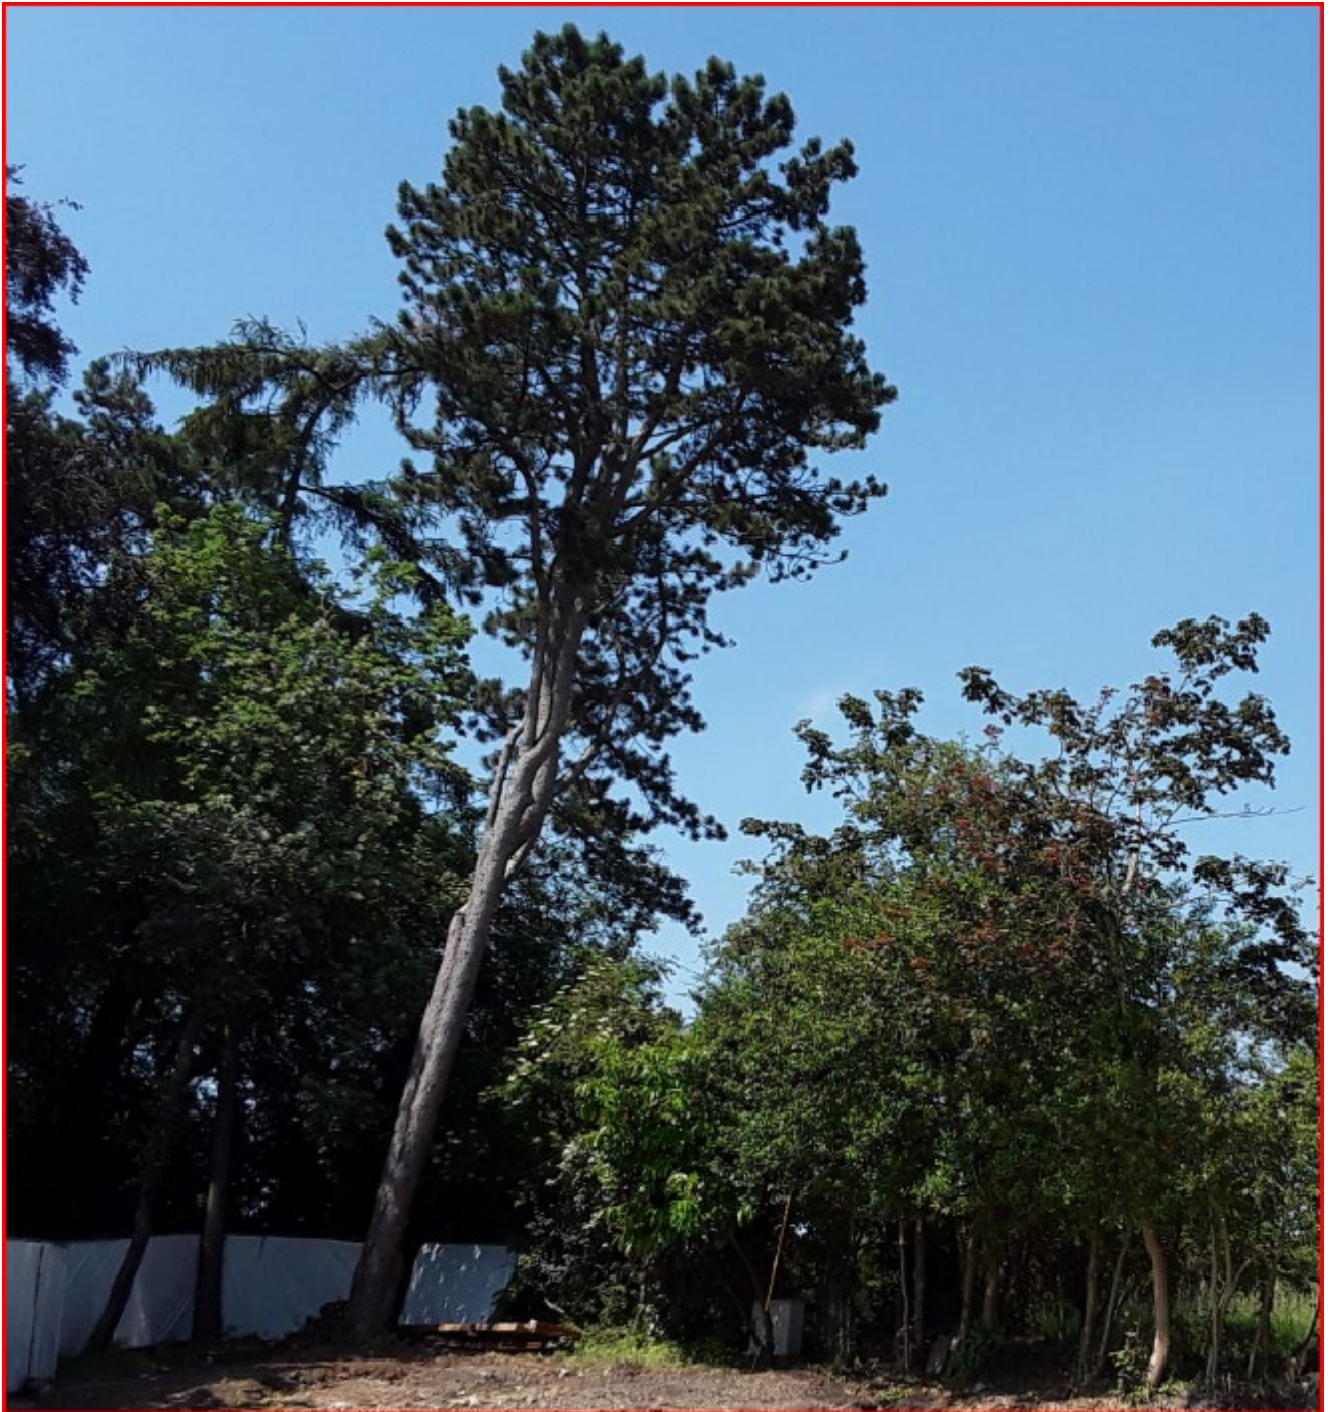
Tree T01, T02, T03 and G04 are at the back of the site.

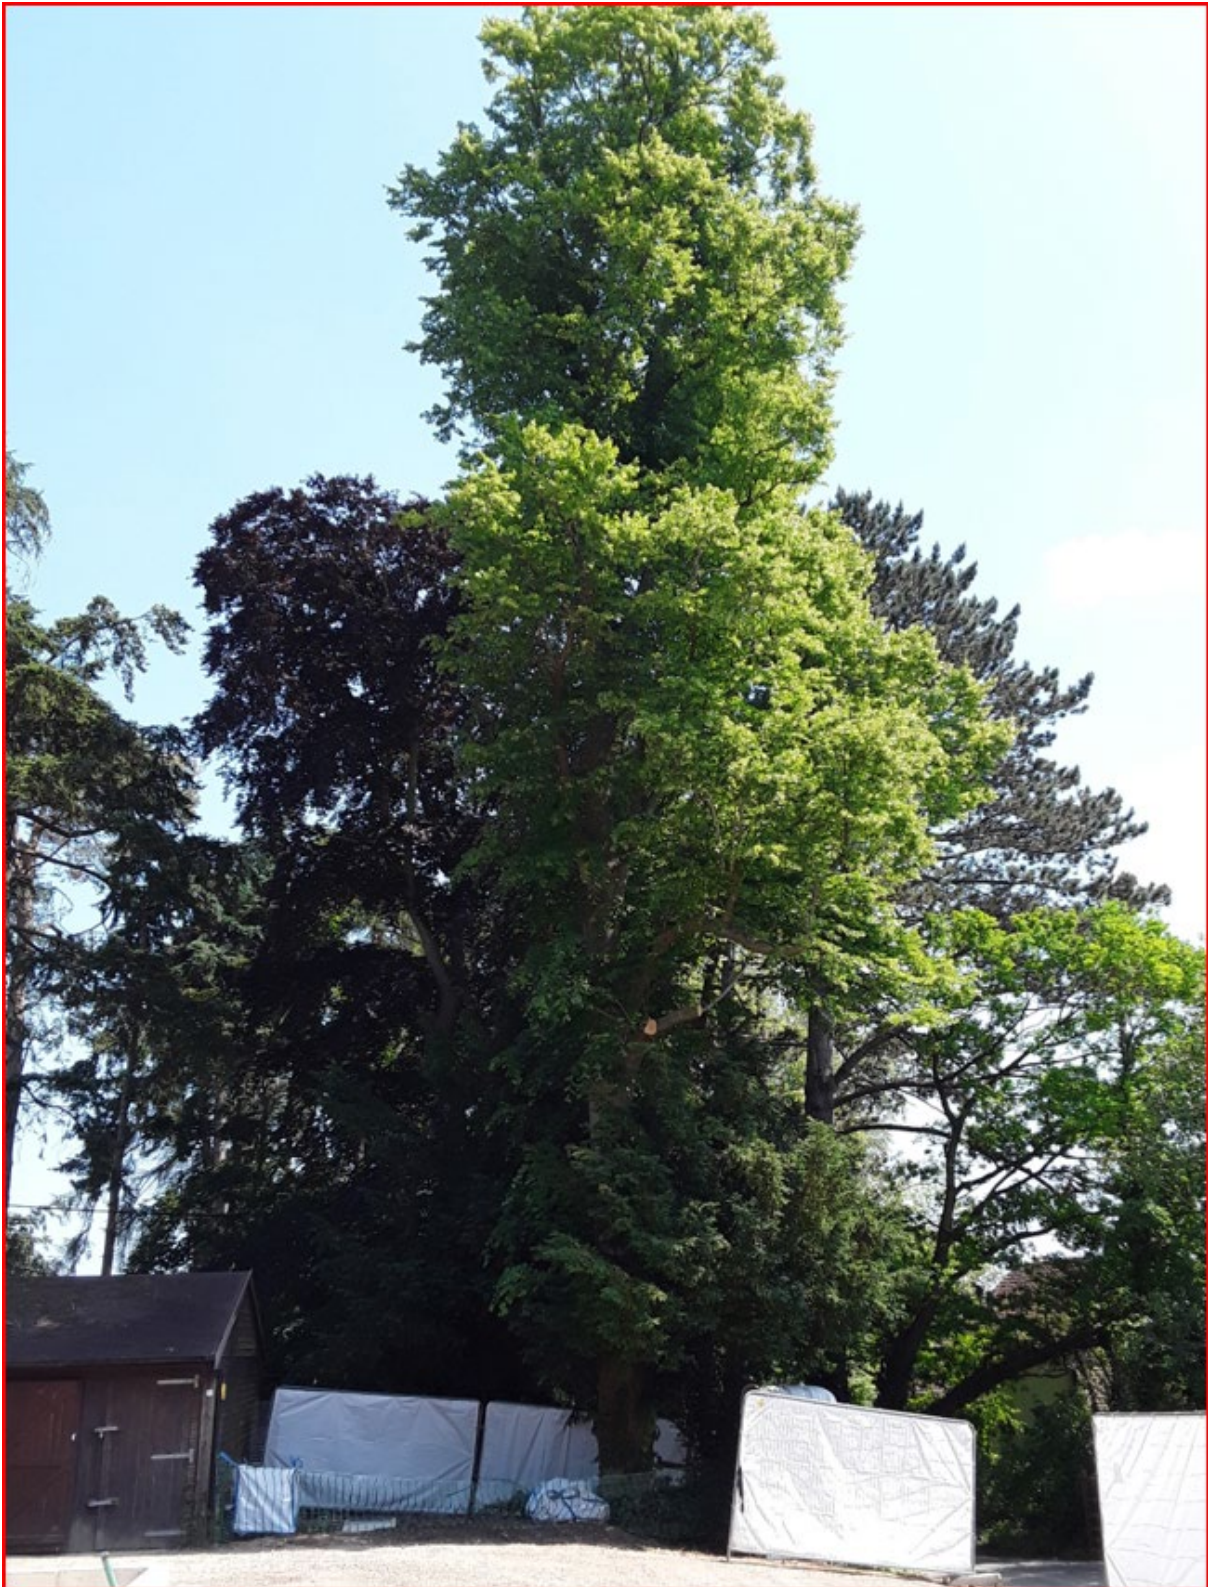
Trees T06, T07 and T10 are at the front of the site

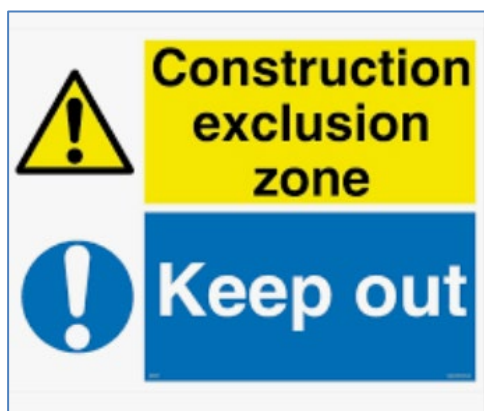
This sign must be displayed on each side of the fencing
