ARBORICULTURAL INFORMATION AND METHOD STATEMENT RELATING TO PLANNING CONDITION 17 OF CHERWELL DISTRICT COUNCIL PLANNING PERMISSION 10/01642/OUT

DEVELOPMENT AREA PHASE 2, HEYFORD PARK, CAMP ROAD, UPPER HEYFORD

**BS5837:2012 'TREES IN RELATION TO DESIGN, DEMOLITION AND
CONSTRUCTION – RECOMMENDATIONS'**

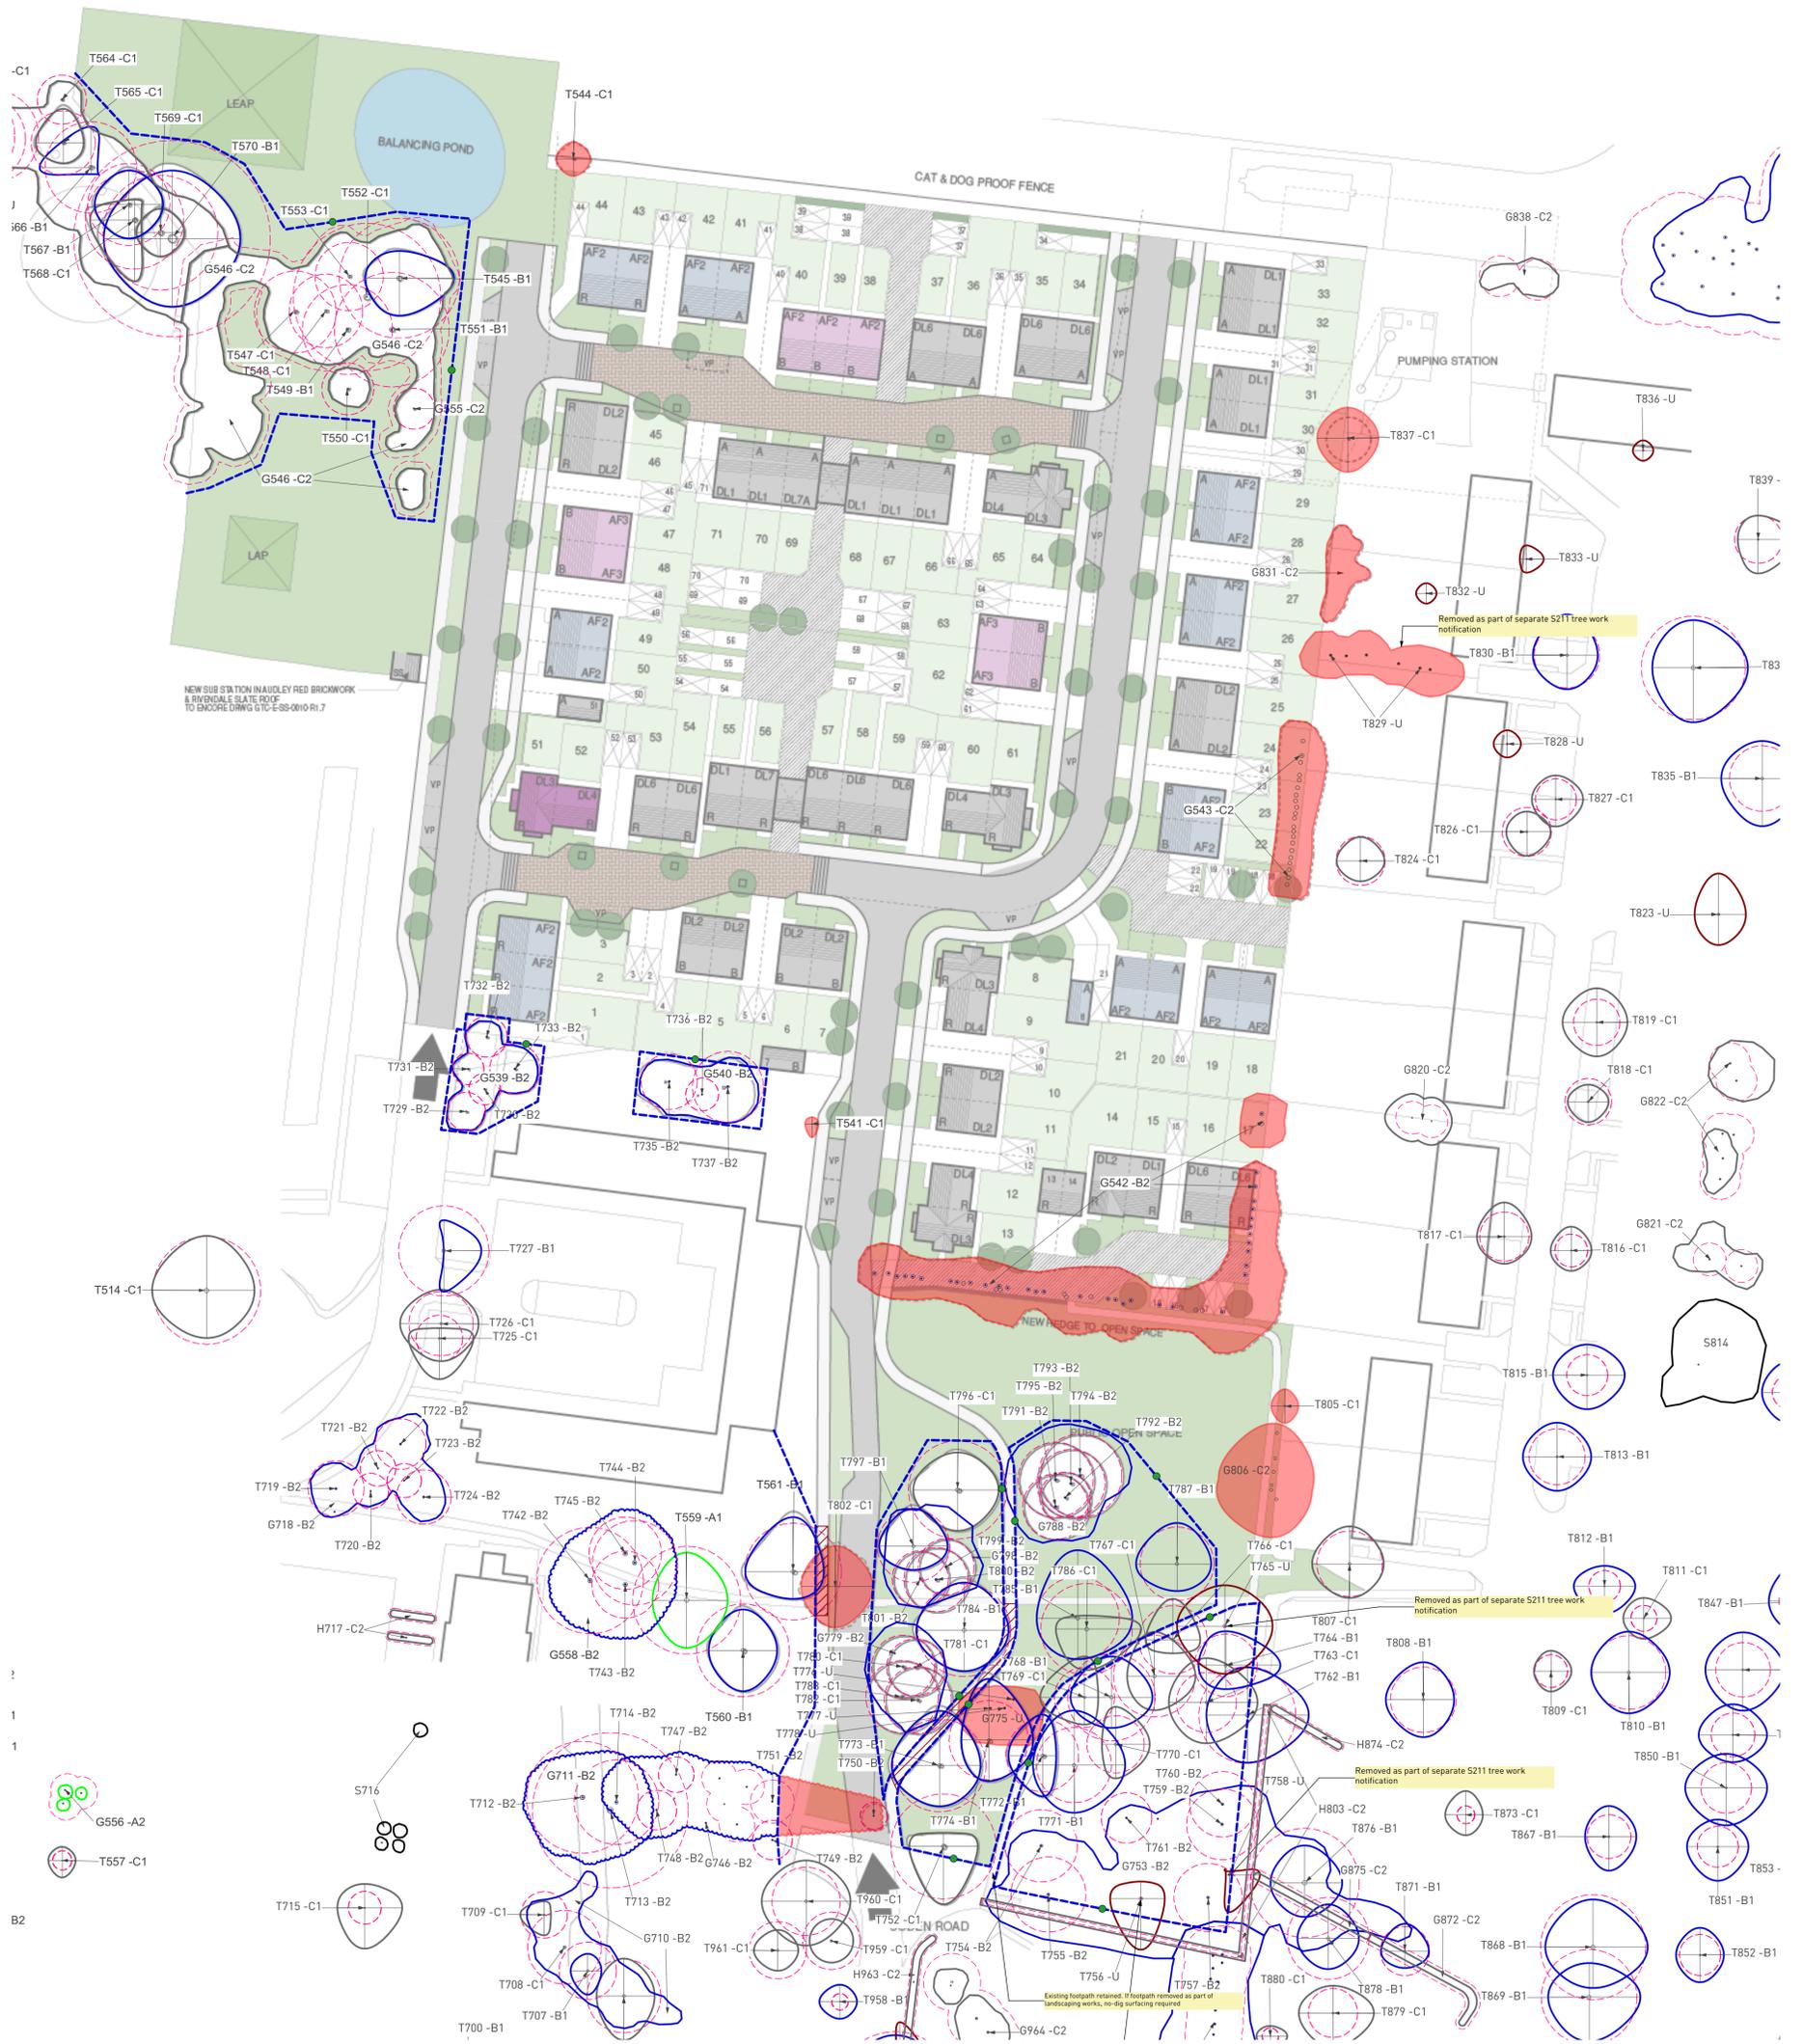
TREE RETENTION/LOSS PLAN & TREE PROTECTION PLAN

- 3.4 The TPP specifies the location of Tree Protection Barriers and Construction Exclusion Zones (CEZs). The plan also shows the location of “no dig” pathways that pass through the root protection areas.

- 3.1 Relevant sections of the site tree survey schedule are attached. Also attached is a Tree Retention/Loss Plan and Tree Protection Plan (TPP).

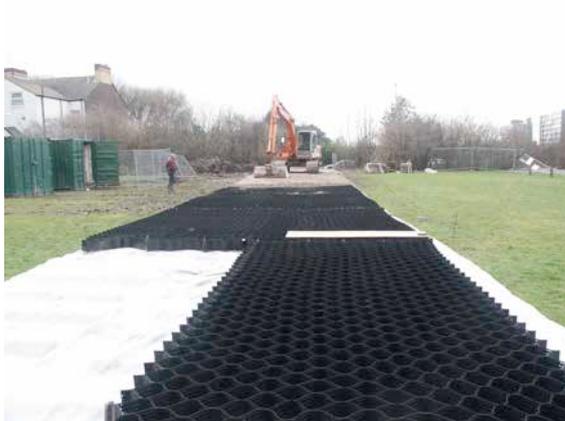
Method Statement

For The Installation of Cellweb Tree Root Protection System.

- 5.1. Lay second layer of Treetex T300 Geotextile separation fabric over the infilled Cellweb sections
- 5.2. Lay sharp sand bedding layer compacted with a vibro compaction plate to recommended depth.
- 5.3. Place block paviors as per manufacturers instructions.

Place 25mm surcharge of the granular material above the Cellweb system and lay the bitumen base and wearing courses.

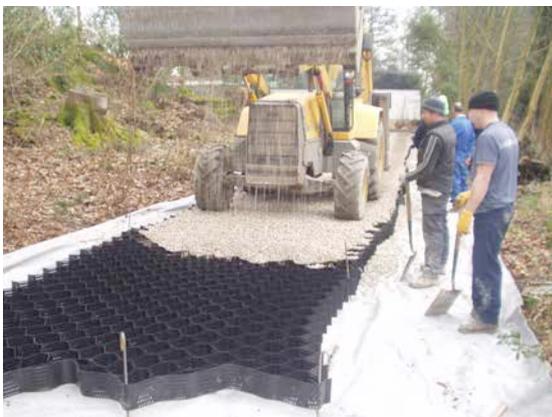
4. Cellular Confinement and Backfill Material.

Expand the Cellweb 2.56m wide panels to the full 8.1 metre length. Pin the Cellweb panels with staking pins to anchor open the cells and staple adjacent panels together to create a continuous mattress. Infill the Cellweb with a no fines angular granular fill (typically 4-20mm) within each open cell. The use of cellular confinement reduces the bearing pressure on the subsoil by stabilising aggregate surfaces against rutting under wheel loads. Comparisons between cellular confinement and traditional aggregate and geogrid-reinforced structures demonstrate a 50%

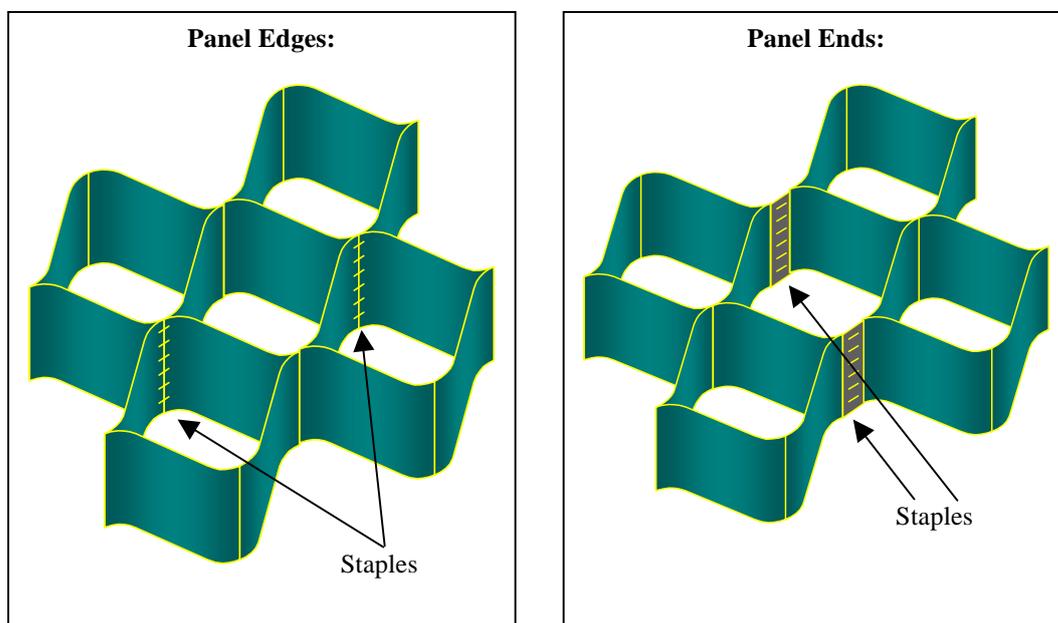
Below are illustrations of the correct stapling procedure for joining both edges and ends of panels together;
