**LONGFORD PARK, BODICOTE, BANBURY
(PHASE 1)**

ARBORICULTURAL METHOD STATEMENT

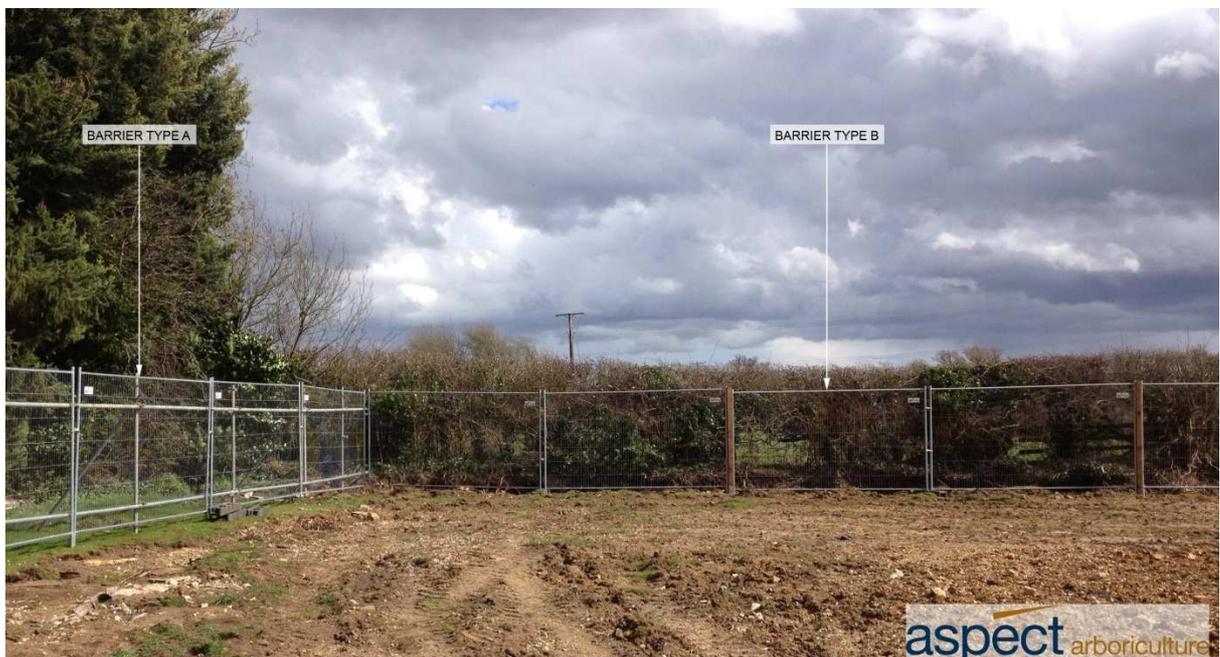
Figure1. Protective Barriers: Tree and Hedgerow Specifications for this Development

- 2.5.1 To ensure integration of retained boundary trees, it is essential to protect their above ground structures and underlying rooting environment from damage during construction. The use of barriers will reasonably prevent: impact damage from construction plant, root tearing, root and soil compaction and soil contamination.
- 2.5.2 The default barrier specifications for this development will consist of the default BS 5837:2012 specification adjacent to trees (shown as barrier type A below) and a revised specification with the absence of 45° braces for hedgerows (barrier type B below).
- 2.5.3 Hedgerow barriers will be secured with the use of pinned rubber feet and a driven 100x100mm timber posts on every second panel as shown below (barrier type B).

The use of mixed barrier specifications has been agreed with CDC's Arboricultural Officer (pers.comms September 2013).

2.5.4 Barrier *positions and specifications* are illustrated in appendix B.

- a. Barriers adjacent to G10 and G14 will be offset from the post-flailed canopy by 1m;
- b. Barriers adjacent to G12 will be erected along a 2m offset from the post-pruned canopy;
- c. Barriers adjacent Tree nos. 10-12 and G7 to be off-set by 11m from the offsite boundary;
- d. Barriers adjacent to Tree nos. 1-5, G4 and G5 to be offset by a minimum distance of 5m from trunks.
- e. Barriers adjacent to T13 will be to be off-set by 15m from its trunk.

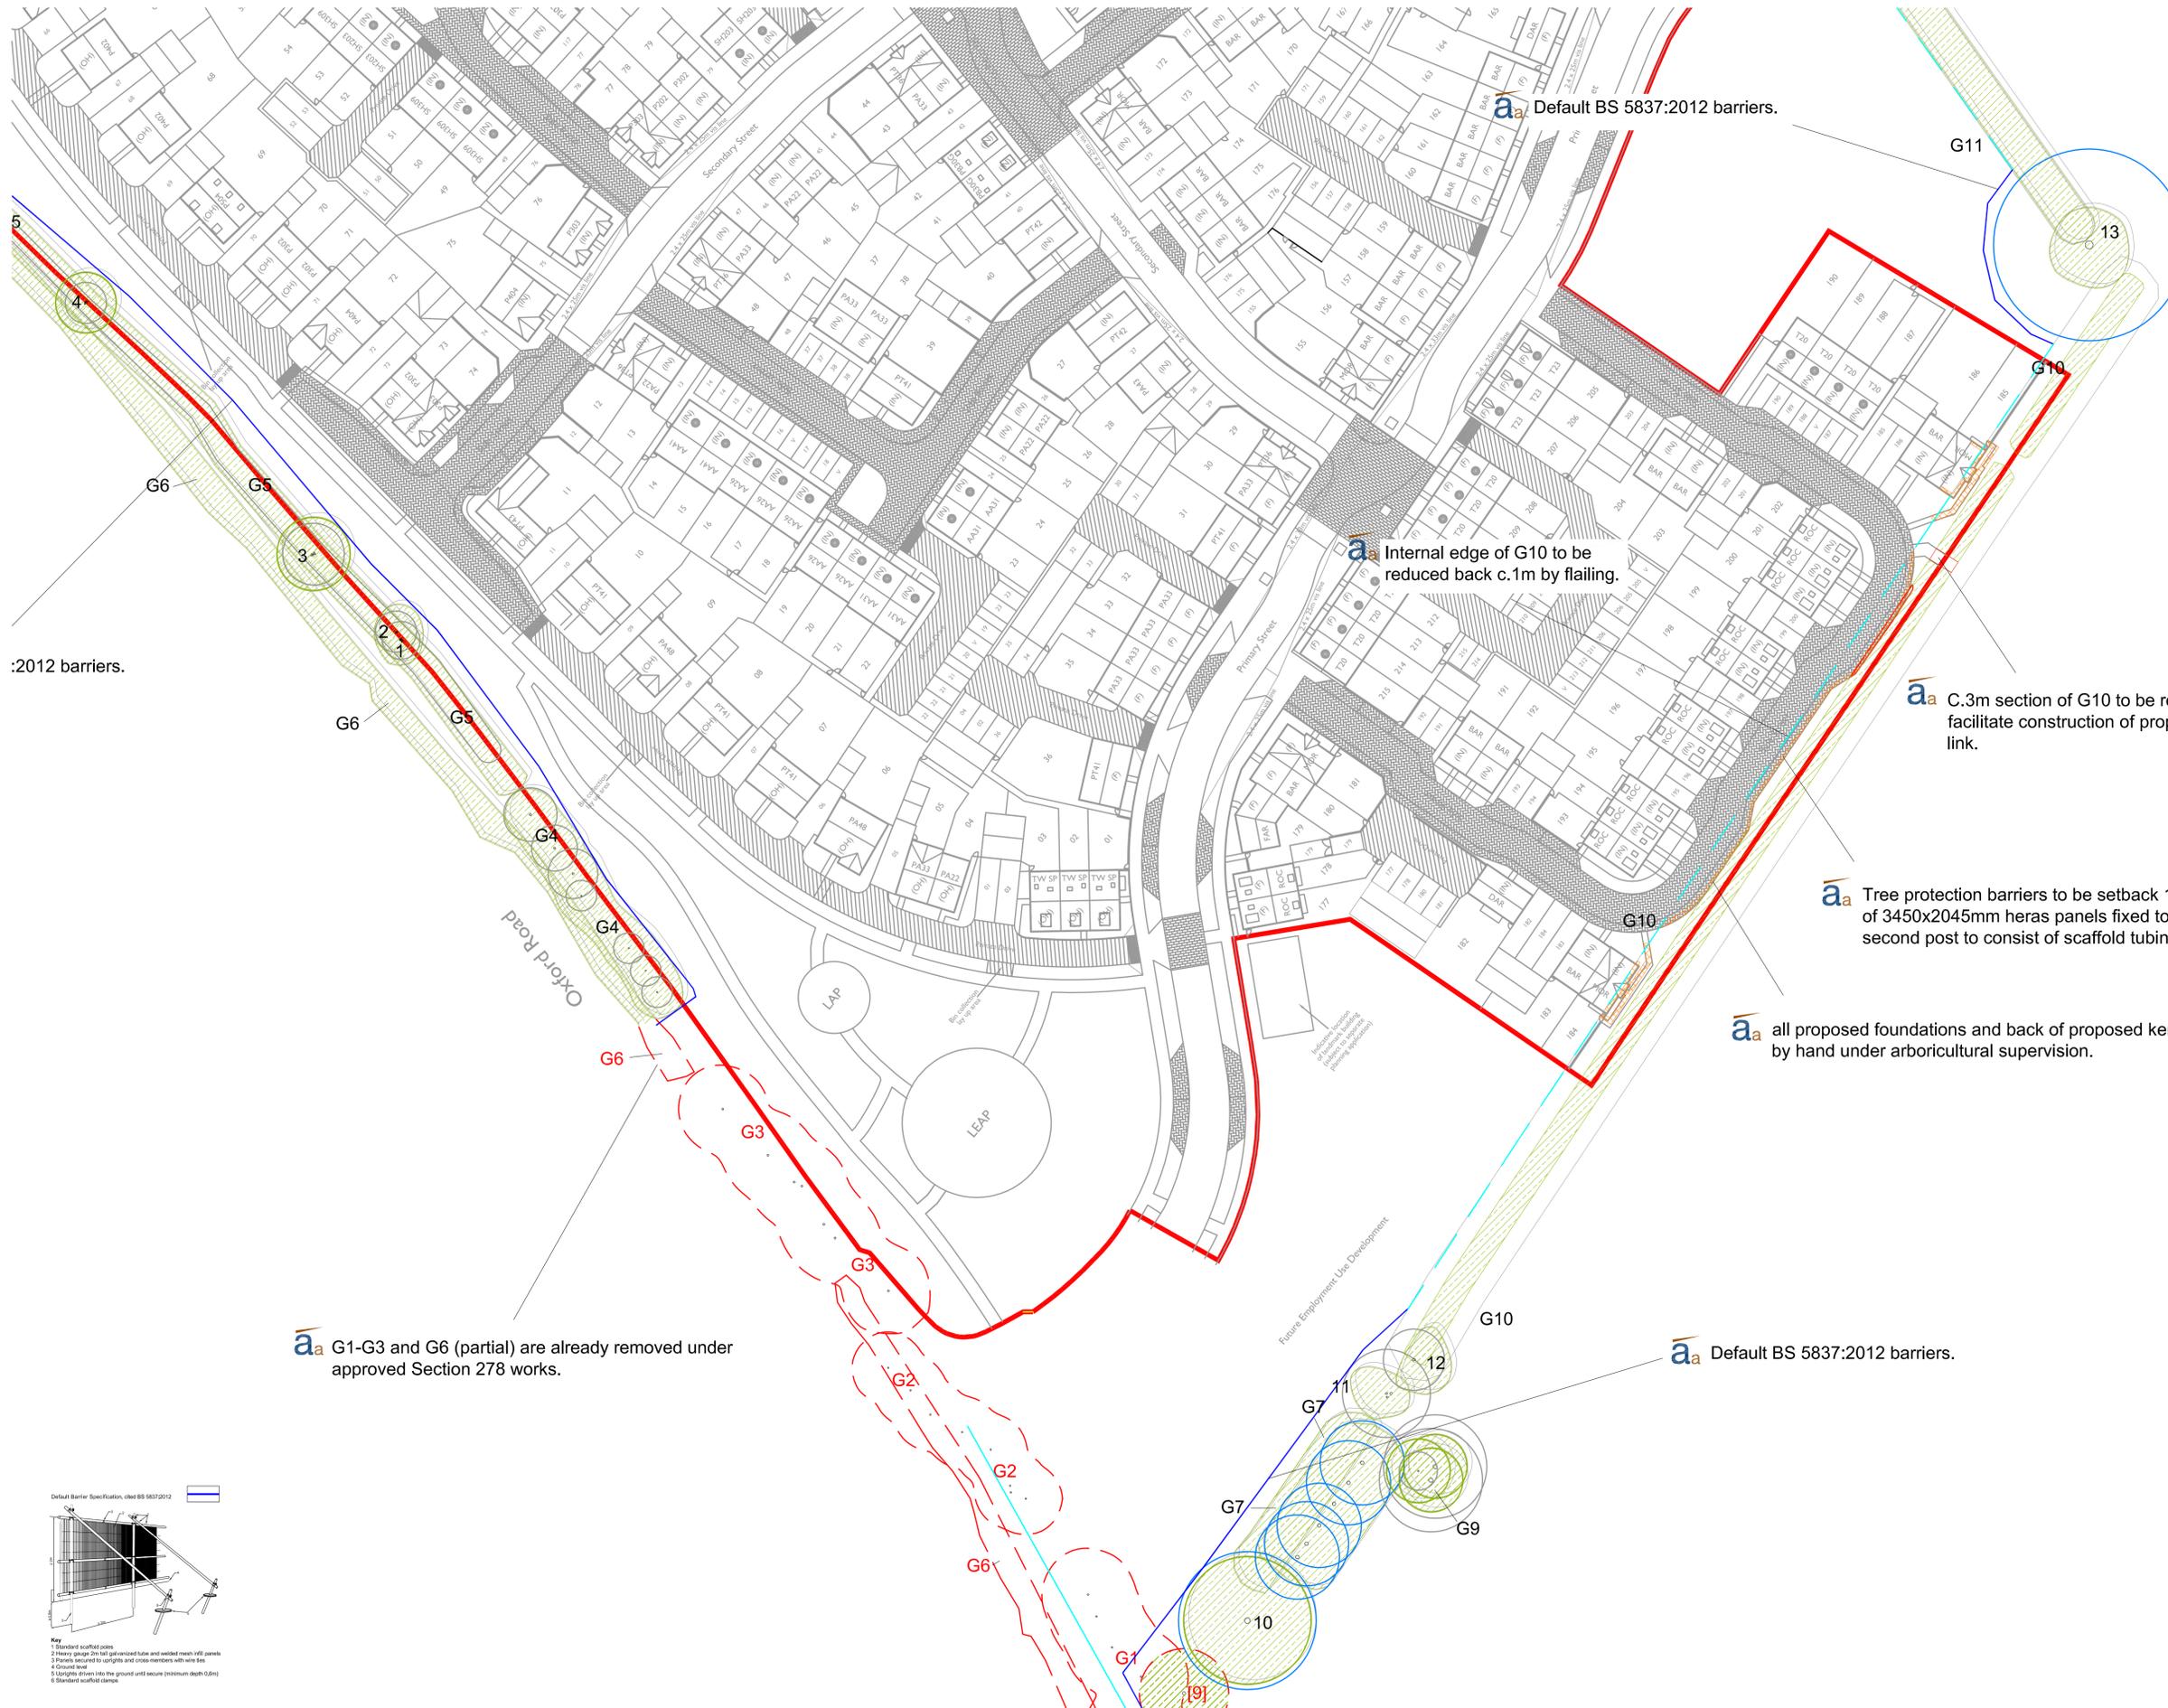
SCALE 1:500 @ A1	DATE SEPT 2013	DRAWN JB
DRAWING NUMBER 8667 TPP 01 North	REVISION G

a_a Barrier position for T15 as agreed on site due to previous plough disturbance (pers. comm. July 2013).

a_a G12 to be pruned back by up to 2.5m by shortening of secondary branches.

a_a Tree protection barriers to be setback 1m from post-flailed canopy.

a_a Internal edge of G14 to be reduced back c.1m by flailing.

a_a Hedgerow protection barriers to be setback 1m from post-flailed canopy (Barrier type B consisting of 3450x2045mm heras panels fixed to 100 x 100mm timber posts for full height. Every second post to consist of scaffold tubing with pinned rubber anchors).

a_a C.3.5m section of G5 to be removed to facilitate construction of pedestrian footpath.

a_a Hedgerow specification barriers (Barrier type B).

a_a Internal edge of G10 to be reduced back c.1m by flailing.

2.1.1 *The tree protection drawing provided in appendix B will be relied upon during setting out of the site and during construction. It should be read in conjunction with the entirety of this document.*

The project arboriculturist will be responsible for the setting-out and monitoring of protective barriers and will work to a 1:200 scale version of the Tree Protection Plan in appendix B. The frequency of monitoring will be set at 8 week intervals for the duration of construction; issues will be resolved on site and reported to CDC's Arboricultural Officer.
