Client	Mr & Mrs. Besterman
Project Address	Muddle Barn Farm, Sibford Gower, Oxon, OX15 5RY
Project Description	Replacement Dwelling

Drawing Title | Proposed Site Elevations sh1 of 3

Rev. D Drawing No. **1759.117**

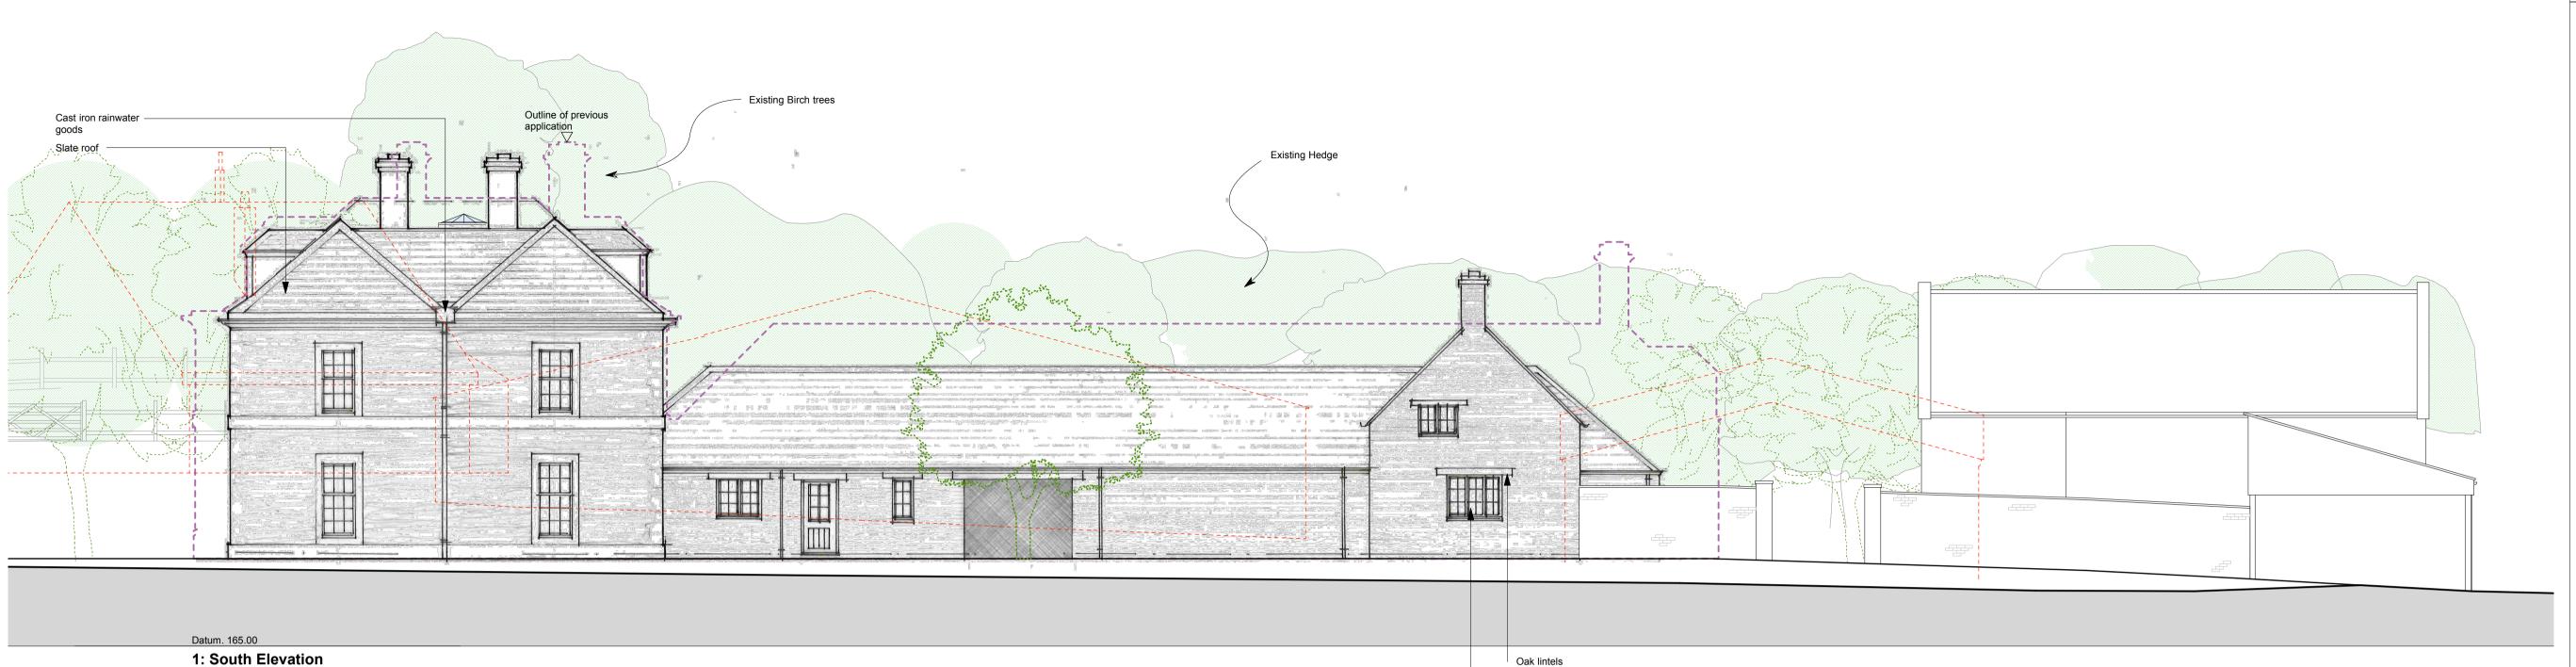
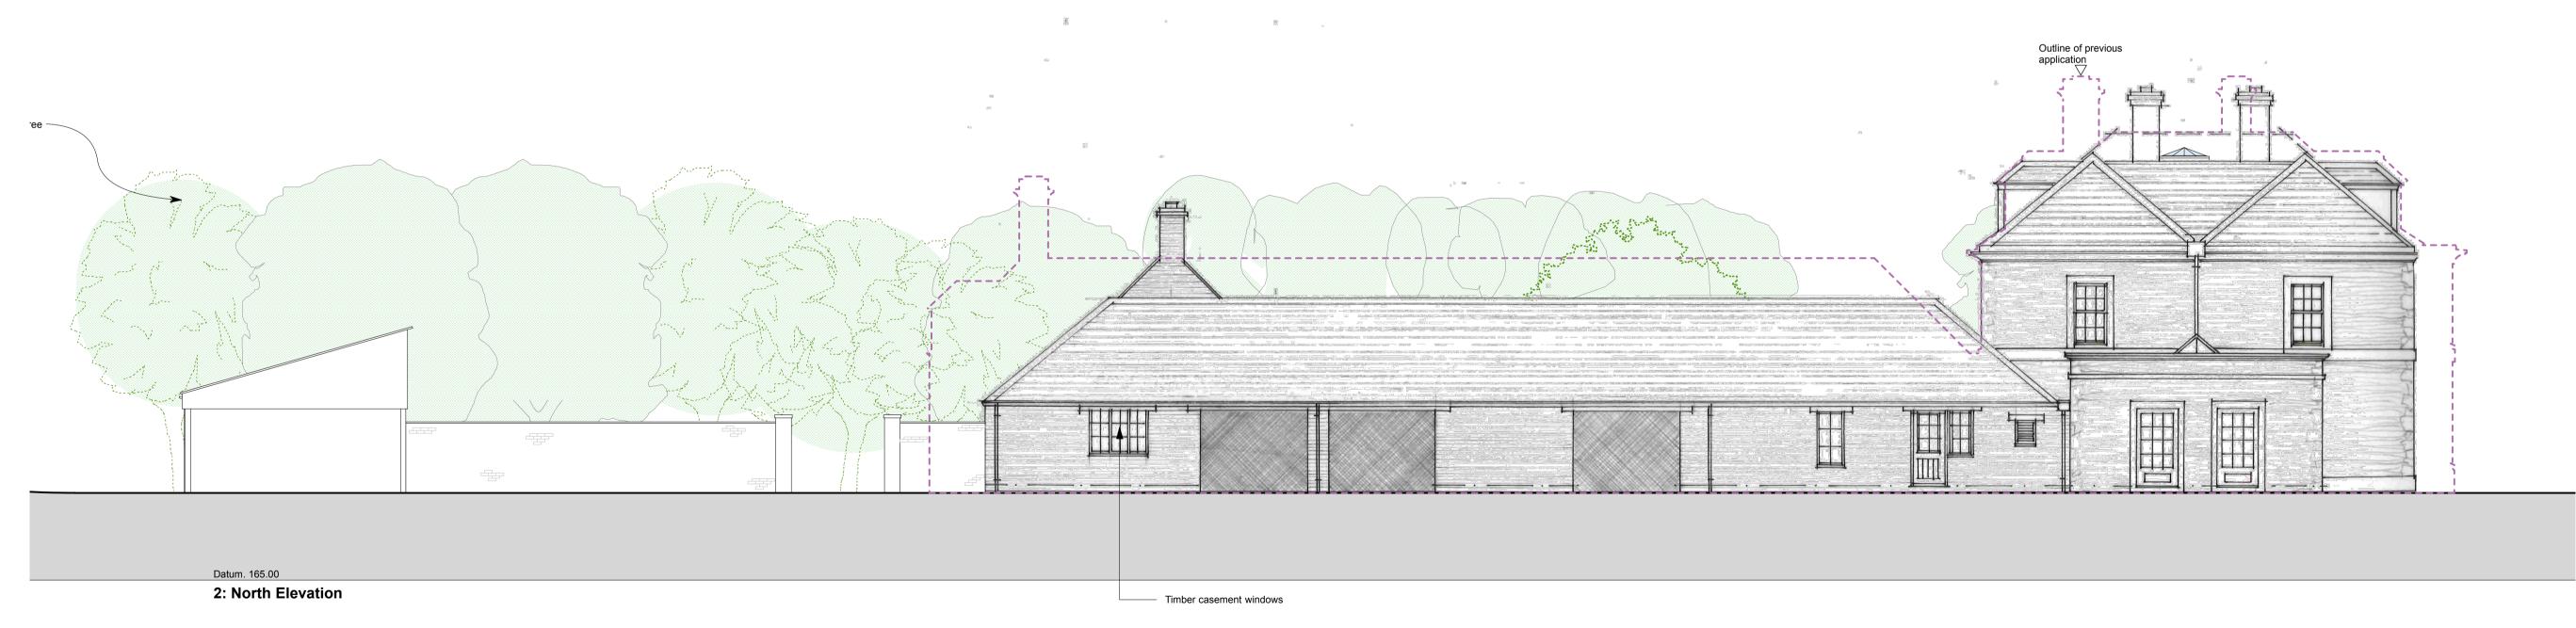
Timber casement windows

Walls - Coursed local oolitic limestone with ashlar detailing and hand made multi red bricks with lime mortar pointing to lower wing.

Roof - Slate

Windows/Doors - Double glazed painted timber

Rain Water Goods - Painted Cast Iron
