Muddle Barn Farm, Sibford Gower, Oxfordshire

Landscape and Visual Assessment for a  
Replacement House

December 2014  
(Revised January 2016)

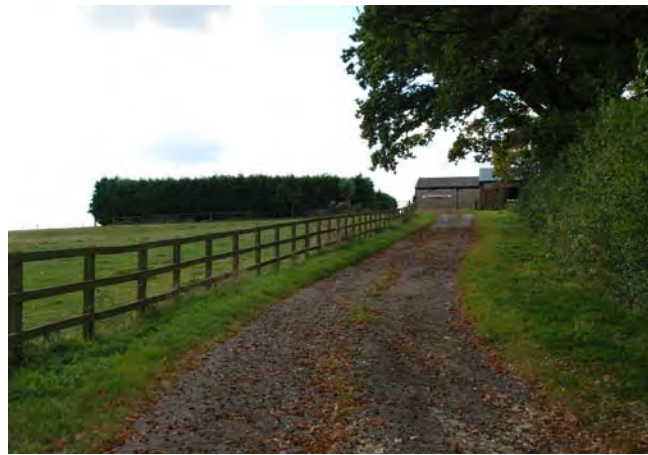
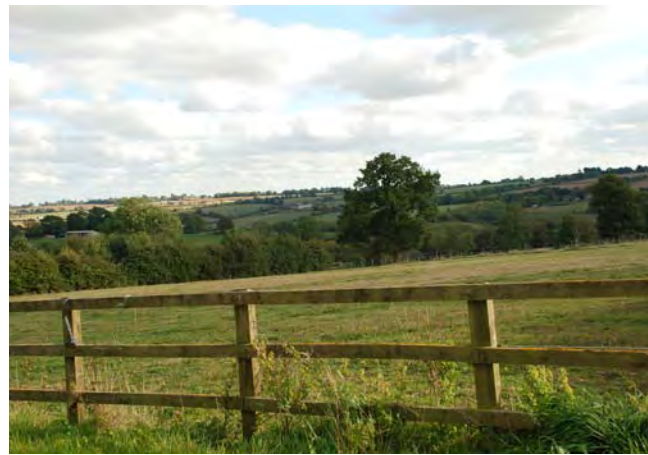
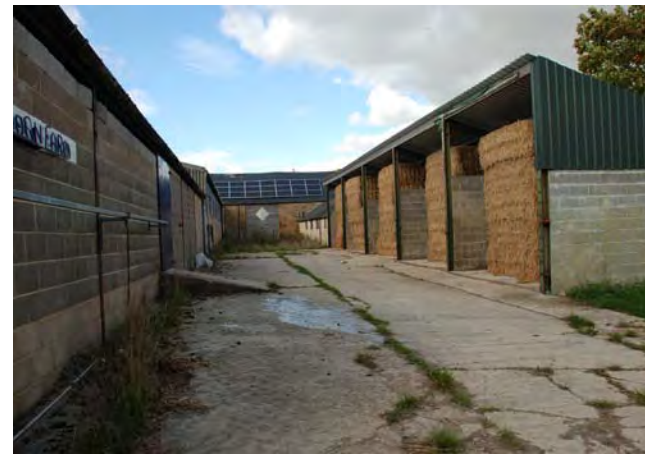
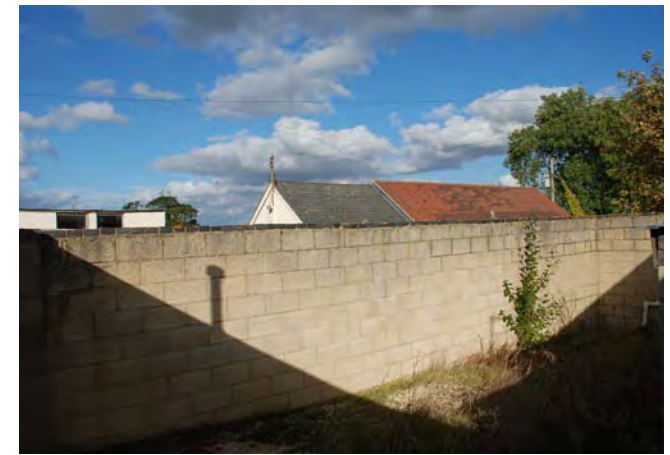
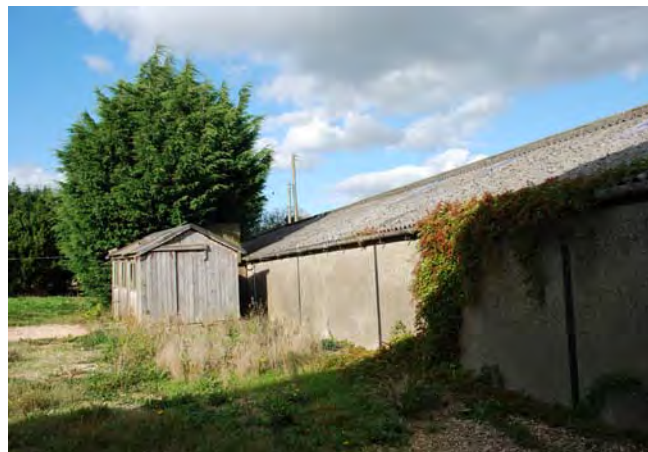
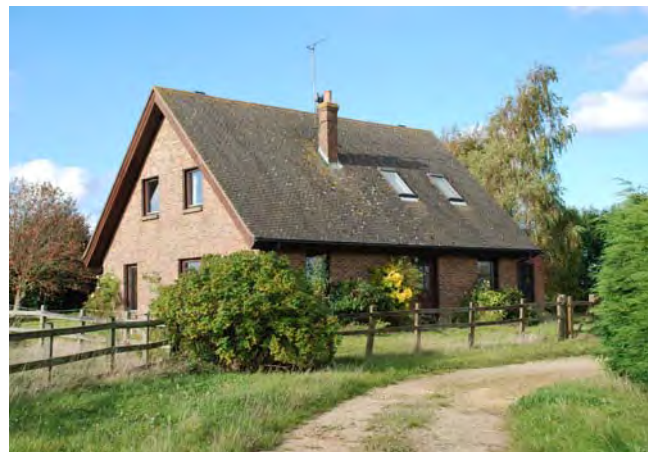
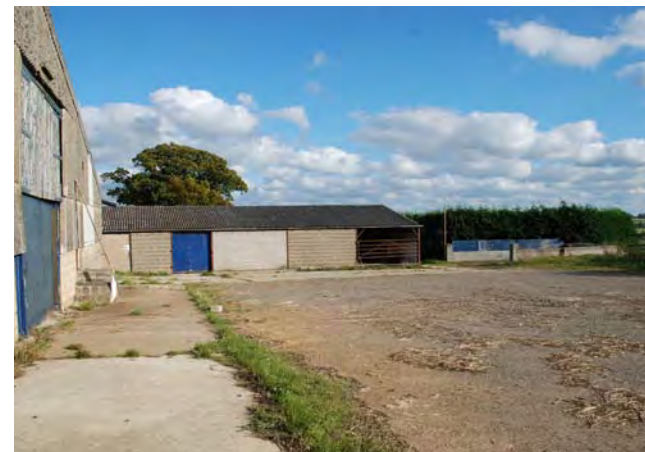
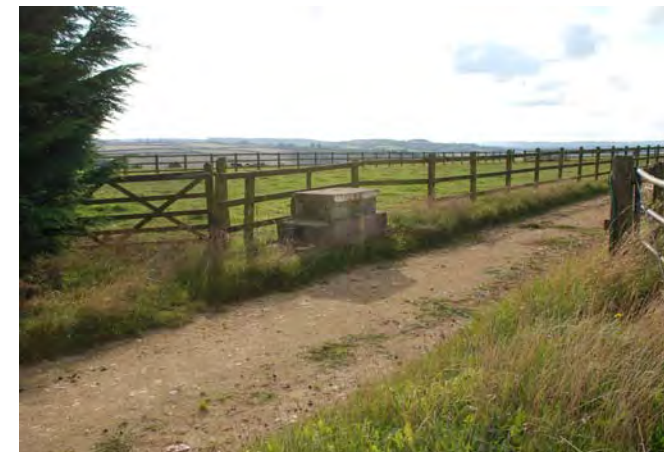
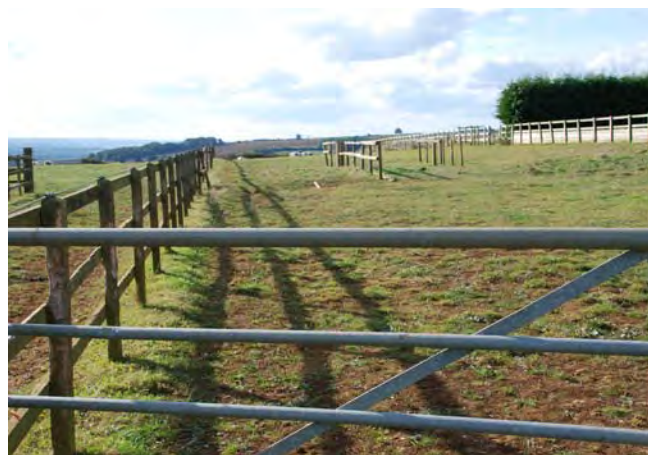
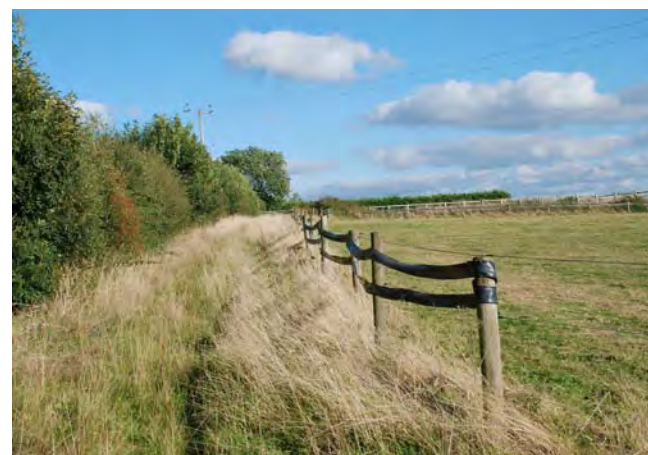
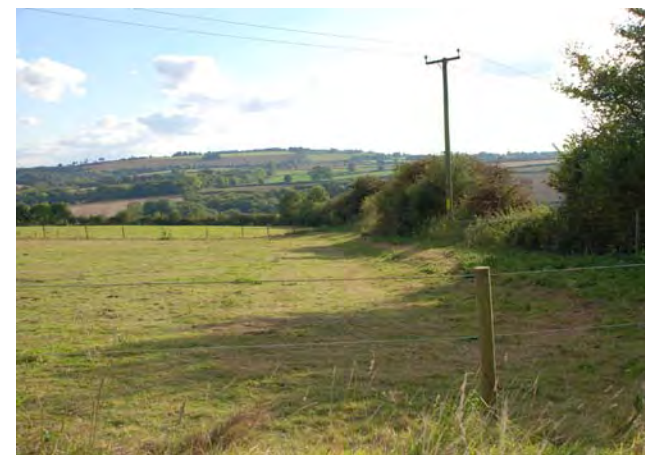
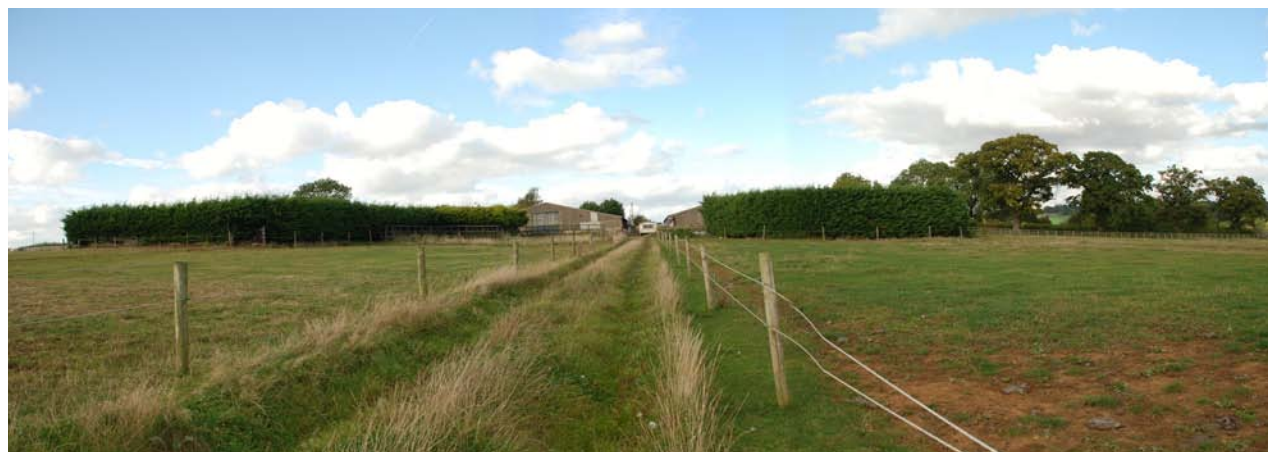
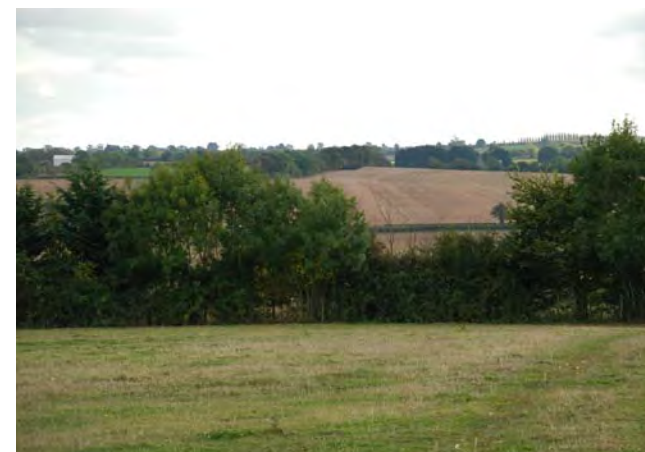
Figure 3

1. Existing access drive

2. Part hedge part fenced east boundary

3. Existing barns to left and right.  
New Barn Farmhouse at centre.

4. Boundary wall. New Barn Farm out buildings  
to north of wall

5. Existing barn at north boundary

6. Existing farmhouse

7. Existing yard looking east

8. Horse paddock fencing, looking southeast

9. Horse paddock, looking west.  
Manege to right of picture.

10. Outgrown hedge along north boundary.  
Manège leylandii hedge on skyline to right.

11. Outgrown hedge along west boundary

12. View from south to yard with lunging pens to left and right

13. Outgrown hedge along south boundary

- 1.3 The site is located on the Oxfordshire/Warwickshire border, 7.5 miles from Banbury, and approximately 1 mile to the south west of the village of Sibford Gower (see Figure 1). The 12.3ha land holding includes pasture, paddocks and equestrian facilities. Muddle Barn Farm is approached by a long driveway that crosses a yard (A) and leads around to the existing farmhouse (B). In addition to the farmhouse there are three barns converted for livery and the exercise of horses (C, D, E) and one barn currently used for storage (F). South of the yard there is a round lunging pen and separate lunging lanes both protected by 3.3m tall Lawson Cypress hedges (G). To the east of the house there is a manege measuring 60 x 20m (H) and a grass dressage arena of similar dimensions (I). These features are shown on Figure 2. Hedges along its north, west and south sides, and part of the east side bound the property. The remaining east boundary comprises walls and fences. Within the site there are four further Lawson cypress hedges but all other field/paddock boundaries within the site are fenced. Photographs of the site are shown in Figure 3.

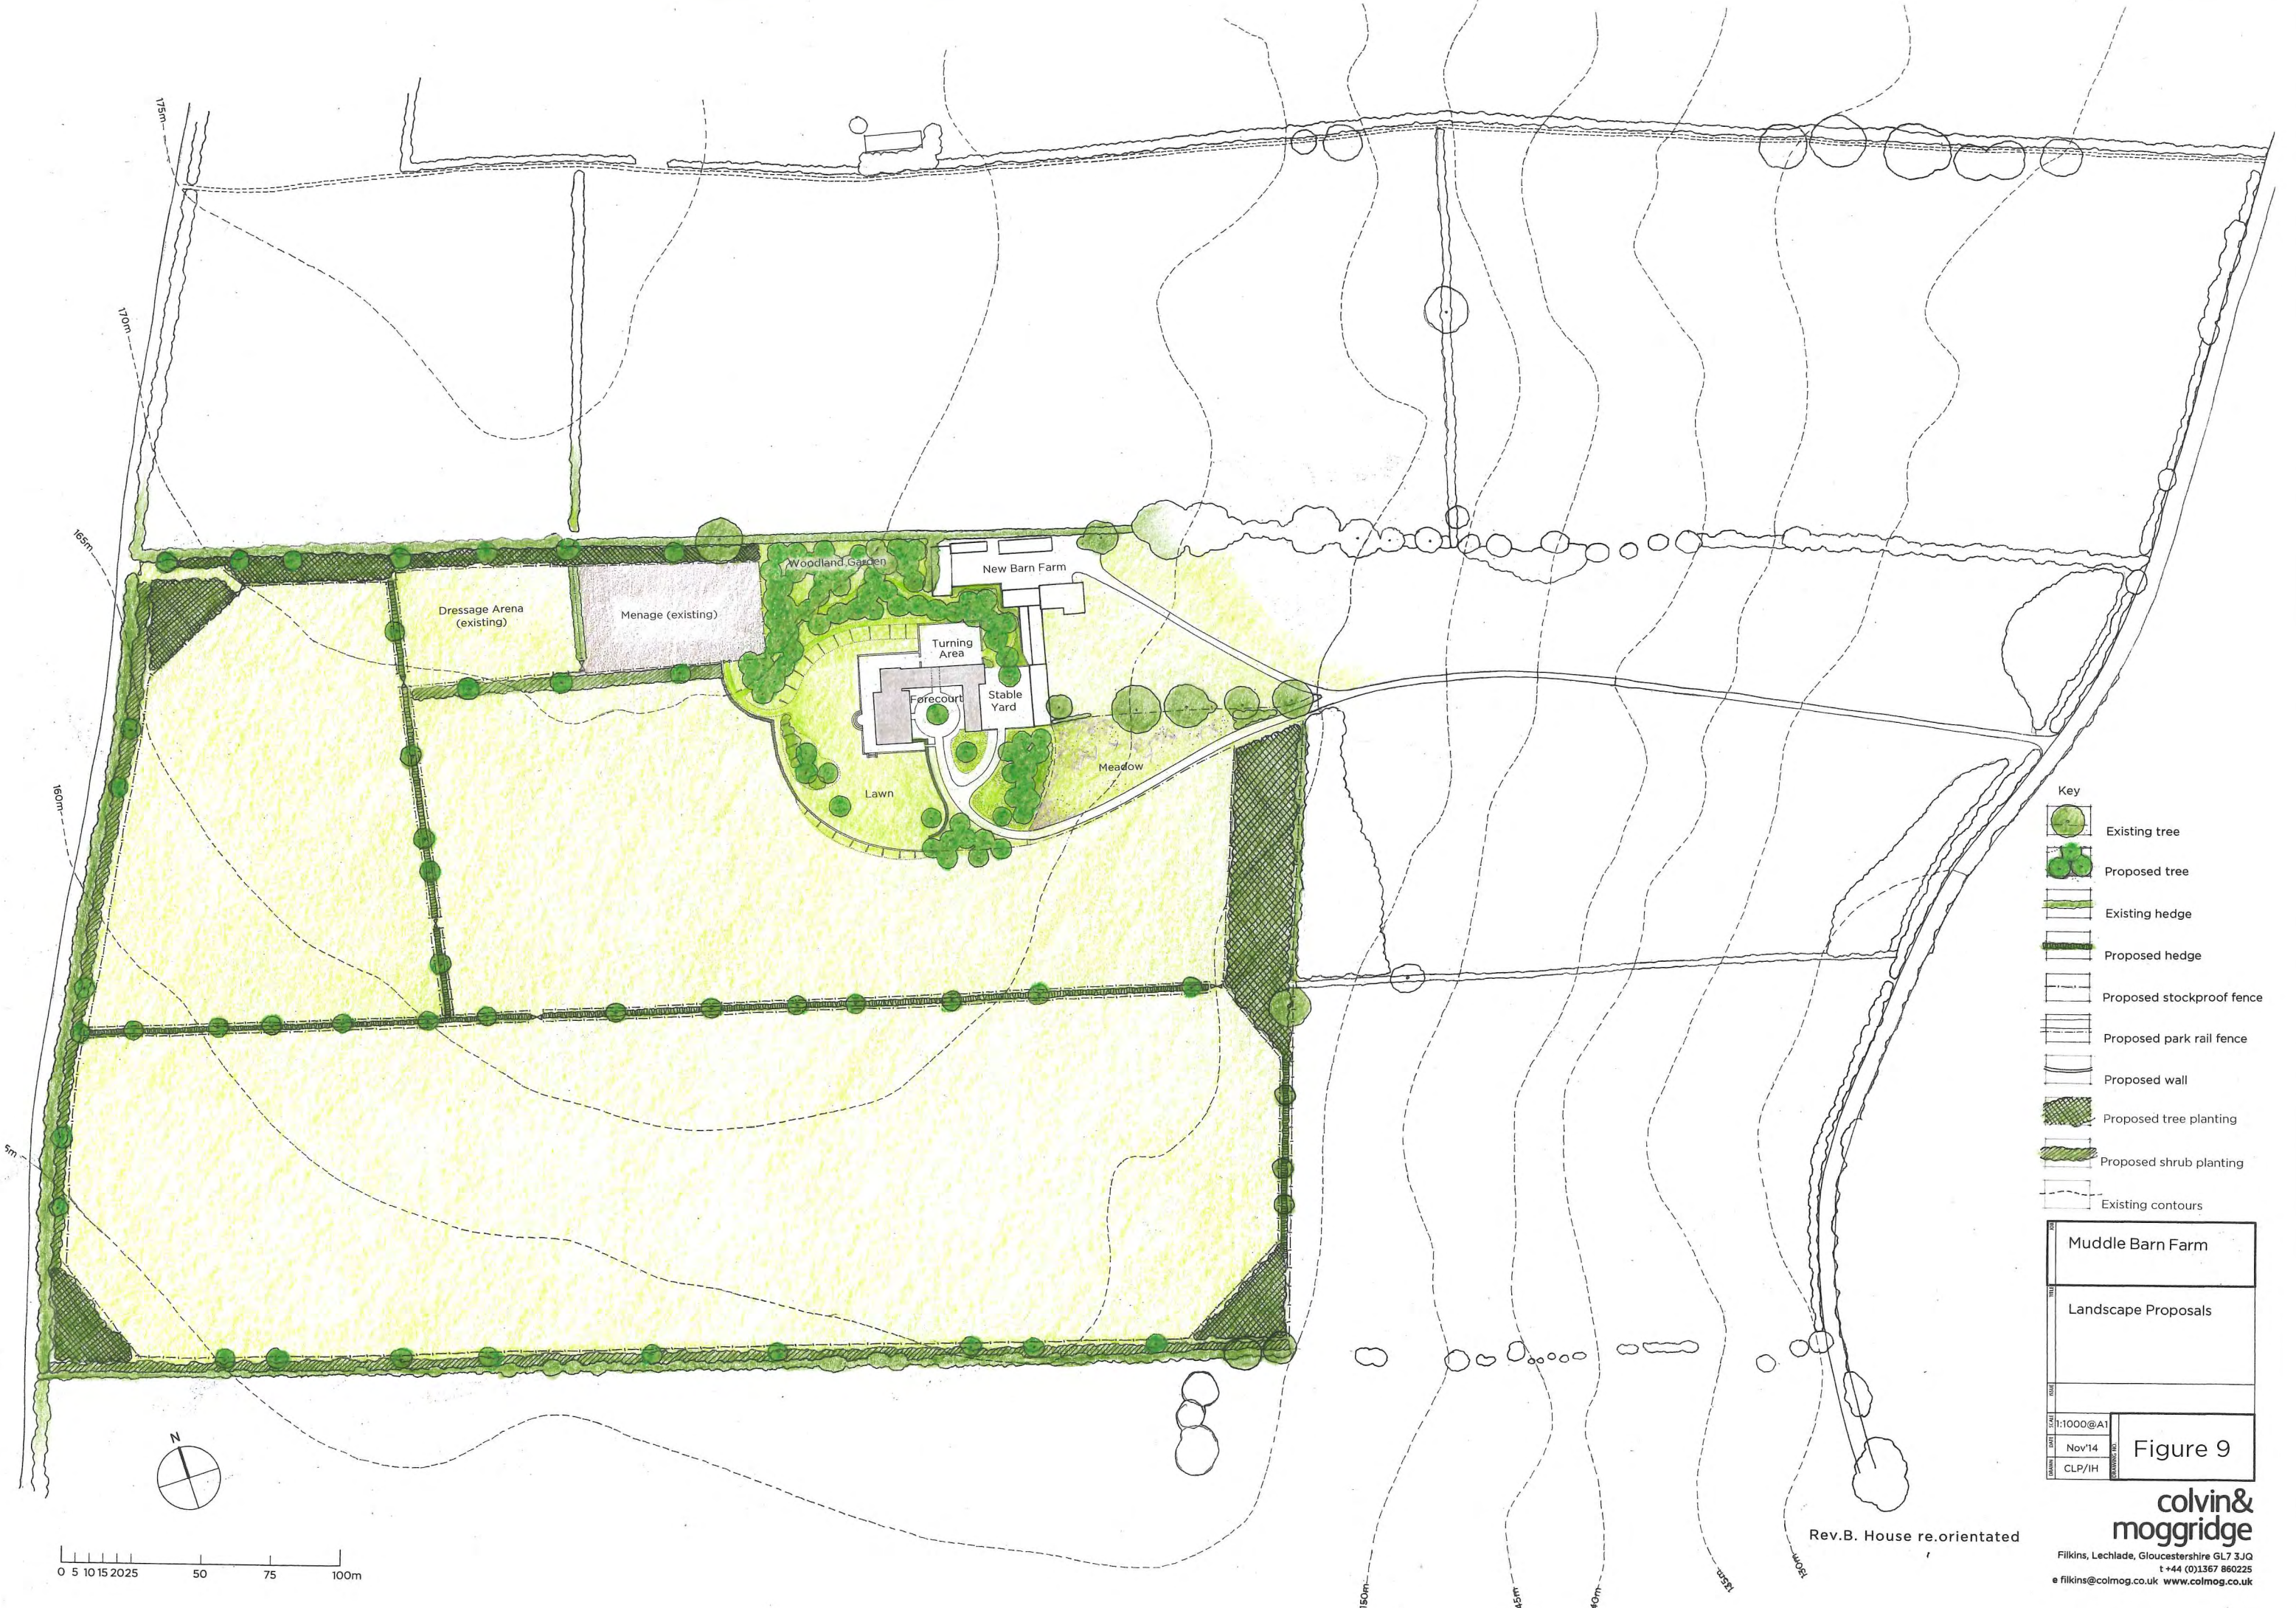
Muddle Barn Farm	
Landscape Proposals	
Scale	1:1000@A1
Date	Nov'14
Drawn	CLP/IH

- Key**
- Existing tree
  - Proposed tree
  - Existing hedge
  - Proposed hedge
  - Proposed stockproof fence
  - Proposed park rail fence
  - Proposed wall
  - Proposed tree planting
  - Proposed shrub planting
  - Existing contours

Rev.B. House re.orientated

- 4.3 Figure 9 shows the landscape masterplan to be developed with the proposed replacement house.
- 4.4 The existing access to Muddle Barn Farm will be replaced with a new gravel drive positioned away from the neighbour's garden boundary to give a sweeping approach to the replacement house. Open-fenced along its south side to allow countryside views, to the north side a wildflower meadow will be established on the area of the former drive and retained grassland. Tree planting between the house and meadow will conceal the house from view until the entrance gate is reached.

new boundary planting is set back from it to allow a strip of tall grassland to establish as well. Some small native woodland plantations are proposed to provide further habitat diversity and reduce the effect of the replacement building on the wider landscape. Combined these measures will consolidate the ecological interest of the hedges, and strengthen landscape character and cross-site connectivity.

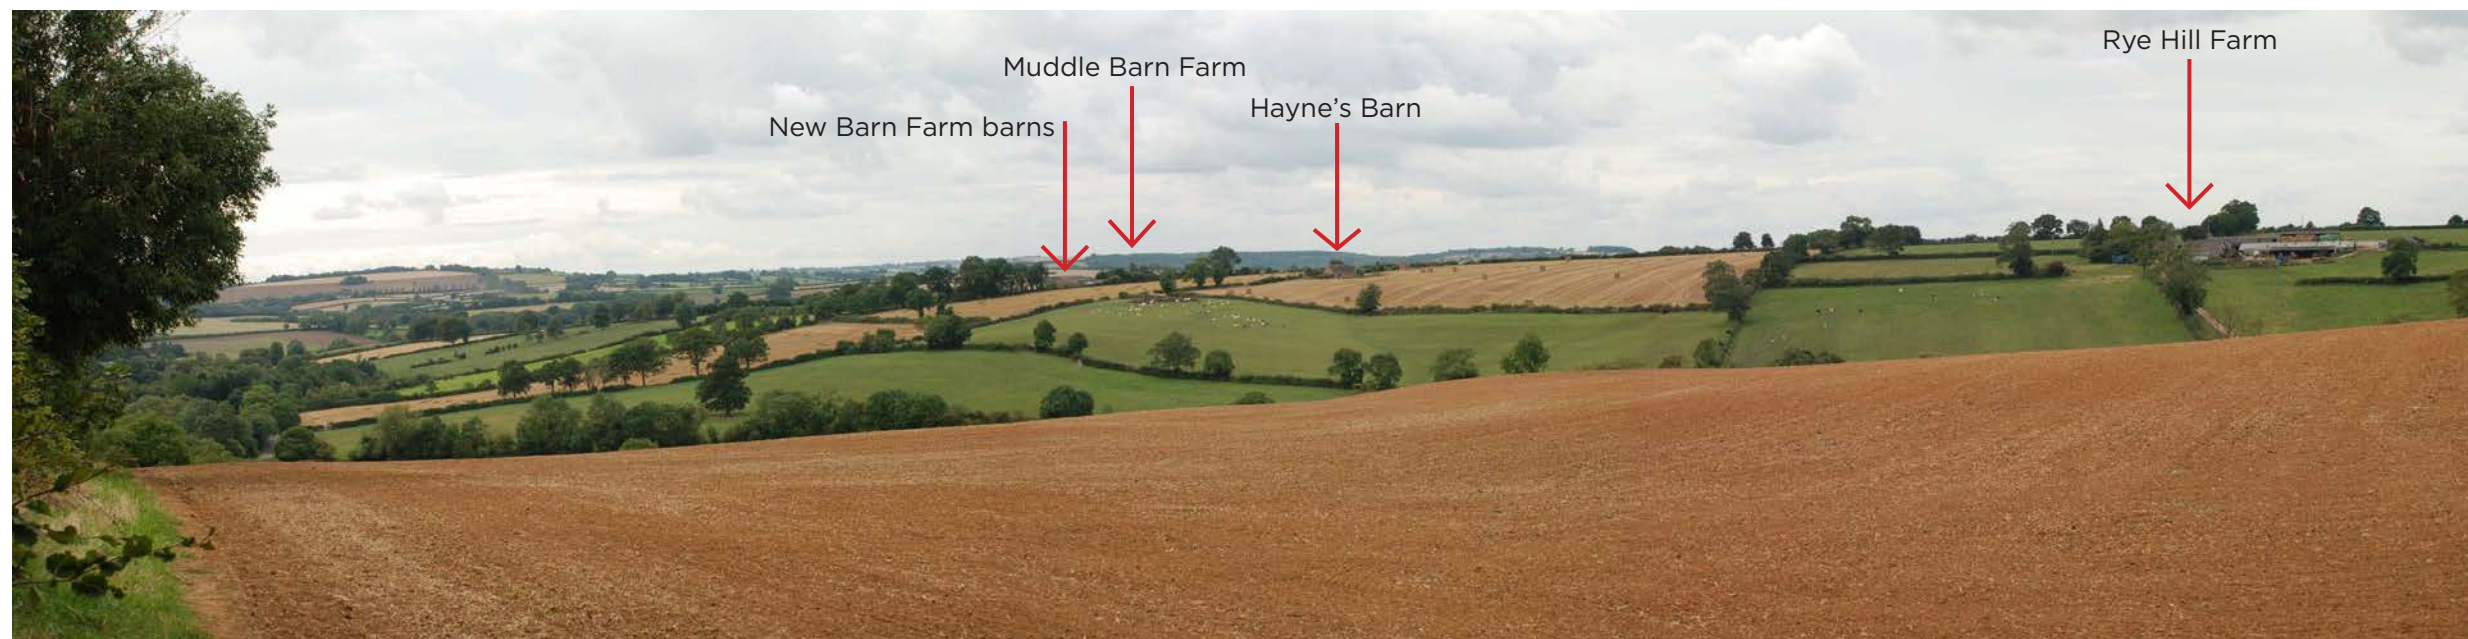
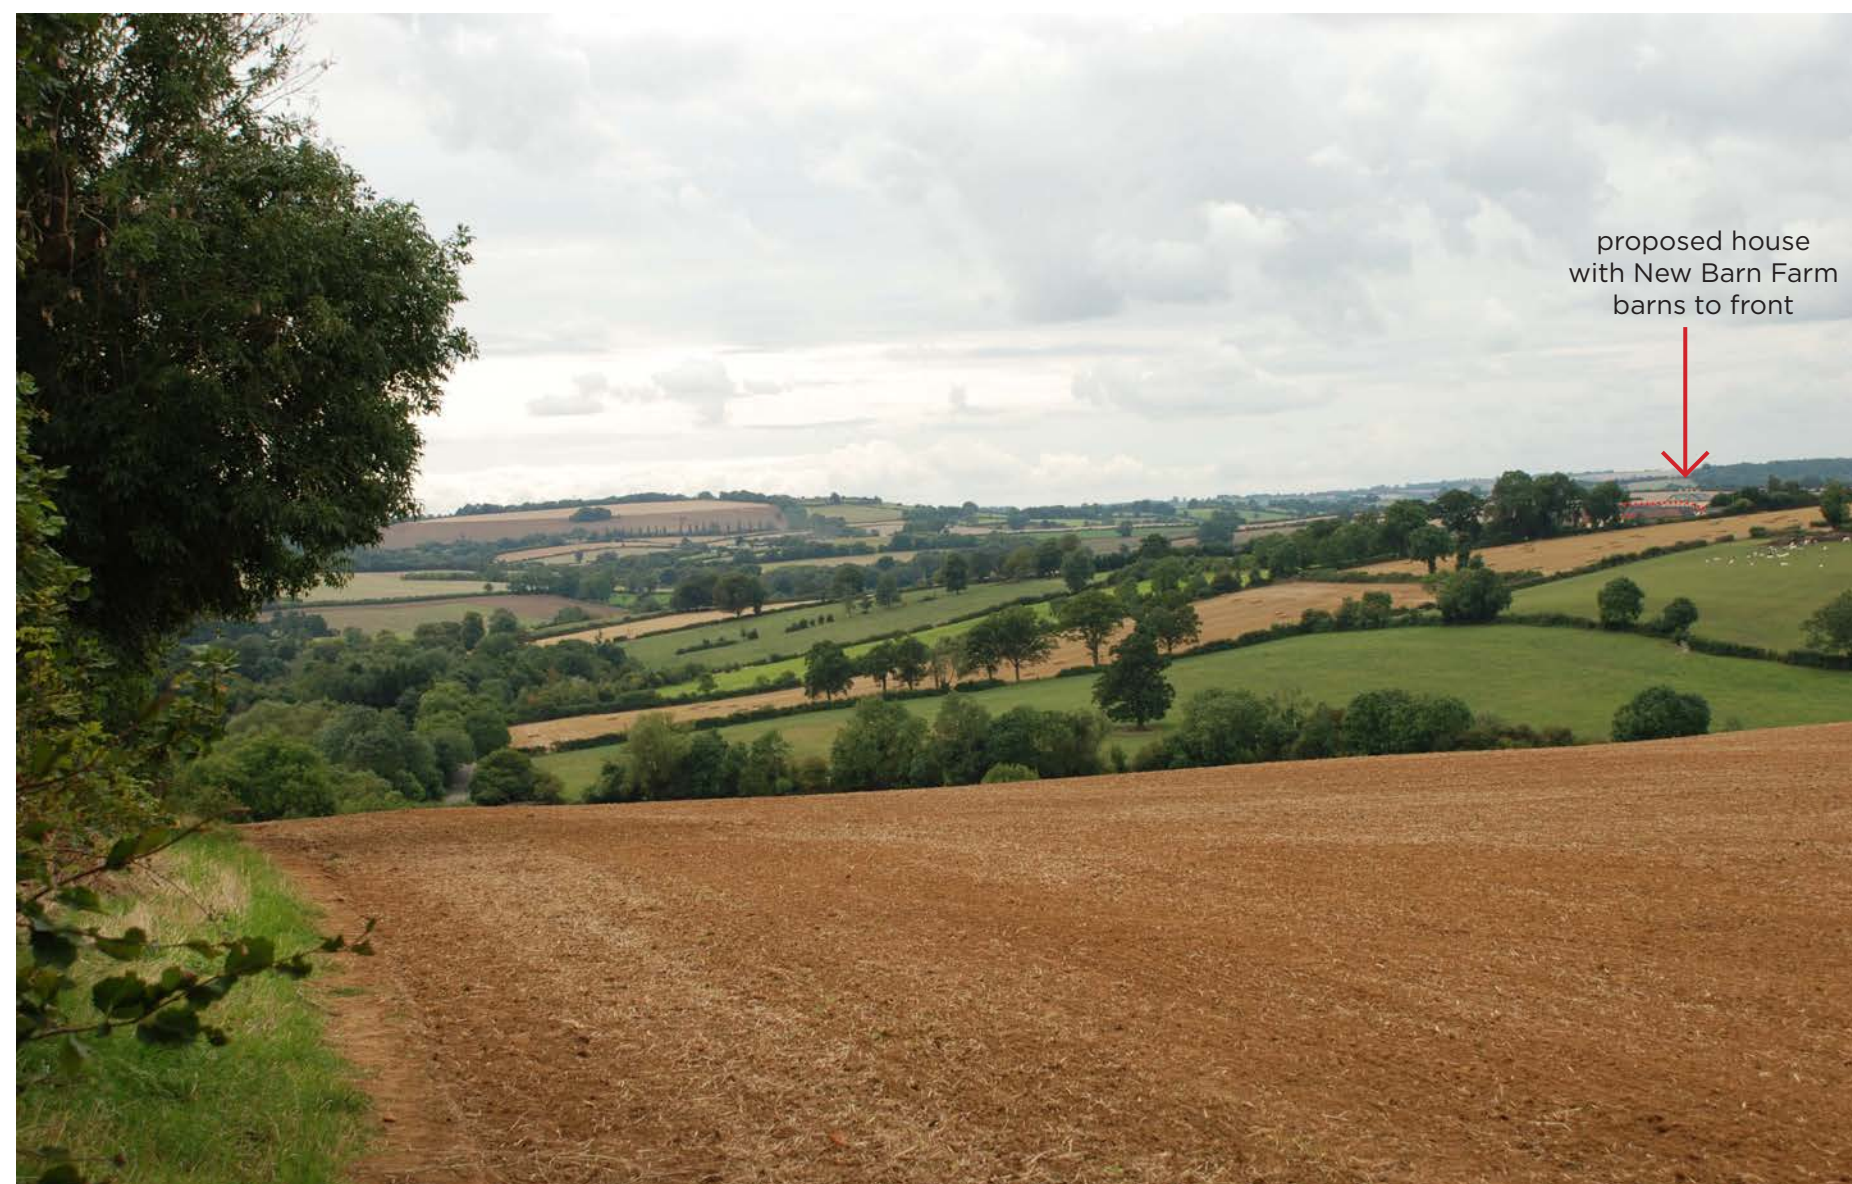
Figure 10  
Viewpoint photograph 1A  
Footpath 348/7

Zoomed in view showing replacement house (buildings to be removed shown with dashed red line)

- 6.13 Magnitude of change: The proposed replacement house will occupy the space of the barns to be removed and will be seen against the skyline. The existing house is inconspicuous and the proposal will introduce a prominent element larger in scale than the existing buildings. The area is already occupied by buildings: New Barn Farm is clearly a dwelling so the proposal is not uncharacteristic of the existing landscape, and the close association with existing buildings will help to bed the replacement house into the landscape. The amount of change is assessed to be **high**.

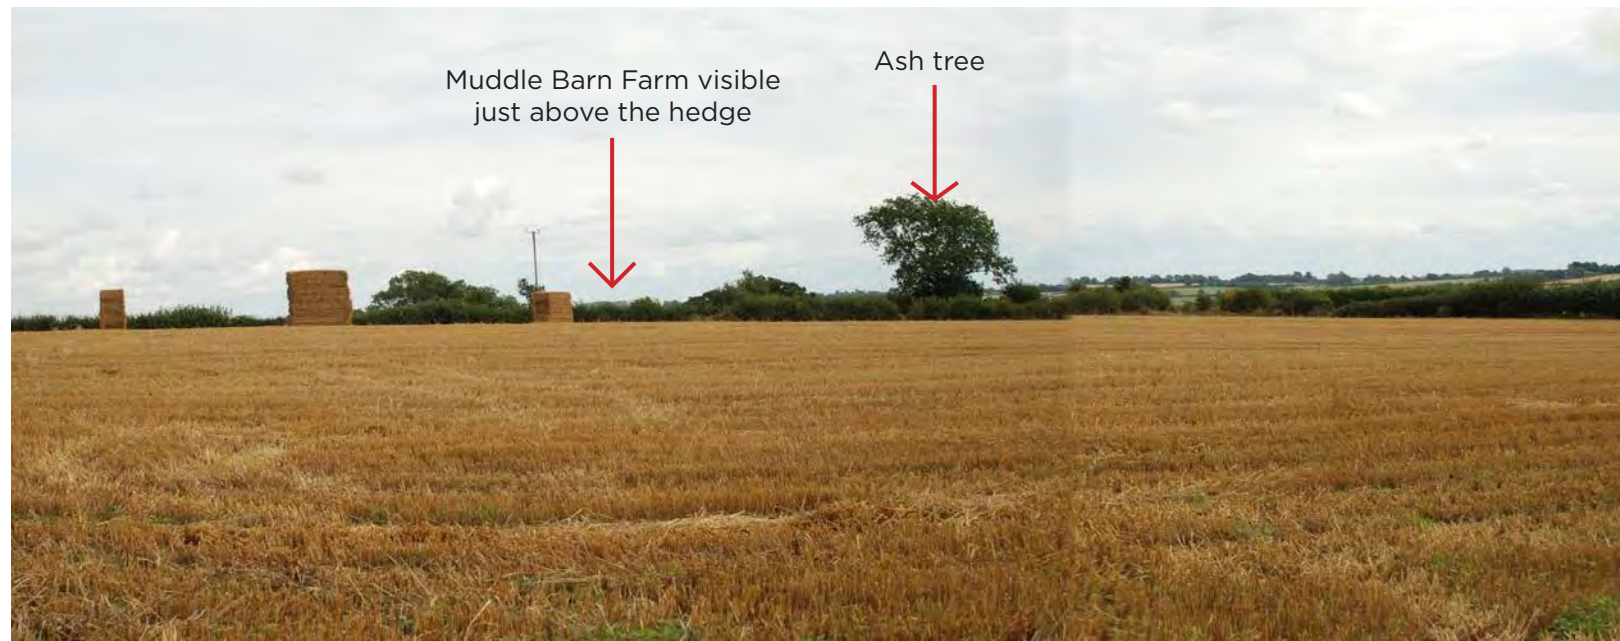
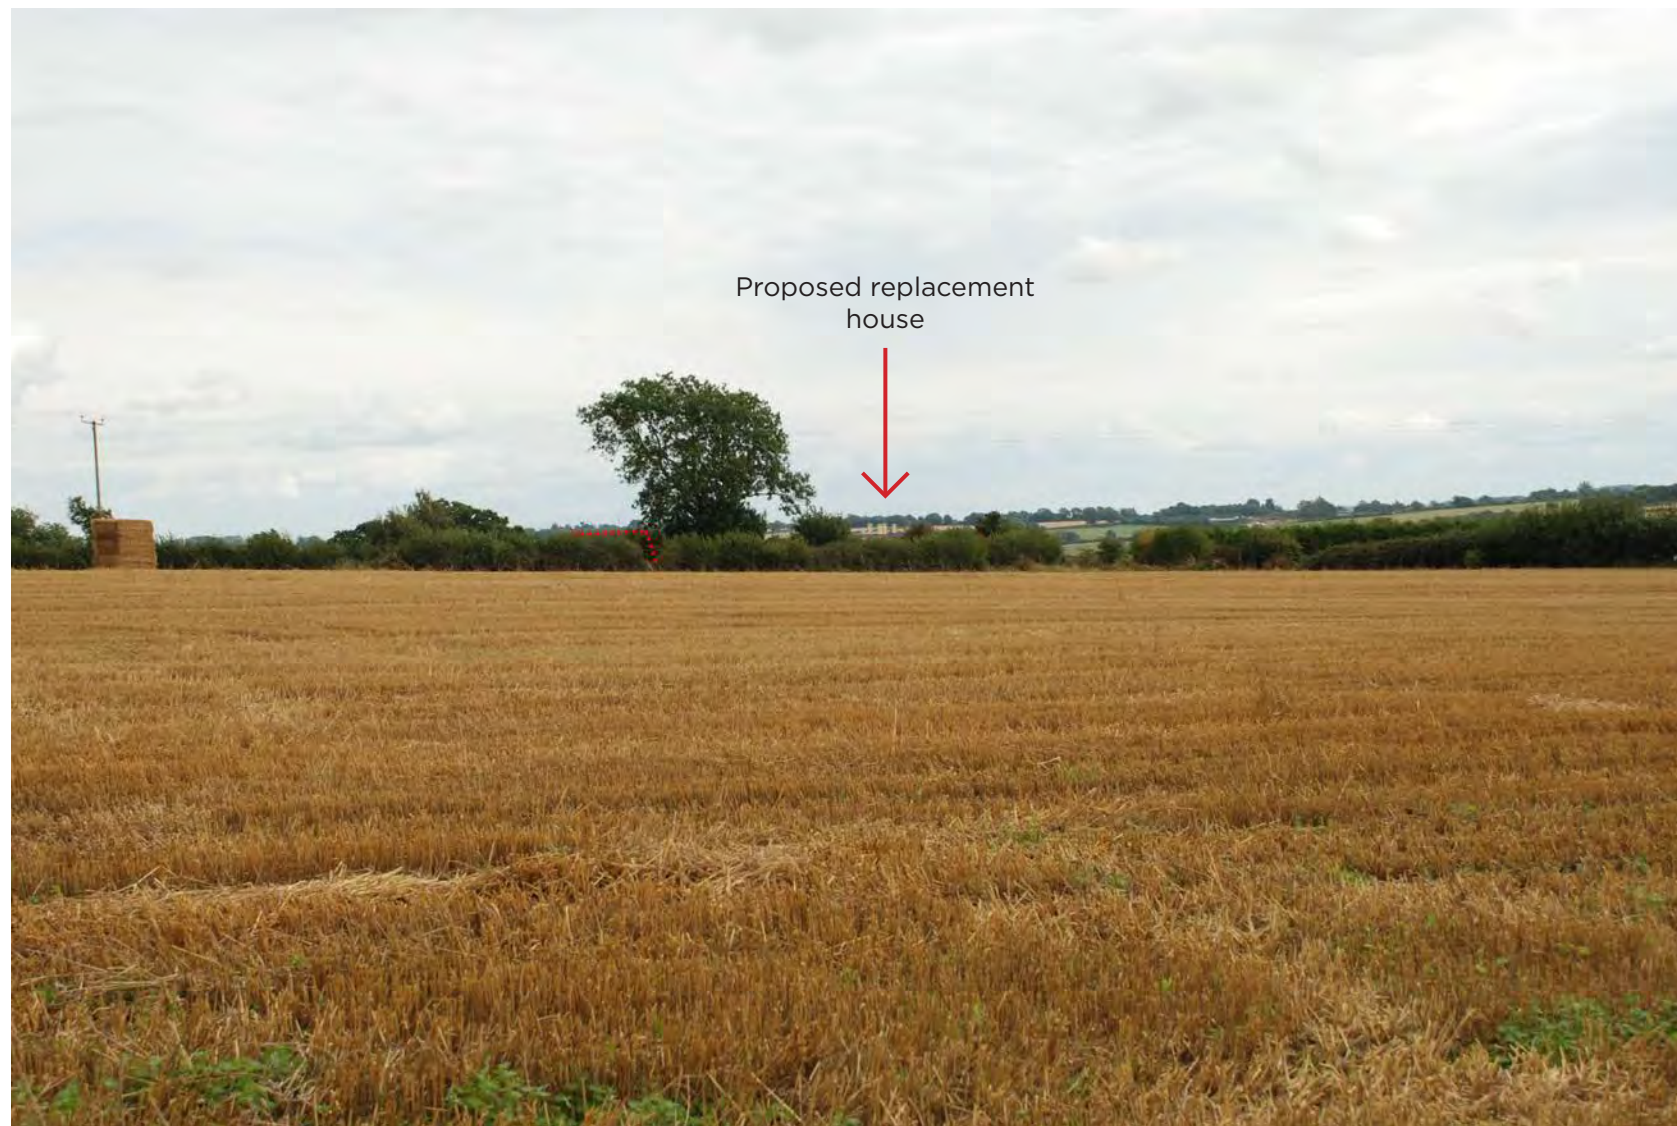
Figure 12  
Viewpoint photograph 2A  
Bridleway 348/2

Zoomed in view showing replacement house (buildings to be removed shown with dashed red line)

- 6.15 Receptor location 2A – Bridleway 348/2 (Figure 12)  
Description of receptor location: This bridleway is a well-used public right of way which extends east west from Colony Road to the south of Sibford Gower to Ditchedge Lane (public right of way SS63) at the Oxfordshire/Warwickshire boundary over a distance of approximately 750m. The proposed development would be seen from much of the western half of the bridleway. Two viewpoints are considered, location 2A and 2B (see 6.20 below).

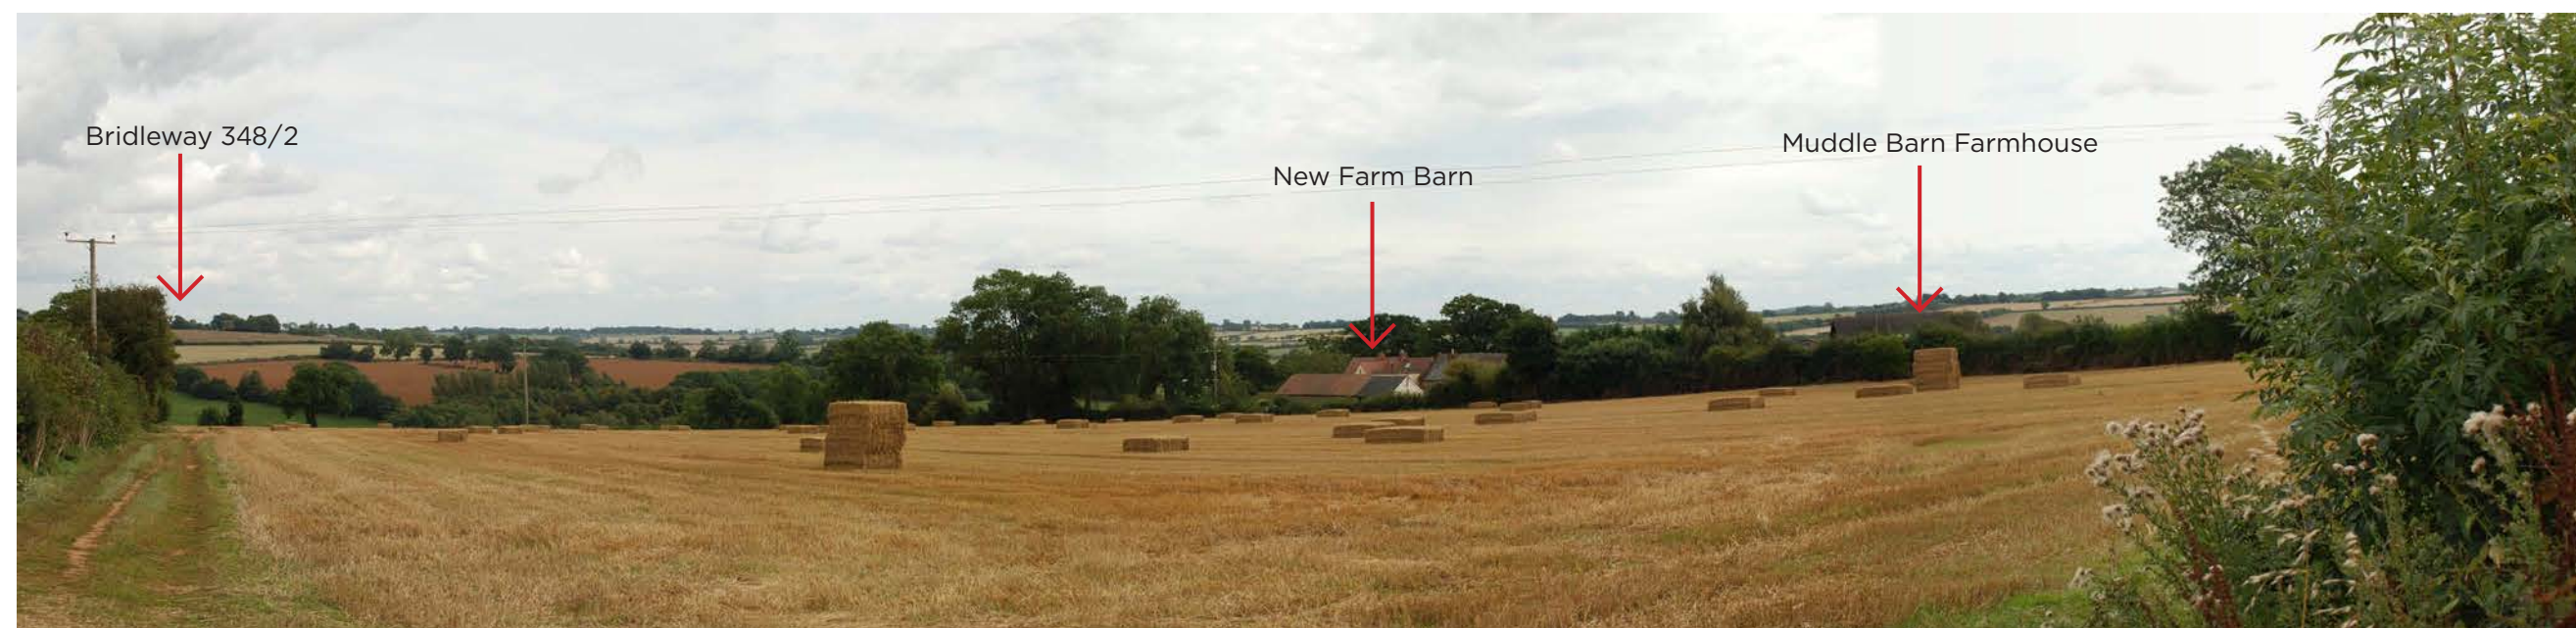
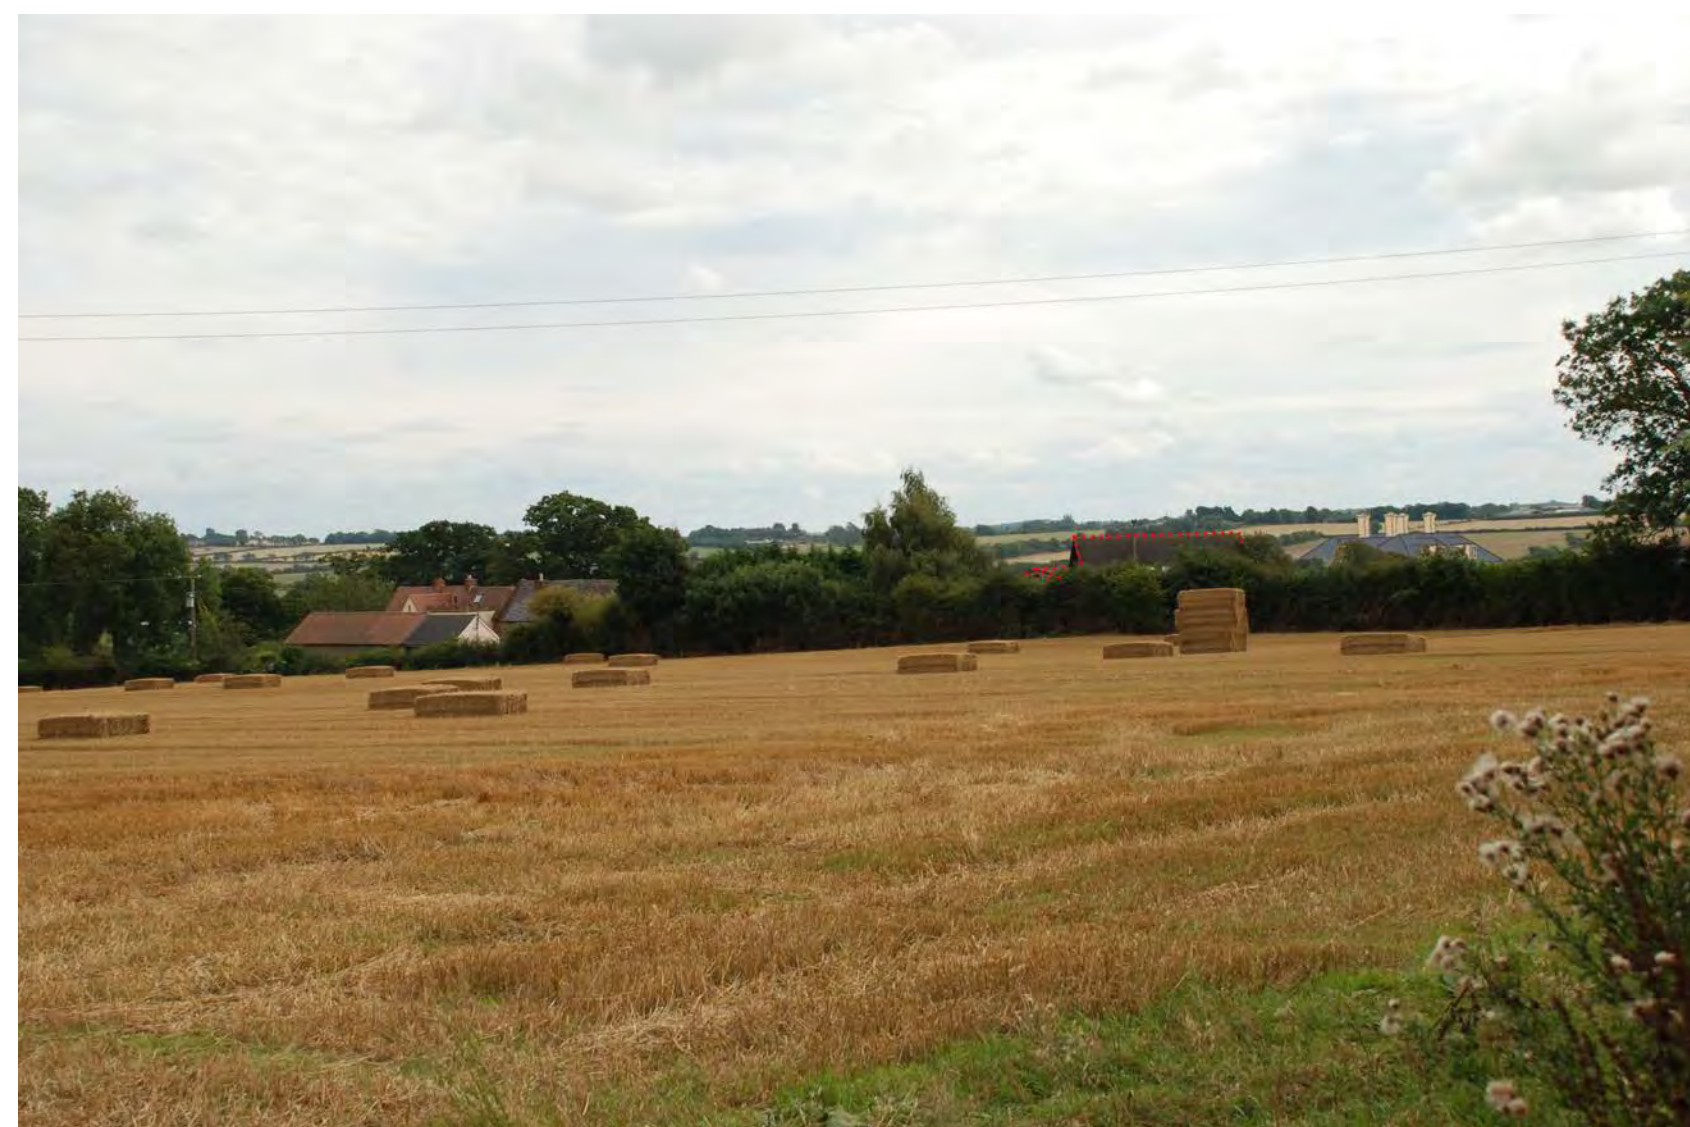
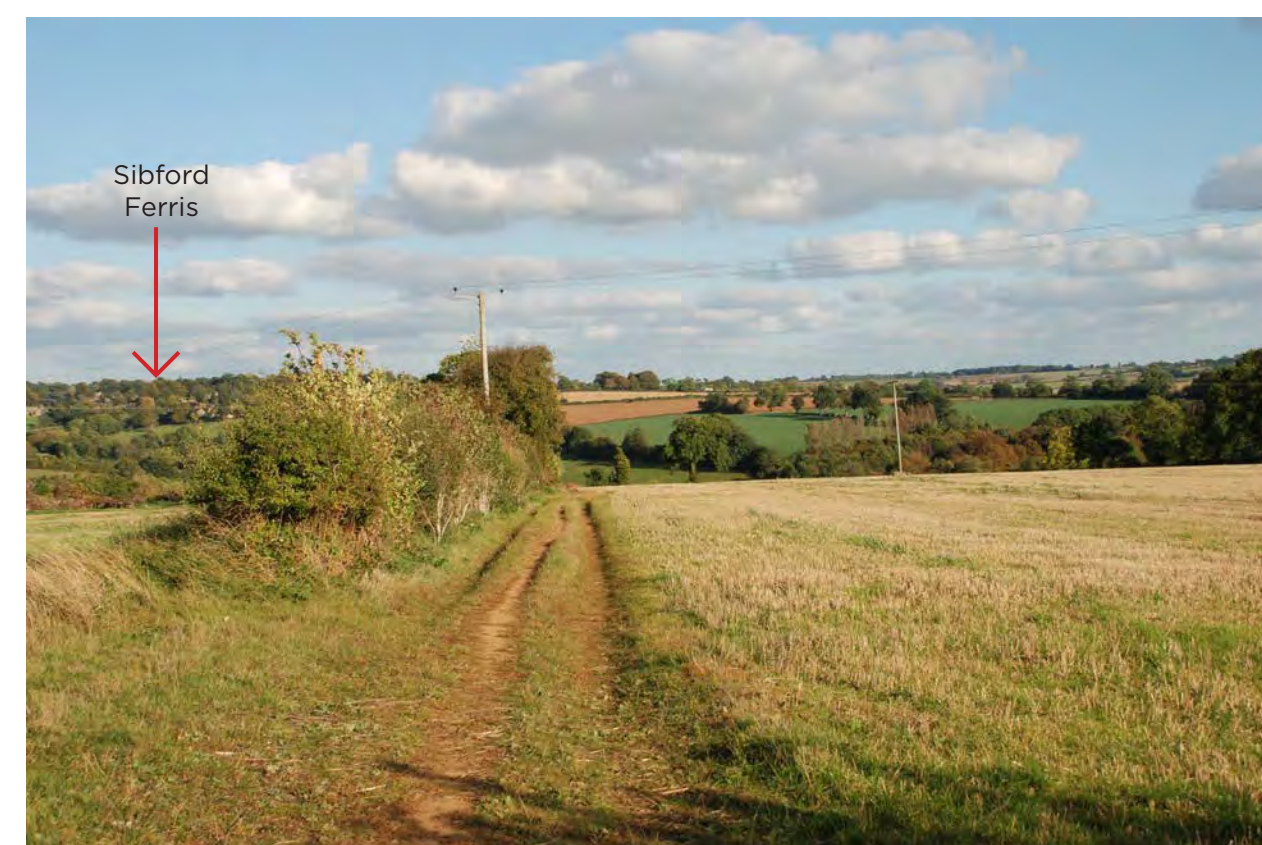
Figure 13  
Viewpoint photograph 2B  
Bridleway 348/2

Zoomed in view showing replacement house (buildings to be removed shown with dashed red line)

View looking east along direction of travel

- 6.20 Receptor location 2B – Bridleway 348/2 (Figure 13)  
Description of receptor location: At this location the viewer is approximately 200m to the northwest of the site of the proposed replacement house.

- 6.23 Magnitude of change: The proposed development will occupy a position to the right of the existing house, the roof and parts of the first floor visible against a distant backdrop of trees and arable land. The boundary hedge that currently screens much of the existing house will screen most of the replacement dwelling. Though taking up an approximately equivalent area of the view, the proposed development will be

6.24 Combined effect: Substantial. Tree planting proposed along the north boundary of the property and within the woodland garden will grow to mitigate the effect of the replacement house on the view. Selected trees will be planted at a large size to reduce the visibility of the proposed house from completion. Additional planting of smaller tree stock will reduce the view of the house further. Ultimately the replacement house will be less visible than the existing house. After mitigation planting, the combined effect will reduce to **negligible**. The effect is considered to be positive because the planting proposals associated with the development will break up the roofline of the replacement house where currently the roof is conspicuous in the view.
