Muddle Barn Farm, Sibford Gower, Oxfordshire

Landscape and Visual Assessment for a  
Replacement House

December 2014  
(Revised January 2016)

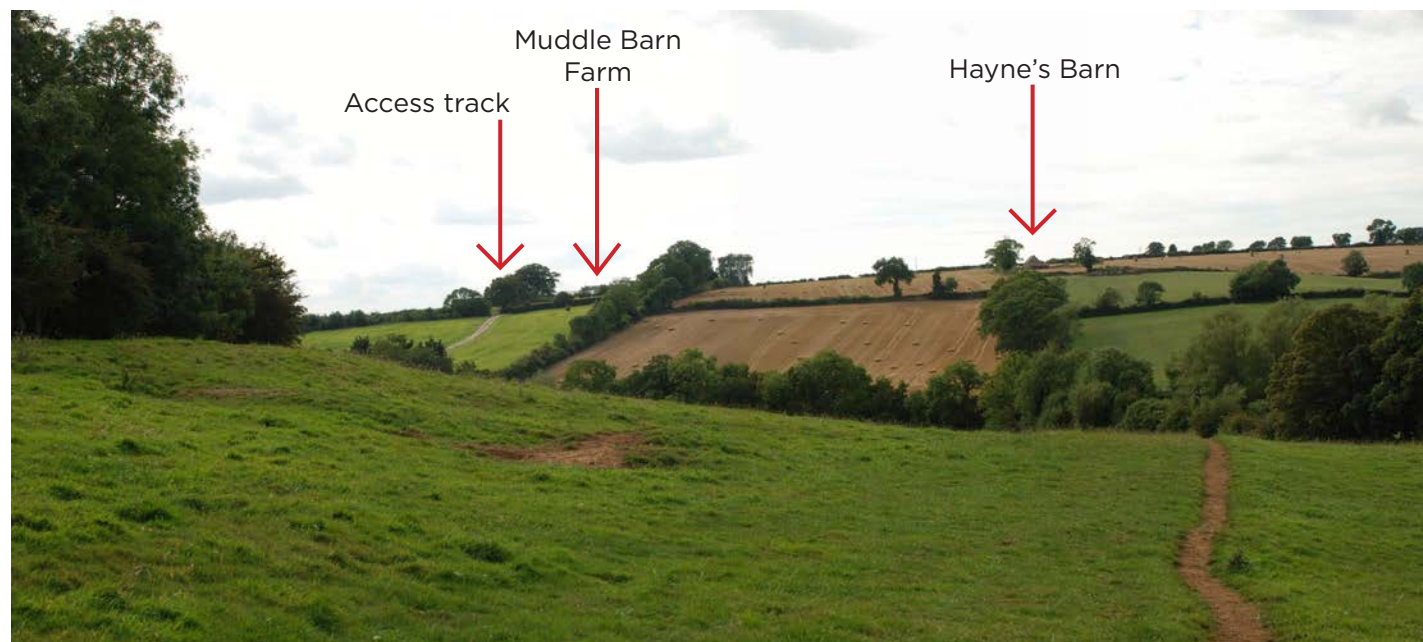
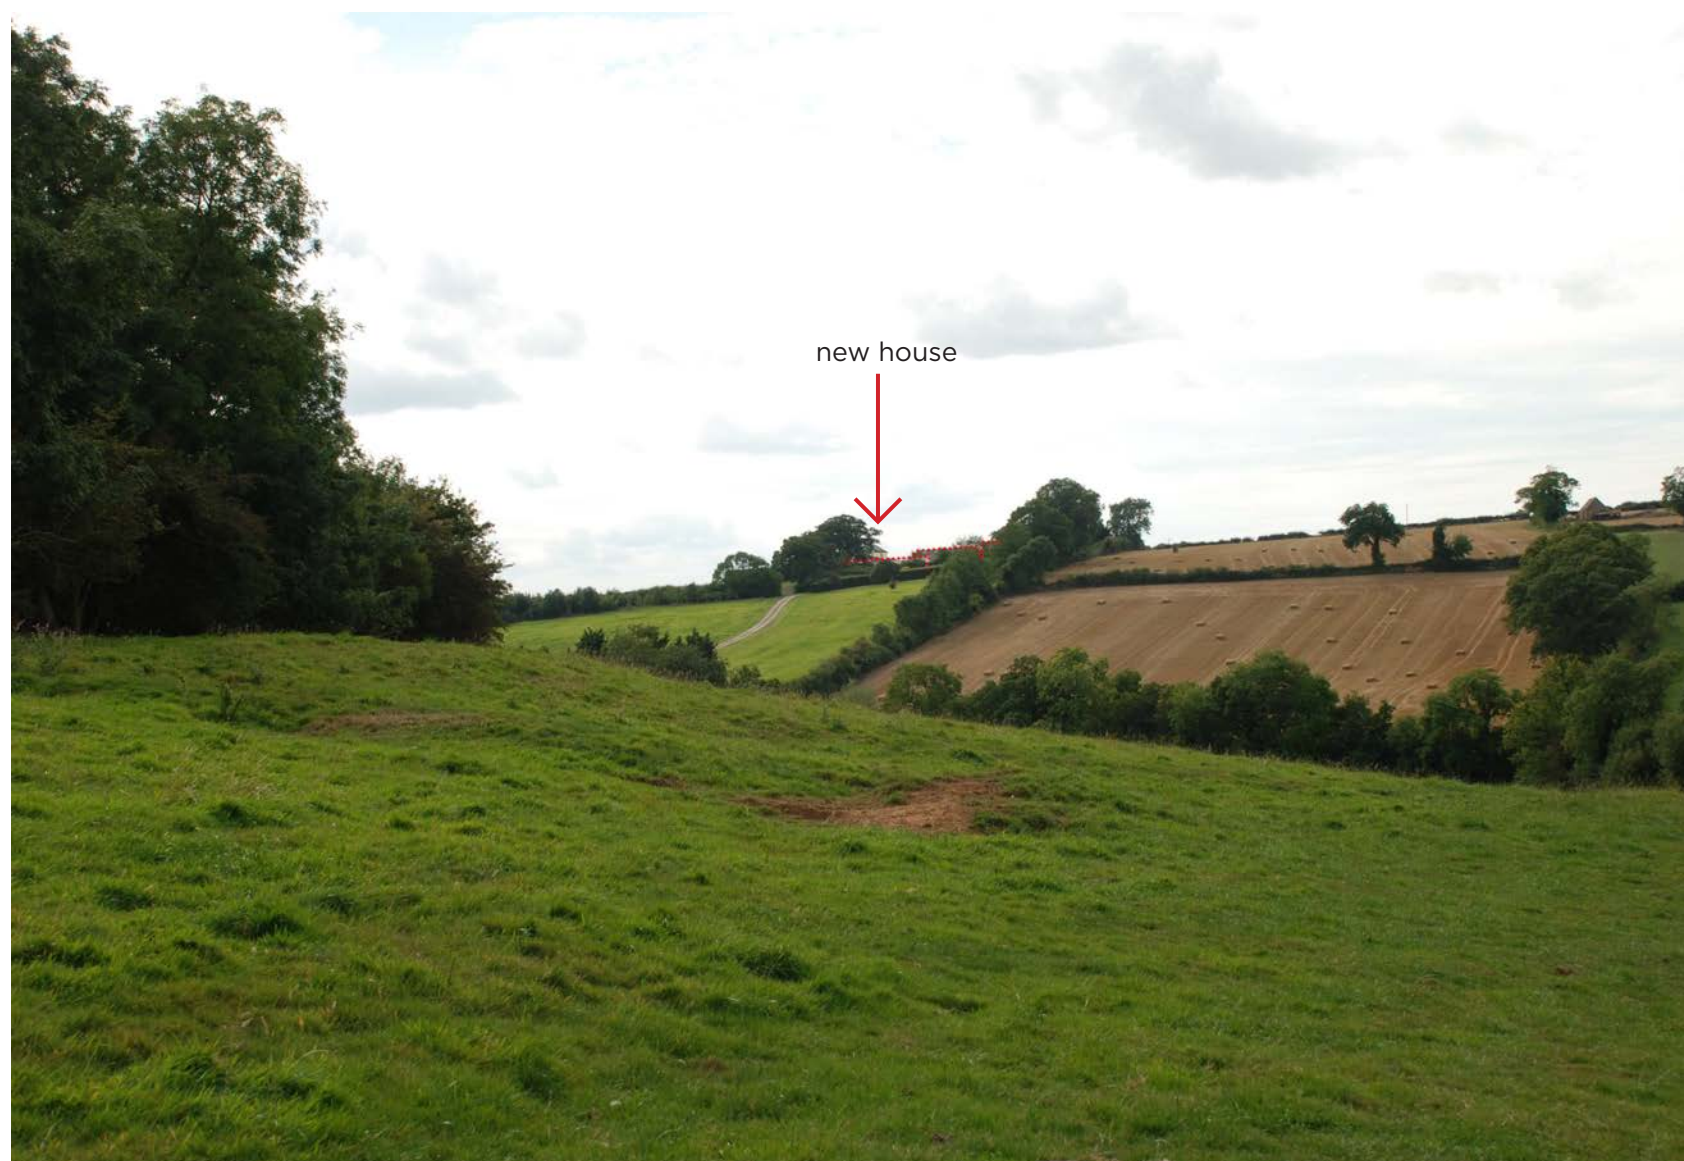
Figure 14  
Viewpoint photograph 3  
Bridleway 347/1

Zoomed in view showing replacement house (buildings to be removed shown with dashed red line)

6.25 Receptor location 3 – Bridleway 347/1 (Figure 14)

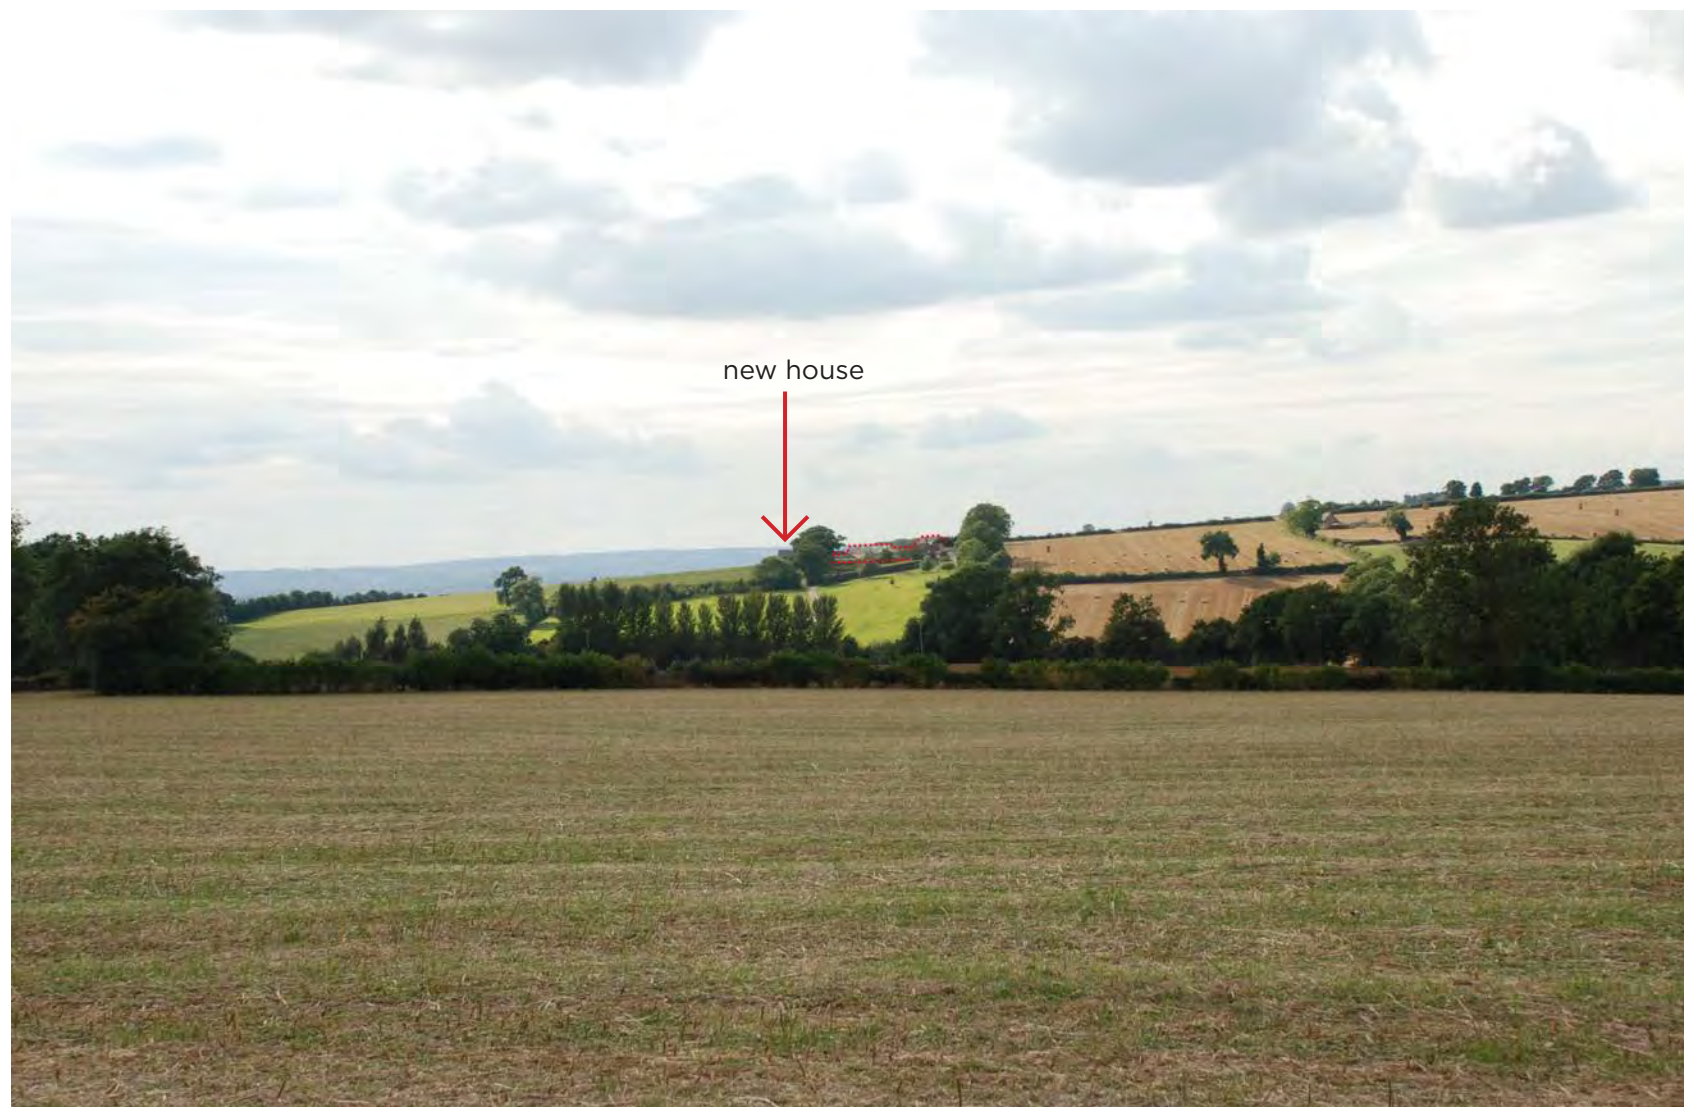
Figure 15  
Viewpoint photograph 4

View showing replacement house (buildings to be removed shown with dashed red line)

6.30 Receptor location 4 – Minor road between Sibford Ferris and Millhill Barn (Figure 15)

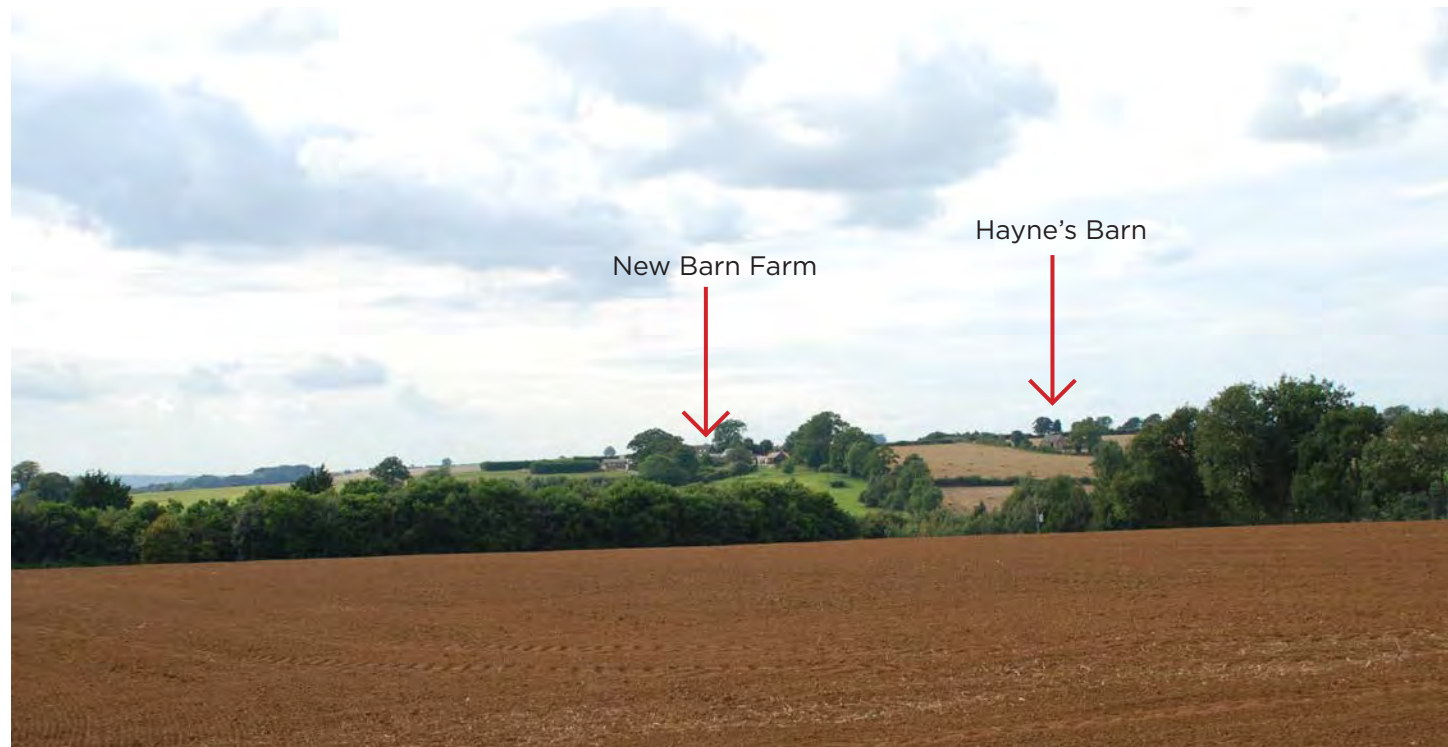
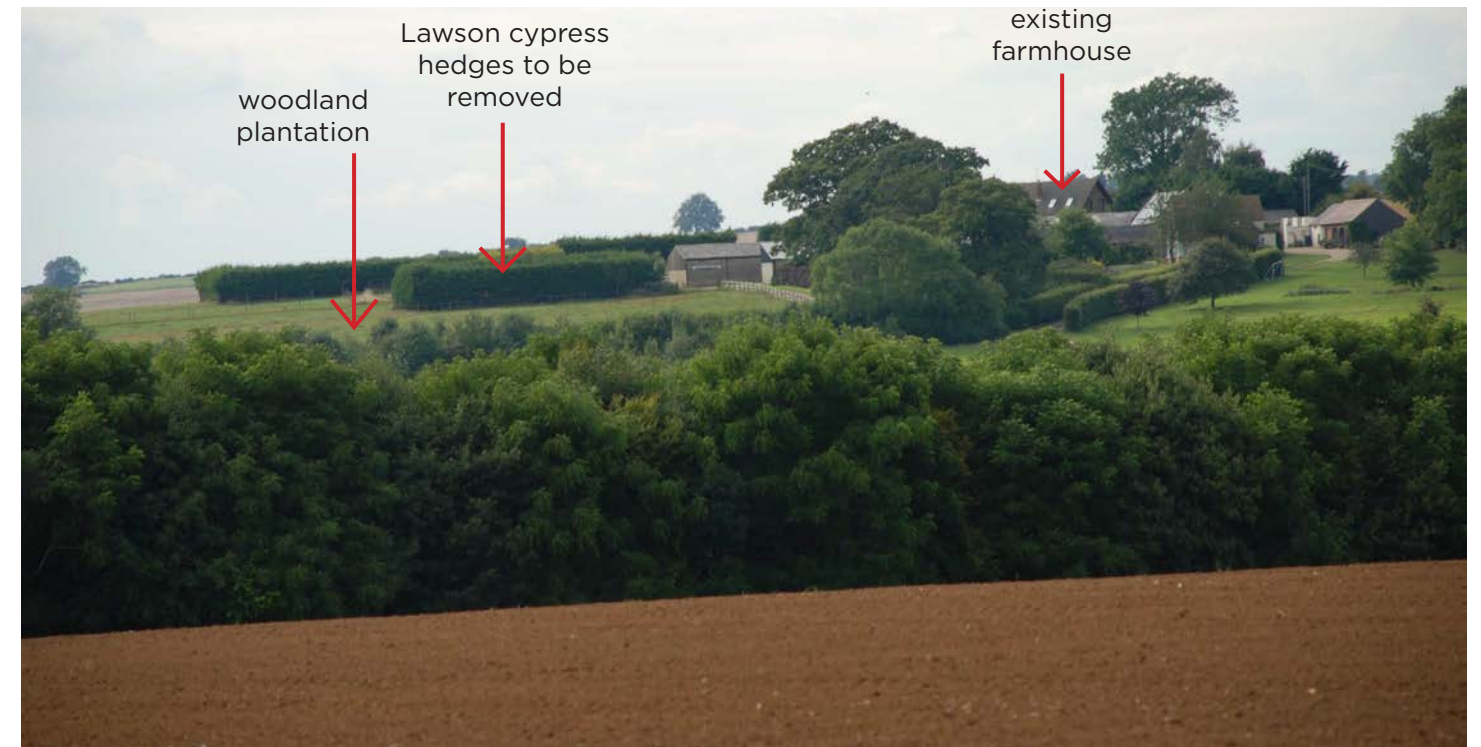
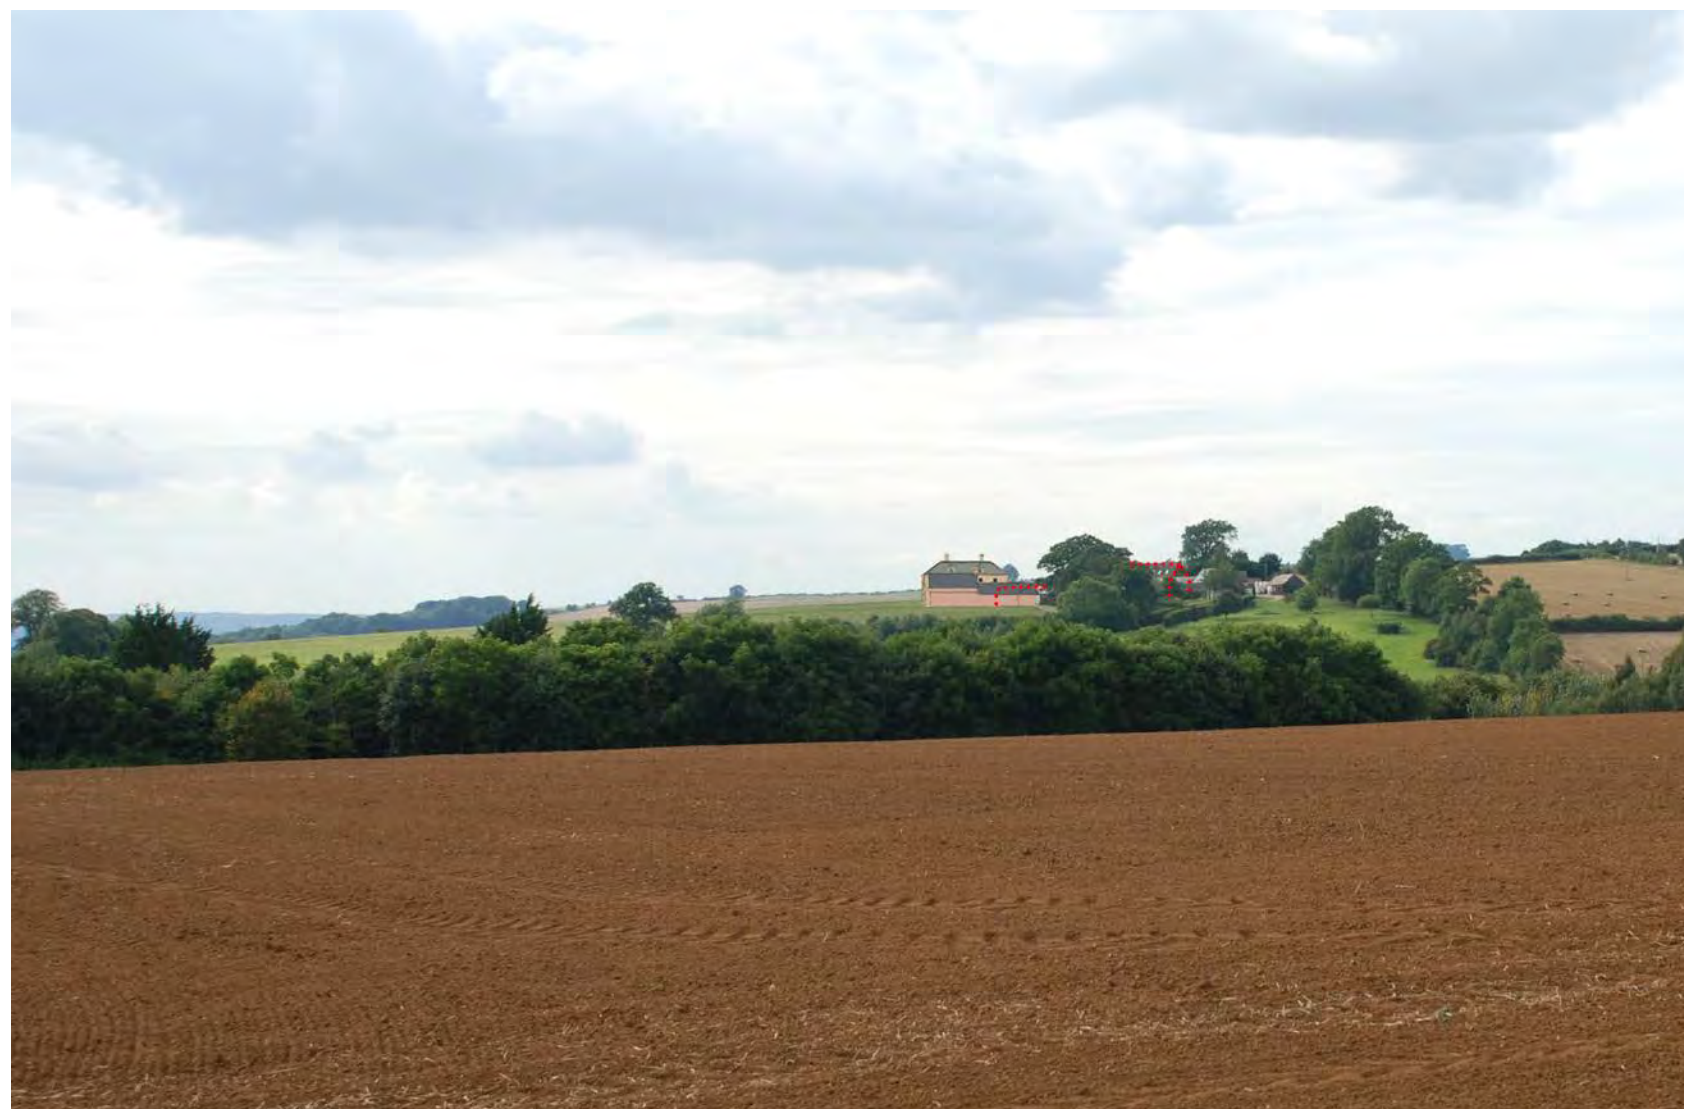
Figure 16  
Viewpoint photograph 5  
Footpath 347/2

Zoomed in view

View showing replacement house (buildings to be removed shown with dashed red line)

6.35 Receptor location 5 – Footpath 347/2 (Figure 16)

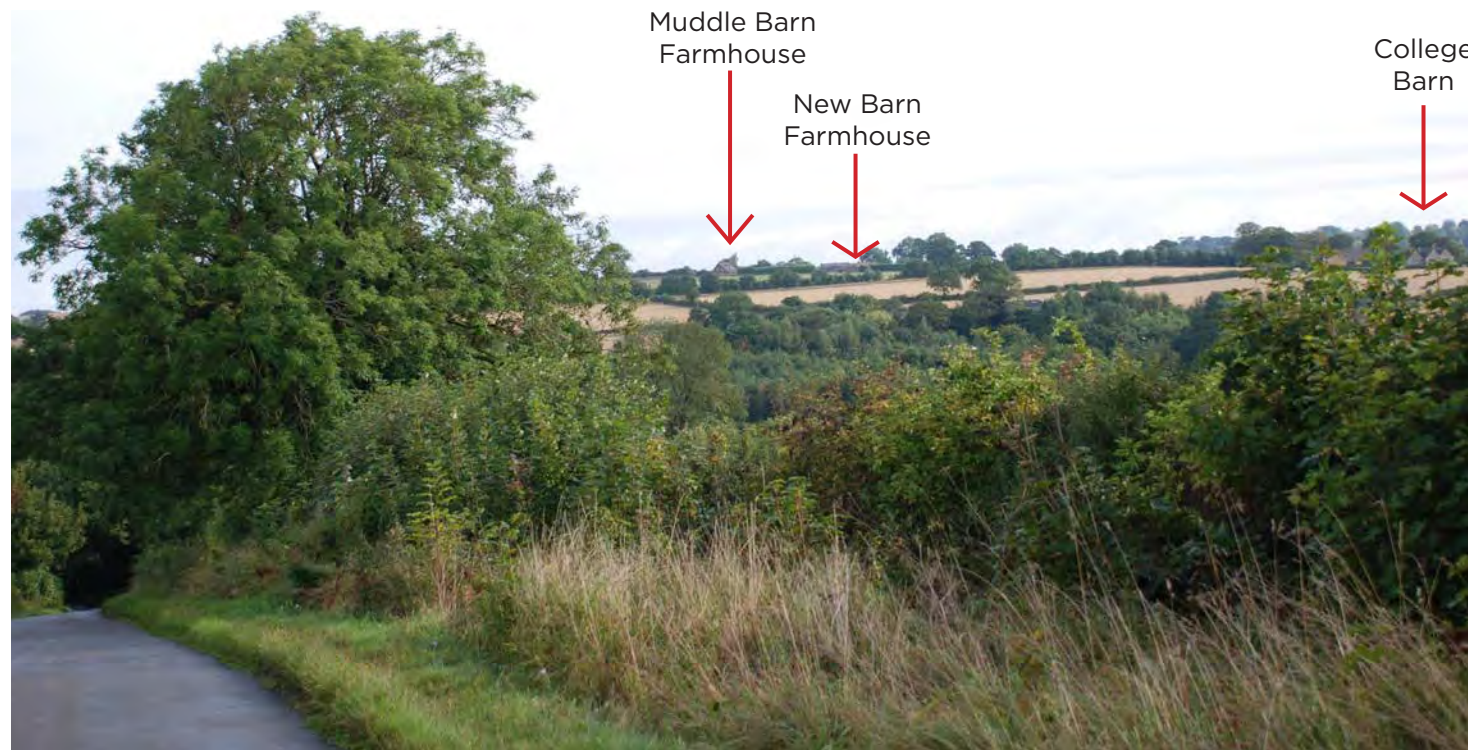
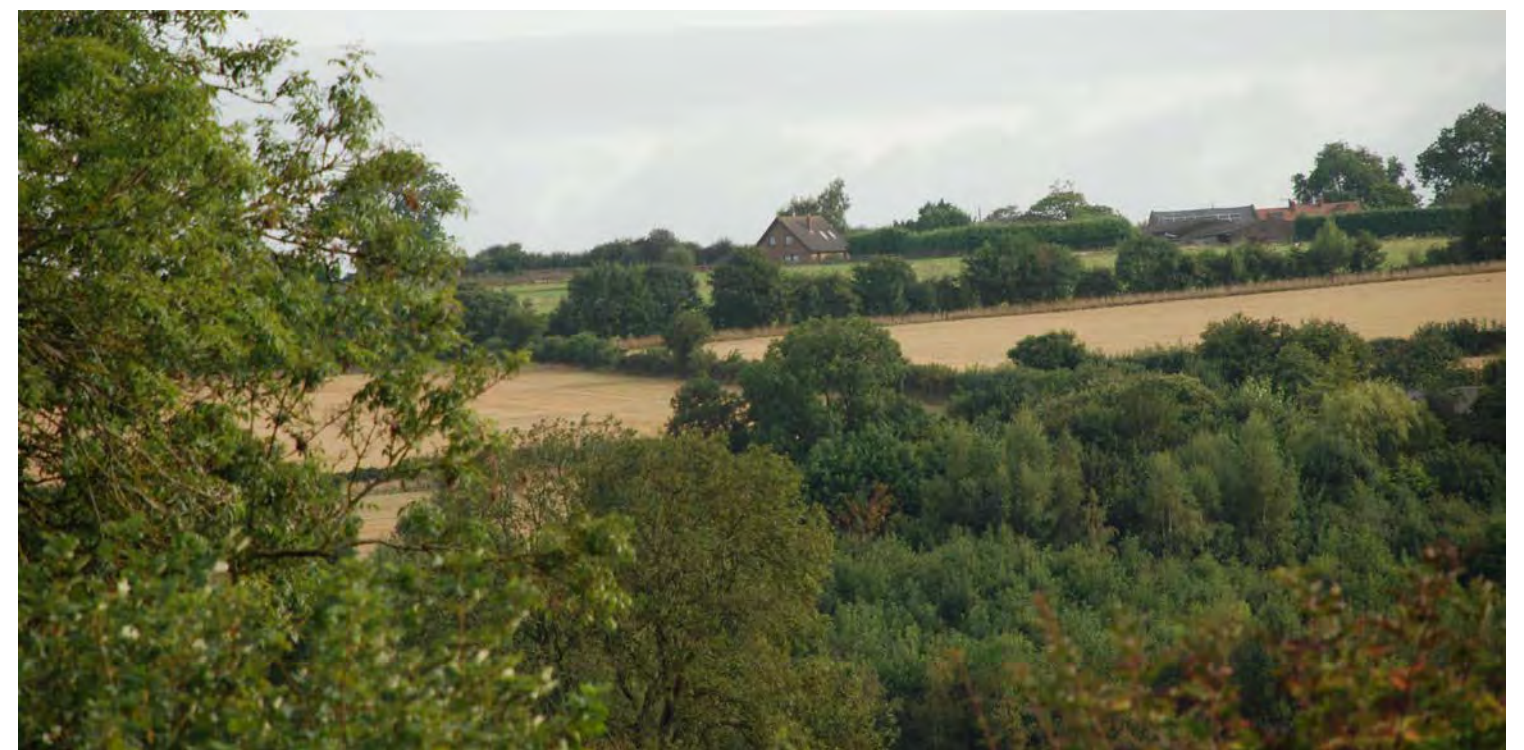
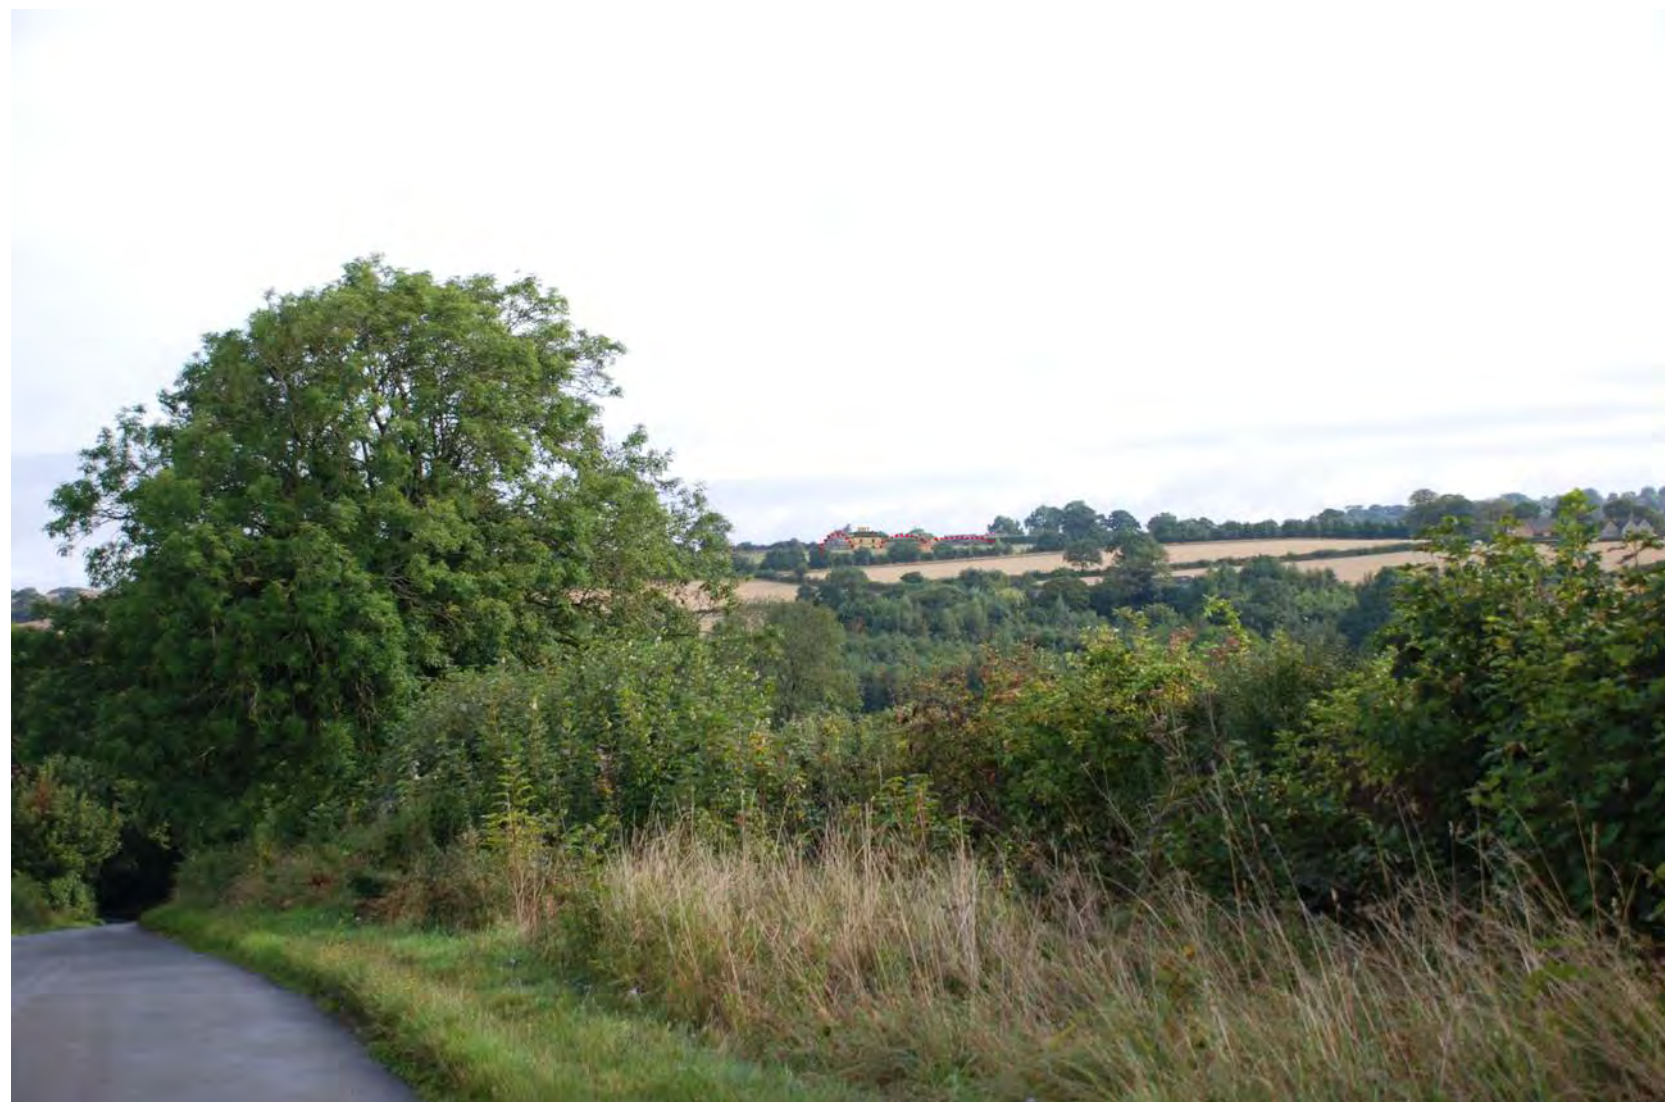
Figure 17  
Viewpoint photograph 6  
Traitors Ford Lane/SS63

Zoomed in view

View showing replacement house (buildings to be removed shown with dashed red line)

6.40 Receptor location 6 – Traitor's Ford Lane/SS63 (Figure 17)

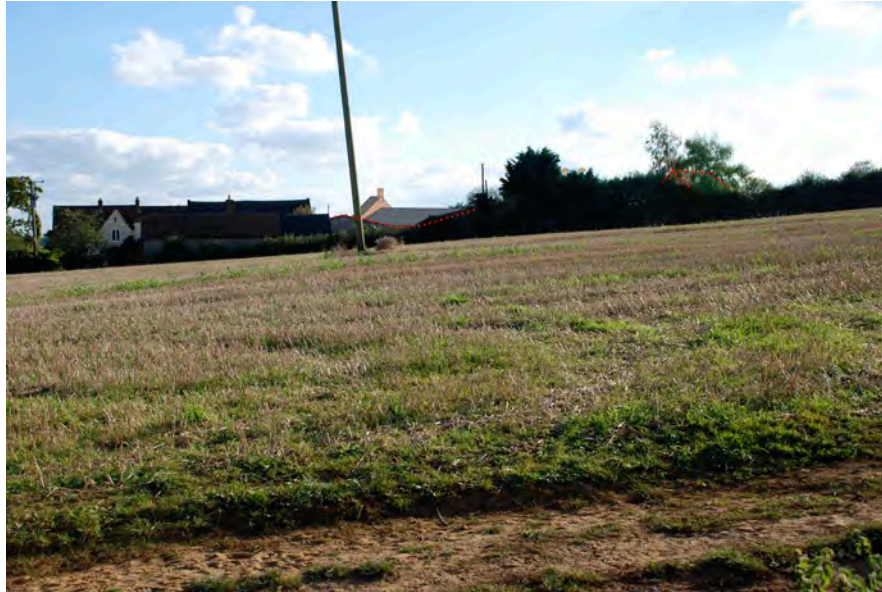
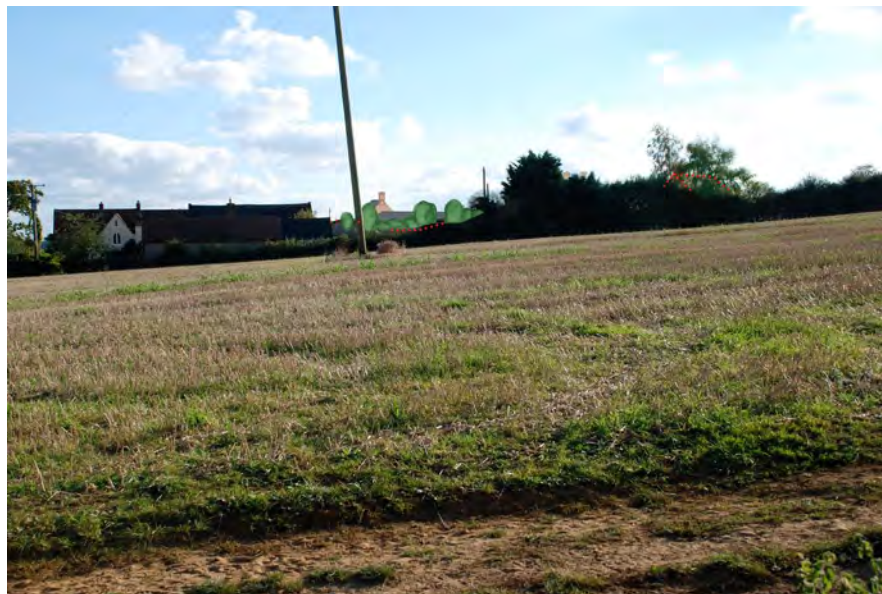
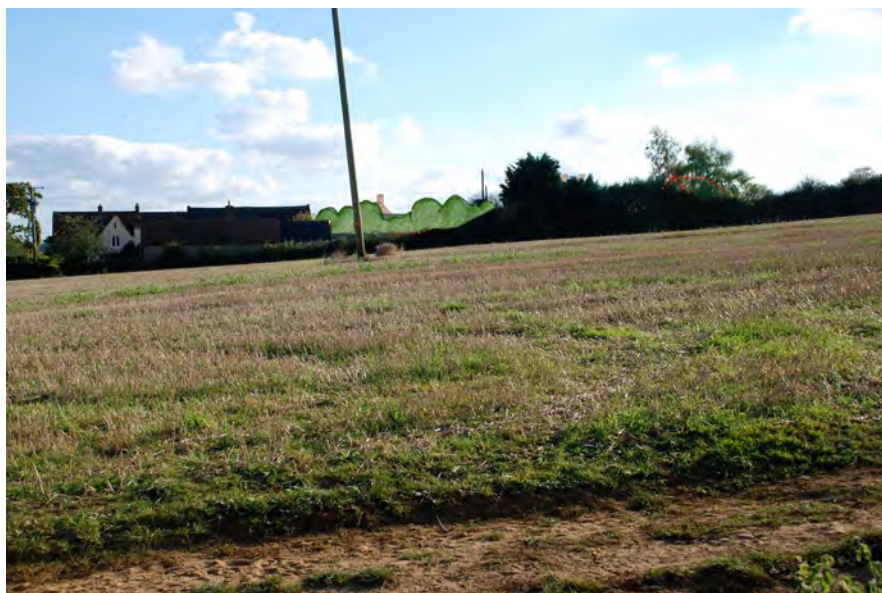
Figure 18  
Sketch showing impact of planting on  
viewpoint 1B (FP 348/7)

Proposed  
view before  
tree planting

Year 1

Year 15

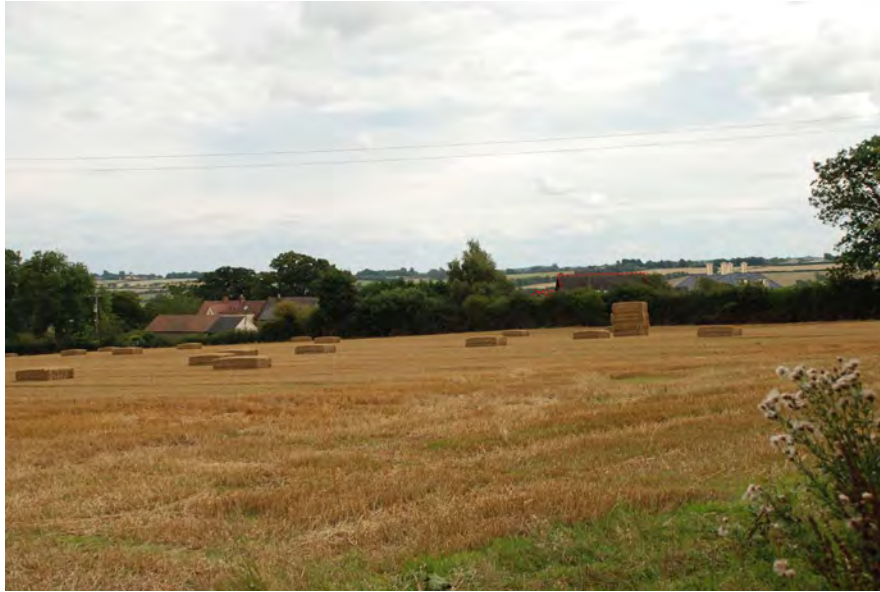
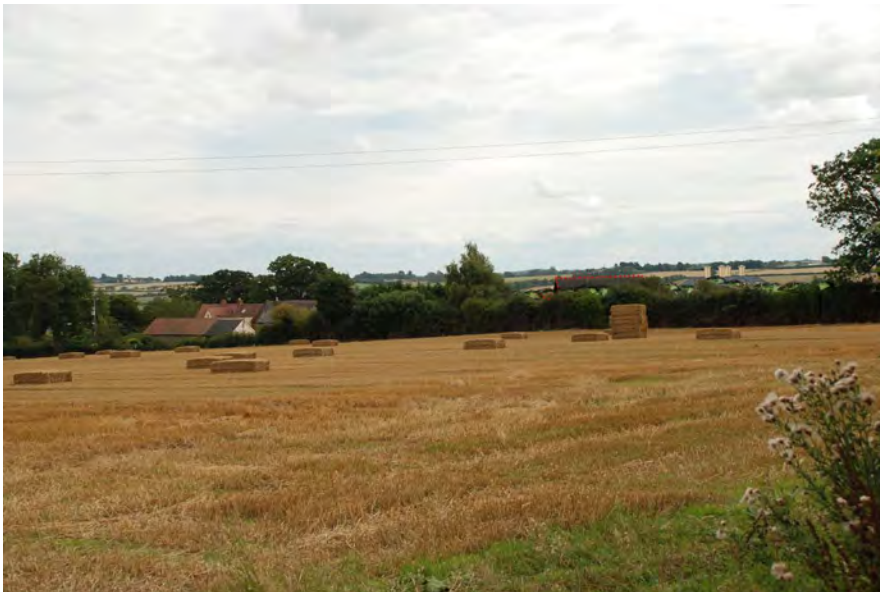
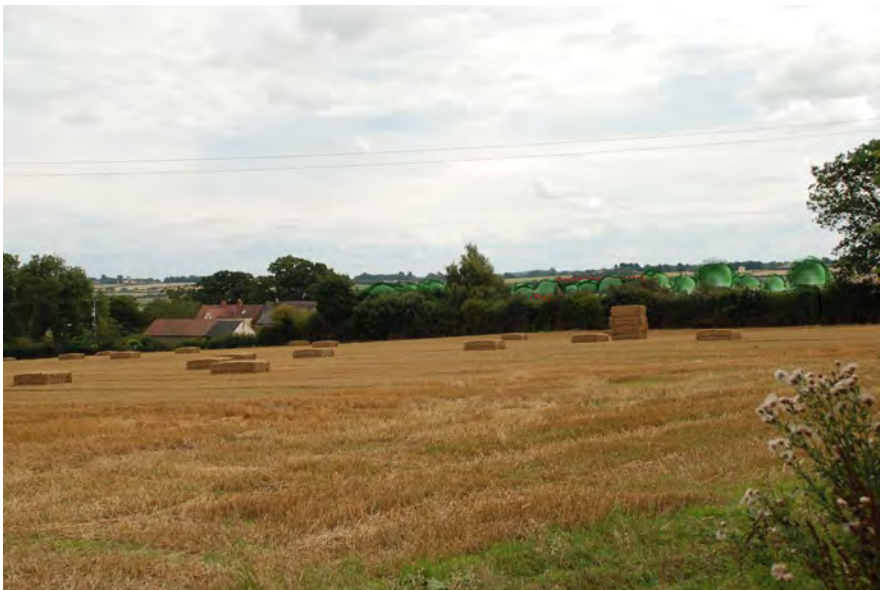
Figure 19  
Sketch showing impact of planting on  
viewpoint 2B (BW 347/1)

Proposed  
view before  
tree planting

Year 1

Year 15

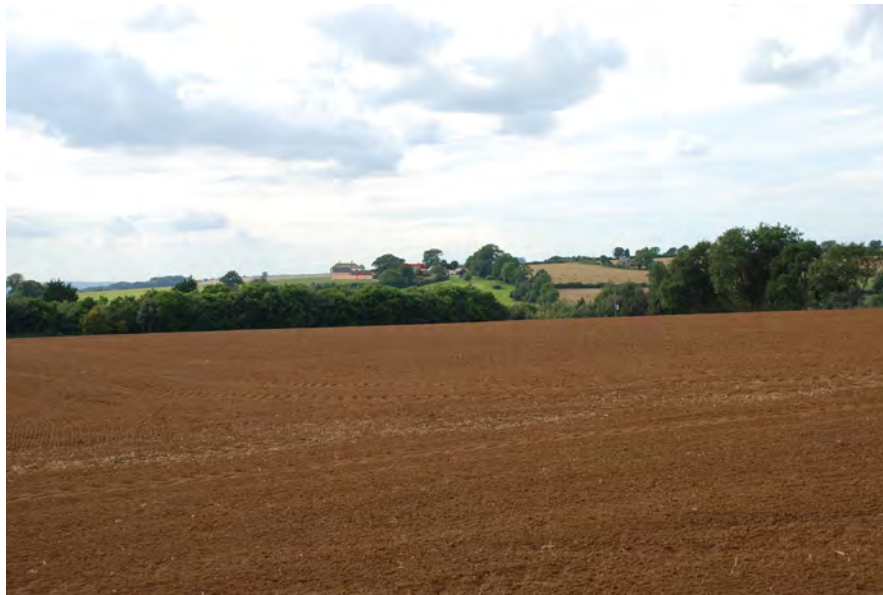
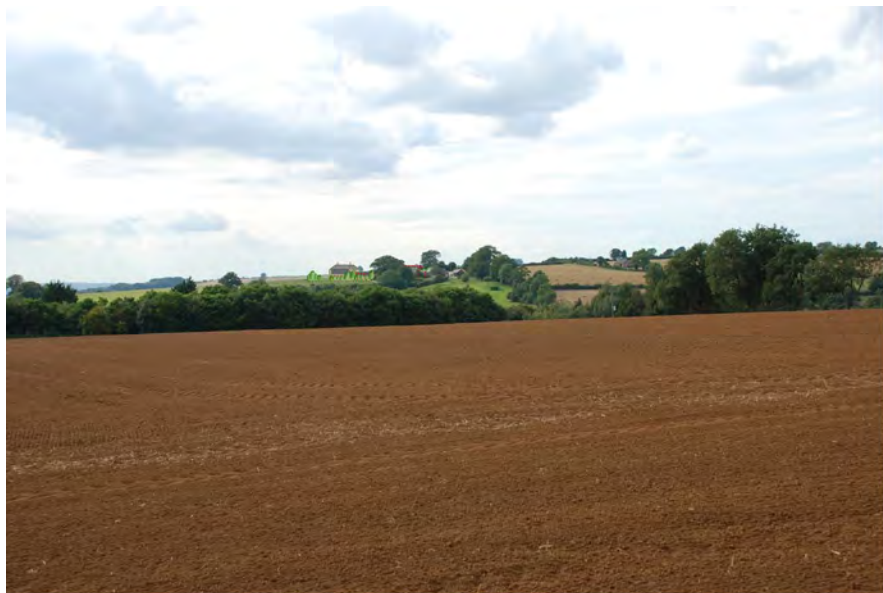
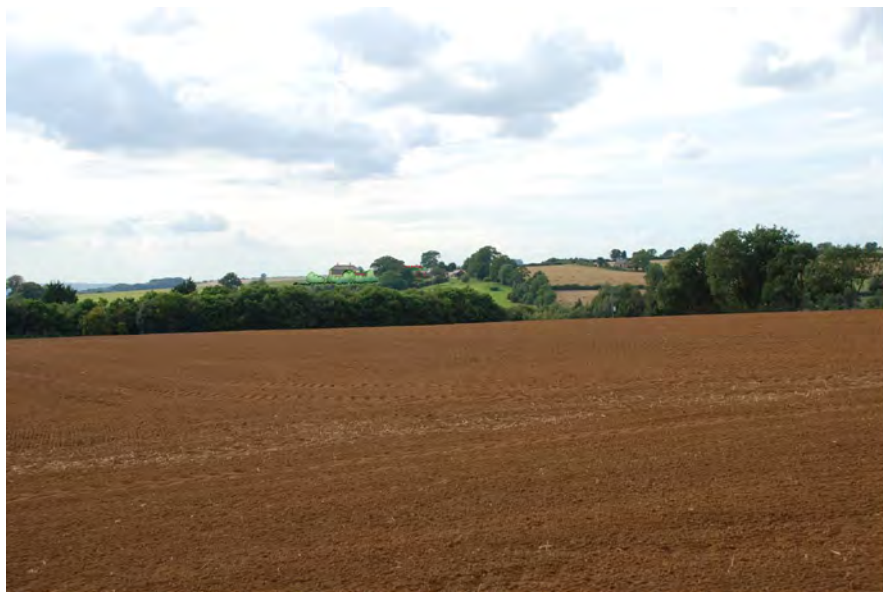
Figure 20

Proposed  
view before  
tree planting

Year 1

Year 15

Sketch showing impact of planting  
on viewpoint VP5 (FP 347/2)
