## Geo Insight

Address: MIRAMAR COTTAGE, 5 THE COLONY, COLONY ROAD, SIBFORD GOWER, OX15 5RY

**Reference:** GS-4851260

**Client:** JNP Group

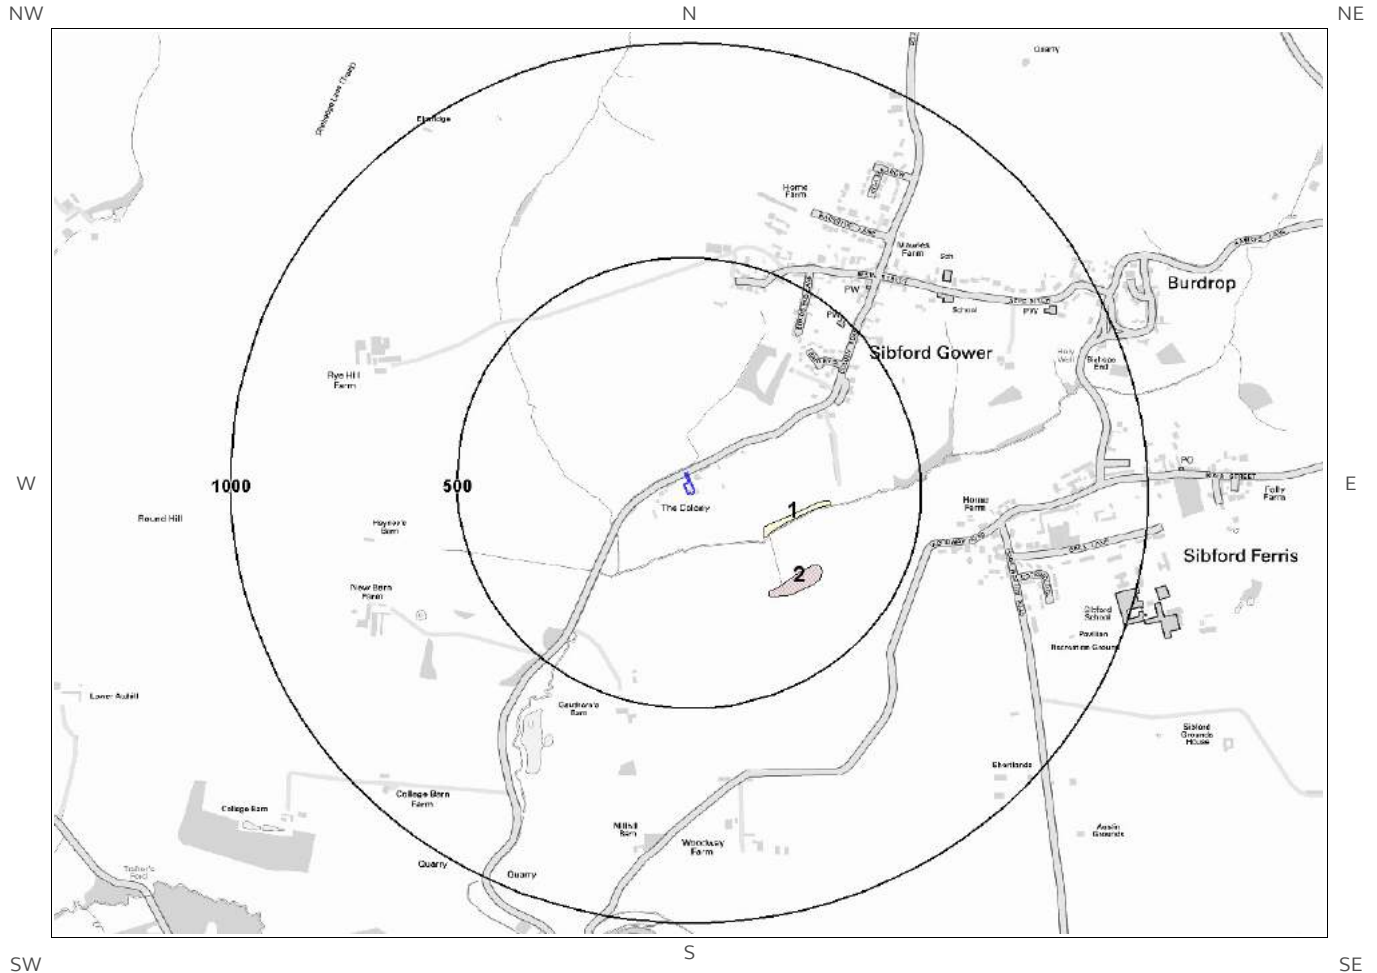
# 1.2 Superficial Deposits and Landslips map (1:10,000 scale)

This Geology shows the main components as discrete layers, these are: Artificial / Made Ground, Superficial / Drift Geology and Landslips. These are all displayed with the BGS Lexicon code for the rock unit and BGS sheet number. Not all of the main geological components have nationwide coverage.

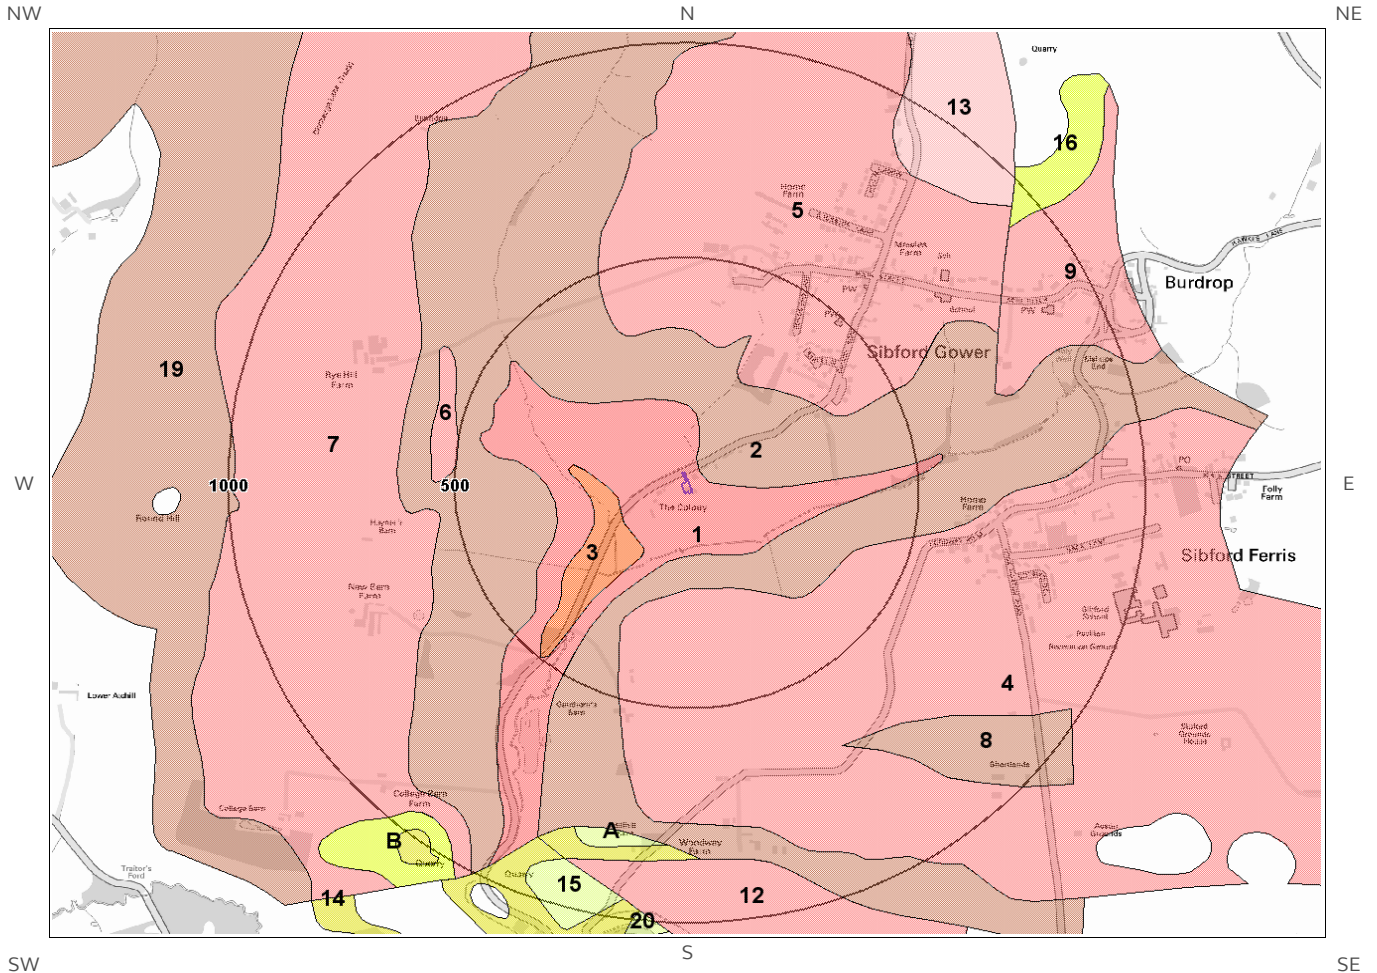
# 2.3 Bedrock and linear features map (1:50,000 scale)

Distance	Direction	Flow Type	Maximum Permeability	Minimum Permeability
0.0	On Site	Mixed	High	Moderate
31.0	E	Fracture	Low	Low

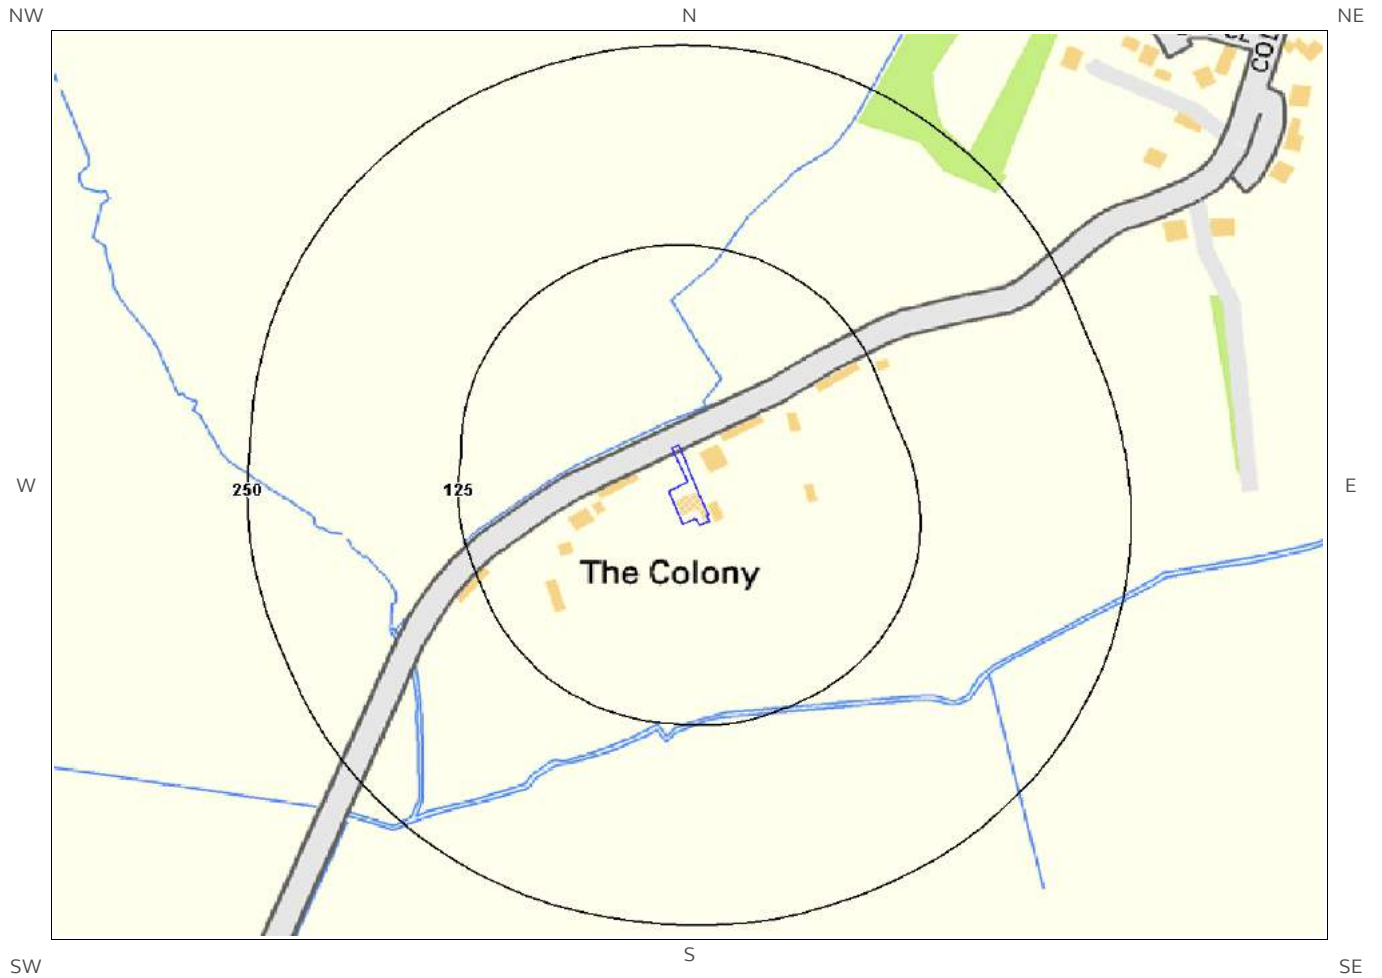
# 4 Ground Workings map

ID	Distance (m)	Direction	NGR	Commodity Produced	Pit Name	Type of working	Status
Not shown	951.0	S	434515 236469	Limestone	Temple Mills	A surface mineral working. It may be termed Quarry, Sand Pit, Clay Pit or Opencast Coal Site	Ceased

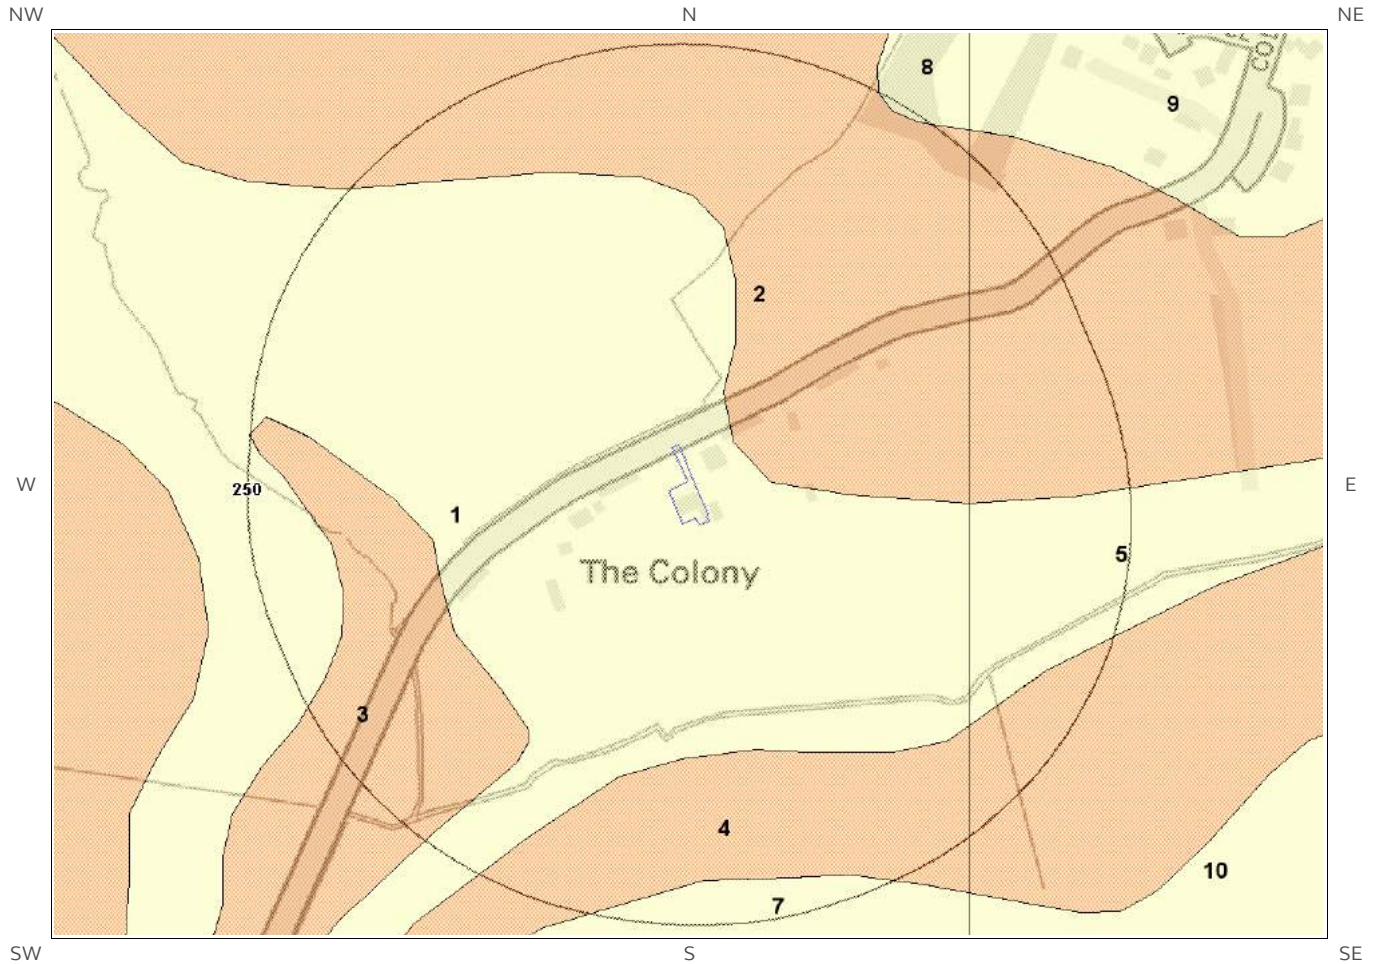
## 6.1 Shrink-Swell Clay map

ID	Distance (m)	Direction	Hazard Rating	Details
1	0.0	On Site	Negligible	Ground conditions predominantly non-plastic. No special actions required to avoid problems due to shrink-swell clays. No special ground investigation required, and increased construction costs or increased financial risks are unlikely likely due to potential problems with shrink-swell clays.
2	31.0	E	Low	Ground conditions predominantly medium plasticity. Do not plant trees with high soil moisture demands near to buildings. For new build, consideration should be given to advice published by the National House Building Council (NHBC) and the Building Research Establishment (BRE). There is a possible increase in construction cost to reduce potential shrink-swell problems. For existing property, there is a possible increase in insurance risk, especially during droughts or where vegetation with high moisture demands is present.

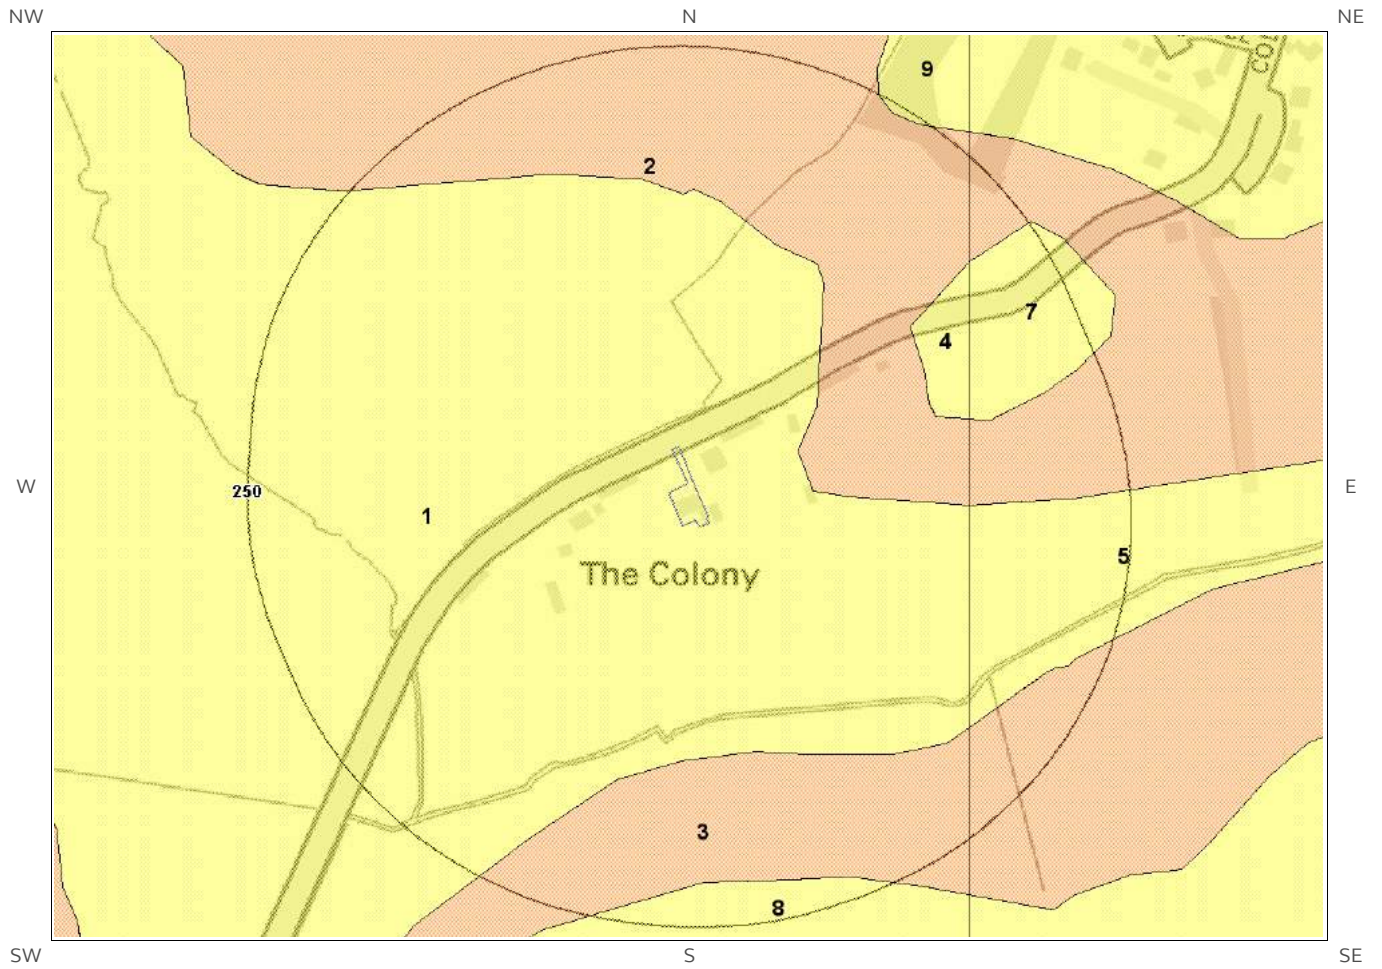
# 6.2 Landslides map

ID	Distance (m)	Direction	Hazard Rating	Details
1	0.0	On Site	Very Low	Slope instability problems are unlikely to be present. No special actions required to avoid problems due to landslides. No special ground investigation required, and increased construction costs or increased financial risks are unlikely due to potential problems with landslides.

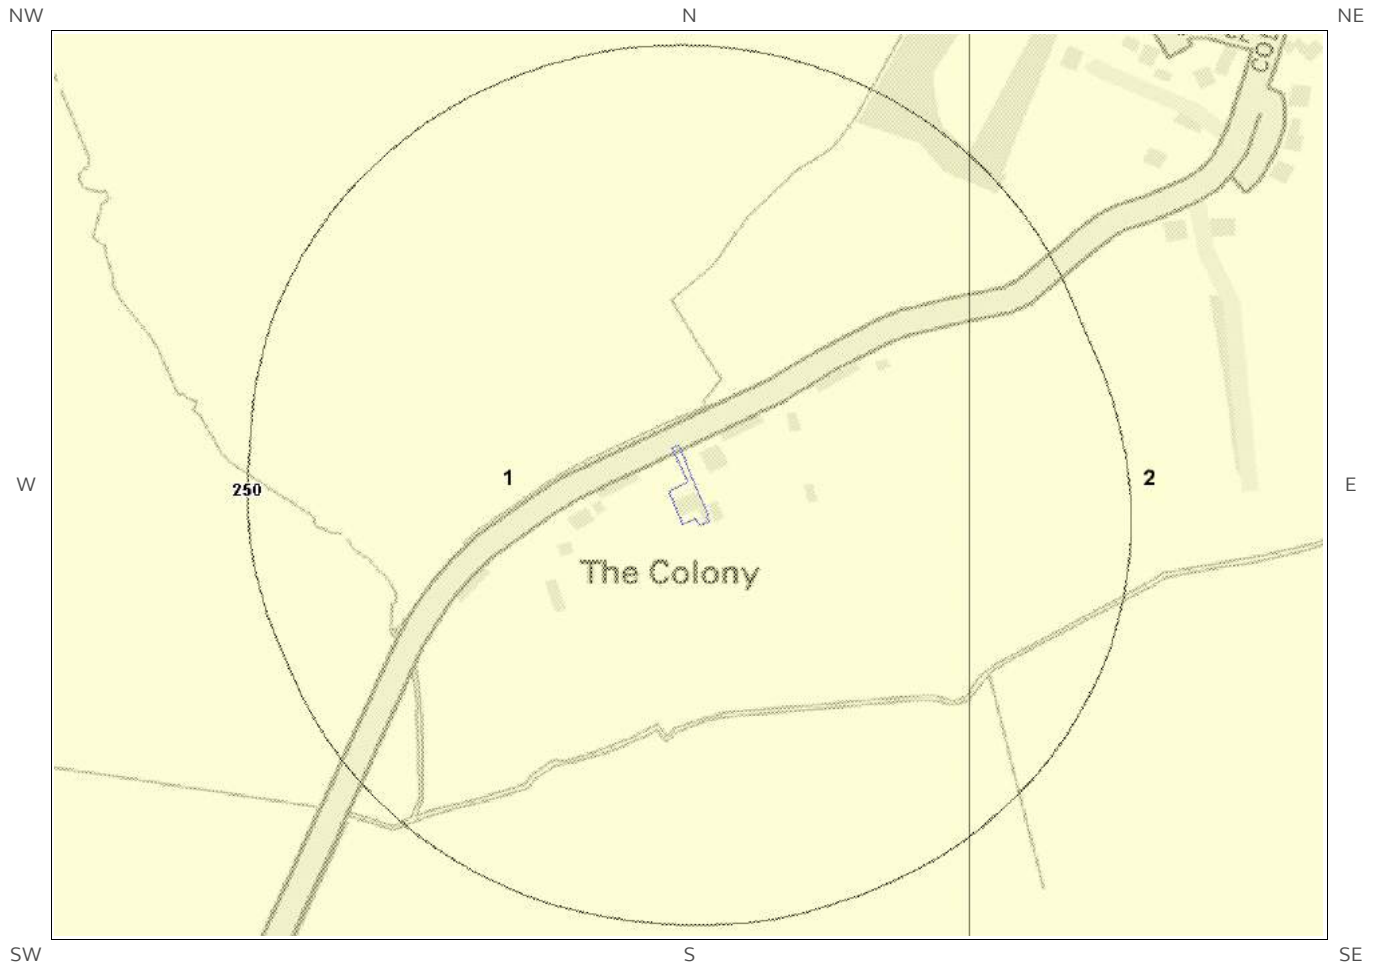
# 6.3 Ground Dissolution of Soluble Rocks map

ID	Distance (m)	Direction	Hazard Rating	Details
1	0.0	On Site	Negligible	Soluble rocks are present, but unlikely to cause problems except under exceptional conditions. No special actions required to avoid problems due to soluble rocks. No special ground investigation required, and increased construction costs or increased financial risks are unlikely due to potential problems with soluble rocks.

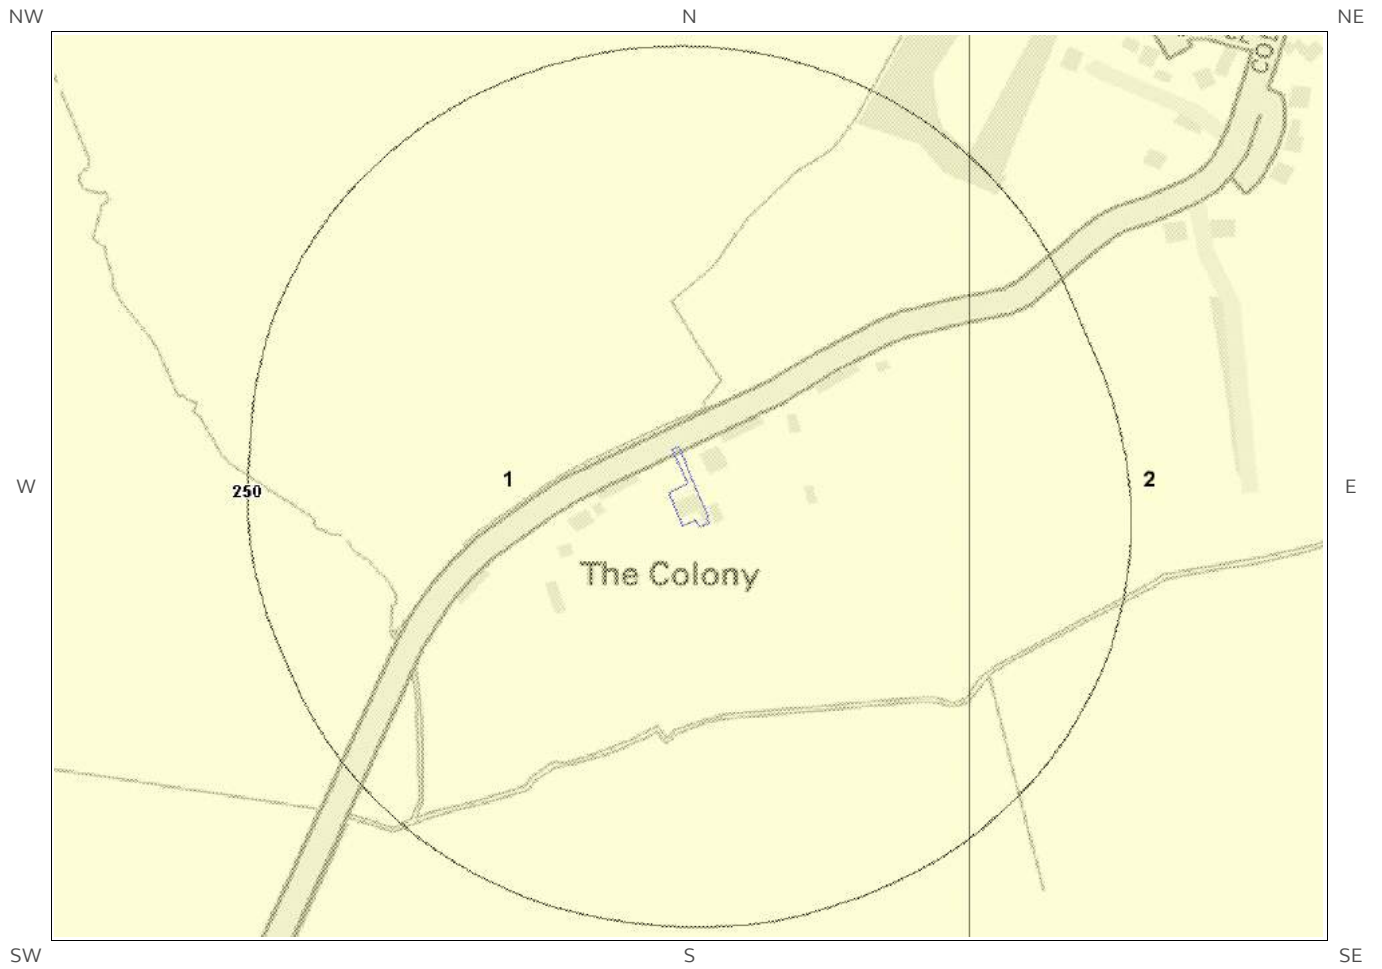
# 6.4 Compressible Deposits map

ID	Distance (m)	Direction	Hazard Rating	Details
1	0.0	On Site	Negligible	No indicators for compressible deposits identified. No special actions required to avoid problems due to compressible deposits. No special ground investigation required, and increased construction costs or increased financial risks are unlikely due to potential problems with compressible deposits.

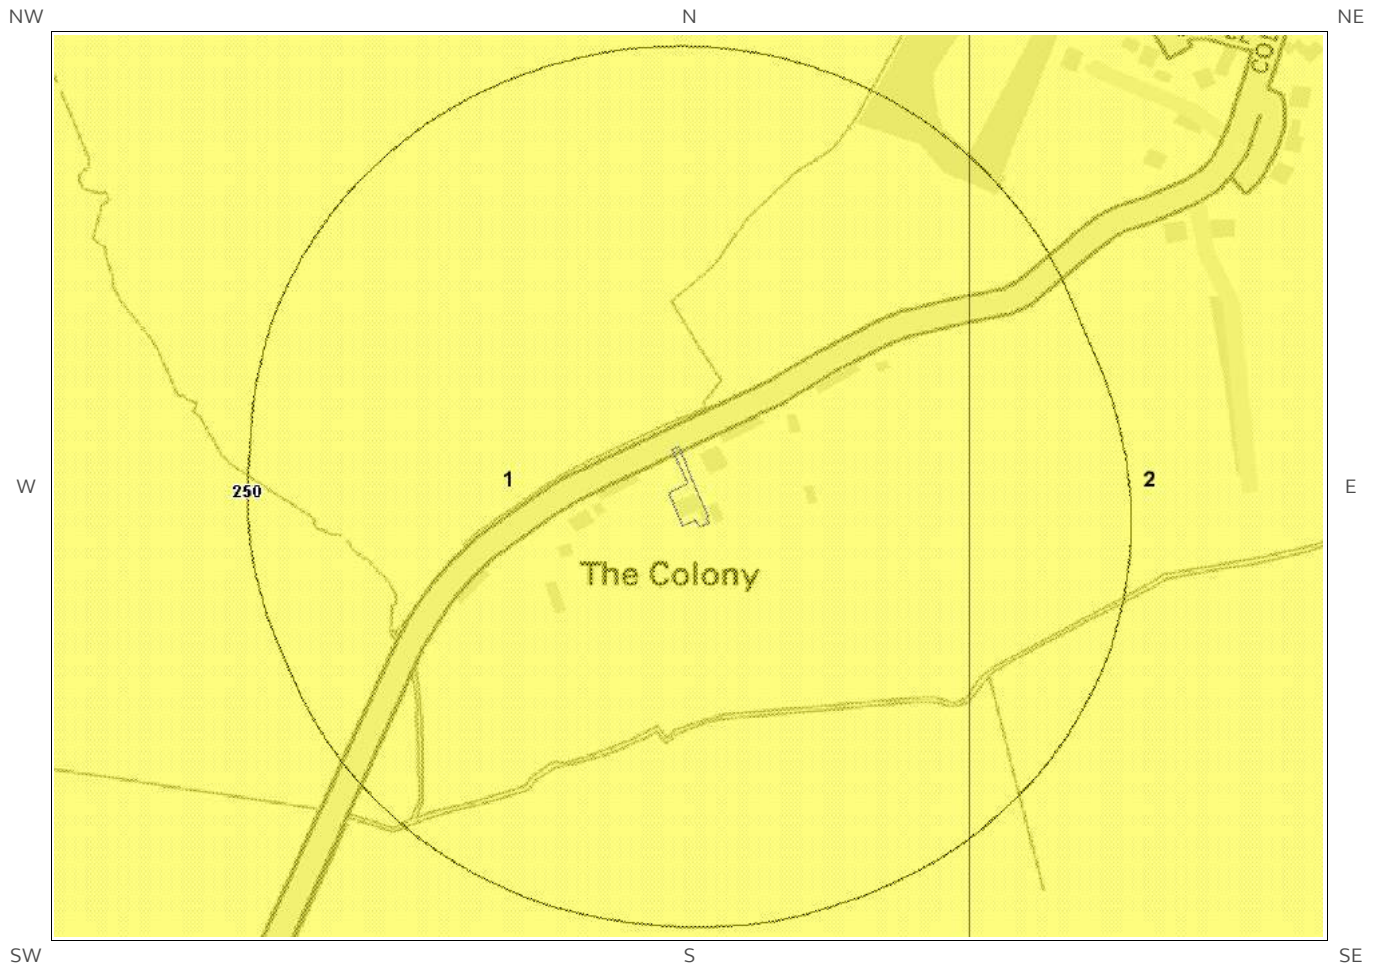
# 6.5 Collapsible Deposits map

ID	Distance (m)	Direction	Hazard Rating	Details
1	0.0	On Site	Very Low	Deposits with potential to collapse when loaded and saturated are unlikely to be present. No special ground investigation required or increased construction costs or increased financial risk due to potential problems with collapsible deposits.

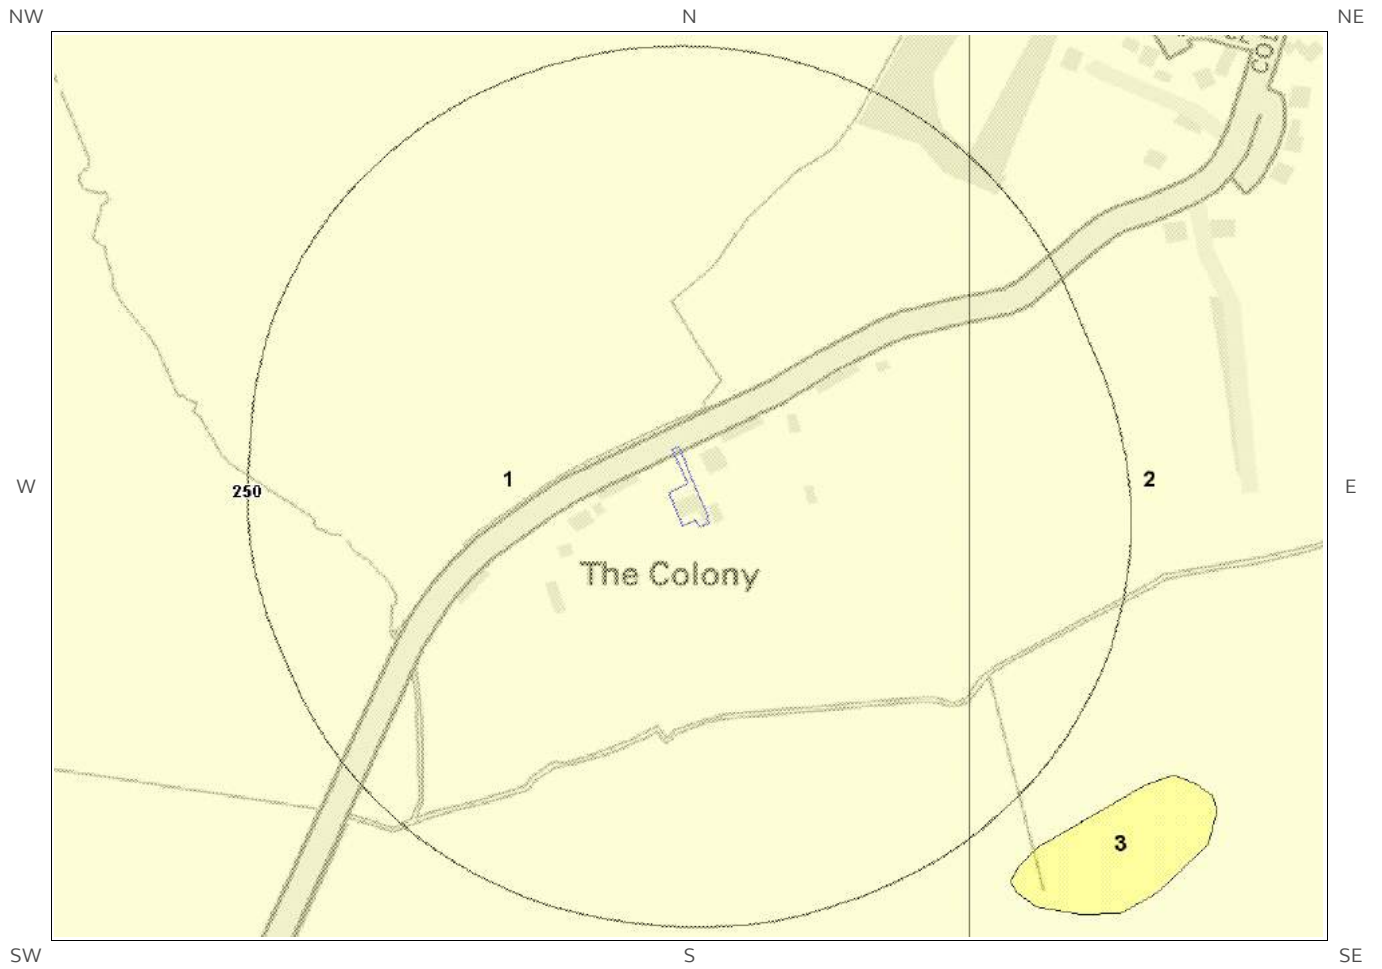
# 6.6 Running Sand map

ID	Distance (m)	Direction	Hazard Rating	Details
1	0.0	On Site	Negligible	No indicators for running sand identified. No special actions required to avoid problems due to running sand. No special ground investigation required, and increased construction costs or increased financial risks are unlikely due to potential problems with running sand.
