**Upper Heyford
New Settlement Area
Development for Residential-led Uses
(Planning Consent 10/01642/OUT)**

REMEDIATION STRATEGY

R1742-R01-v3

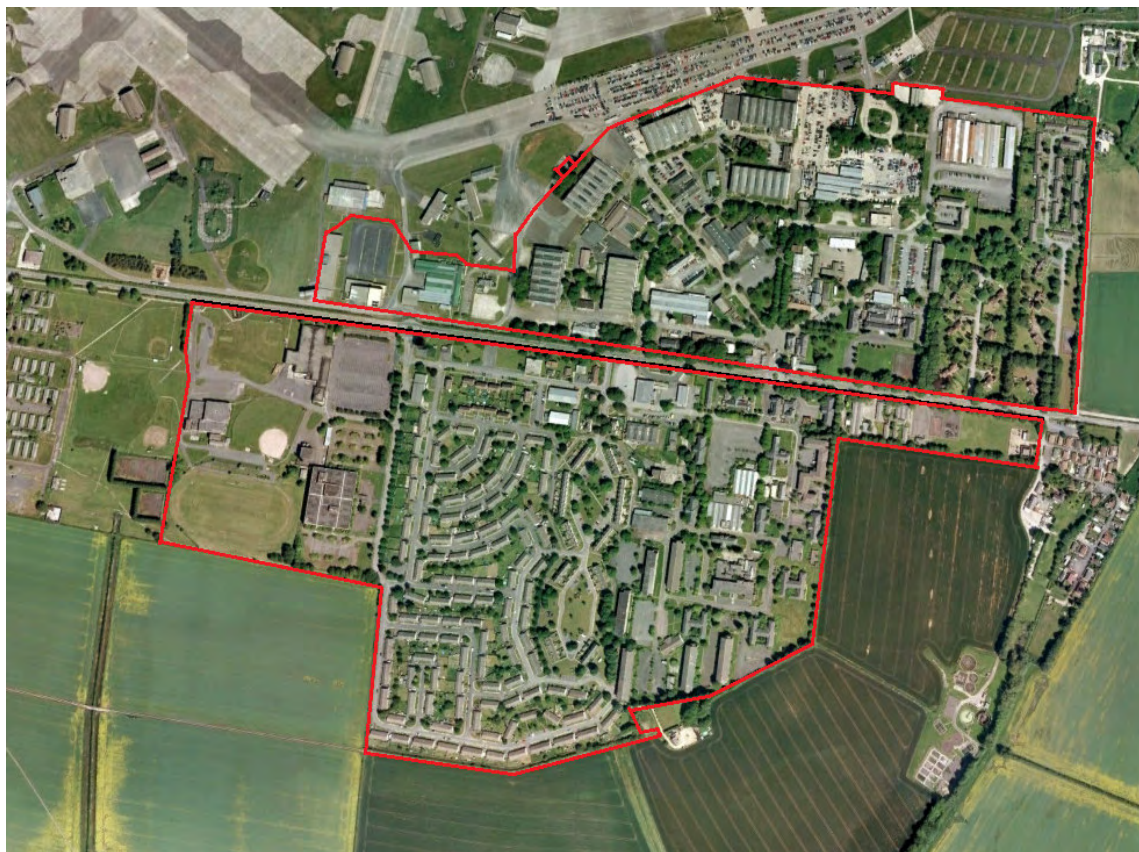
Figure 3.2. Recent Aerial Photograph

3.4.1. The aerial photograph below shows the recent land condition, including a mix of occupied and disused buildings and landscaping / open space.

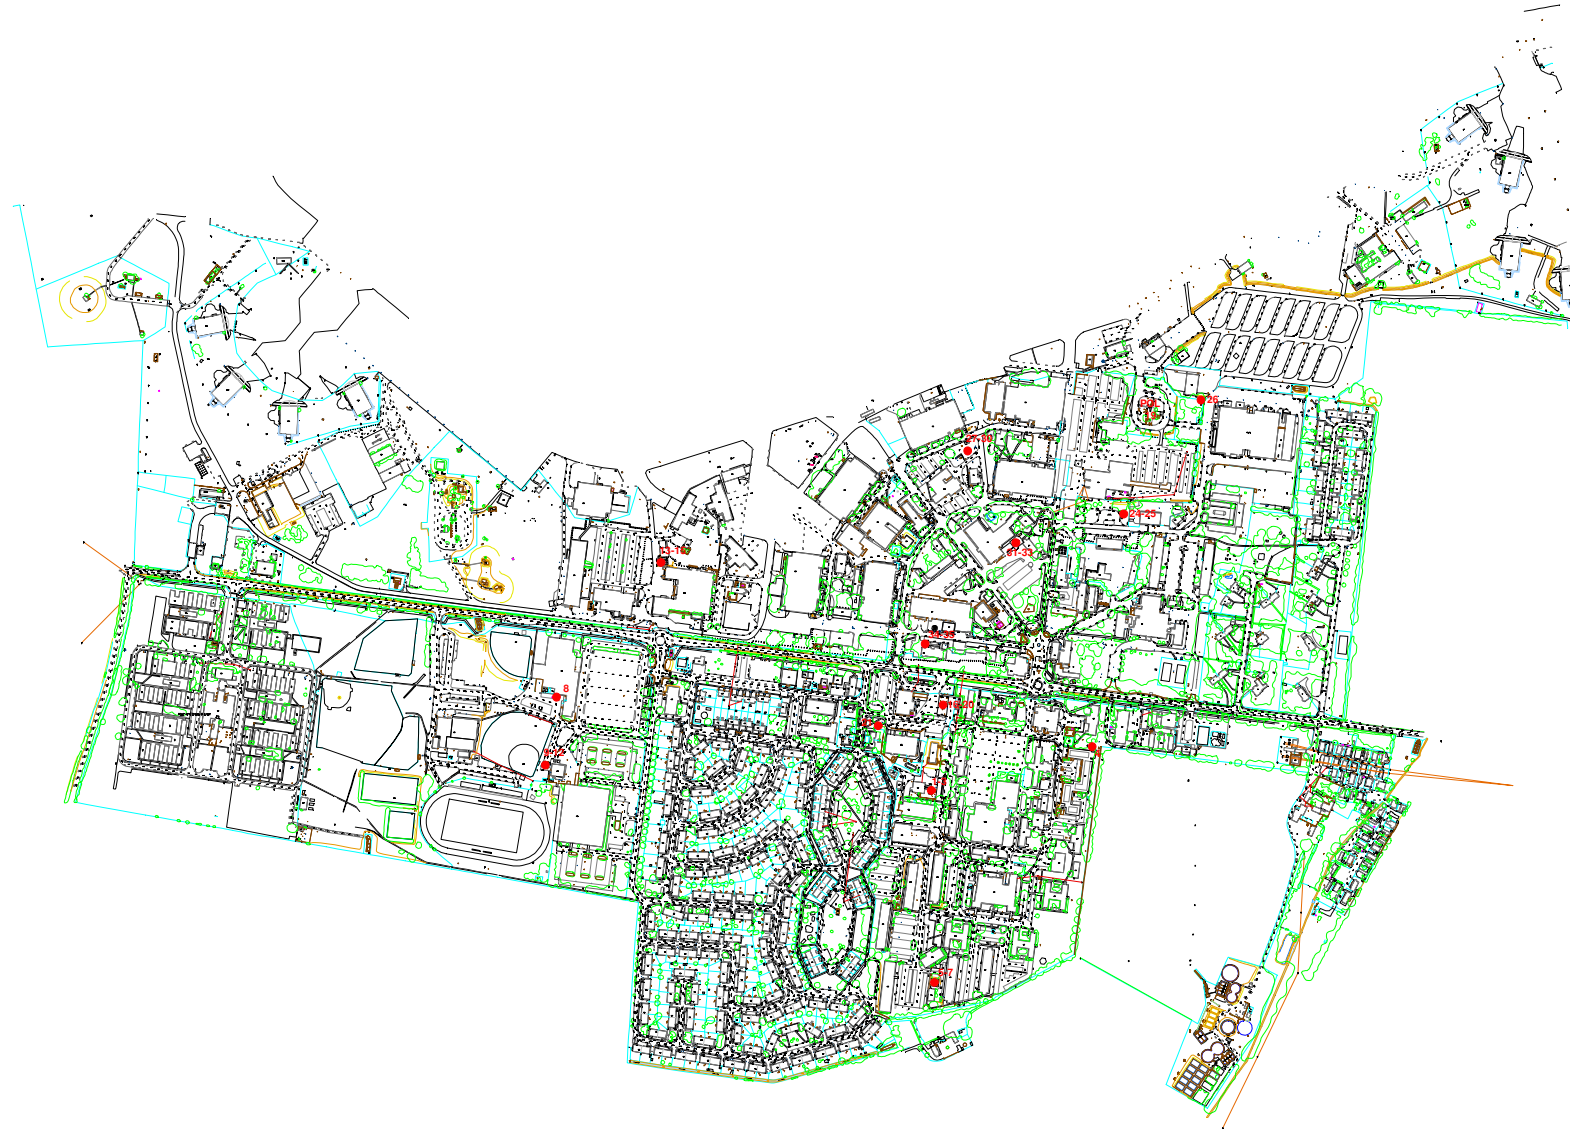
D01

- 1.5. The site boundary and layout is shown on drawing D01.
- 1.6. Conditions of the planning permission relevant to contamination remediation are worded as follows:

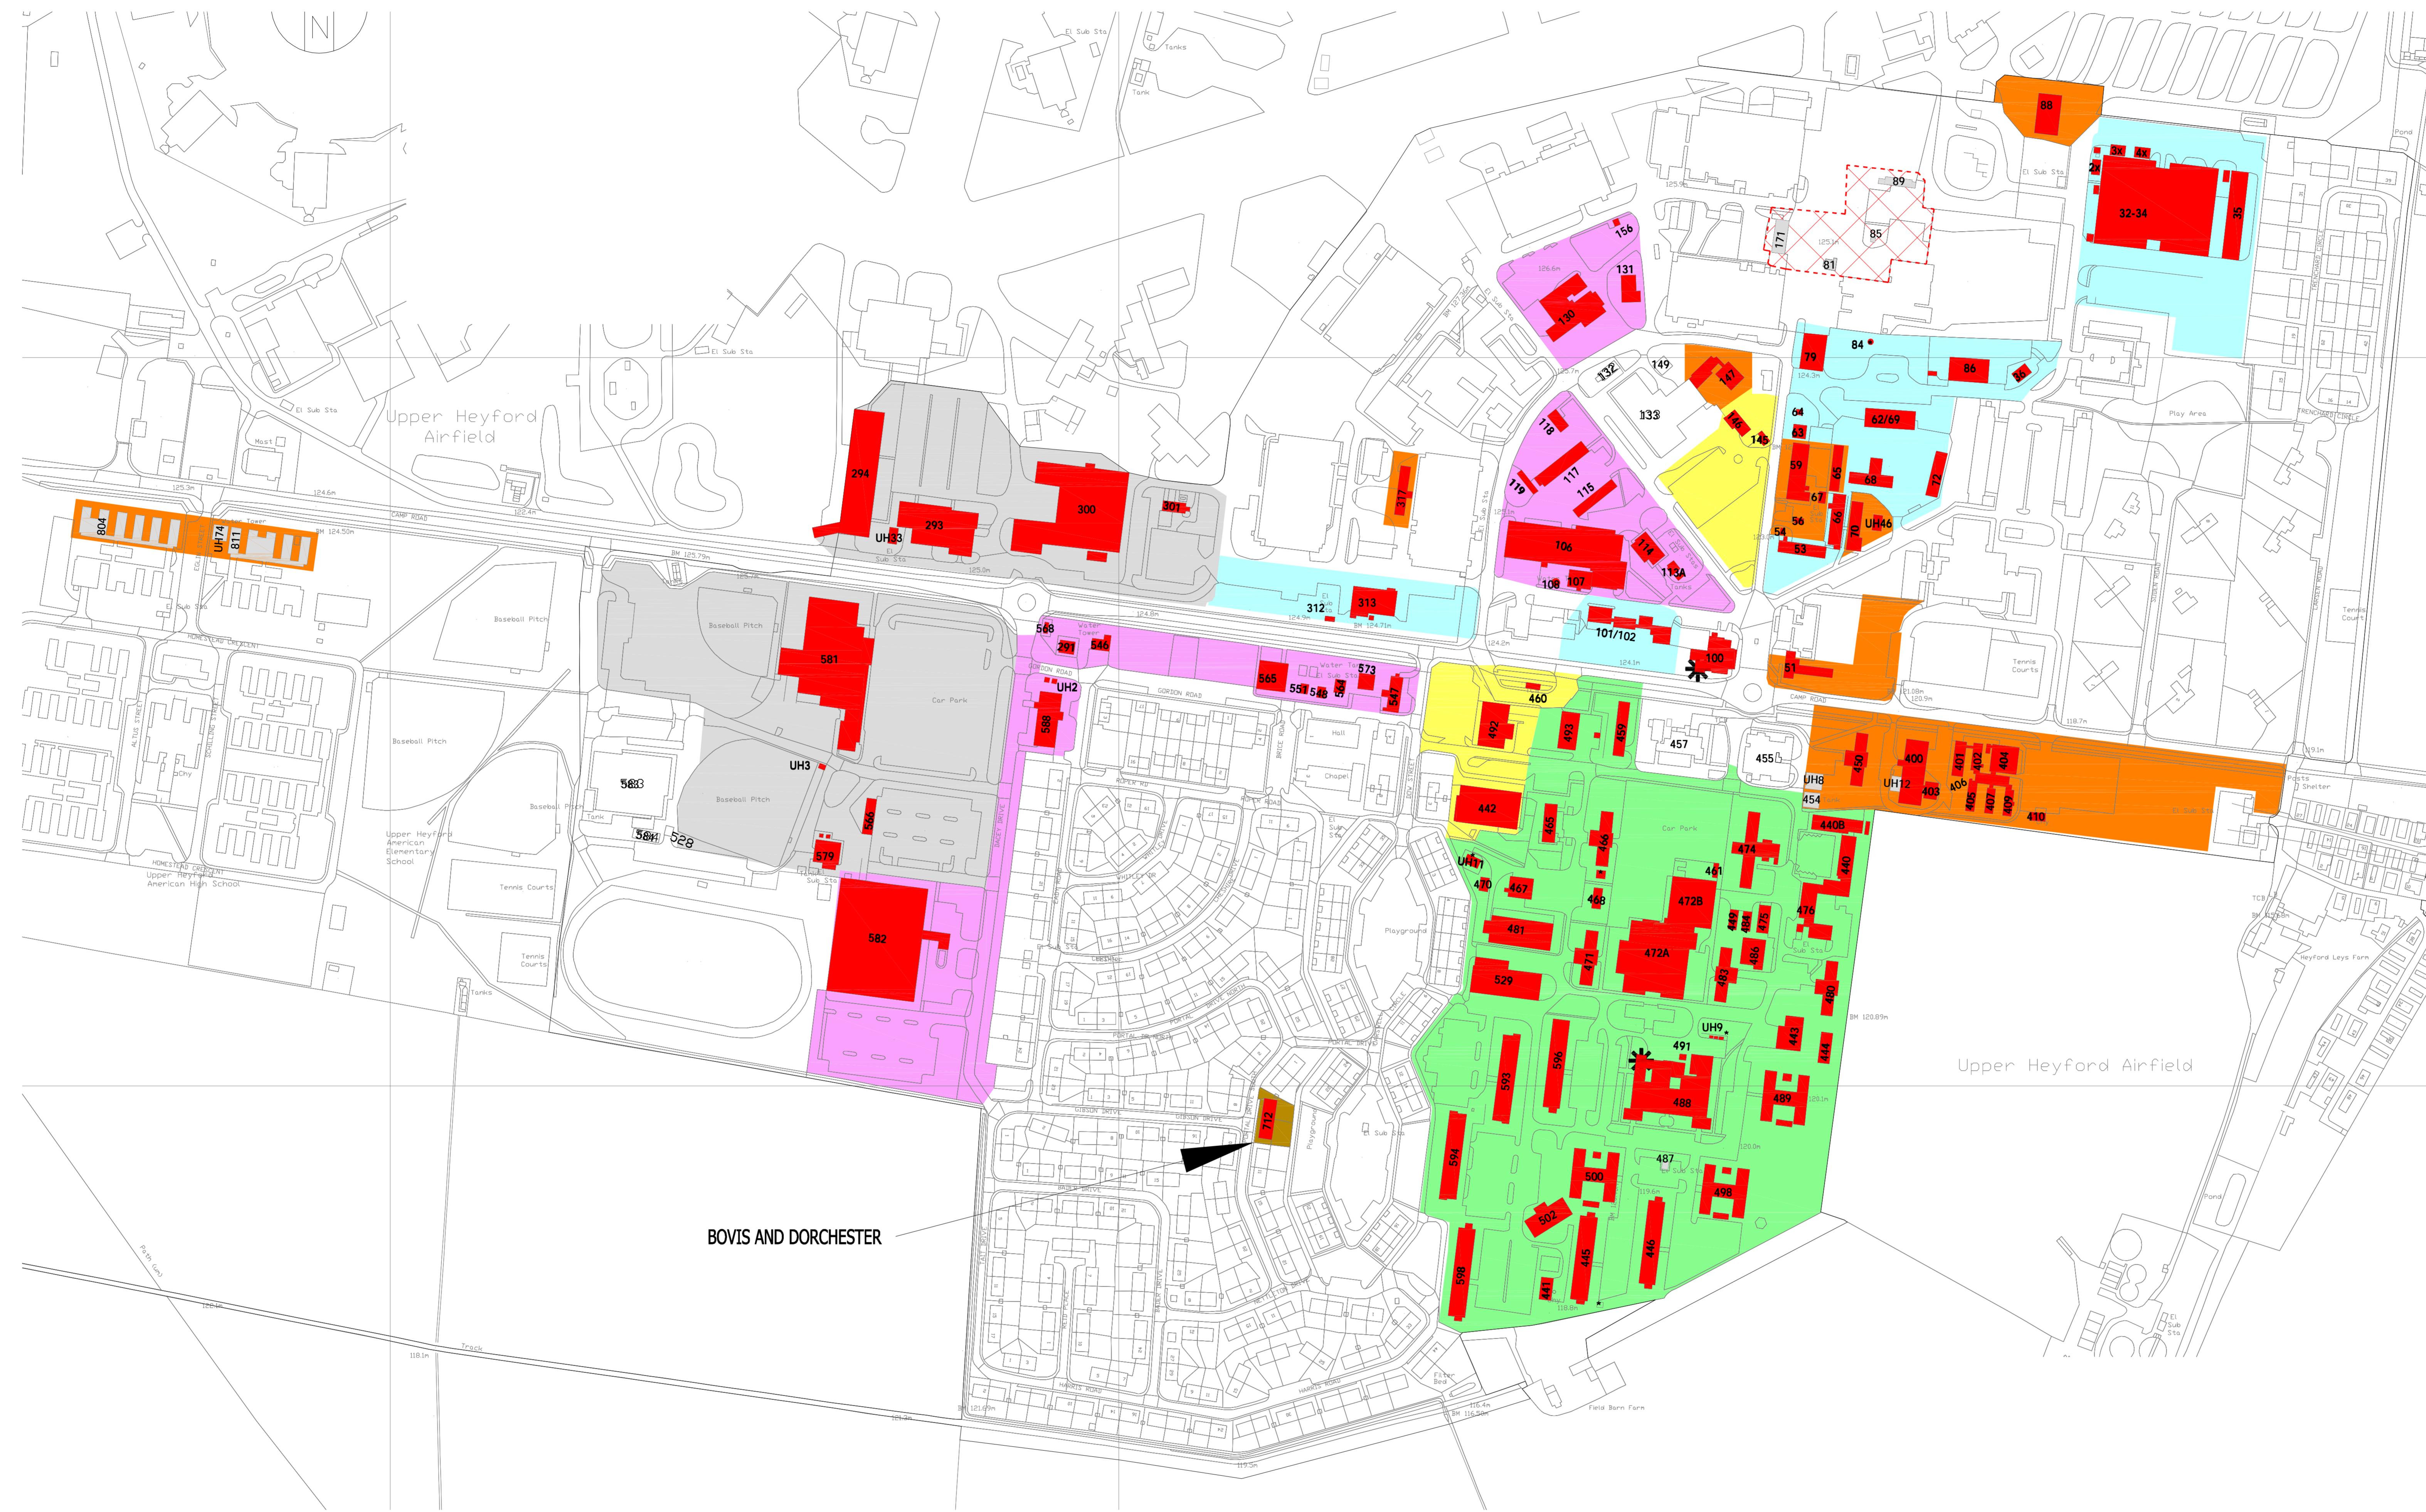
UPPER HEYFORD - DEMOLITION PHASING PLAN

Current Phasing Plan (December 2013)
